*Massachusetts Coastal Infrastructure  
Inventory and Assessment Project*  
*Massachusetts Department of Conservation and Recreation*  
*Office of Waterways*

## Middle Cape Cod

Barnstable  
Yarmouth  
Dennis

**MASSACHUSETTS COASTAL INFRASTRUCTURE INVENTORY AND ASSESSMENT PROJECT**

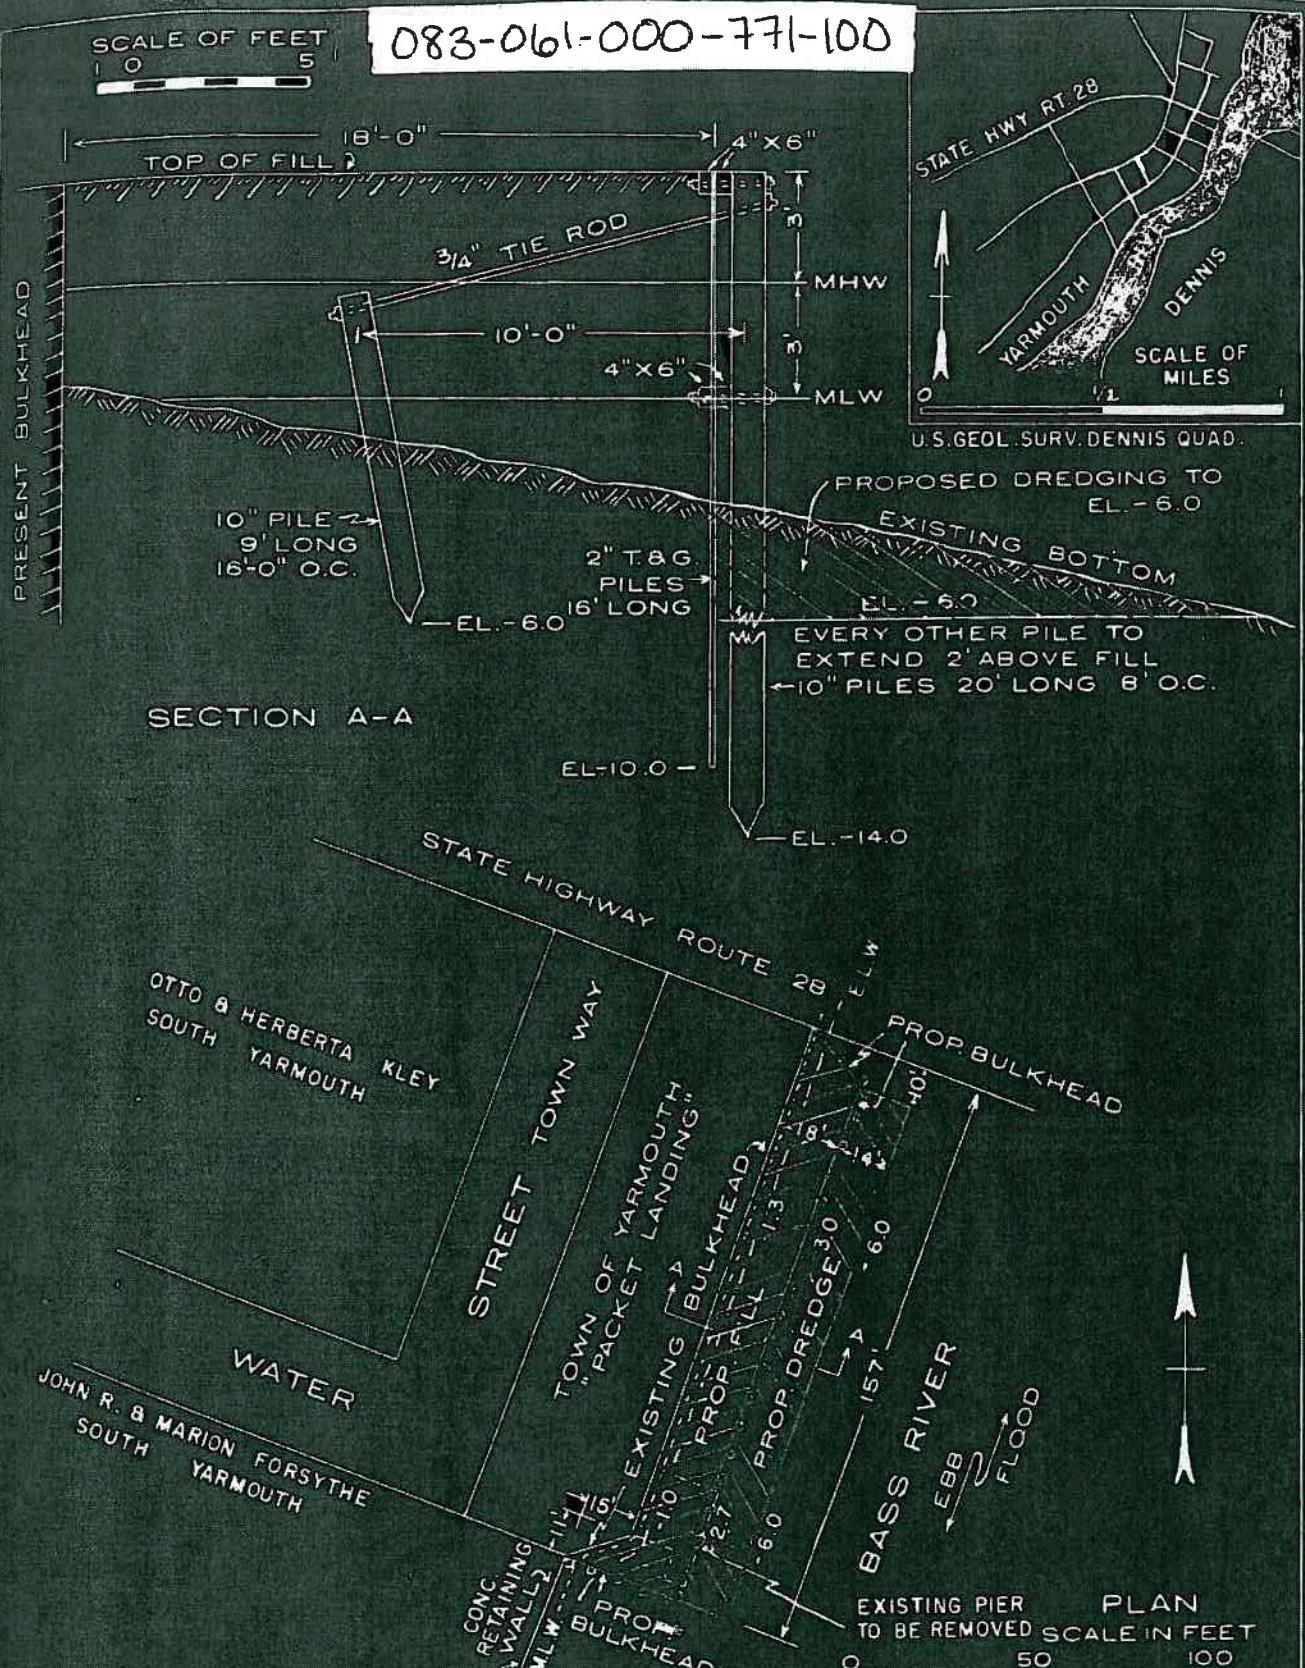
NO. 3741  
APPROVED BY DEPARTMENT OF PUBLIC WORKS  
MAY 16, 1955

PLAN ACCOMPANYING PETITION OF  
TOWN OF YARMOUTH  
TO BUILD A TIMBER BULKHEAD, BACKFILL  
AND DREDGE IN  
BASS RIVER  
YARMOUTH

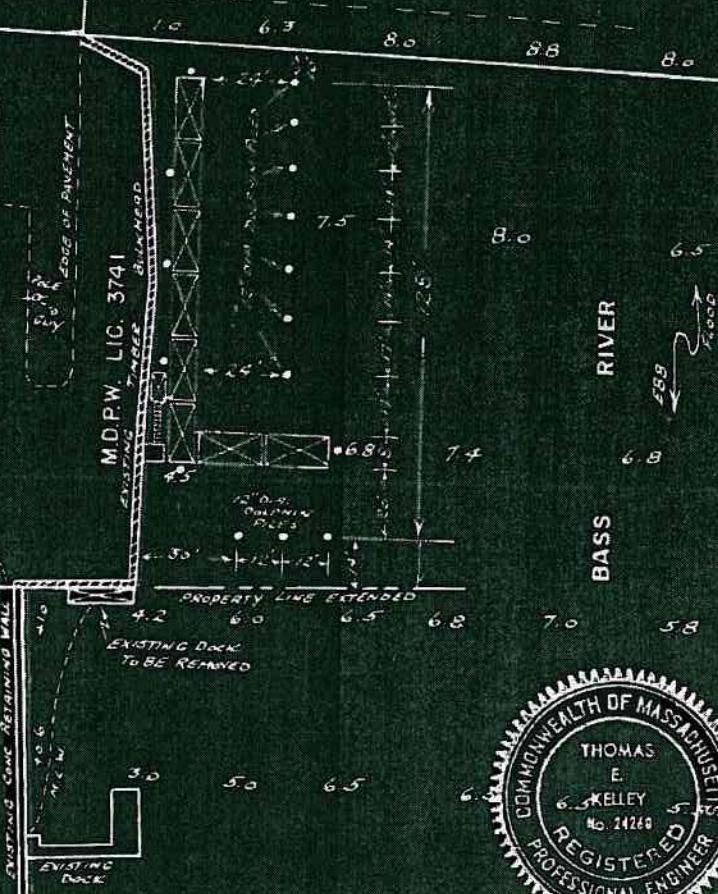
PLAN ACCOMPANYING PETITION OF  
THE TOWN OF YARMOUTH  
TO BUILD AND MAINTAIN A TIMBER PIER,  
TO PLACE FIXED PILES, TO PLACE A FLOATING  
PIER AND TO MAINTAIN EXISTING TIMBER BULKHEAD

IN BASS RIVER  
AT SOUTH YARMOUTH  
TOWN OF YARMOUTH  
MASSACHUSETTS

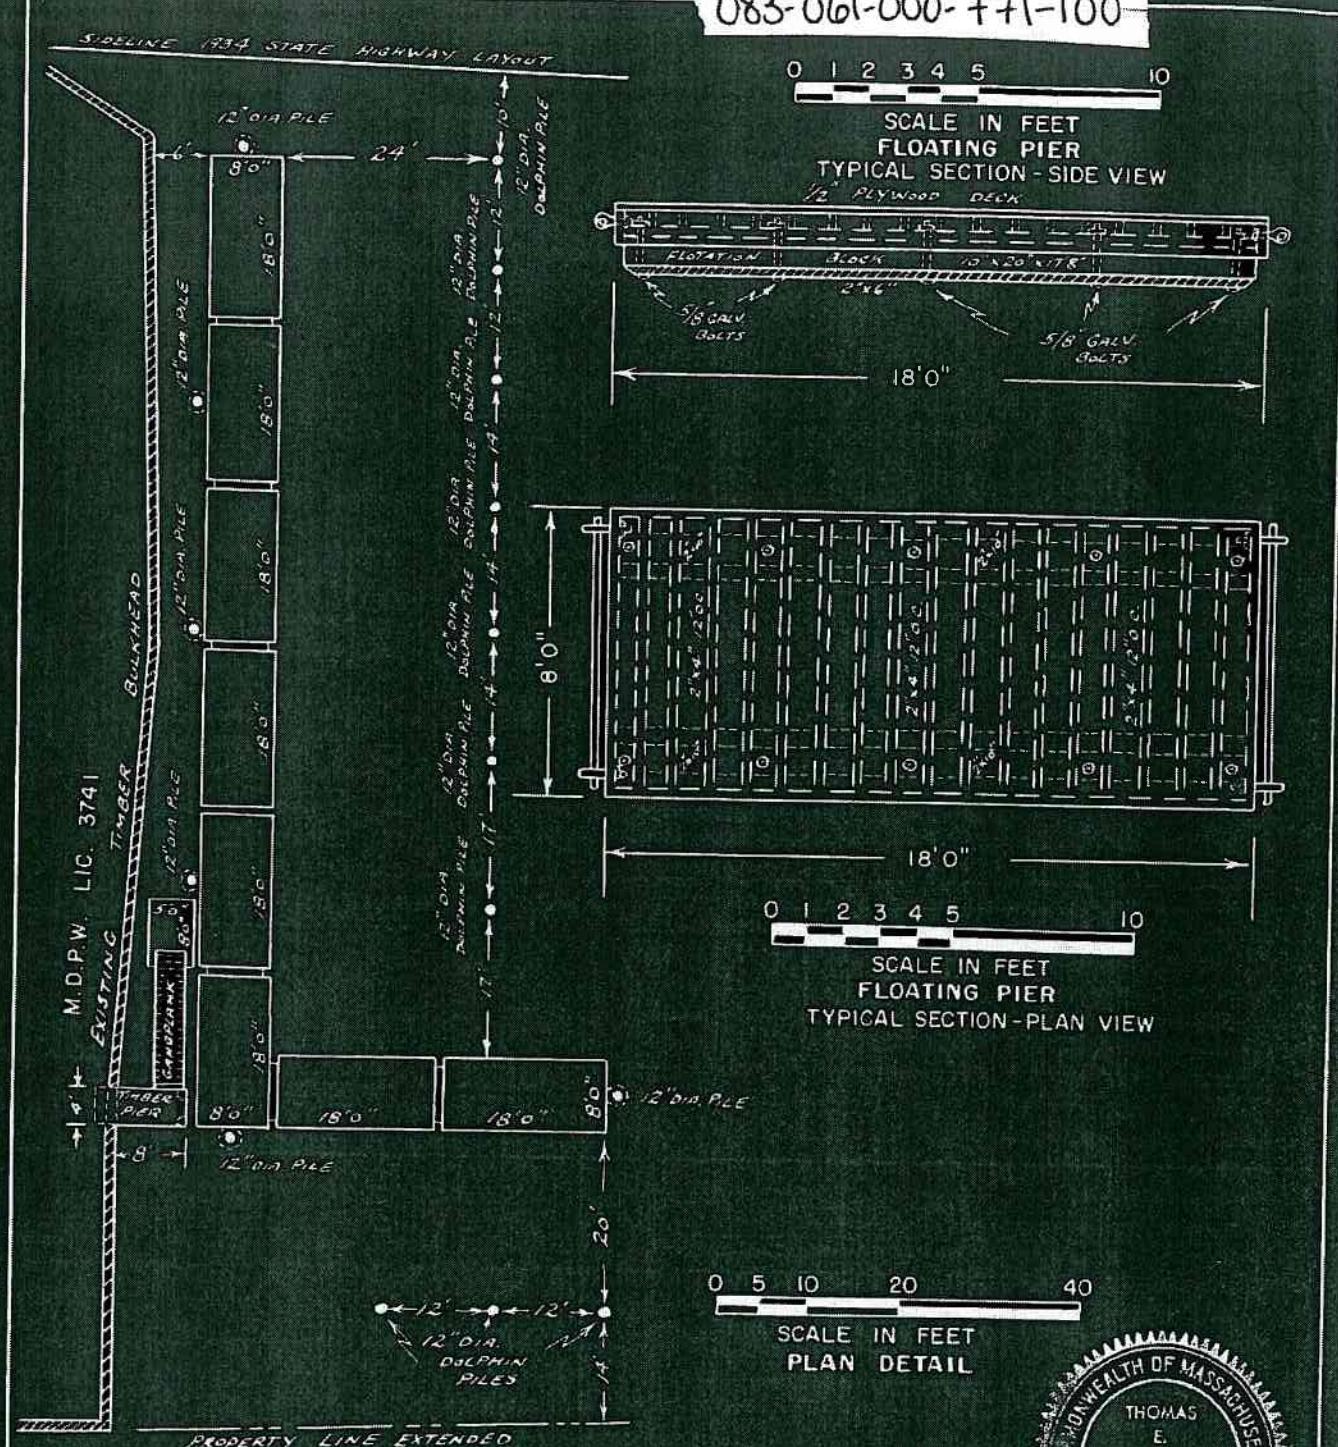
HEET 2 OF 2

**PLAN ACCOMPANYING PETITION OF  
THE TOWN OF YARMOUTH  
TO BUILD AND MAINTAIN A TIMBER PIER,  
TO PLACE FIXED PILES, TO PLACE A FLOATING  
PIER AND TO MAINTAIN EXISTING TIMBER BULKHEAD  
IN BASS RIVER  
AT SOUTH YARMOUTH  
TOWN OF YARMOUTH  
MASSACHUSETTS**

SCALE AS SHOWN MASSACHUSETTS FEBRUARY 1972

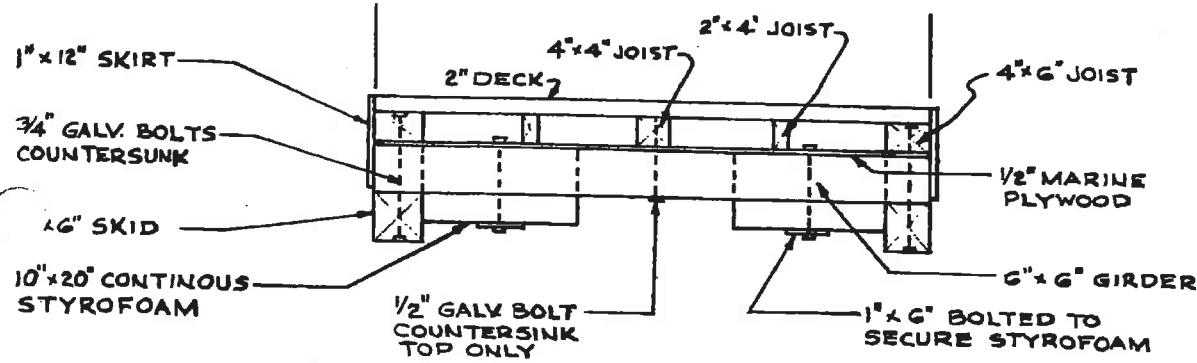
**TYPICAL FLOAT SECTION 6'-0" WIDE**  
SCALE:  $1/2" = 1'-0"$

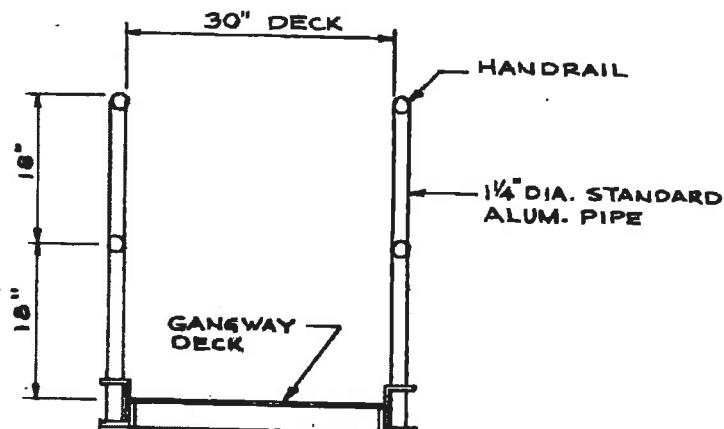
**30" x 16'-0" ALUMINUM GANGWAY DETAIL**  
NO SCALE

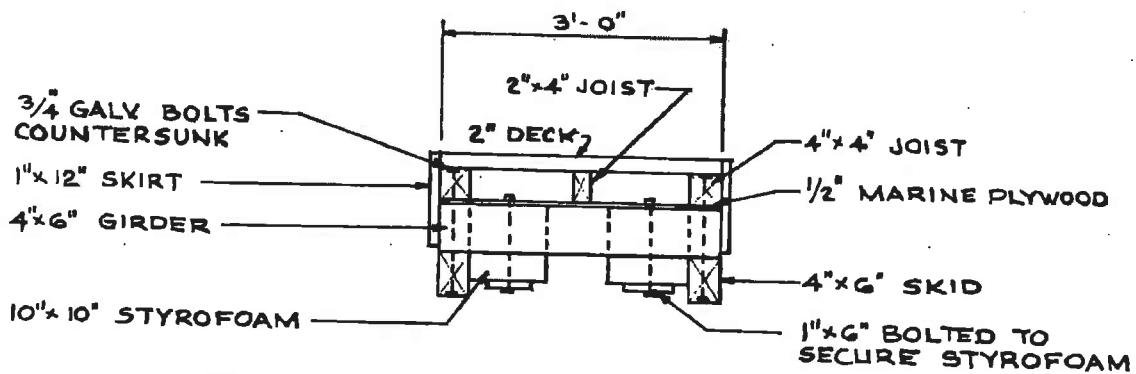
**TYPICAL FLOAT SECTION 3'-0" WIDE**  
SCALE:  $1/2" = 1'-0"$

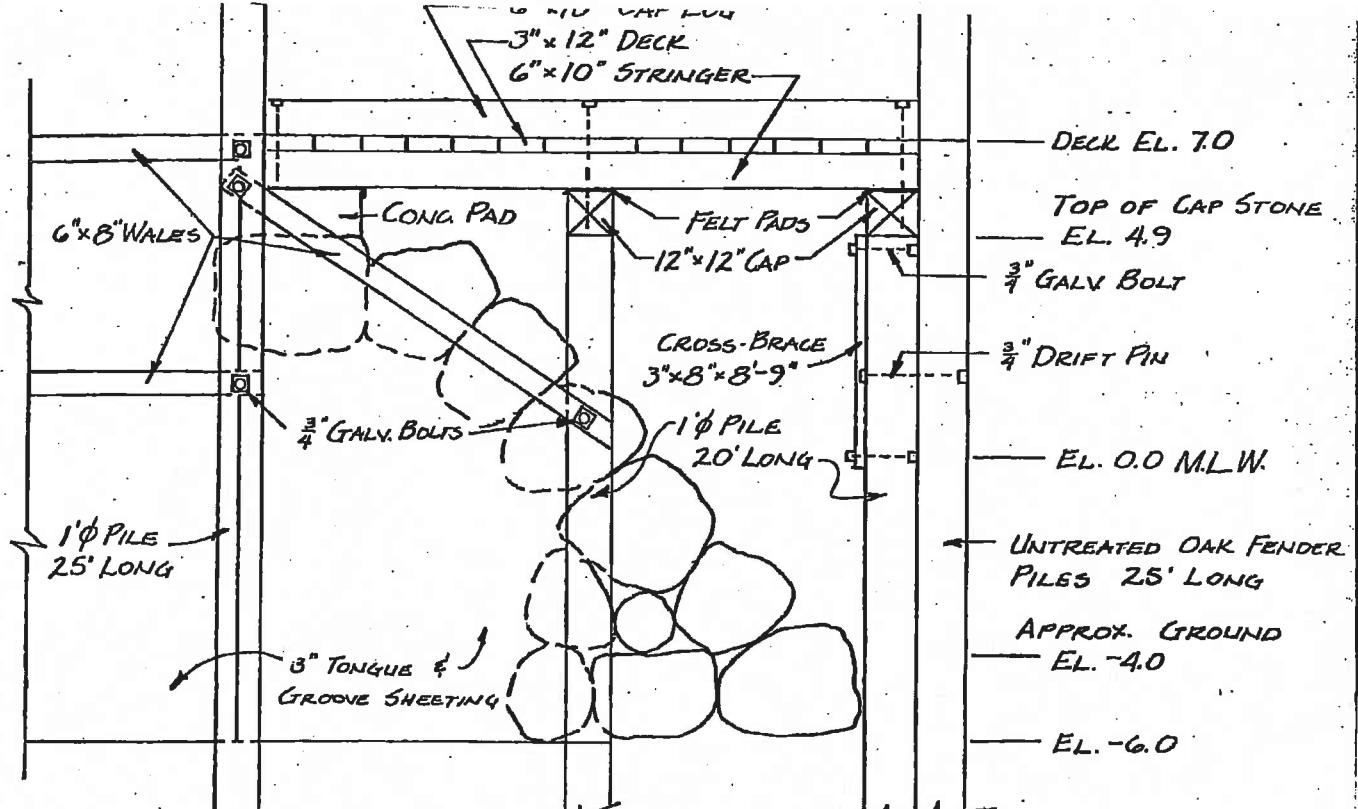
PROFILE OF BULKHEAD & WHARF

SCALE:  $\frac{1}{4}$ " = 1'-0"

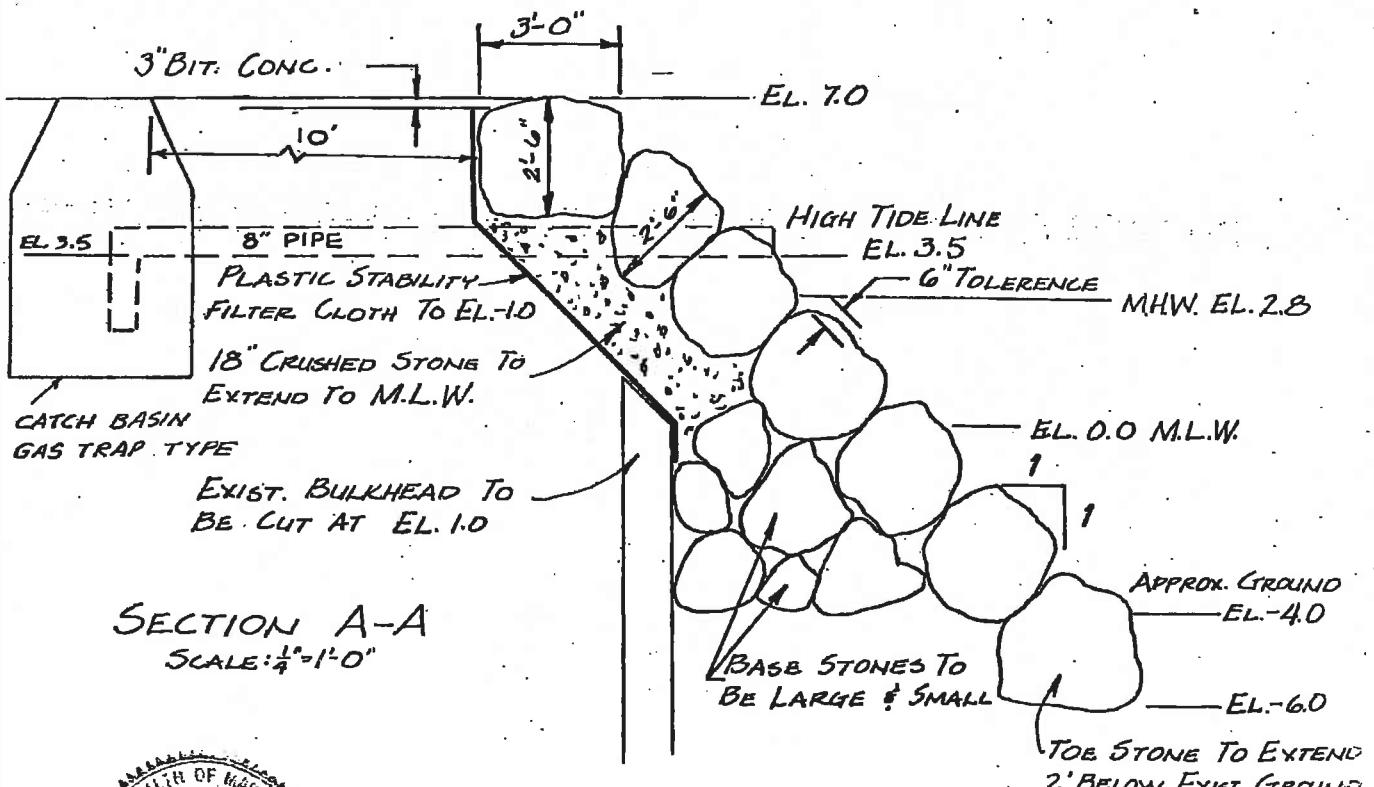
SECTION A-A

SCALE:  $\frac{1}{4}$ " = 1'-0"

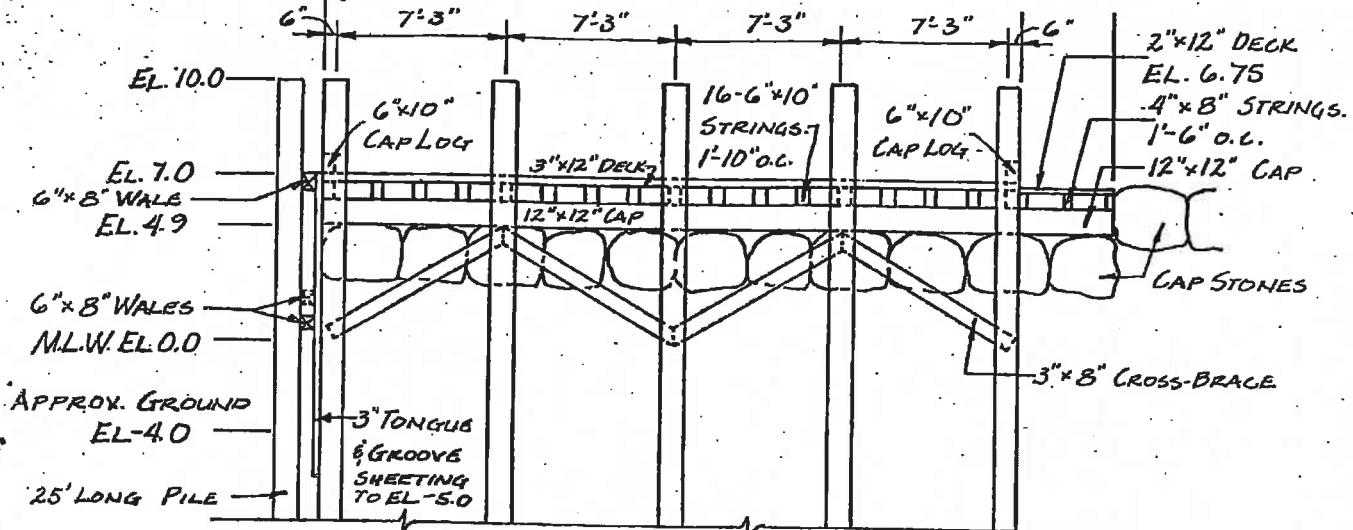
5 UNTREATED OAK FENDER PILES 7'-3" O.C. 25' LONG

WHARF ELEVATION SCALE:  $\frac{1}{8}$ " = 1'-0"

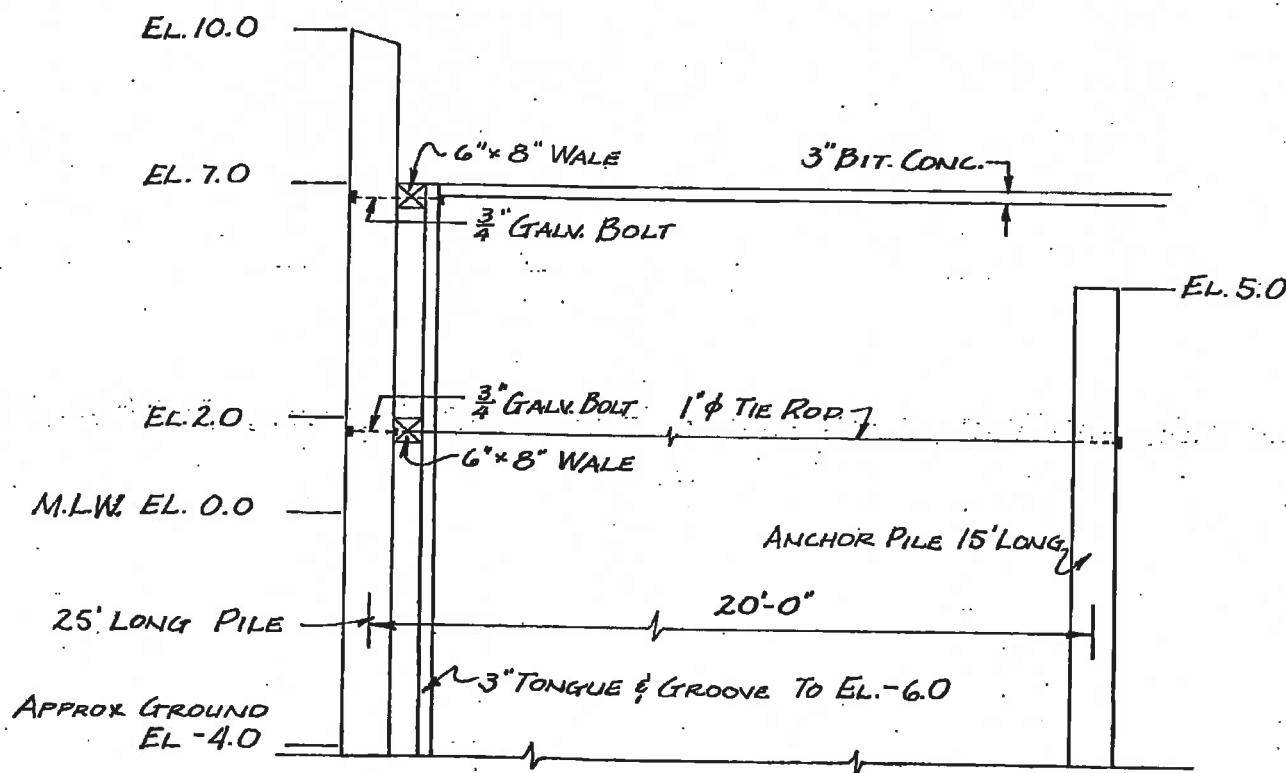
DETAIL OF BULKHEAD SCALE:  $\frac{1}{4}$ " = 1'-0"

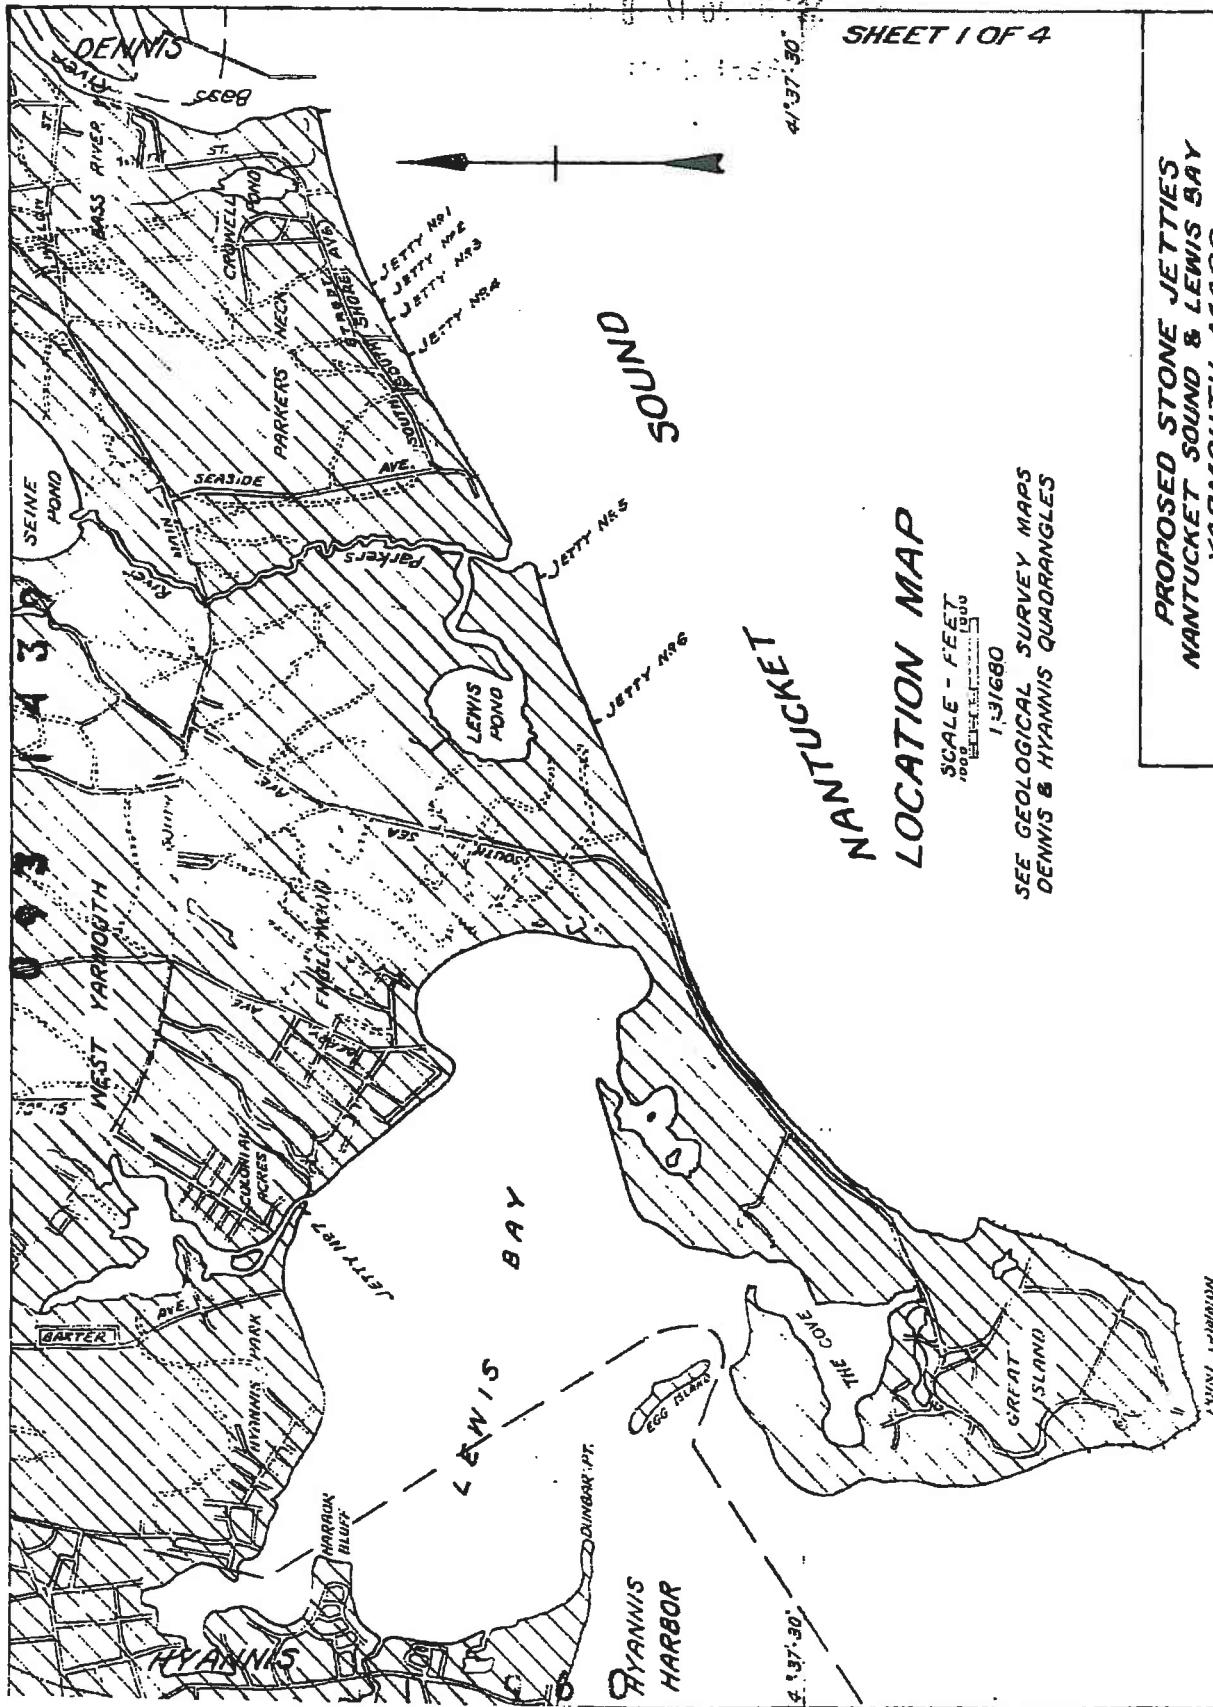
SHEET 1 OF 4

PROPOSED STONE JETTIES  
NANTUCKET SOUND & LEWIS BAY  
YARMOUTH - MASS.  
APPLICATION BY  
DEPARTMENT OF PUBLIC WORKS OF MASSACHUSETTS  
DIVISION OF WATERWAYS  
OCTOBER 1951  
C. H. H. [Signature]  
DISTRICT WATERWAYS ENGINEER  
NO. 2870-A

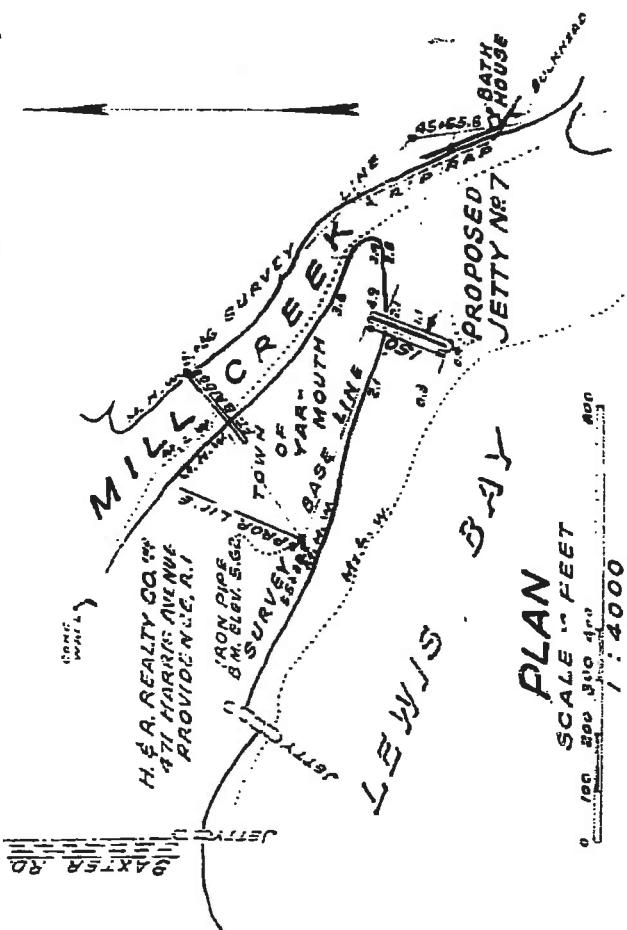
PROPOSED PROFILE  
SCALE IN FEET  
1:4000

JETTY N°7

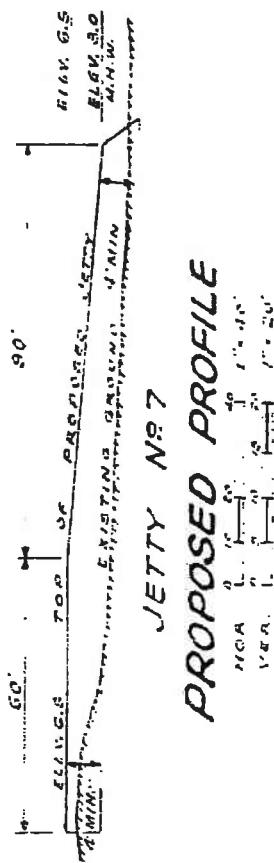
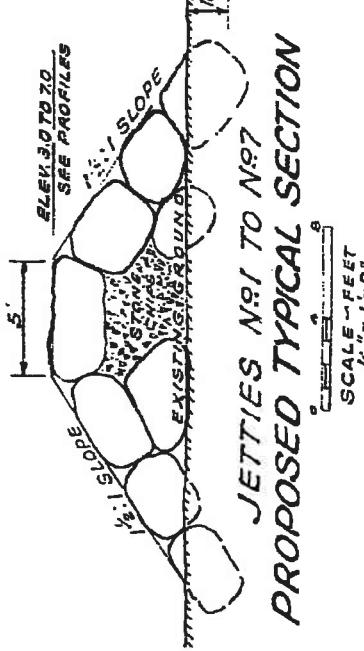
JETTIES N°1 TO N°7  
PROPOSED TYPICAL SECTION

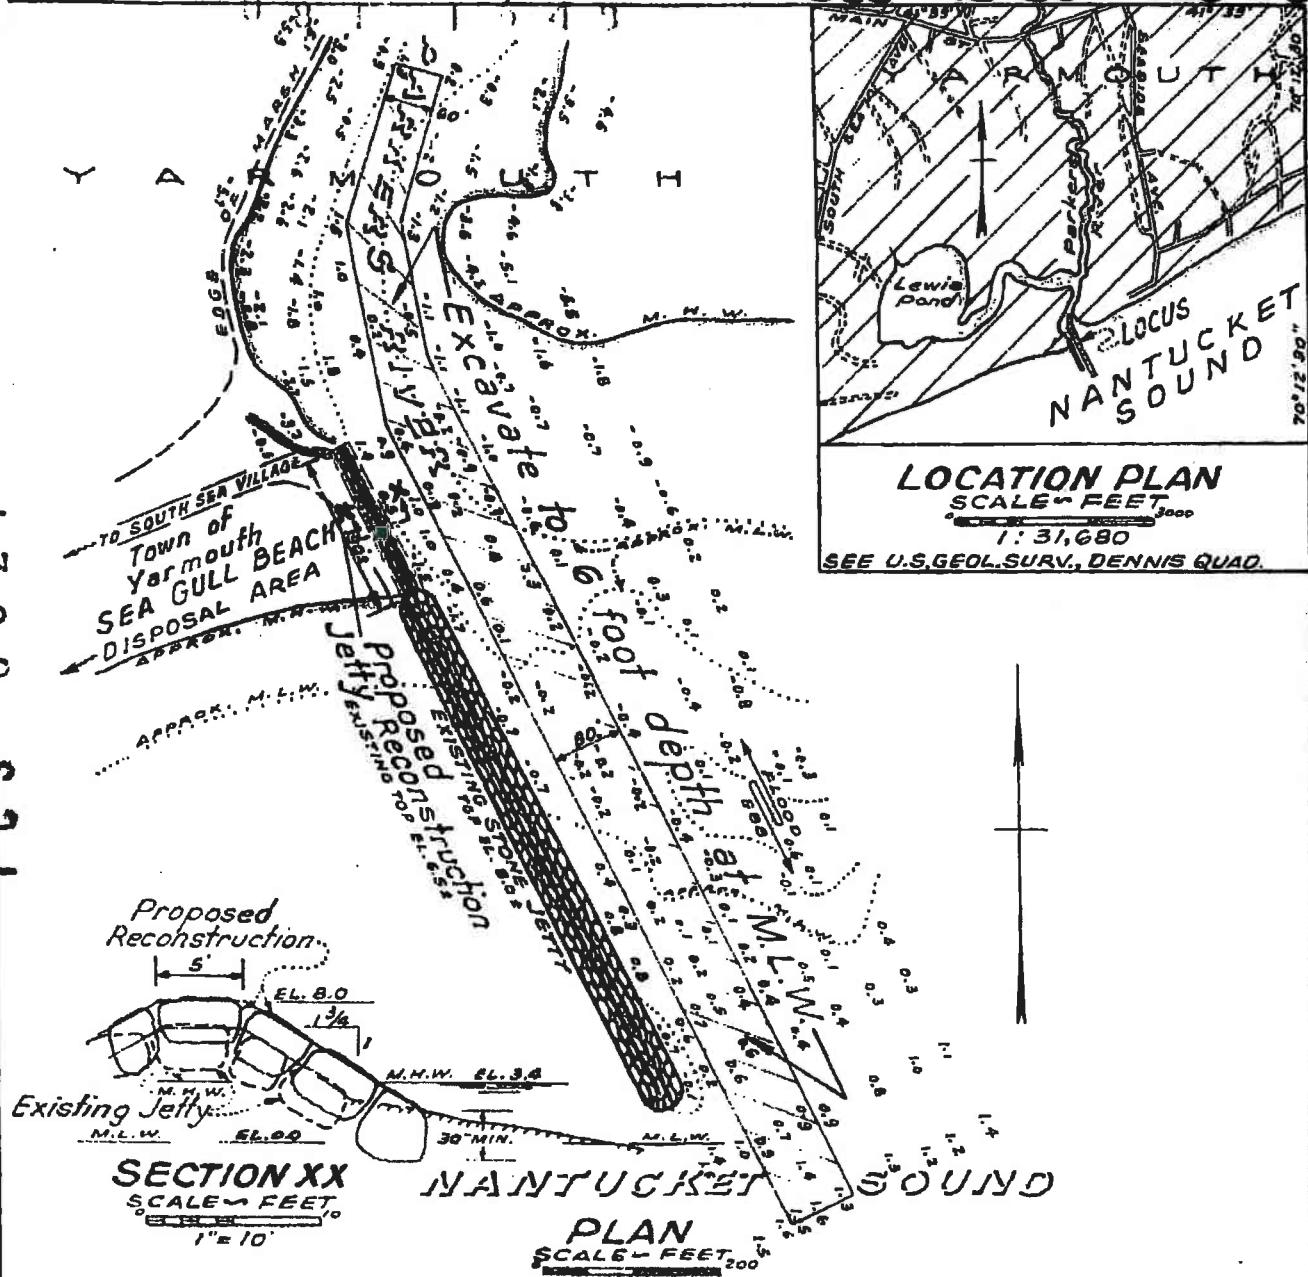
083-015-000-023-100

SOUNDINGS ARE IN FEET AND TENTHS  
AND REFER TO PLANE OF MEAN LOW  
WATER. MINUS FIGURES SHOW ELEV-  
ATIONS ABOVE THE SAME PLANE.  
EXCAVATED MATERIAL APPROX. 34,000 C.Y.  
TO BE DEPOSITED ON TOWN OF YARMOUTH  
BEACH AREA APPROX. 500 TO 1500 FT. WEST  
OF PROPOSED WORK. DEPOSIT SHALL ALL  
BE ABOVE M.H.W AND THE TOP ROUGHLY  
GRADED NOT EXCEEDING ELEVATION 7.  
JETTY RECONSTRUCTION AS PER THIS PLAN AND  
SECTION USING EXISTING AND NEW STONE.  
LOCATION OF PROJECT SHOWN IN RED.

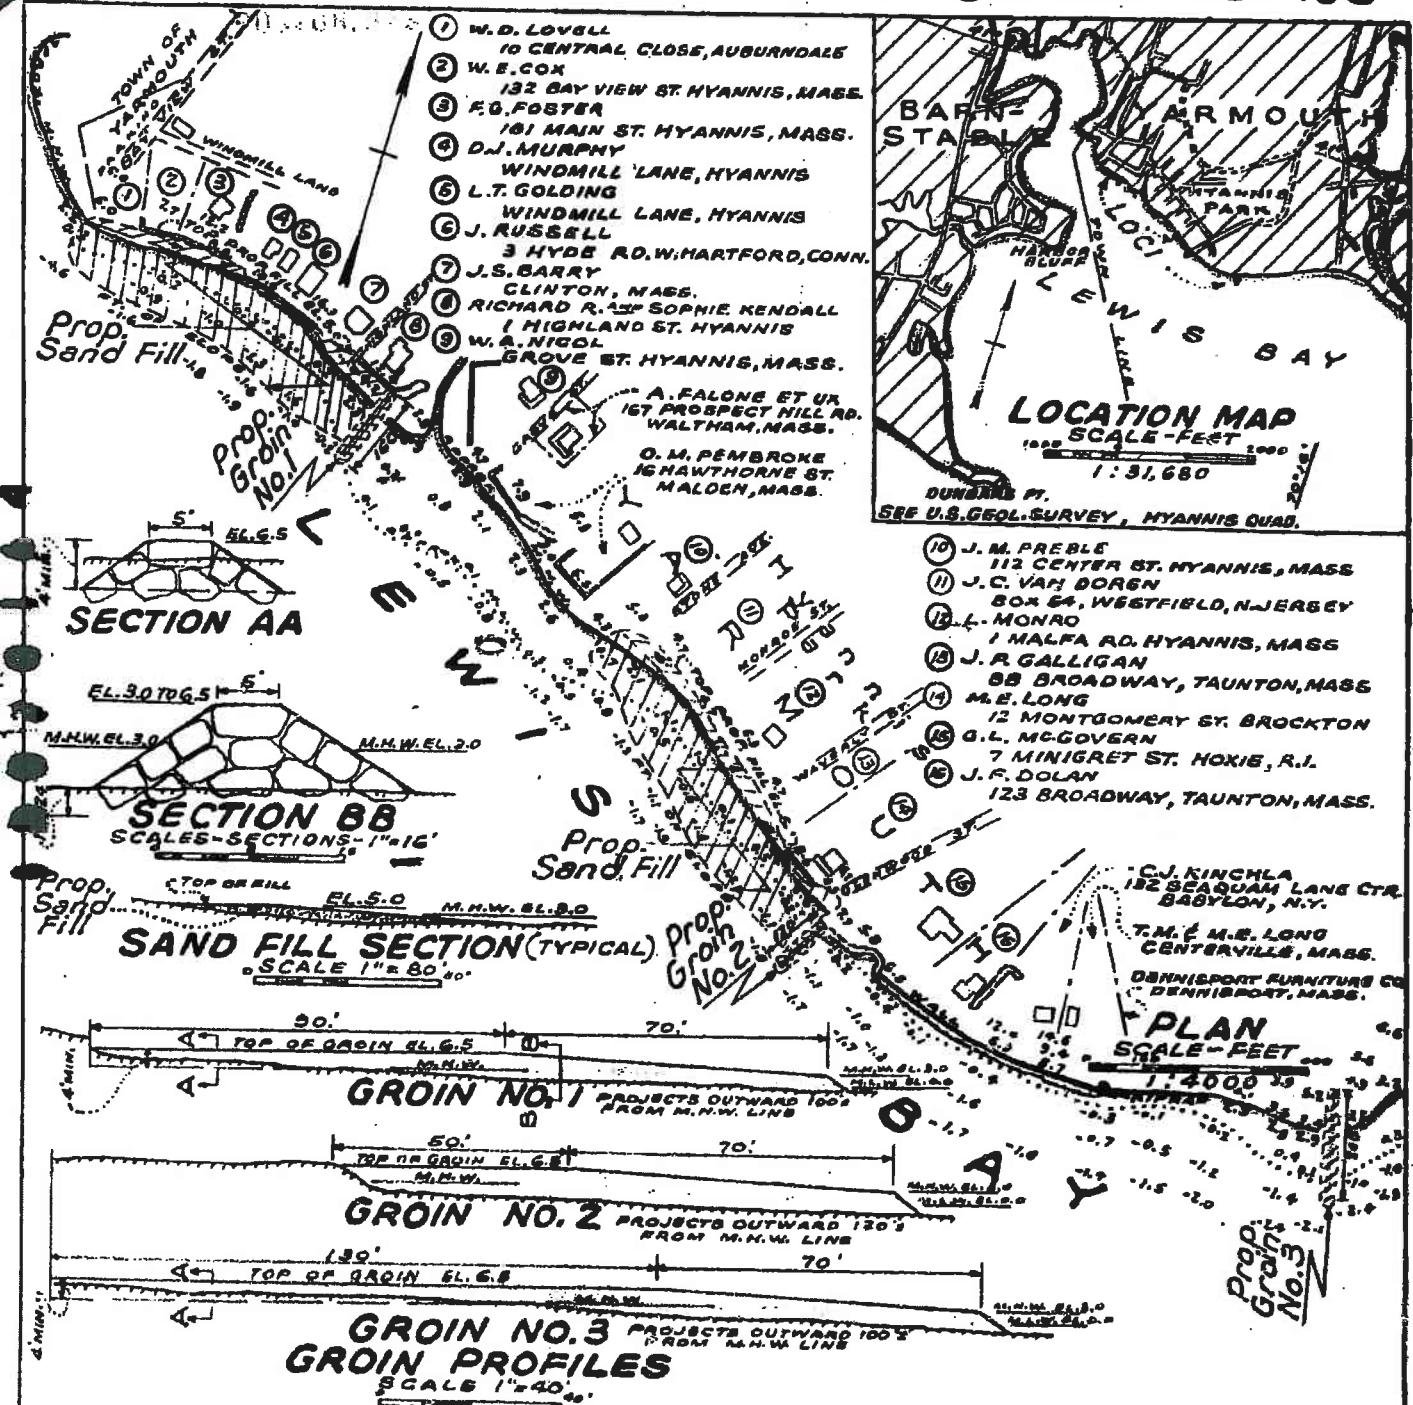
083-016-000-059-100

ELEVATIONS ARE IN FEET AND TENTHS  
ABOVE THE PLANE OF MEAN LOW WATER  
MINUS FIGURES SHOW DEPTHS BELOW  
THE SAME PLANE.  
APPROX. EXISTING GROUND SHOWN THUS:   
ALL GROIN SIDE AND END SLOPES 1.5 TO 1.  
LOCATION OF PROPOSED WORK SHOWN IN RED.

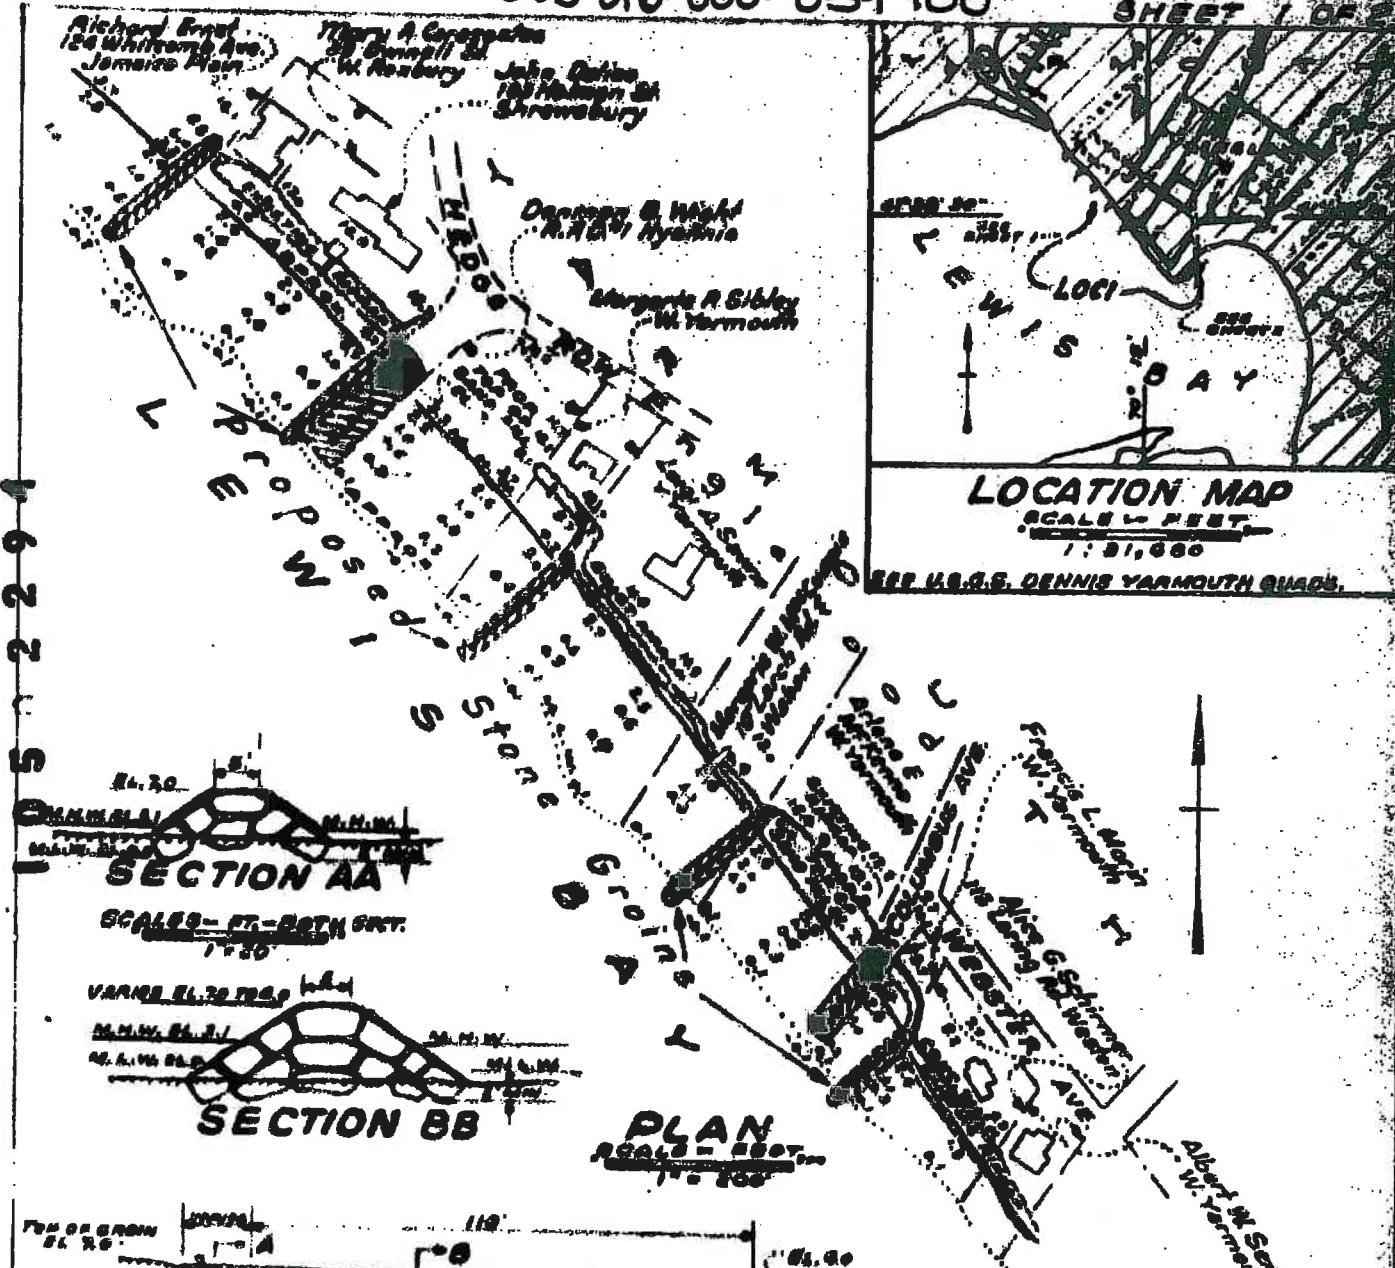
SHEET 1 OF 2

ELEVATIONS ARE IN FEET AND FRACTIONAL AND REFER TO PLANE OF MEAN LOW WATER. MINUS FIGURES SHOW DEPTHS BELOW THE BANDE PLANE. APPROX. EXISTING GROUND THUS REAR BIDE AND END SLOPES FOR GROINS ARE ALL 1.5 TO 1.0. LOCATION OF PROPOSED WORK IN RED. AVERAGE PROJECTION OF GROINS FROM M.H.W. LINE INTO TIDEWATER IS APPROXIMATELY 110 FEET.

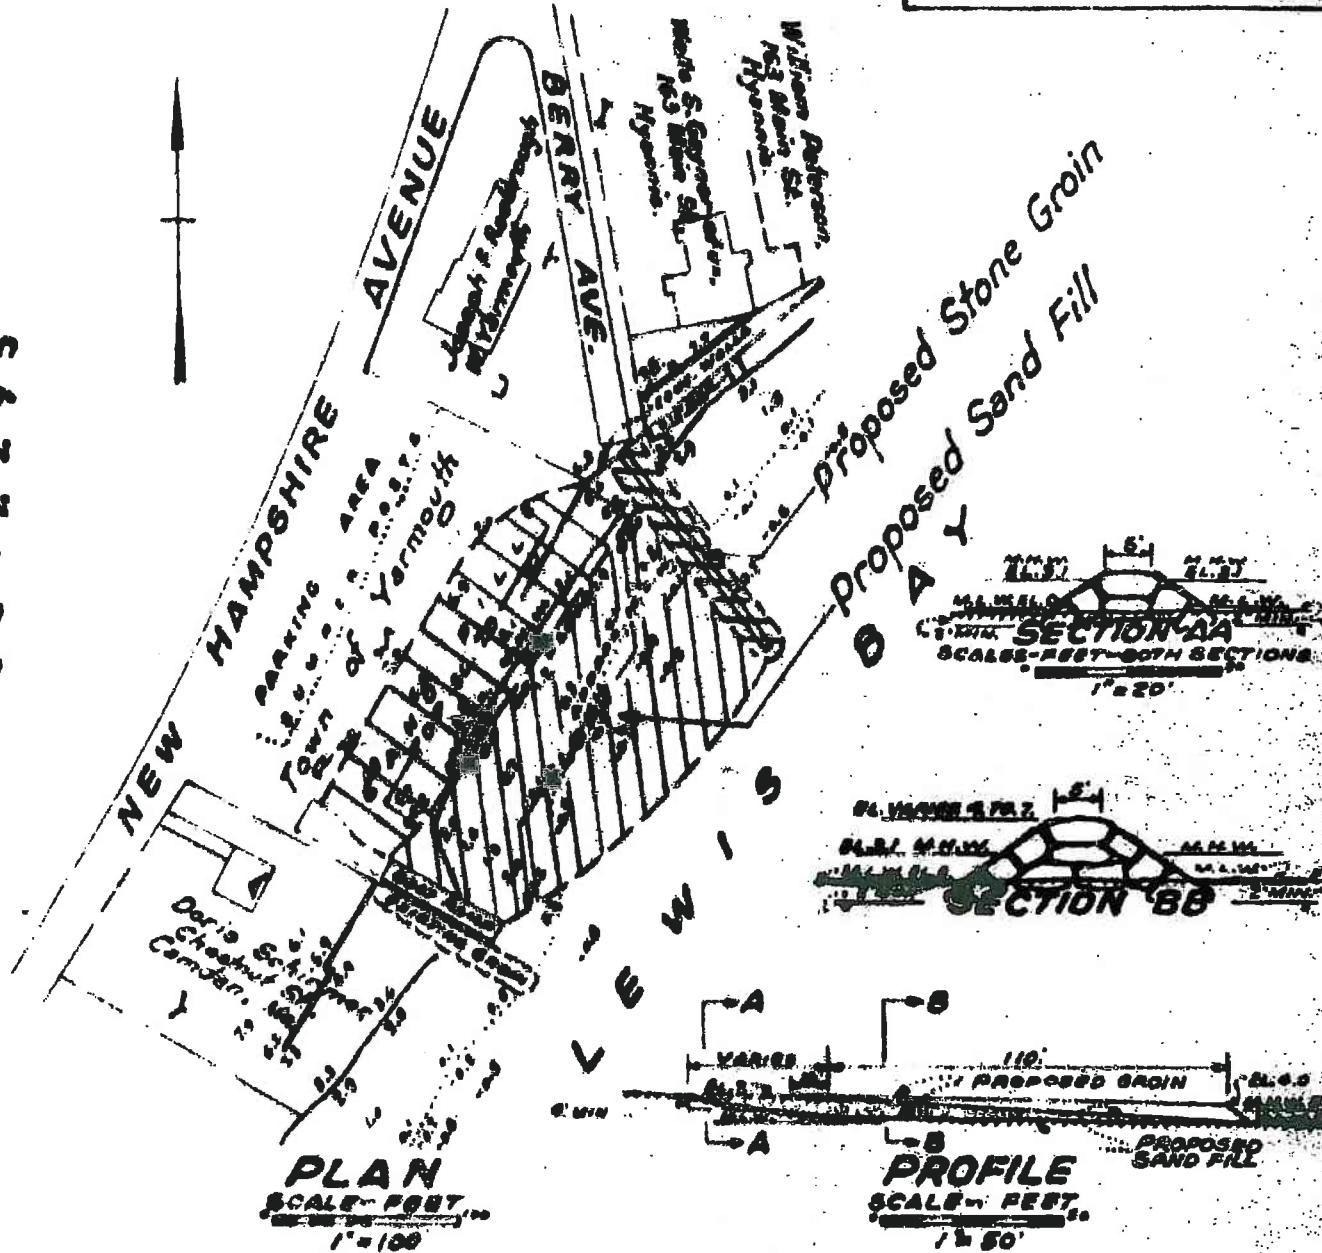
ELEVATIONS ARE IN FEET AND TENTHS  
AND REFER TO PLANE OF MEAN LOW  
WATER. MINUS FIGURES SHOW DEPTHS  
BELOW THE BARGE PLANE.  
APPENDIX: EXISTING GROUND THUS  
BIDS AND BND BLDGES FOR GROIN 1,870 LF.  
LOCATION OF PROPOSED WORK IS SHOWN  
IN RED.  
PROJECTION OF GROIN END AT N.W. LINE  
INTO TIDEWATER IS APPROXIMATELY 100  
FEET.

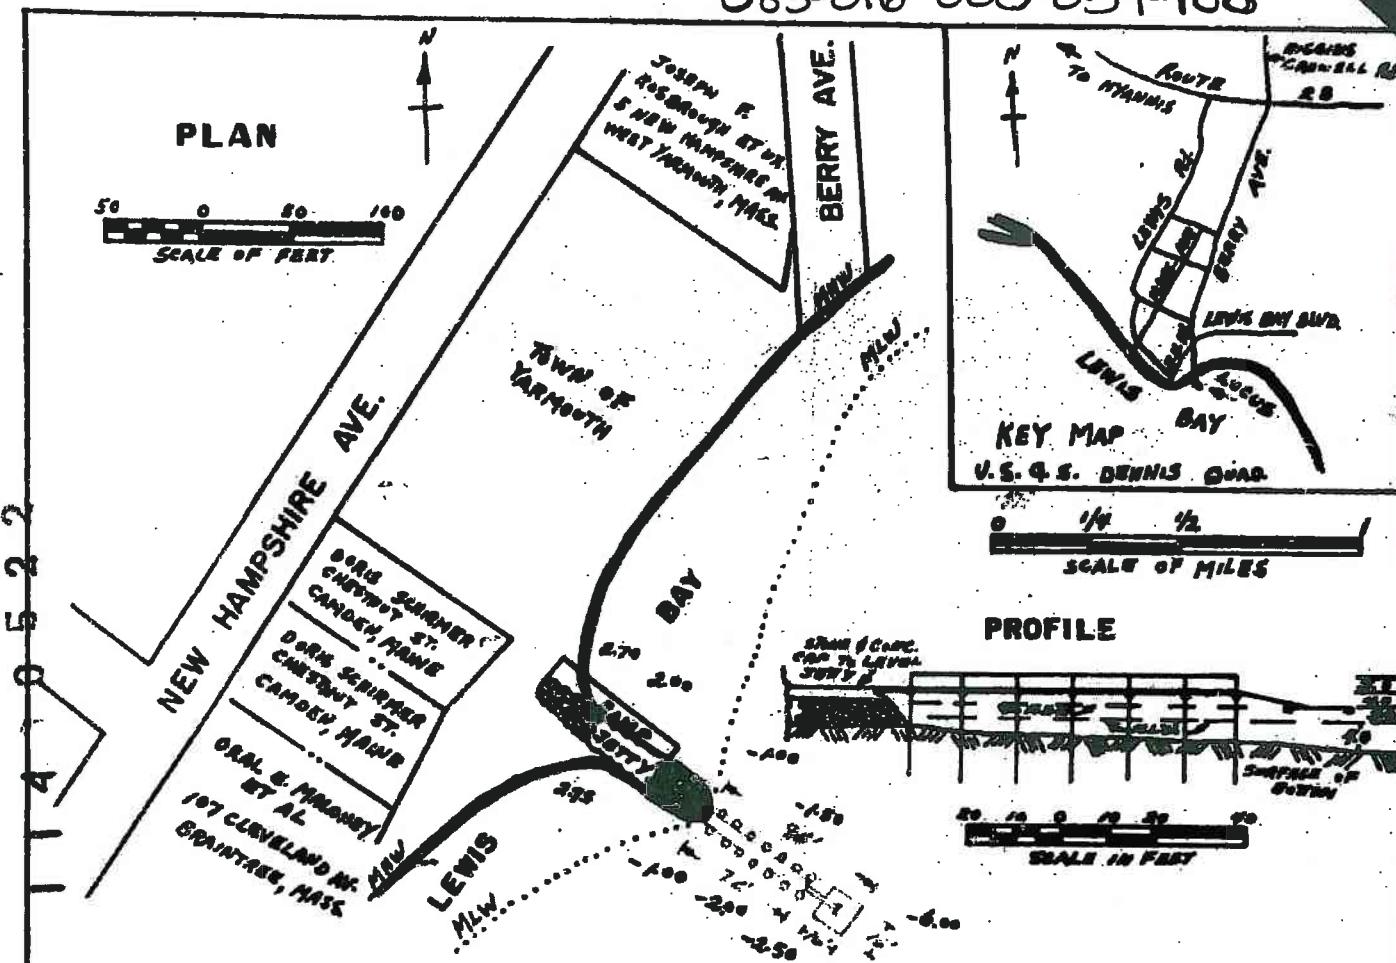
**NOTE :-**  
PROPOSED WORK SHOWN IN RED.  
ELEVATIONS SHOWN IN FEET AND  
TENTHS AND SHOW HEIGHT ABOVE  
THE PLANE OF MEAN LOW WATER.  
MINUS FIGURES ARE SOUNDINGS  
AND SHOW DEPTHS BELOW SAME PLANE.

PROPOSED PIER  
IN LEWIS BAY AT WEST YARMOUTH  
COUNTY OF BARNSTABLE, MASS.  
APPLICATION BY THE TOWN OF YARMOUTH  
JUNE 4, 1963

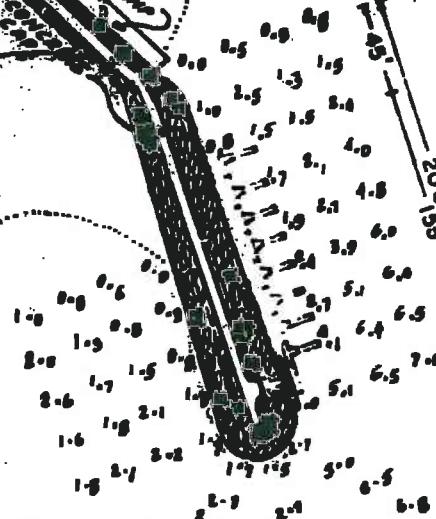
EXISTING STONE GROWN WHTN  
CONCRETE CAP MASS. D.P.W.  
LICENCE 4720 & 3055

CONCRETE CAP  
ELEV. 7.0  
MHN ELEV. 3.2  
(MLW ELEV. 0.00)
