*Massachusetts Coastal Infrastructure  
Inventory and Assessment Project*  
*Massachusetts Department of Conservation and Recreation*  
*Office of Waterways*

## Middle Cape Cod

Barnstable  
Yarmouth  
Dennis

**MASSACHUSETTS COASTAL INFRASTRUCTURE INVENTORY AND ASSESSMENT PROJECT**

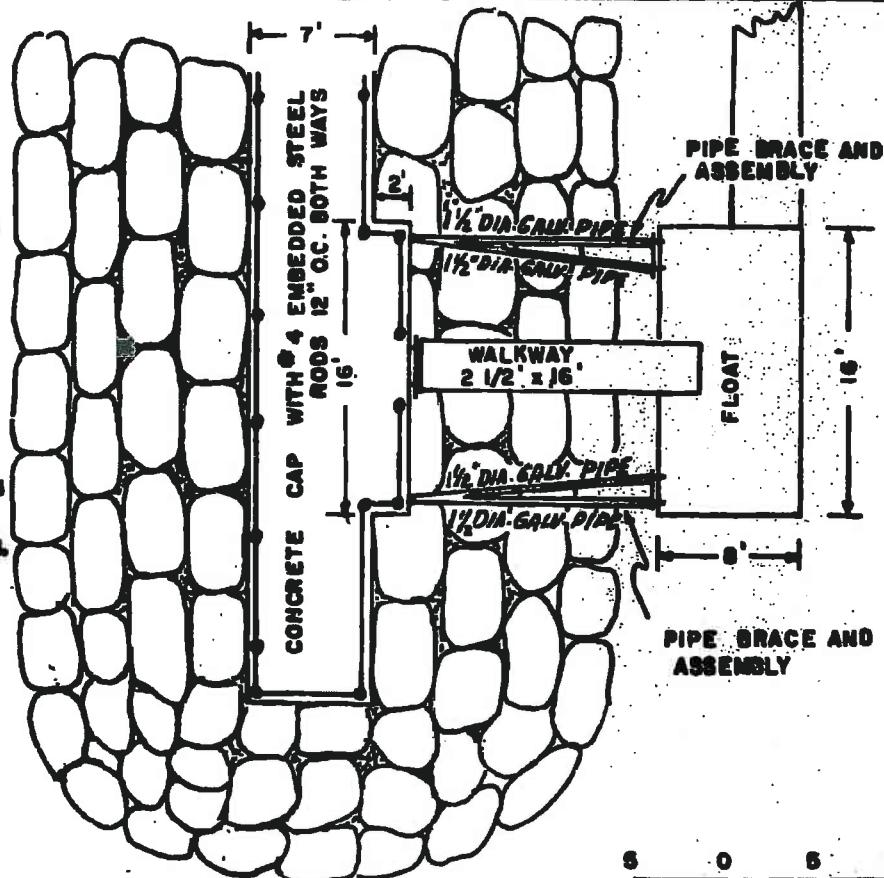
DETAIL CONCRETE CAP & FLOAT

2 1/2" DIA. GALV. POST AND RAIL  
6'-0" ON CENTER

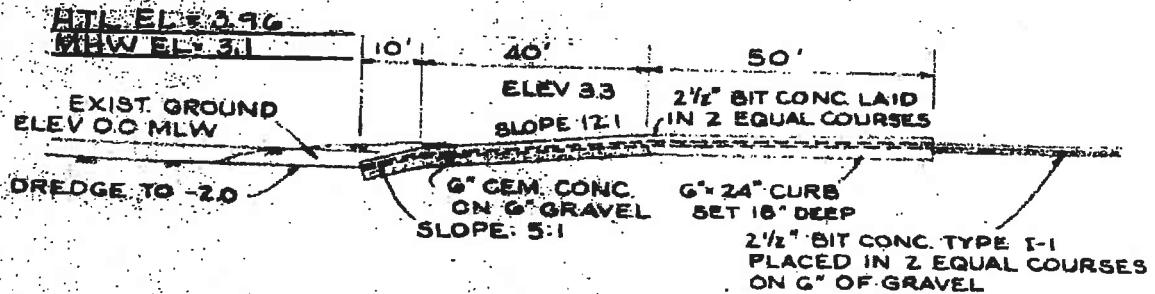
### RAMP PROFILE

NOTE: PORTION OF RAMP TO REMAIN SHALL BE DRILLED TO ALLOW REINFORCEMENT STEEL MAT TO SECURE JOINT

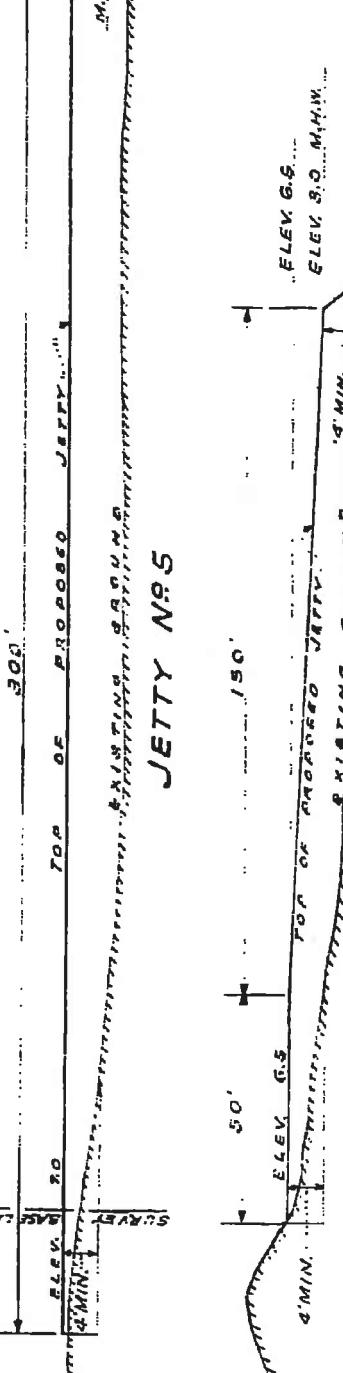
### JETTY NO. 5

ELEV. 2.0  
M.L.W. ELEV. 3.0 M.L.W.

### PROPOSED PROFILES

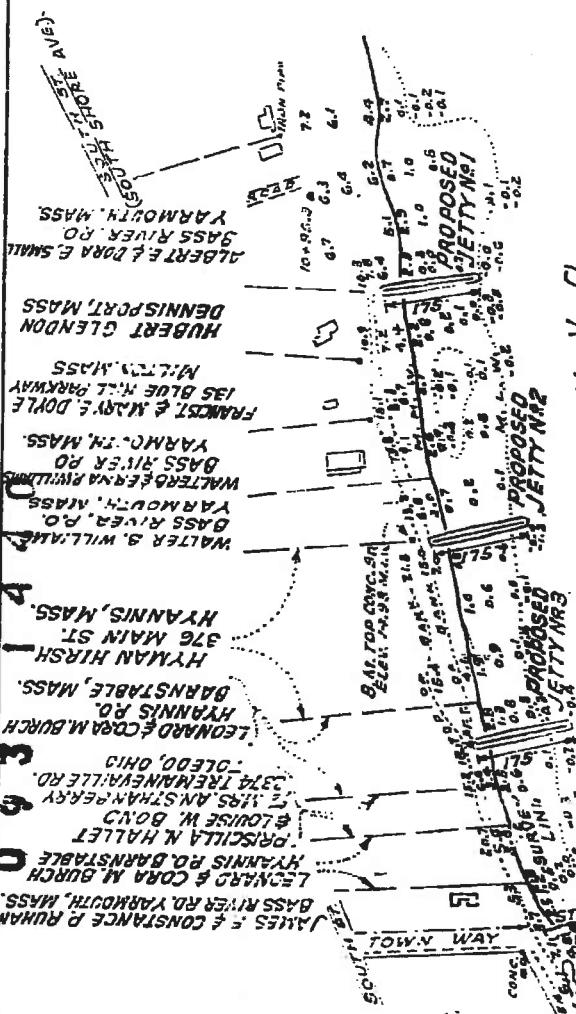
PLAN

50' U.V.D.  
 PROPOSED JETTY No. 2  
 PROPOSED JETTY No. 1  
 1:4000

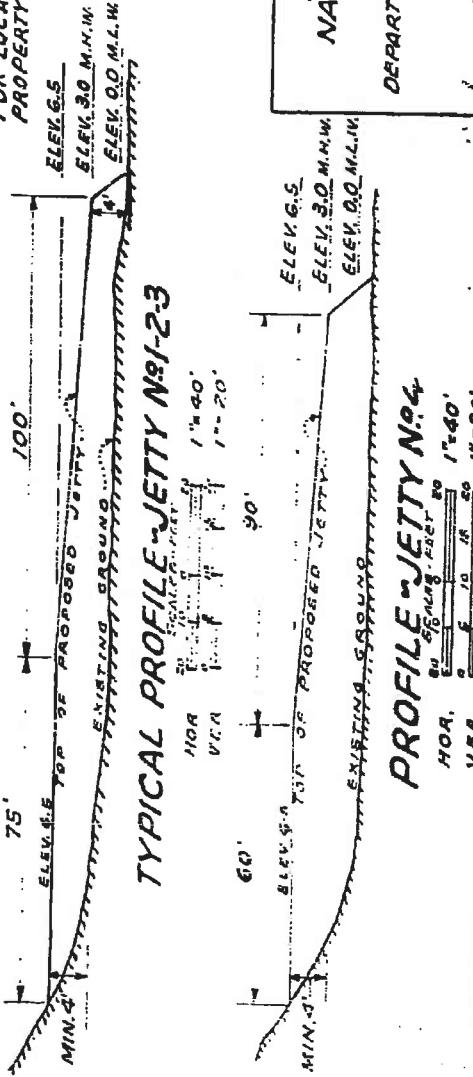
TYPICAL PROFILE-JETTY No. 2-3

ELEV. 6.5  
 ELEV. 3.0 M.H.W.  
 ELEV. 0.0 M.L.W.

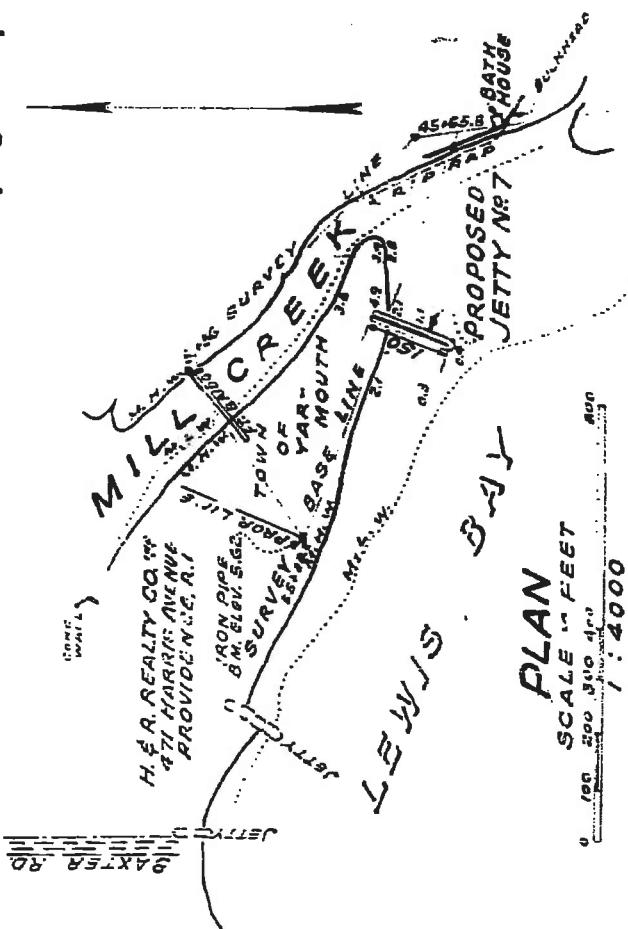
JETTY NO. 7  
PROPOSED PROFILE  
ELEV. 6.50  
ELEV. 3.0  
M.A.W.

PROPOSED PROFILE  
ELEV. 6.50  
ELEV. 3.0  
M.A.W.

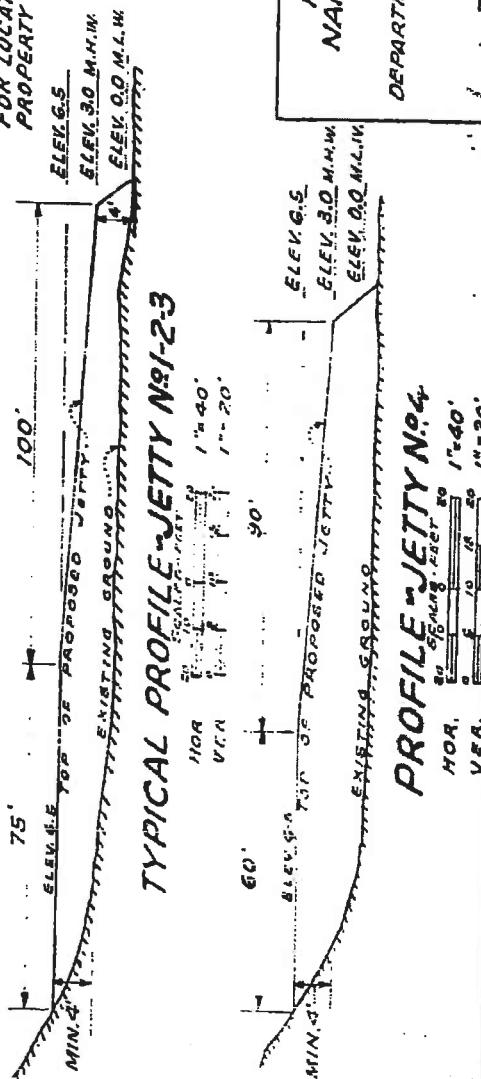
**TYPICAL PROFILE E-SJETTY No. 1-2-3**

ELEVATIONS ARE IN FEET AND TENTHS  
AND SHOW HEIGHTS ABOVE PLANE OF M.L.W.  
MINUS FIGURES SHOW DEPARTS BELOW THE SAME PLANE.  
FOR TYPICAL SECTION SEE SHEET 1.  
FOR LOCATION MAP SEE SHEET 1.  
PROPERTY LINES ARE APPROXIMATE.

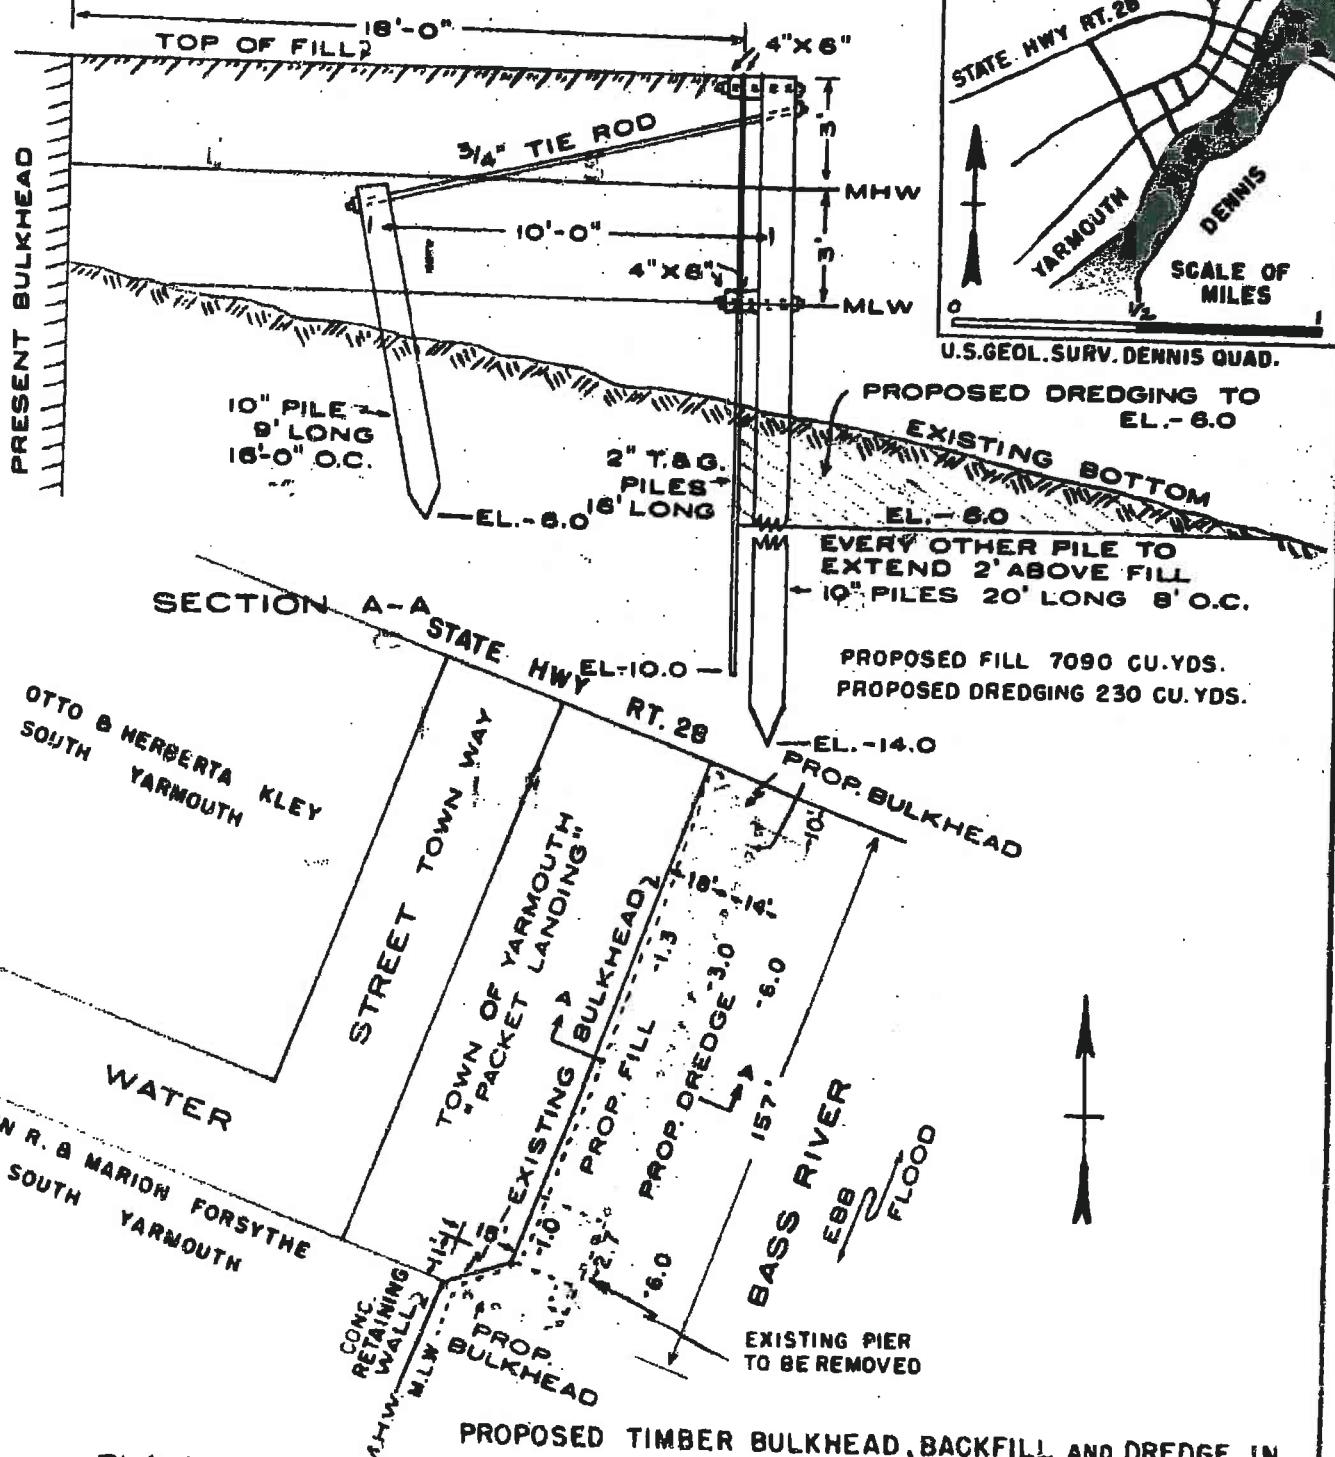
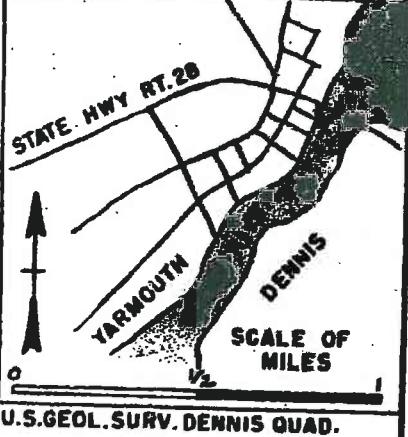
PROPOSED TIMBER BULKHEAD, BACKFILL AND DREDGE IN  
BASS RIVER

YARMOUTH  
COUNTY OF BARNSTABLE, MASSACHUSETTS  
APPLICATION BY THE TOWN OF YARMOUTH  
APRIL 20, 1955

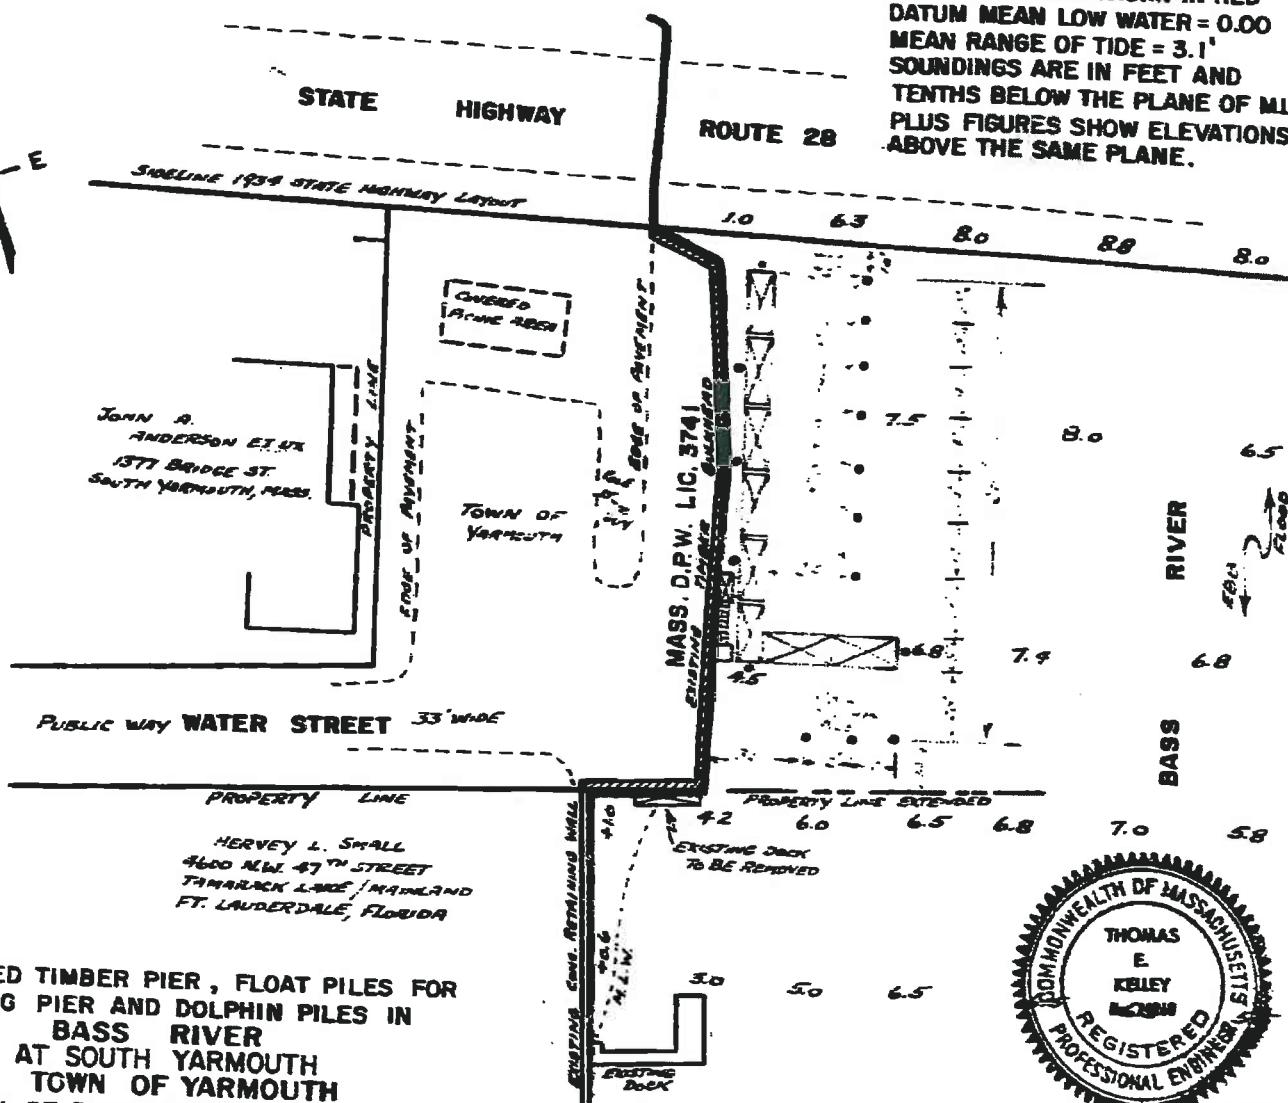
PROPOSED TIMBER PIER, FLOAT PILES FOR  
FLOATING PIER AND DOLPHIN PILES IN  
BASS RIVER  
AT SOUTH YARMOUTH  
TOWN OF YARMOUTH  
COUNTY OF BARNSTABLE, MASSACHUSETTS  
APPLICATION BY  
THE TOWN OF YARMOUTH  
SCALE AS SHOWN FEBRUARY 1972

PROPOSED WORK SHOWN IN RED  
DATUM MEAN LOW WATER = 0.00  
MEAN RANGE OF TIDE = 3.1'  
SOUNDINGS ARE IN FEET AND  
TENTHS BELOW THE PLANE OF M.L.W.  
PLUS FIGURES SHOW ELEVATIONS  
ABOVE THE SAME PLANE.

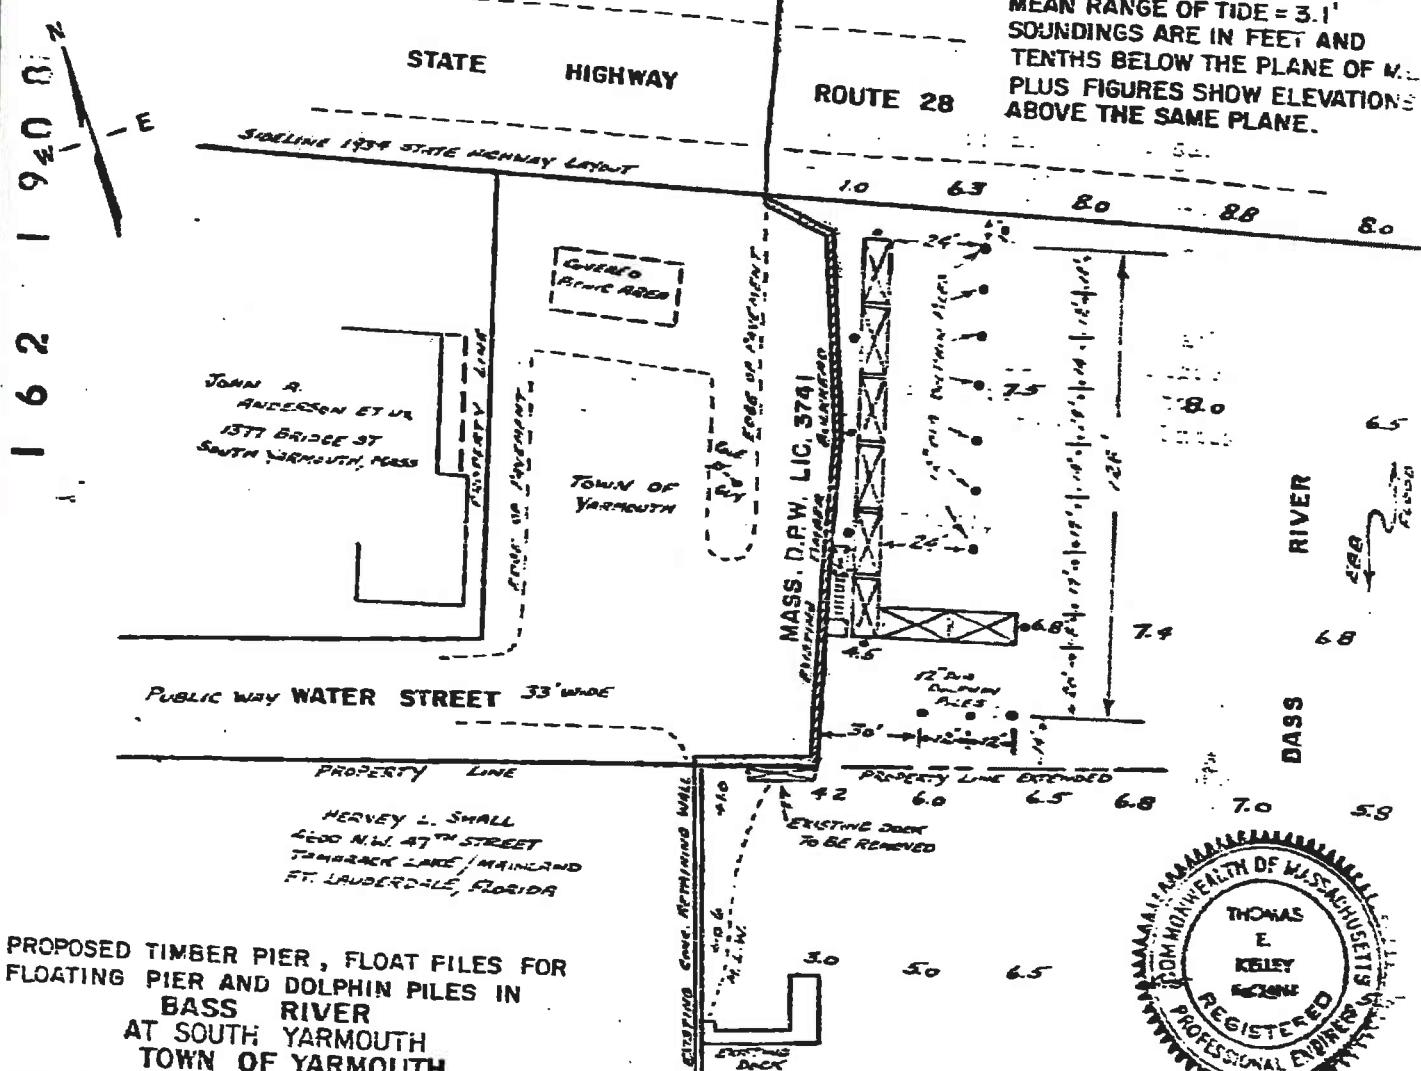
PROPOSED TIMBER PIER, FLOAT FILES FOR  
FLOATING PIER AND DOLPHIN PILES IN  
BASS RIVER  
AT SOUTH YARMOUTH  
TOWN OF YARMOUTH  
COUNTY OF BARNSTABLE, MASSACHUSETTS  
APPLICATION BY  
THE TOWN OF YARMOUTH  
SCALE AS SHOWN

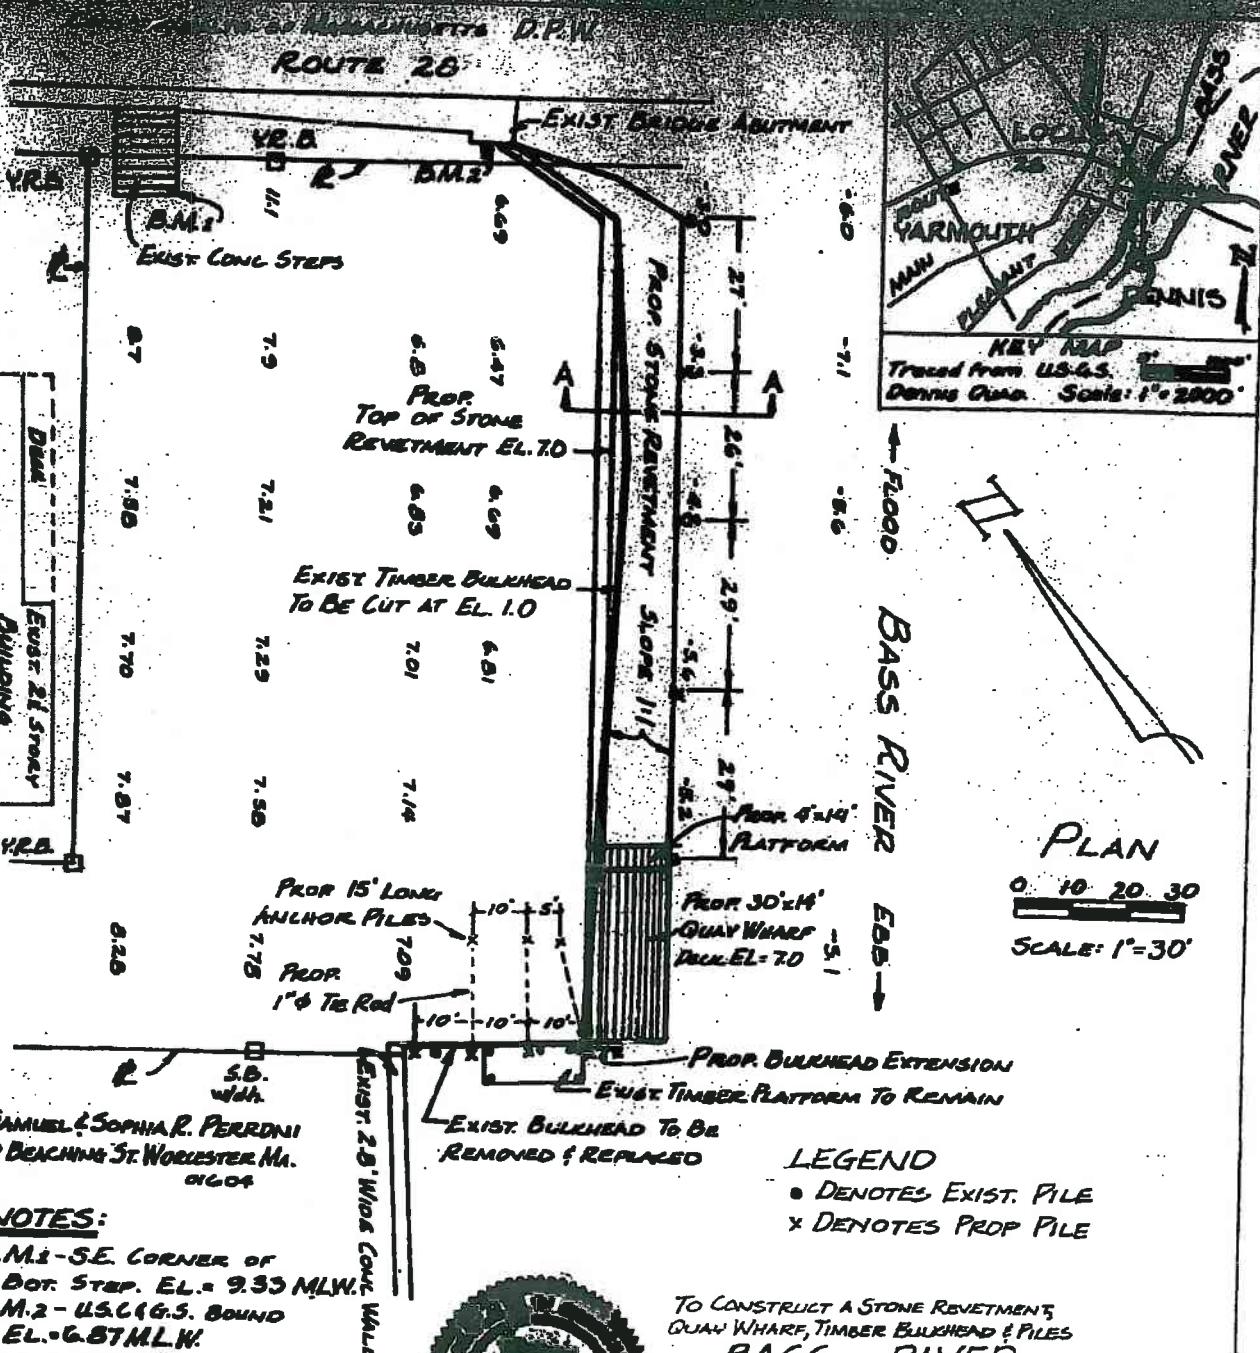
TO CONSTRUCT A STONE REVETMENT,  
QUAY WHARF, TIMBER BULKHEAD & PILES

**BASS RIVER**  
YARMOUTH, BARNSTABLE Co., MA.

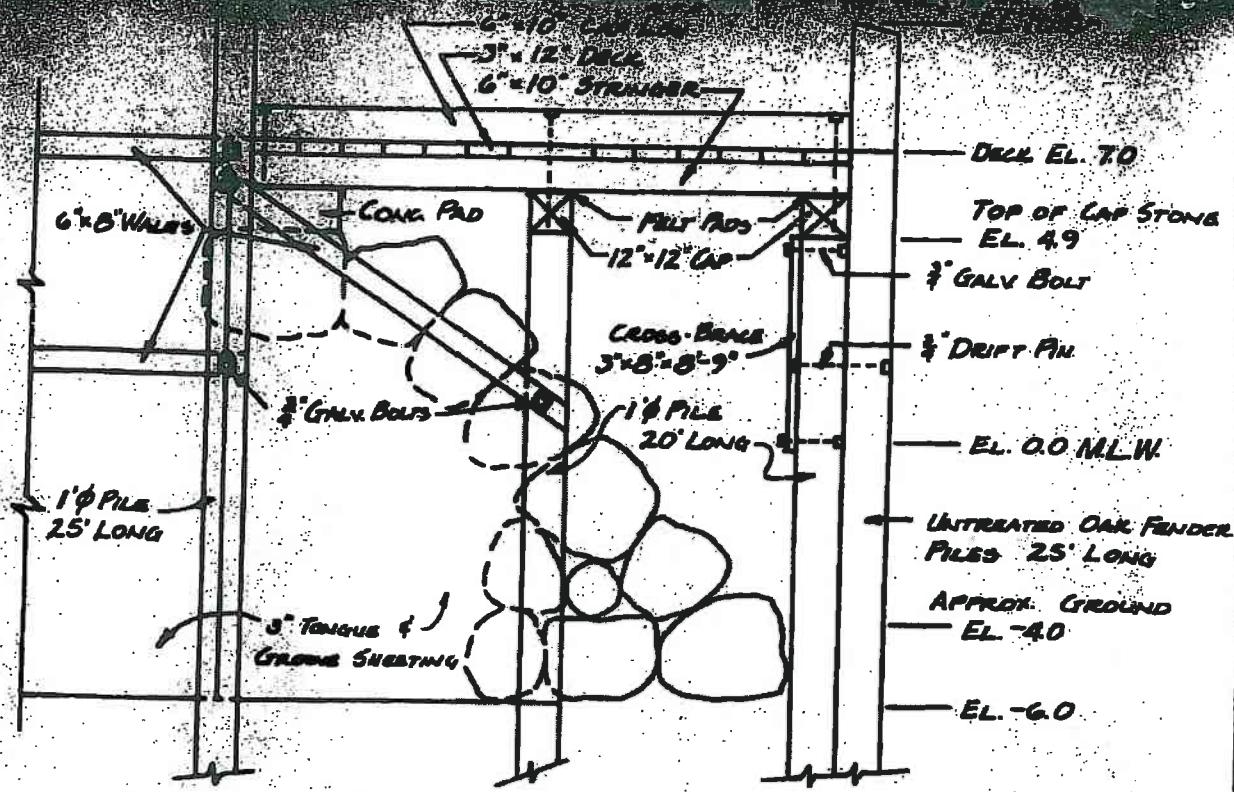
PROFILE OF BULKHEAD & WHARF

SCALE:  $\frac{1}{4} = 1'-0"$

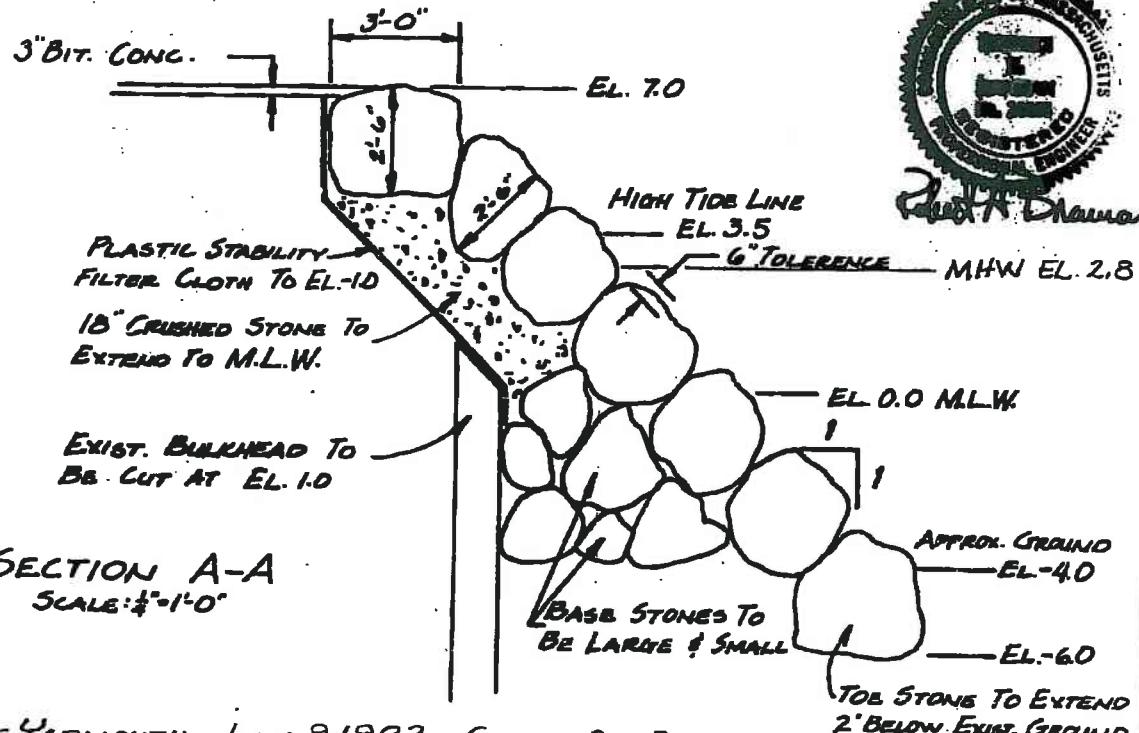
SECTION A-A

SCALE:  $\frac{1}{4} = 1'-0"$

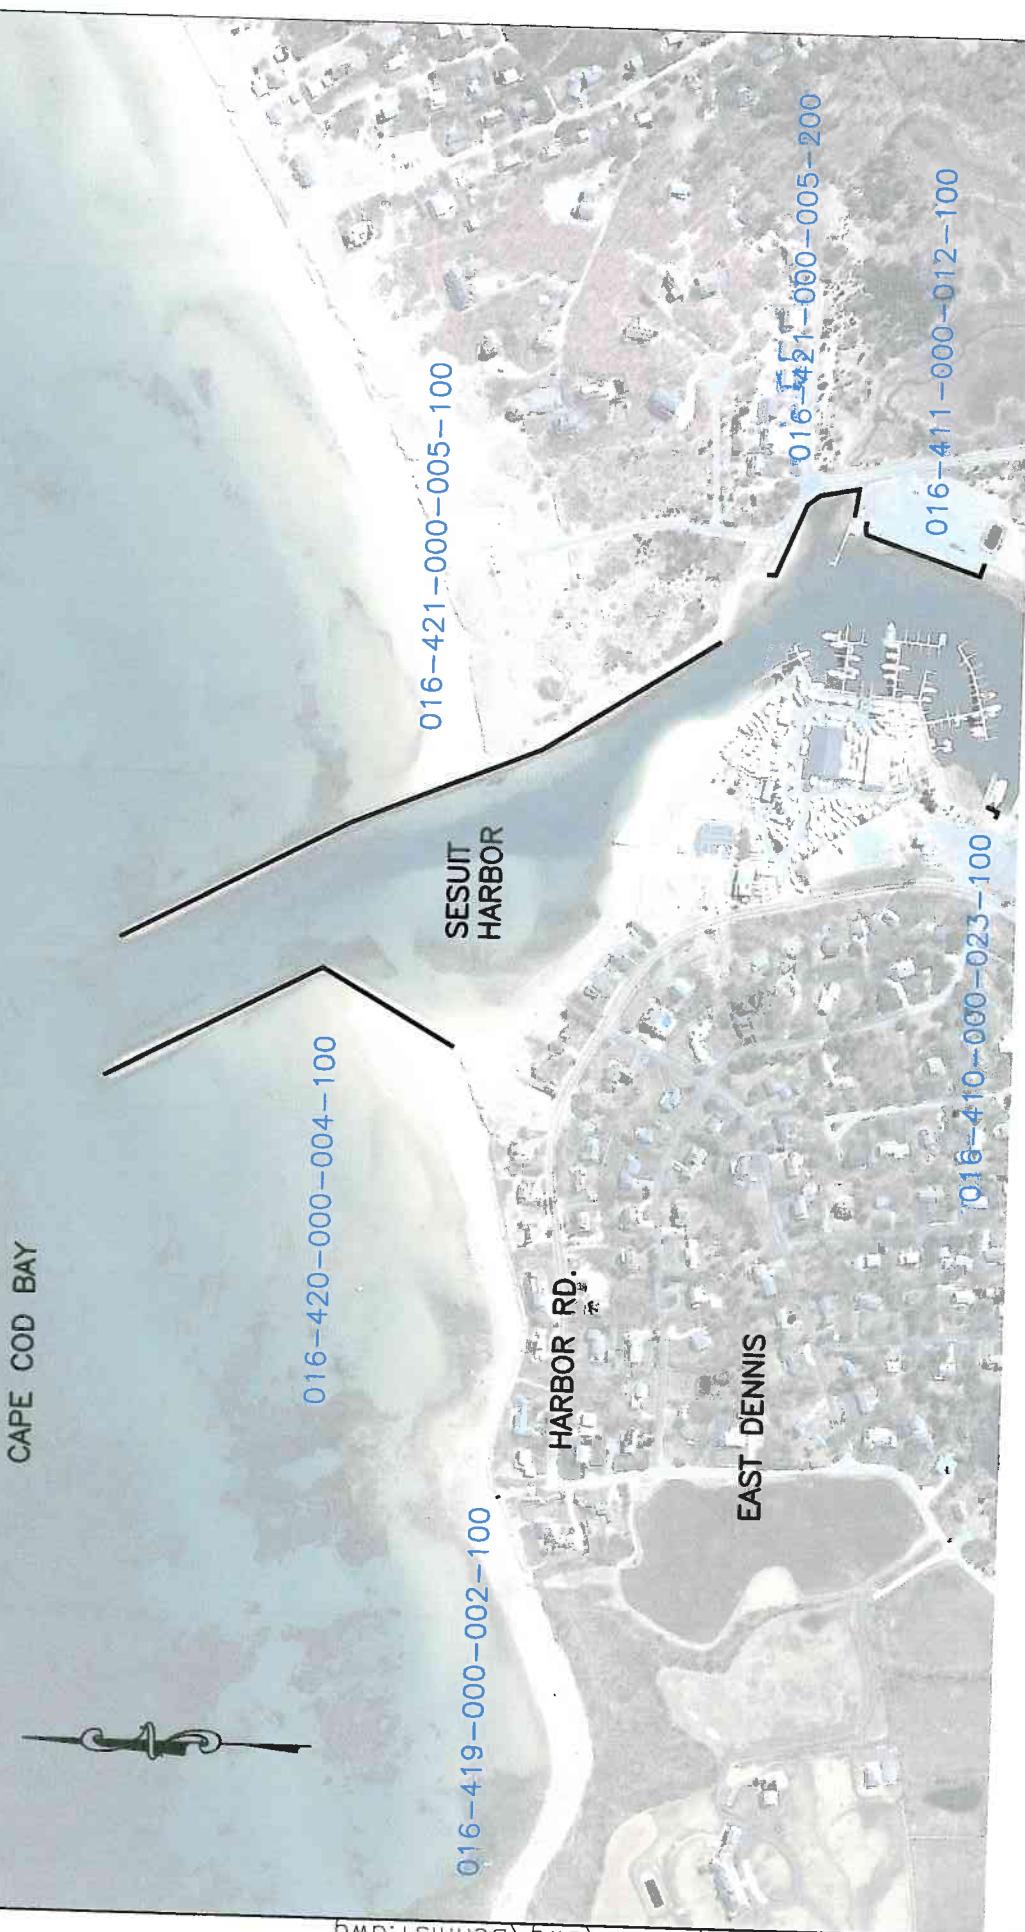
SHEET 3

## COASTAL STRUCTURE LOCATION PLAN

Within the Town of Dennis, there were 49 structures which had public or unknown ownership which provide significant coastal protection. The location of the structures can be seen in Sheets 1 through Sheet 14 in Section IV-B of this report. The structures were categorized by their type and by their structural condition based on a preliminary field assessment. The distribution of structures by type and condition can be seen in the following table:

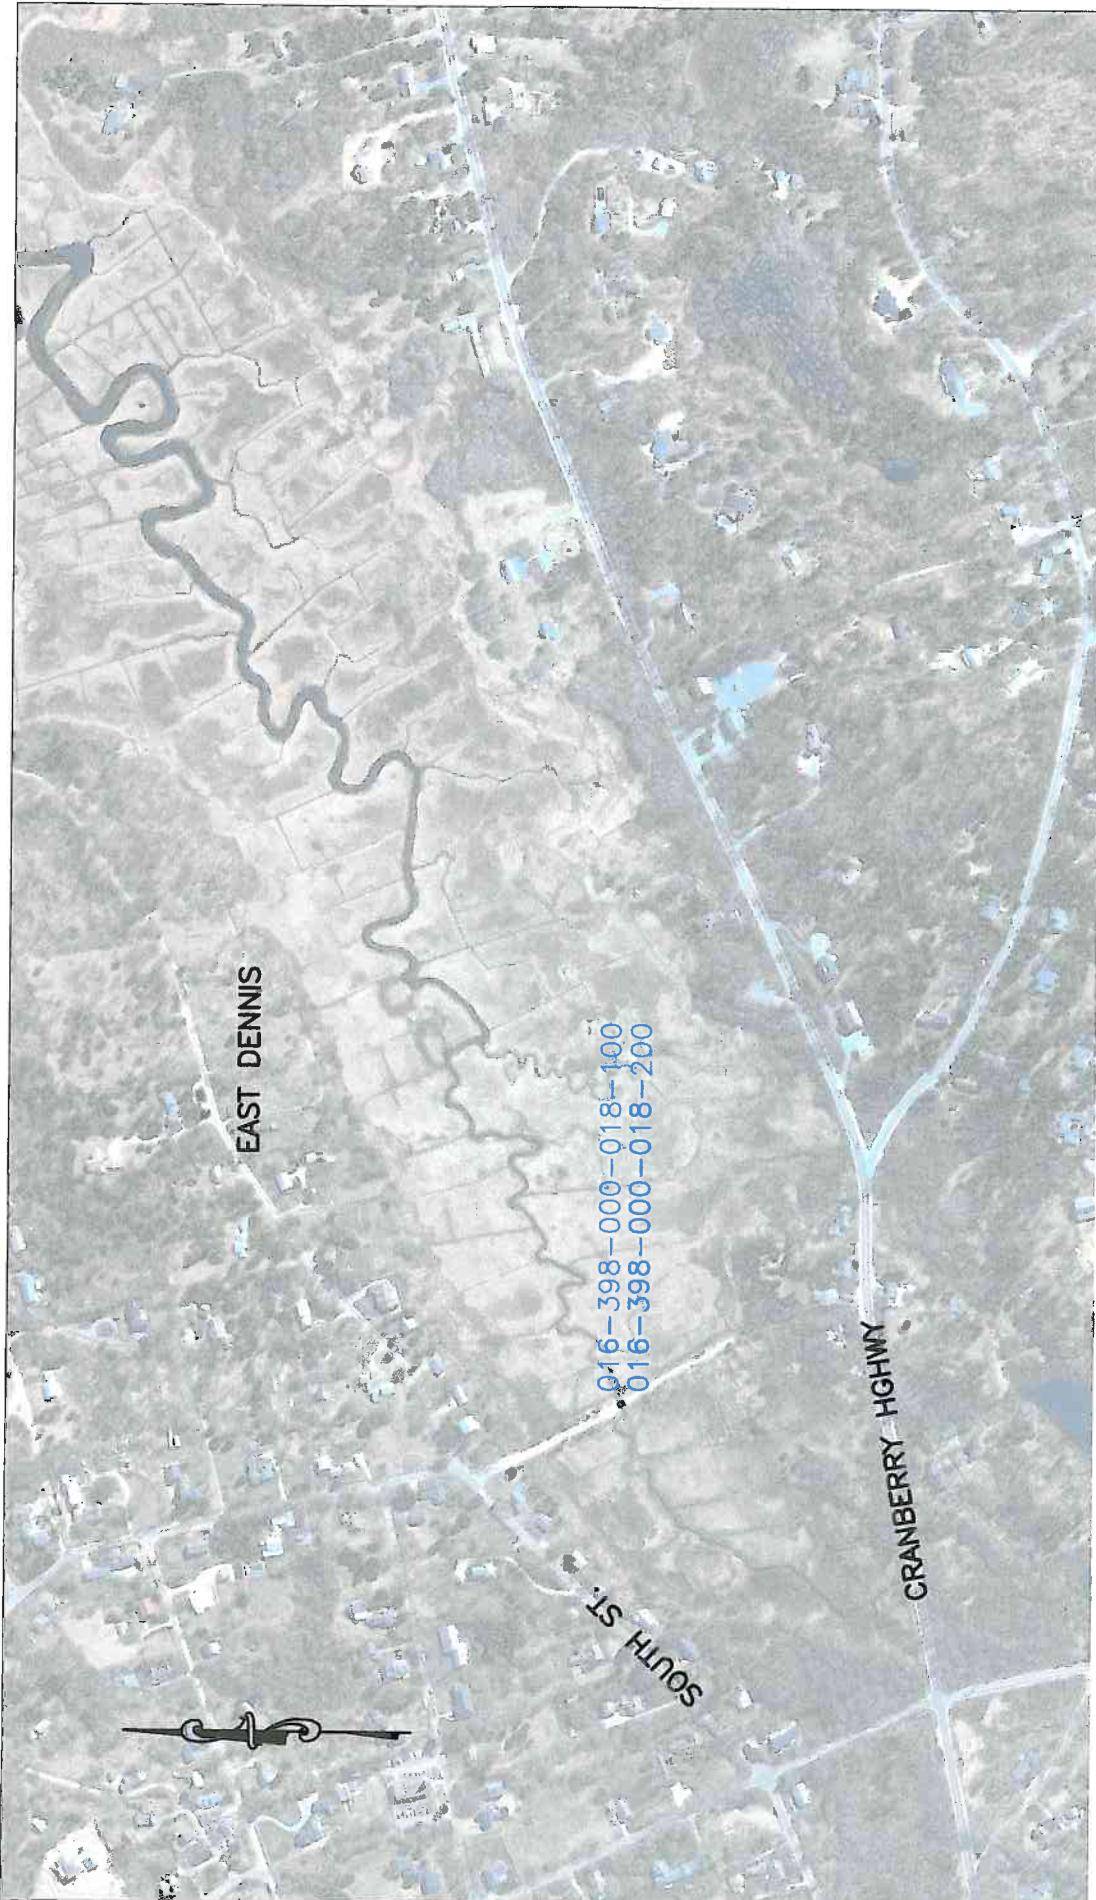
SHEET 5

## COASTAL STRUCTURE LOCATION PLAN

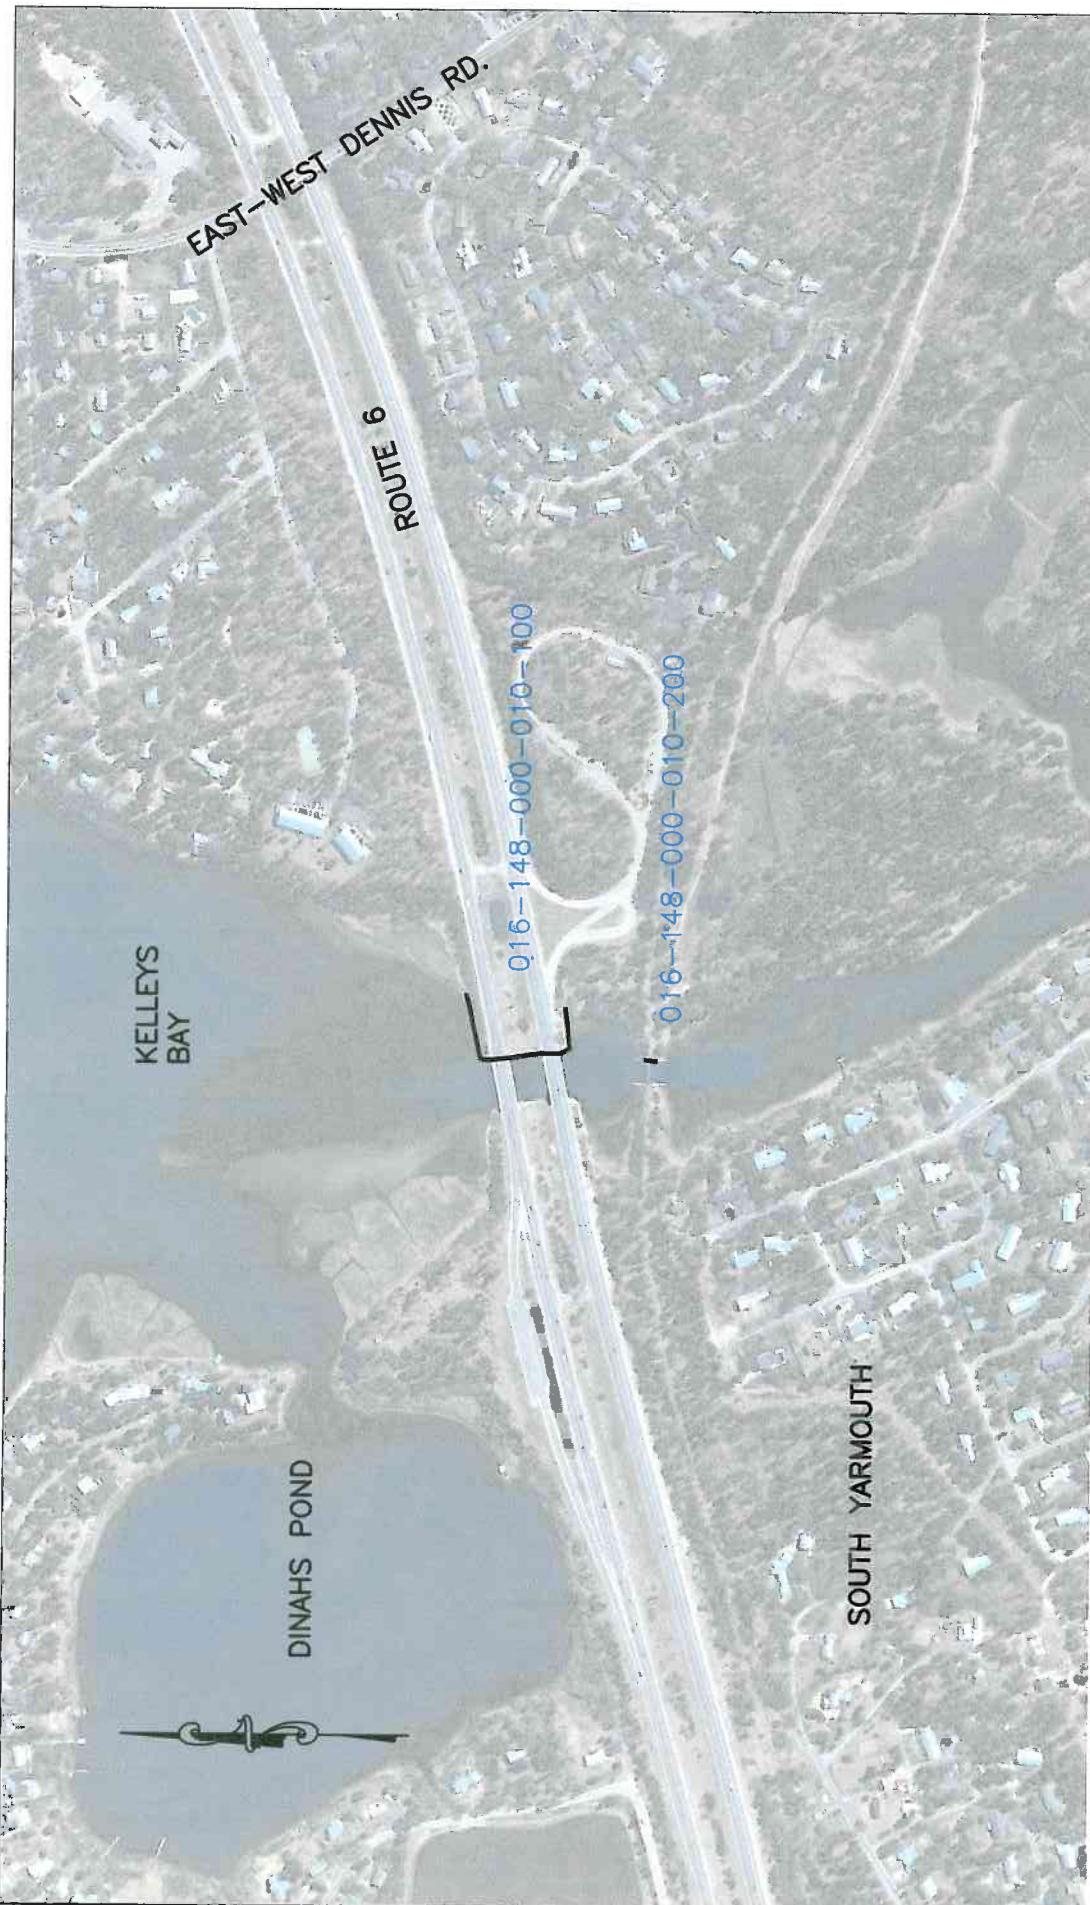
SHEET 6

## COASTAL STRUCTURE LOCATION PLAN
