*Massachusetts Coastal Infrastructure  
Inventory and Assessment Project*  
*Massachusetts Department of Conservation and Recreation*  
*Office of Waterways*

## Middle Cape Cod

Barnstable  
Yarmouth  
Dennis

**MASSACHUSETTS COASTAL INFRASTRUCTURE INVENTORY AND ASSESSMENT PROJECT**

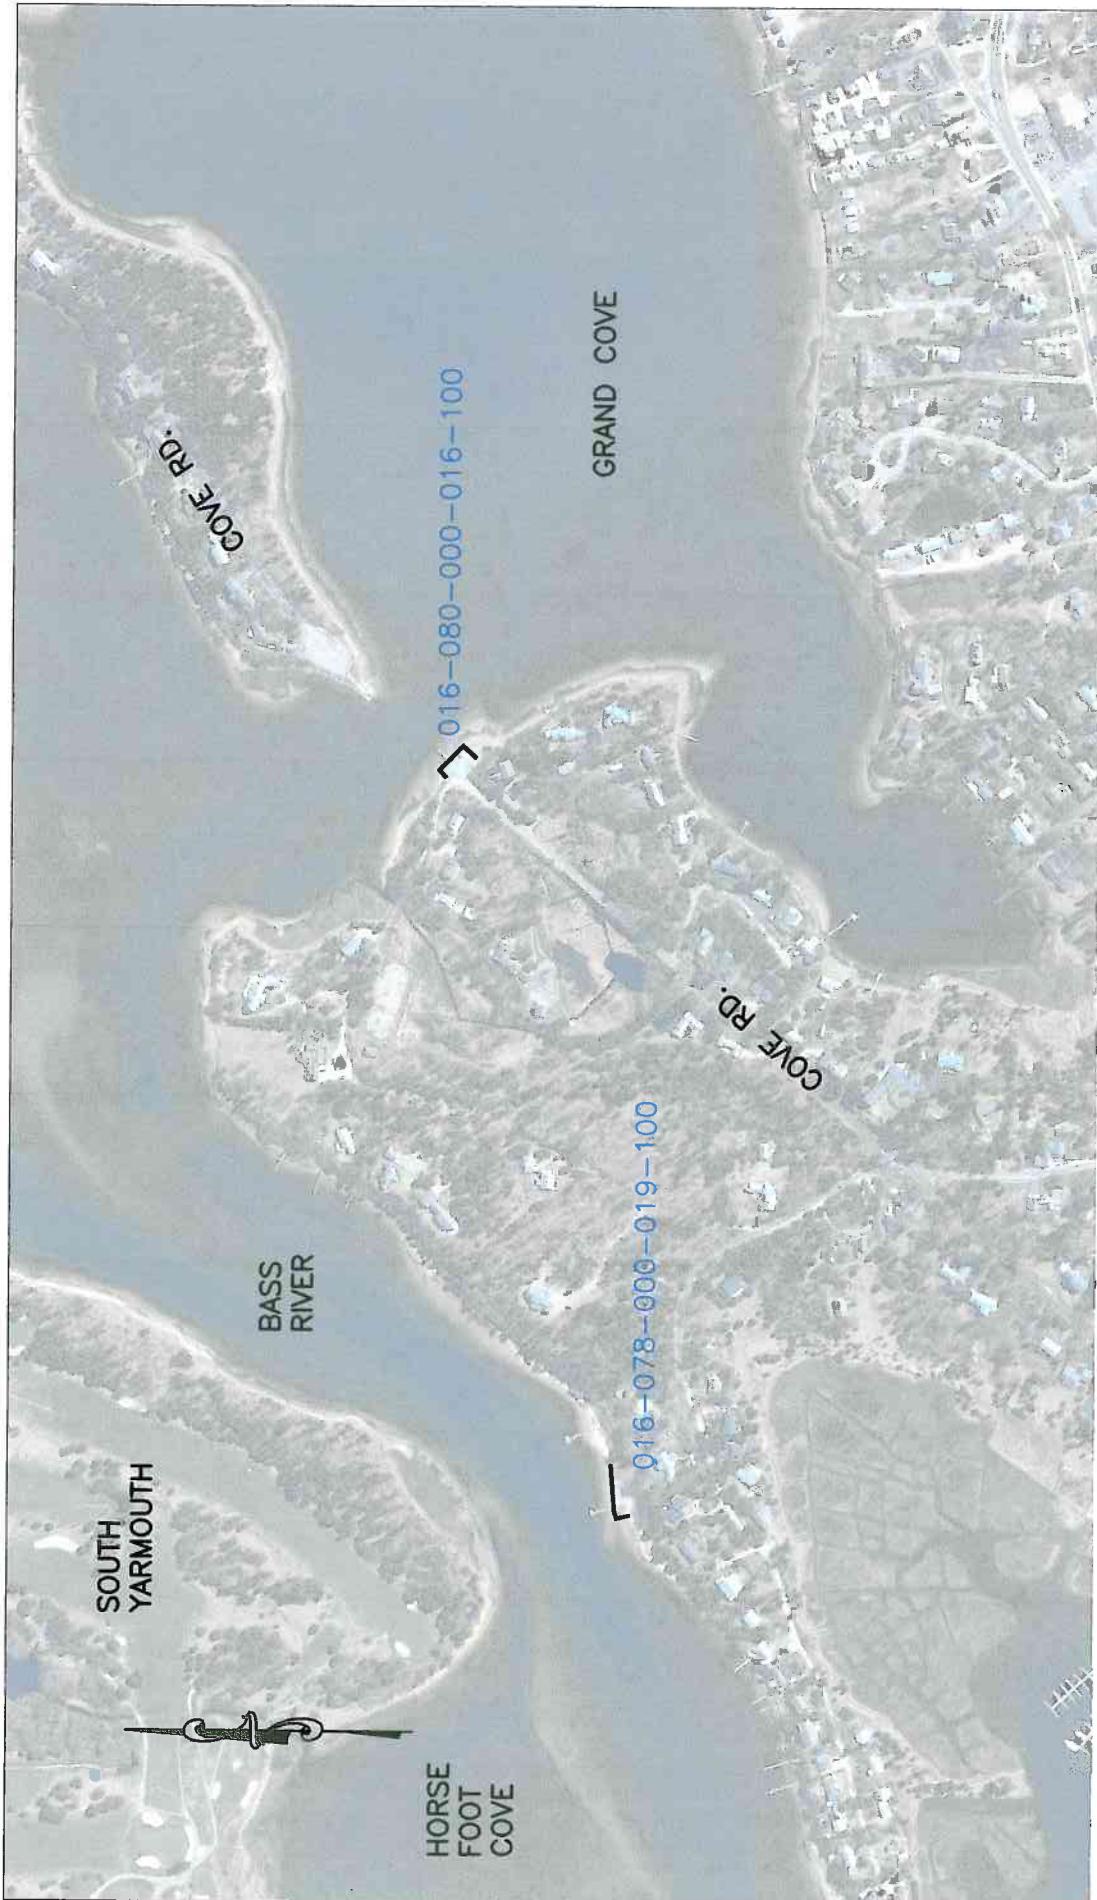
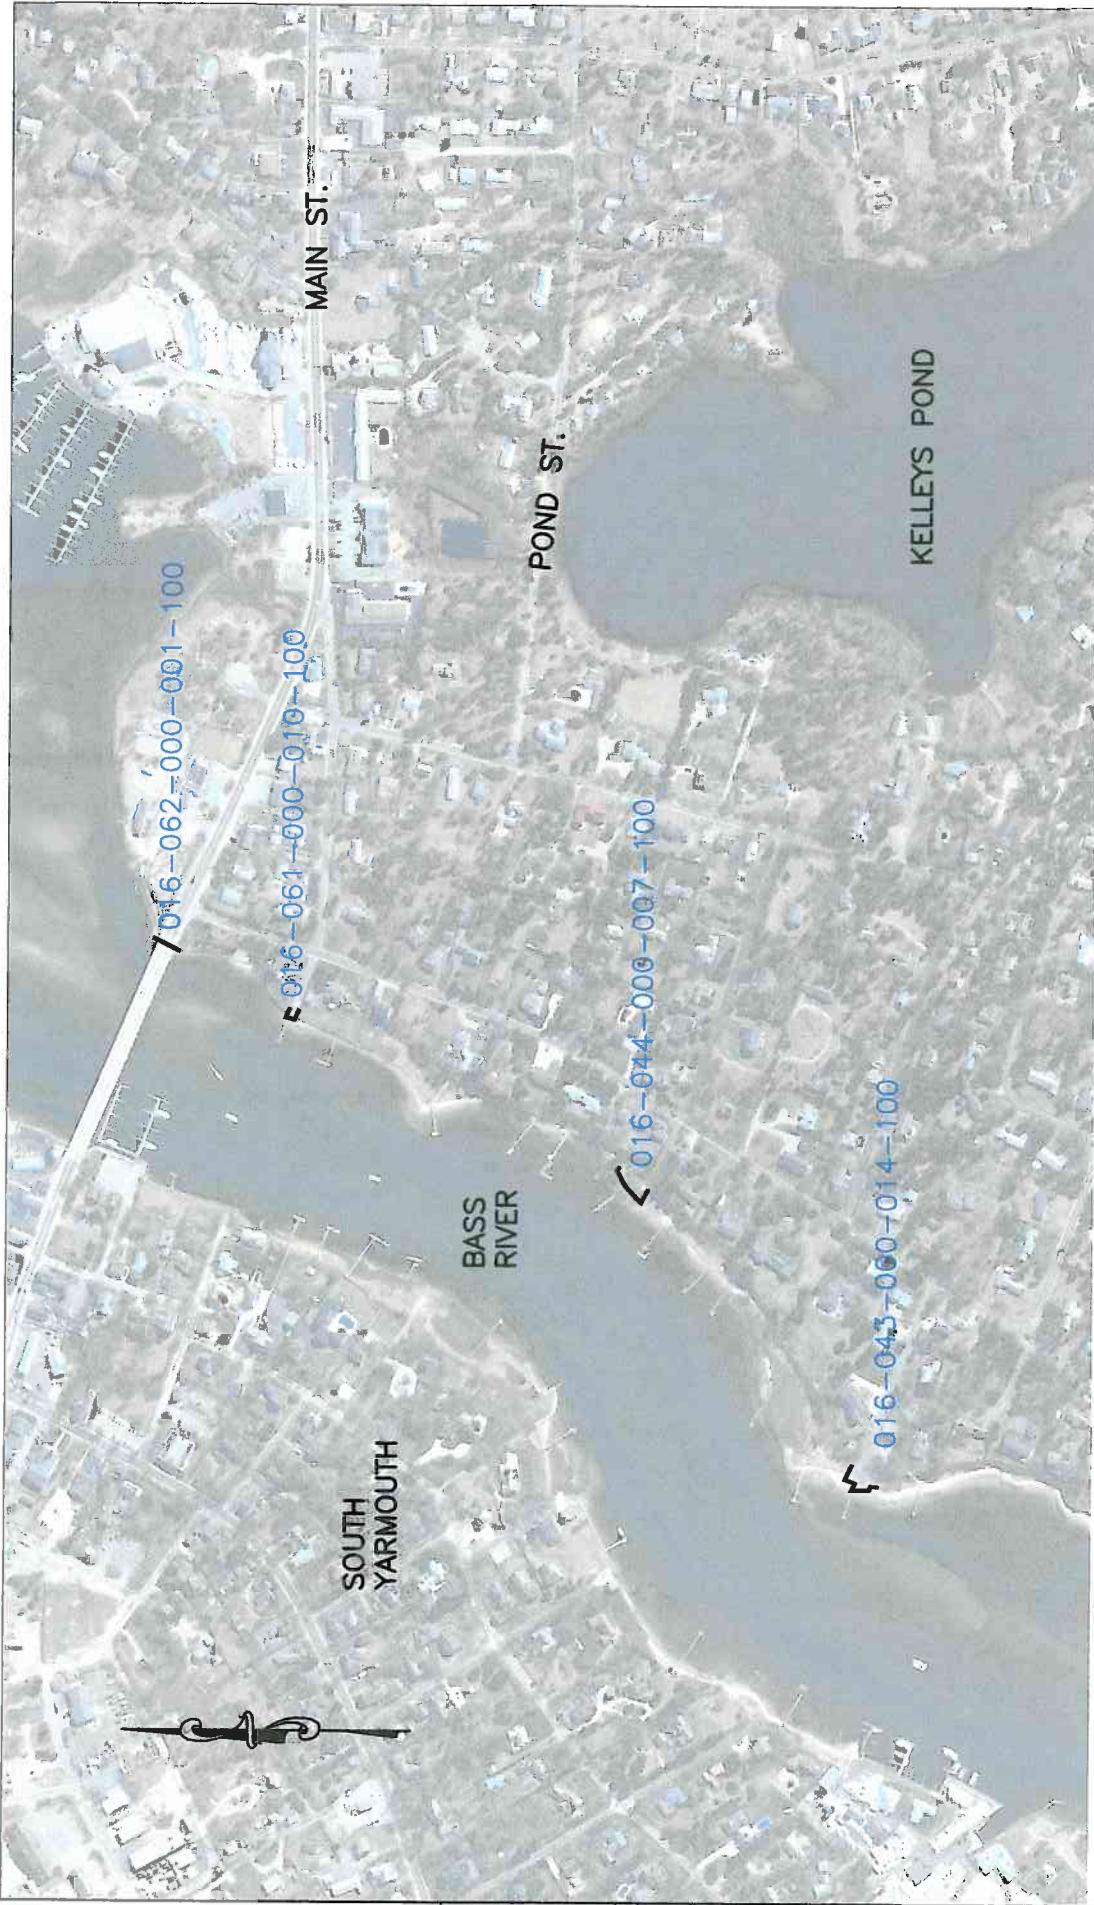
SHEET 8

## COASTAL STRUCTURE LOCATION PLAN

Within the Town of Dennis, there were 49 structures which had public or unknown ownership which provide significant coastal protection. The location of the structures can be seen in Sheets 1 through Sheet 14 in Section IV-B of this report. The structures were categorized by their type and by their structural condition based on a preliminary field assessment. The distribution of structures by type and condition can be seen in the following table:

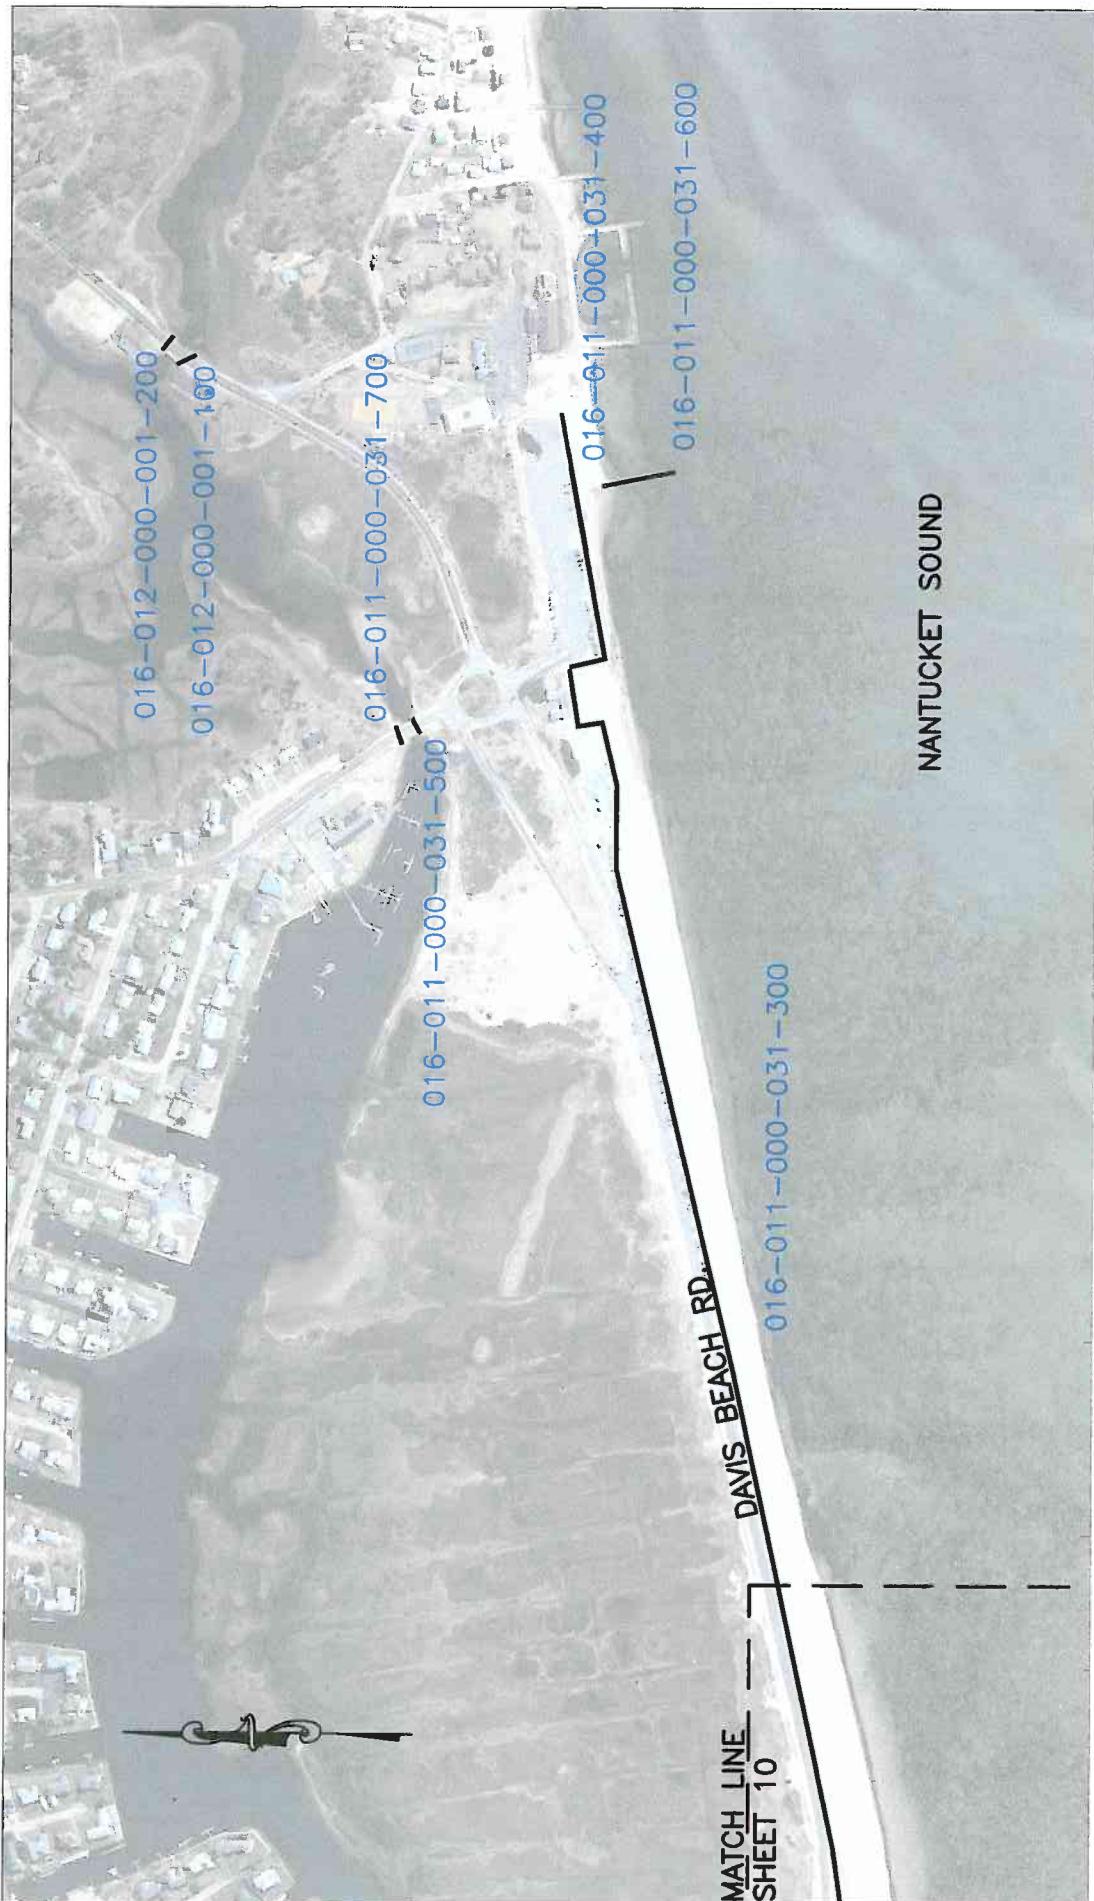
SHEET 11

## COASTAL STRUCTURE LOCATION PLAN

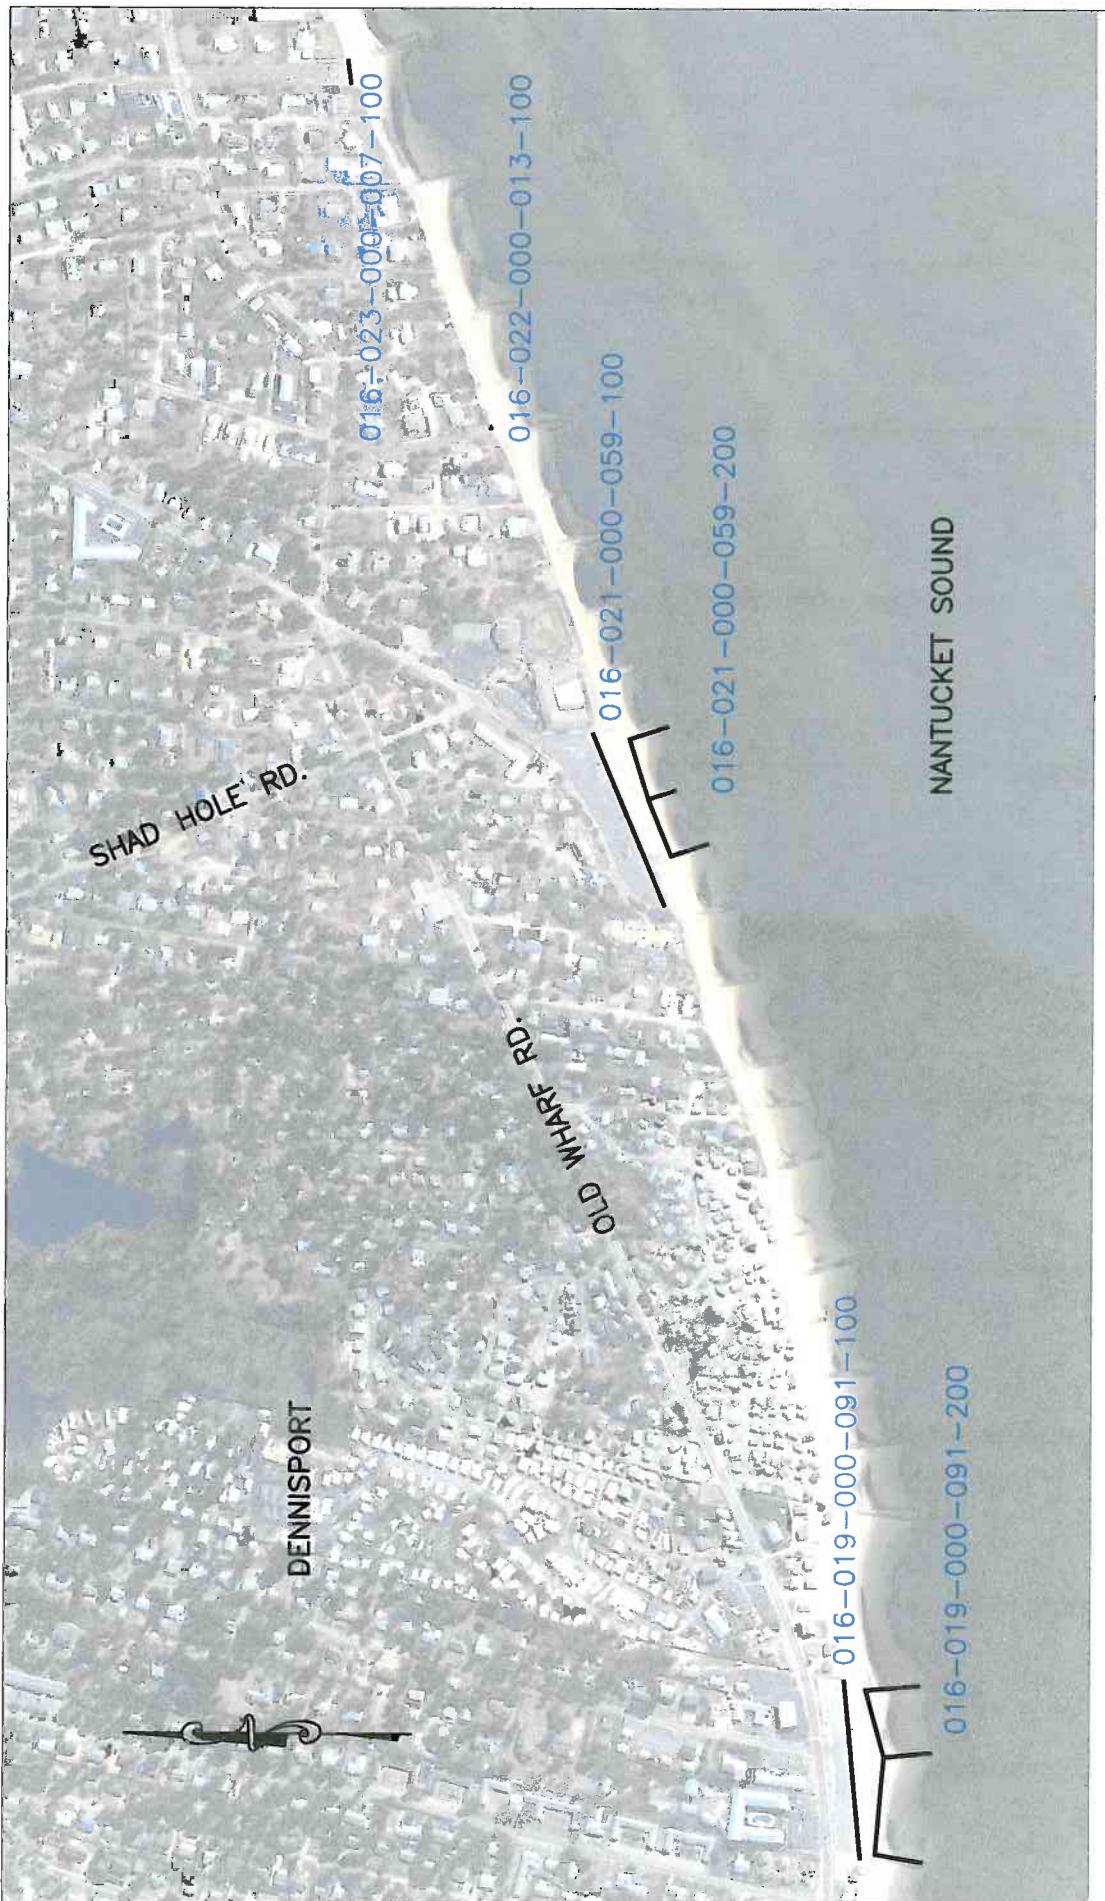
SHEET 13

## COASTAL STRUCTURE LOCATION PLAN

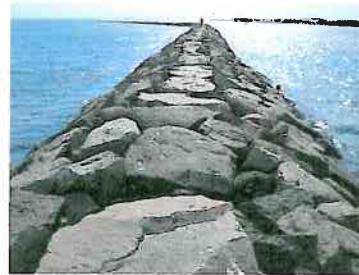
1280 Feet	Feet NAVD 88	V13	15 Feet NGVD	
Primary Type:	Primary Material:	Primary Height:		
Groin/ Jetty	Stone	10 to 15 Feet		
Secondary Type:	Secondary Material:	Secondary Height:		
<b>Structure Summary :</b> This structure is the east jetty at the Bass River. A few single armor stones are cracked. There is some minor displacement of the armor stone but the structure is generally in good condition.				
<i>Condition</i>	B	<i>Priority</i>	III	
<i>Rating</i>	Good	<i>Rating</i>	Moderate Priority	
<i>Level of Action</i>	Minor	<i>Action</i>	Consider for Active Project Improvement Listing	
<i>Description</i>	Structure observed to exhibit very minor problems, superficial in nature. Minor erosion to landform is present. Structure / landform adequate to provide protection from a major coastal storm with no damage. Actions taken to prevent / limit future deterioration and extend life of structure.	<i>Description</i>	Inshore Structures with potential for Infrastructure Damage and/or Limited Residential Dwellings (<1 dwelling impacted / 100 feet of shoreline)

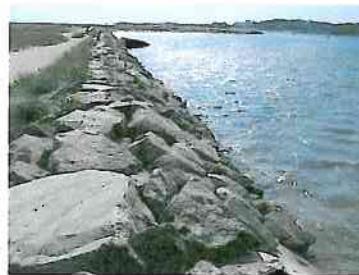
960 Feet	Feet NAVD 88	V13	13 Feet NGVD	
Primary Type:	Primary Material:	Primary Height:		
Revetment	Stone	5 to 10 Feet		
Secondary Type:	Secondary Material:	Secondary Height:

This structure is the revetment from the jetty to the front of the parking lot. There is some minor slumping and weathering of the armor stones. The structure is generally in good condition.

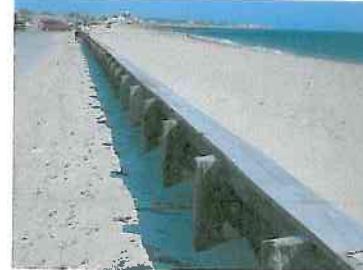
Length:	Top Elevation:	FIRM Map Zone:	FIRM Map Elevation:
735 Feet	Feet NAVD 88	V13	13 Feet NGVD
Primary Type:	Primary Material:	Primary Height:	
Bulkhead/ Seawall	Wood	5 to 10 Feet	
Secondary Type:	Secondary Material:	Secondary Height:

This structure is a bulkhead fronting the eastern-most portion of the town parking lot immediately west of the Lighthouse Inn. The cap is cracked and missing in sections and the majority of the wall is covered by beach.

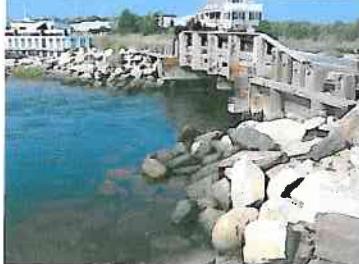
50 Feet	Feet NAVD 88	V13	13 Feet NGVD	
Primary Type:	Primary Material:	Primary Height:		
Revetment	Stone	Under 5 Feet		
Secondary Type:	Secondary Material:	Secondary Height:

These structures are the armored abutments of the Loring Ave bridge (South Side). The abutments are riprap that is generally in good condition.

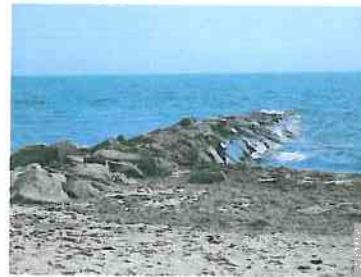
Length: Top Elevation: FIRM Map Zone: FIRM Map Elevation:  
 190 V13 15  
 Feet Feet NAVD 88 Feet NGVD

Primary Type: Primary Material: Primary Height:  
 Groin/ Jetty Stone Under 5 Feet

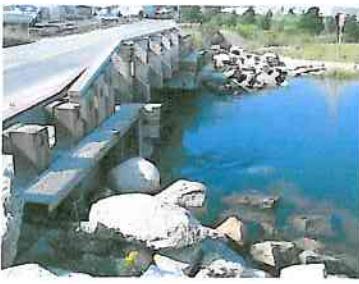
50 Feet	Feet NAVD 88	V13	13 Feet NGVD	
Primary Type:	Primary Material:	Primary Height:		
Revetment	Stone	Under 5 Feet		
Secondary Type:	Secondary Material:	Secondary Height:

These structures are the armored abutments of the Loring Ave bridge (North Side). The abutments are riprap that is generally in good condition.

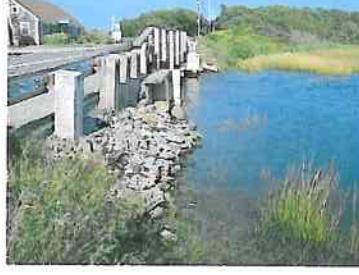
55 Feet	Feet NAVD 88	A11	11 Feet NGVD	
Primary Type:	Primary Material:	Primary Height:		
Revetment	Stone	Under 5 Feet		
Secondary Type:	Secondary Material:	Secondary Height:

These structures are the armored abutments of the Lighthouse Road bridge (South Side). The armor stones are small and in good condition.

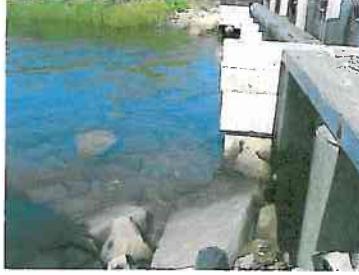
50 Feet	Feet NAVD 88	A11	11 Feet NGVD	
Primary Type:	Primary Material:	Primary Height:		
Revetment	Stone	Under 5 Feet		
Secondary Type:	Secondary Material:	Secondary Height:

These structures are the armored abutments of the Lighthouse Road bridge (North Side). The armor stones are small and in good condition.

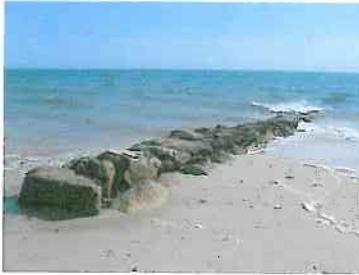
155 Feet	Feet NAVD 88	V13	15 Feet NGVD	
Primary Type:	Primary Material:	Primary Height:		
Groin/ Jetty	Stone	Under 5 Feet		
Secondary Type:	Secondary Material:	Secondary Height:		
<b>Structure Summary :</b> This structure is a groin at the end of the Trotting Park Road extension with unknown ownership. The groin is being flanked at high tide and the stone is in good condition.				
<i>Condition</i>	B	<i>Priority</i>	I	
<i>Rating</i>	Good	<i>Rating</i>	None	
<i>Level of Action</i>	Minor	<i>Action</i>	Long Term Planning Considerations	
<i>Description</i>	Structure observed to exhibit very minor problems, superficial in nature. Minor erosion to landform is present. Structure / landform adequate to provide protection from a major coastal storm with no damage. Actions taken to prevent / limit future deterioration and extend life of structure.	<i>Description</i>	No Inshore Structures or Residential Dwelling Units Present

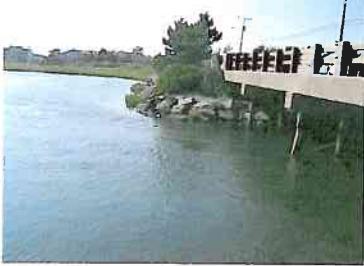
Length:	Top Elevation:	FIRM Map Zone:	FIRM Map Elevation:
60 Feet	Feet NAVD 88	A8	10 Feet NGVD
Primary Type:	Primary Material:	Primary Height:

Revetment	Stone	5 to 10 Feet	
Secondary Type:	Secondary Material:	Secondary Height:

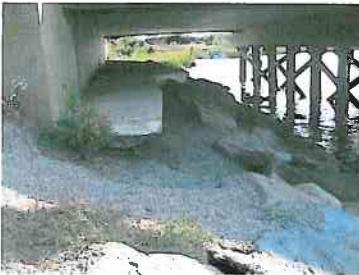
55 Feet	Feet NAVD 88	A8	10 Feet NGVD	
Primary Type:	Primary Material:	Primary Height:		
Revetment	Stone	5 to 10 Feet		
Secondary Type:	Secondary Material:	Secondary Height:

These structures are the abutments of the Lower County Road bridge that crosses the Swan River (East Side). The eastern section is beginning to slump down with a gap forming between the riprap and the bridge foundation.

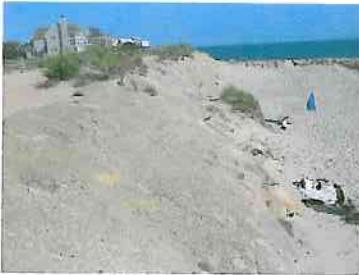
300 Feet	Feet NAVD 88	V8	17 Feet NGVD	
Primary Type:	Primary Material:	Primary Height:		
Revetment	Stone	10 to 15 Feet		
Secondary Type:	Secondary Material:	Secondary Height:

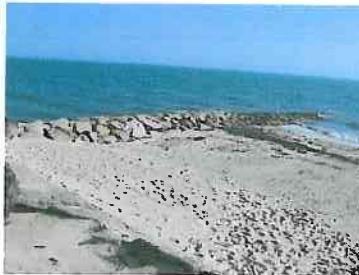
215 Feet	Feet NAVD 88	V8	17 Feet NGVD	
Primary Type:	Primary Material:	Primary Height:		
Groin/ Jetty	Stone	5 to 10 Feet		
Secondary Type:	Secondary Material:	Secondary Height:

This structure is the groin at the east of the parking lot at Haigis Beach. The crest and the side slopes are in good condition. The beach is accreted on the west side of the groin with an offset on the east side.

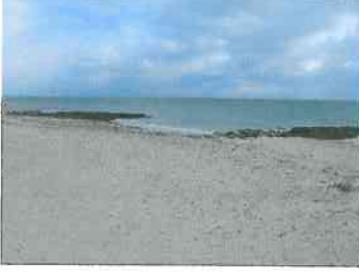
Length: 395 Feet	Top Elevation: Feet NAVD 88	FIRM Map Zone: V13	FIRM Map Elevation: 15 Feet NGVD
Primary Type: Groin/ Jetty	Primary Material: Stone	Primary Height: Under 5 Feet

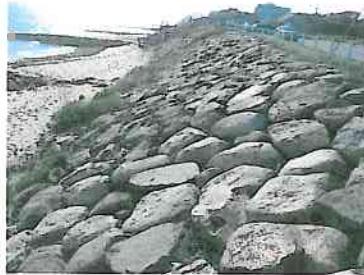
485 Feet	Feet NAVD 88	V8	20 Feet NGVD	
Primary Type:	Primary Material:	Primary Height:		
Revetment	Stone	5 to 10 Feet		
Secondary Type:	Secondary Material:	Secondary Height:

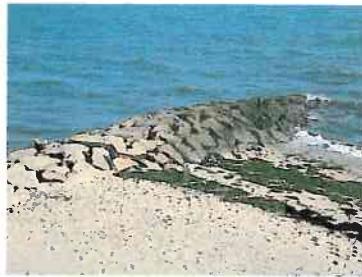
Length:	Top Elevation:	FIRM Map Zone:	FIRM Map Elevation:
290 Feet		V8	20 Feet NGVD
Primary Type:	Primary Material:	Primary Height:	
Groin/ Jetty	Stone	Under 5 Feet	
Secondary Type:	Secondary Material:	Secondary Height:

These structures are three groins at the end of Sea Street. They are generally in good condition but the heads are becoming unraveled. The central groin is shorter than the outer two structures and there is little offset in the shoreline position on either side.

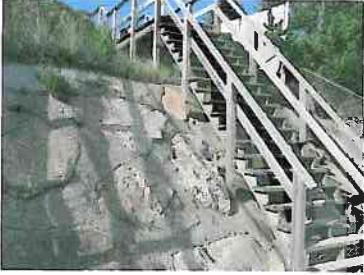
15 Feet	Feet NAVD 88	V8	20 Feet NGVD	
Primary Type:	Primary Material:	Primary Height:		
Revetment	Stone	10 to 15 Feet		
Secondary Type:	Secondary Material:	Secondary Height:

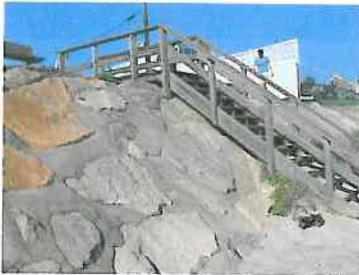
70 Feet	Feet NAVD 88	V8	20 Feet NGVD	
Primary Type:	Primary Material:	Primary Height:		
Revetment	Stone	5 to 10 Feet		
Secondary Type:	Secondary Material:	Secondary Height:

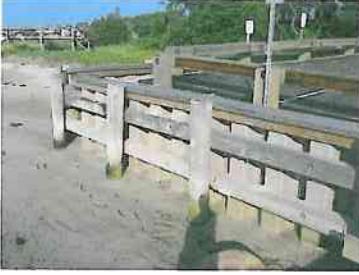
Length:	Top Elevation:	FIRM Map Zone:	FIRM Map Elevation:	
170 Feet		A11	11 Feet NGVD

Primary Type:	Primary Material:	Primary Height:		
Bulkhead/ Seawall	Wood	5 to 10 Feet		
Secondary Type:	Secondary Material:	Secondary Height:

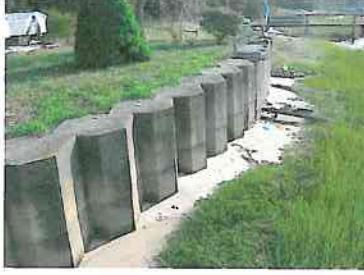
Length:	Top Elevation:	FIRM Map Zone:	FIRM Map Elevation:	
160 Feet	Feet NAVD 88	A8	8 Feet NGVD

Primary Type:	Primary Material:	Primary Height:		
Bulkhead/ Seawall	Concrete	5 to 10 Feet		
Secondary Type:	Secondary Material:	Secondary Height:

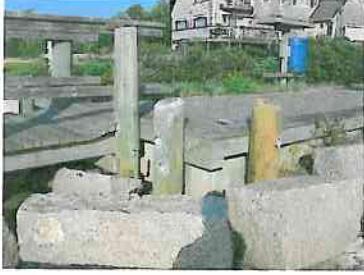
Primary Type:	Primary Material:	Primary Height:		
Bulkhead/ Seawall	Wood	5 to 10 Feet		
Secondary Type:	Secondary Material:	Secondary Height:

This structure is a wooden bulkhead at the Ferry Street landing. The timbers are clear and in good condition. The structure is fronted by stacked granite blocks.

<i>Condition</i>	A	<i>Priority</i>	II
<i>Rating</i>	Excellent	<i>Rating</i>	Low Priority
<i>Level of Action</i>	None	<i>Action</i>	Future Project Consideration
<i>Description</i>	Like new condition. Structure expected to withstand major coastal storm without damage. Stable landform (beach, dune or bank). Adequate system exists to provide protection from major coastal storm.	<i>Description</i>	Inshore Structures Present with Limited potential for Significant Infrastructure Damage

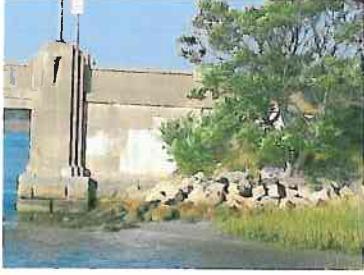
Primary Type:	Primary Material:	Primary Height:		
Revetment	Stone	5 to 10 Feet		
Secondary Type:	Secondary Material:	Secondary Height:

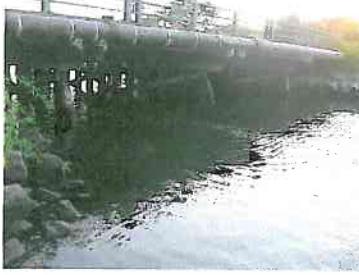
Primary Type:	Primary Material:	Primary Height:		
Revetment	Stone	Under 5 Feet		
Secondary Type:	Secondary Material:	Secondary Height:

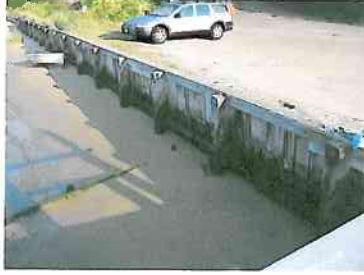
175 Feet	Feet NAVD 88	A6	8 Feet NGVD	
Primary Type:	Primary Material:	Primary Height:		
Bulkhead/ Seawall	Wood	5 to 10 Feet		
Secondary Type:	Secondary Material:	Secondary Height:

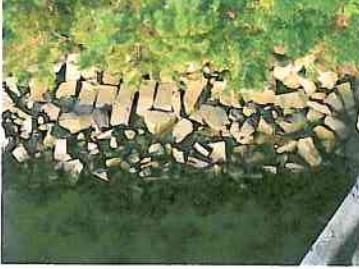
Primary Type:	Primary Material:	Primary Height:		
Revetment	Stone	Under 5 Feet		
Secondary Type:	Secondary Material:	Secondary Height:

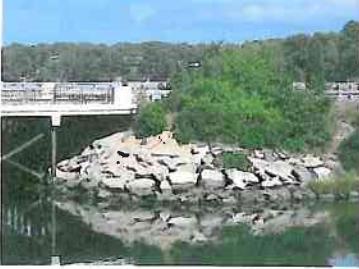
Length:	Top Elevation:	FIRM Map Zone:	FIRM Map Elevation:
510 Feet	Feet NAVD 88	A4	6 Feet NGVD
Primary Type:	Primary Material:	Primary Height:	
Revetment	Stone	5 to 10 Feet	
Secondary Type:	Secondary Material:	Secondary Height:

These structures are the Route 6 bridge abutments over the Bass River. They are generally in good condition but the armor is partially unraveled at the water line. The toe section appears to be partially slumping.

<i>Condition</i>	C	<i>Priority</i>	IV
<i>Rating</i>	Fair	<i>Rating</i>	High Priority
<i>Level of Action</i>	Moderate	<i>Action</i>	Consider for Next Project Construction Listing
<i>Description</i>	Structure is sound but may exhibit minor deterioration, section loss, cracking, spalling, undermining, and/or scour. Structure adequate to withstand major coastal storm with little to moderate damage. Actions taken to reinforce structure to provide full protection from major coastal storm and for extending life of structure. Moderate wind or wave damage to landform exists. Landform may not be sufficient to fully protect shoreline during a major coastal storm. Actions taken to provide addition material for full protection and extended life.	<i>Description</i>	High Value Inshore Structures with Potential for Infrastructure Damage and/or Moderate Density Residential Dwellings ( 1-10 dwellings impacted / 100 feet of shoreline)

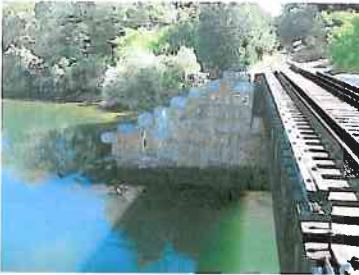
Bulkhead/ Seawall	Stone	10 to 15 Feet	
Secondary Type:	Secondary Material:	Secondary Height:

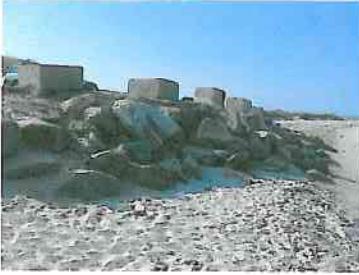
45 Feet	Feet NAVD 88	V4	15 Feet NGVD	
Primary Type:	Primary Material:	Primary Height:		
Revetment	Stone	5 to 10 Feet		
Secondary Type:	Secondary Material:	Secondary Height:

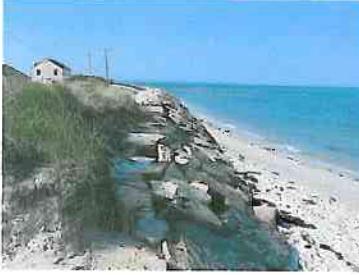
520 Feet	Feet NAVD 88	V4	15 Feet NGVD	
Primary Type:	Primary Material:	Primary Height:		
Revetment	Stone	10 to 15 Feet		
Secondary Type:	Secondary Material:	Secondary Height:

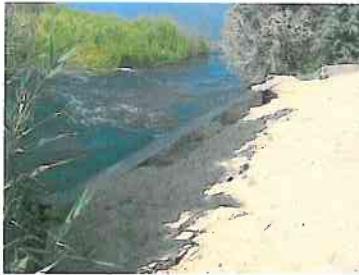
30 Feet	Feet NAVD 88	A3	11 Feet NGVD	
Primary Type:	Primary Material:	Primary Height:		
Bulkhead/ Seawall	Wood	5 to 10 Feet		
Secondary Type:	Secondary Material:	Secondary Height:

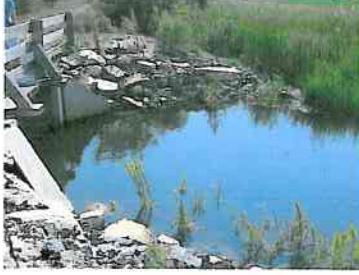
15 Feet	Feet NAVD 88	A3	11 Feet NGVD	
Primary Type:	Primary Material:	Primary Height:		
Revetment	Stone	Under 5 Feet		
Secondary Type:	Secondary Material:	Secondary Height:

These structures are the abutments at Sea Street (north side). There are new concrete abutments at the footpath over the creek. The concrete and riprap are in good condition.

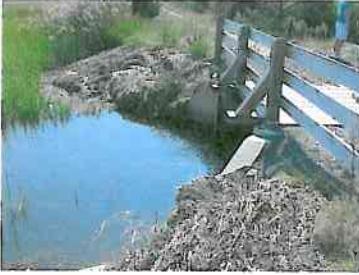
15 Feet	Feet NAVD 88	A3	11 Feet NGVD	
Primary Type:	Primary Material:	Primary Height:		
Revetment	Stone	Under 5 Feet		
Secondary Type:	Secondary Material:	Secondary Height:

These structures are the abutments at Sea Street (south side). There are new concrete abutments at the footpath over the creek. The concrete and riprap are in good condition.

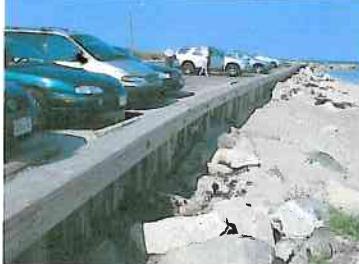
345 Feet	Feet NAVD 88	V4	15 Feet NGVD	
Primary Type:	Primary Material:	Primary Height:		
Bulkhead/ Seawall	Wood	Under 5 Feet		
Secondary Type:	Secondary Material:	Secondary Height:

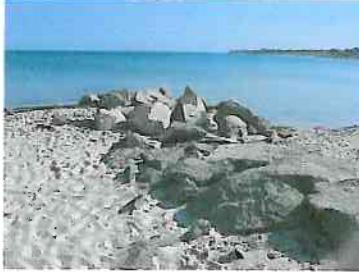
65 Feet	Feet NAVD 88	V4	16 Feet NGVD	
Primary Type:	Primary Material:	Primary Height:		
Groin/ Jetty	Stone	Under 5 Feet		
Secondary Type:	Secondary Material:	Secondary Height:

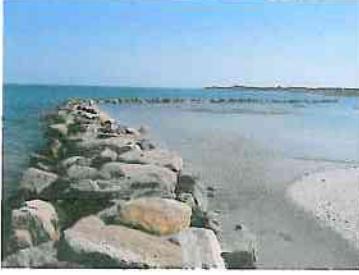
Length:	Top Elevation:	FIRM Map Zone:	FIRM Map Elevation:
740 Feet		V4	17 Feet NGVD
Primary Type:	Primary Material:	Primary Height:	
Breakwater	Stone	5 to 10 Feet	
Secondary Type:	Secondary Material:	Secondary Height:

This structure is a stone breakwater at Nobscusset Harbor. The armor at the west end and on the sides is becoming unraveled. The crest elevation along the outer portion is markedly lower than the body of the structure. The stones at the outer end show no interlocking.

<i>Condition</i>	D	<i>Priority</i>	I
<i>Rating</i>	Poor	<i>Rating</i>	None
<i>Level of Action</i>	Major	<i>Action</i>	Long Term Planning Considerations
<i>Description</i>	Structure exhibits advanced levels of deterioration, section loss, cracking, spalling, undermining, and/or scour. Structure has strong risk of significant damage and possible failure during a major coastal storm. Structure should be monitored until repairs/reconstruction can be initiated. Actions taken to reconstruct structure to regain full capacity to resist a major coastal storm. Landform eroded, stability threatened. Landform not adequate to provide protection during major coastal storm. Actions taken to recreate landform to adequate limits for full protection from a major coastal storm.		
<i>Description</i>		No Inshore Structures or Residential Dwelling Units Present

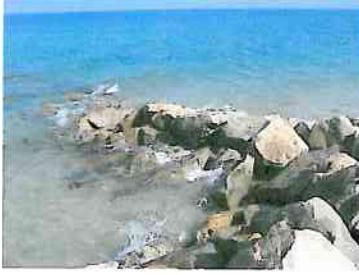
300 Feet	Feet NAVD 88	V4	16 Feet NGVD	
Primary Type:	Primary Material:	Primary Height:		
Groin/ Jetty	Stone	Under 5 Feet		
Secondary Type:	Secondary Material:	Secondary Height:

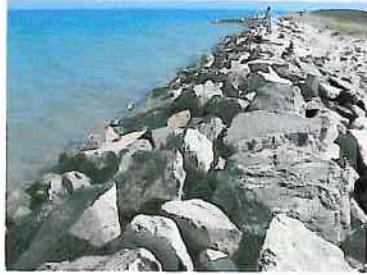
485 Feet	Feet NAVD 88	V4	16 Feet NGVD	
Primary Type:	Primary Material:	Primary Height:		
Revetment	Stone	5 to 10 Feet		
Secondary Type:	Secondary Material:	Secondary Height:

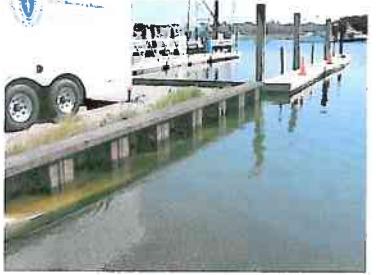
50 Feet	Feet NAVD 88	A3	11 Feet NGVD	
Primary Type:	Primary Material:	Primary Height:		
Bulkhead/ Seawall	Steel	10 to 15 Feet		
Secondary Type:	Secondary Material:	Secondary Height:

This structure is a bulkhead at the town landing inside Sesuit Harbor. The front and cap are rusted and weathered. There is a small amount of erosion of the fill behind the southeast corner.

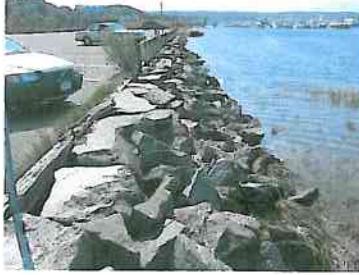
380 Feet	Feet NAVD 88	A4	12 Feet NGVD	
Primary Type:	Primary Material:	Primary Height:		
Revetment	Stone	5 to 10 Feet		
Secondary Type:	Secondary Material:	Secondary Height:

This structure is a bulkhead on the east side of Sesuit Harbor fronted by a stone revetment. The wooden bulkhead is weathered and deteriorating and the revetment appears to be in good condition.

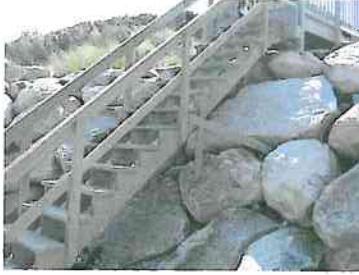
20 Feet	Feet NAVD 88	V4	16 Feet NGVD	
Primary Type:	Primary Material:	Primary Height:		
Revetment	Stone	10 to 15 Feet		
Secondary Type:	Secondary Material:	Secondary Height:

This structure is a stairway with a stone revetment at the end of Stephen Phillip Road. The side slopes and crest are in good condition. The stone shows some minor discoloration from weathering.

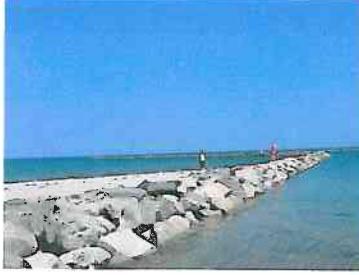
1020 Feet	Feet NAVD 88	V4	17 Feet NGVD	
Primary Type:	Primary Material:	Primary Height:		
Groin/ Jetty	Stone	10 to 15 Feet		
Secondary Type:	Secondary Material:	Secondary Height:

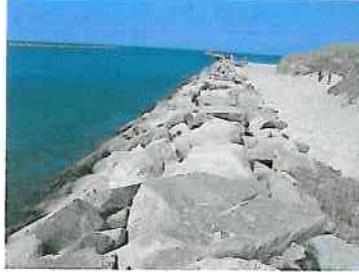
Length:	Top Elevation:	FIRM Map Zone:	FIRM Map Elevation:
1720 Feet		V4	15 Feet NGVD
Primary Type:	Primary Material:	Primary Height:	
Groin/ Jetty	Stone	10 to 15 Feet	
Secondary Type:	Secondary Material:	Secondary Height:

This structure is the east jetty at Sesuit Harbor. The jetty is generally in good condition. There is some slumping of the armor stone. Some erosion is evident behind the landward end.

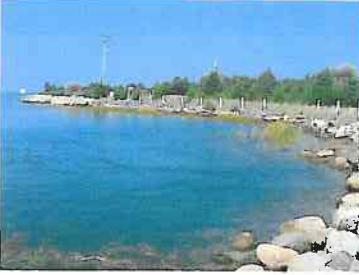
435 Feet	Feet NAVD 88	A4	12 Feet NGVD	
Primary Type:	Primary Material:	Primary Height:		
Revetment	Stone	5 to 10 Feet		
Secondary Type:	Secondary Material:	Secondary Height:

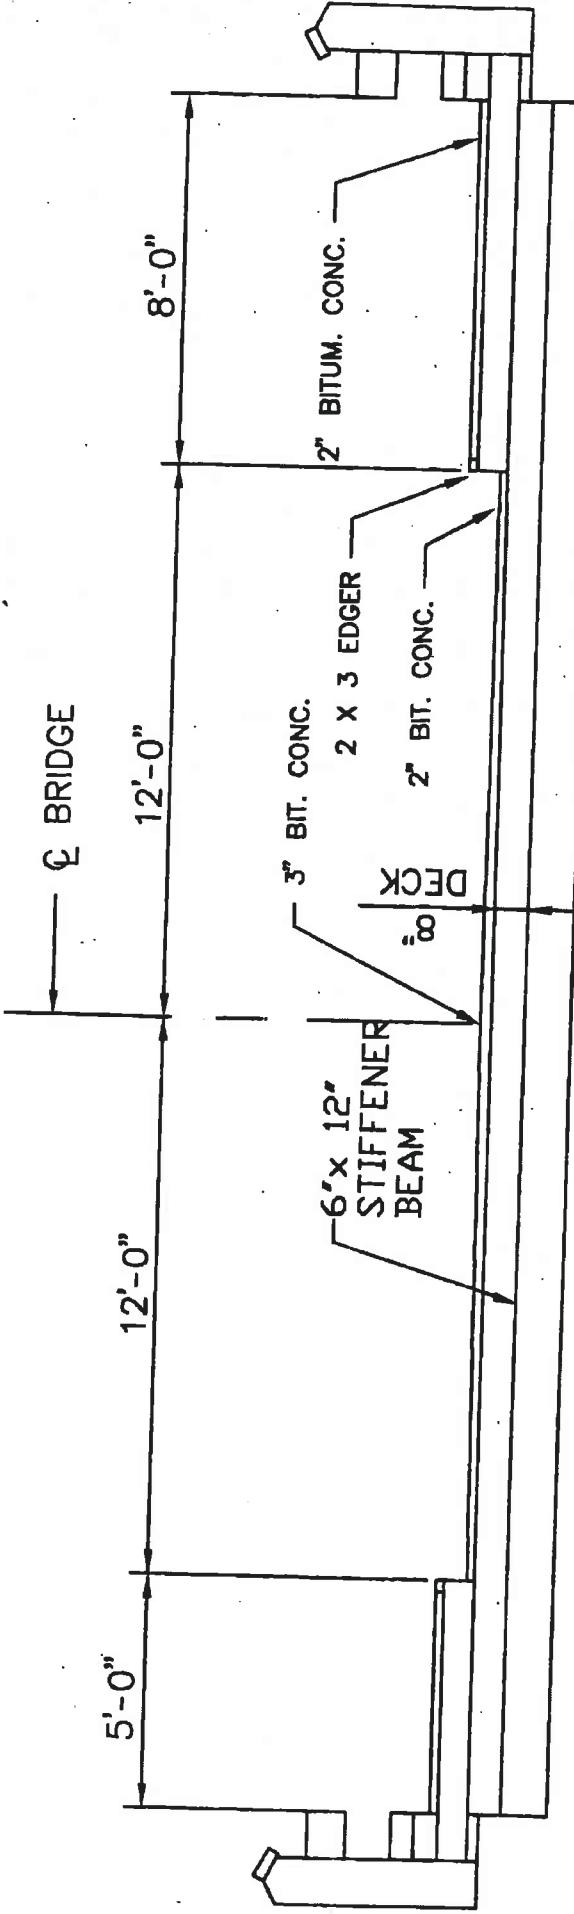
TYPICAL BRIDGE SECTION AT STIFFENER BEAM

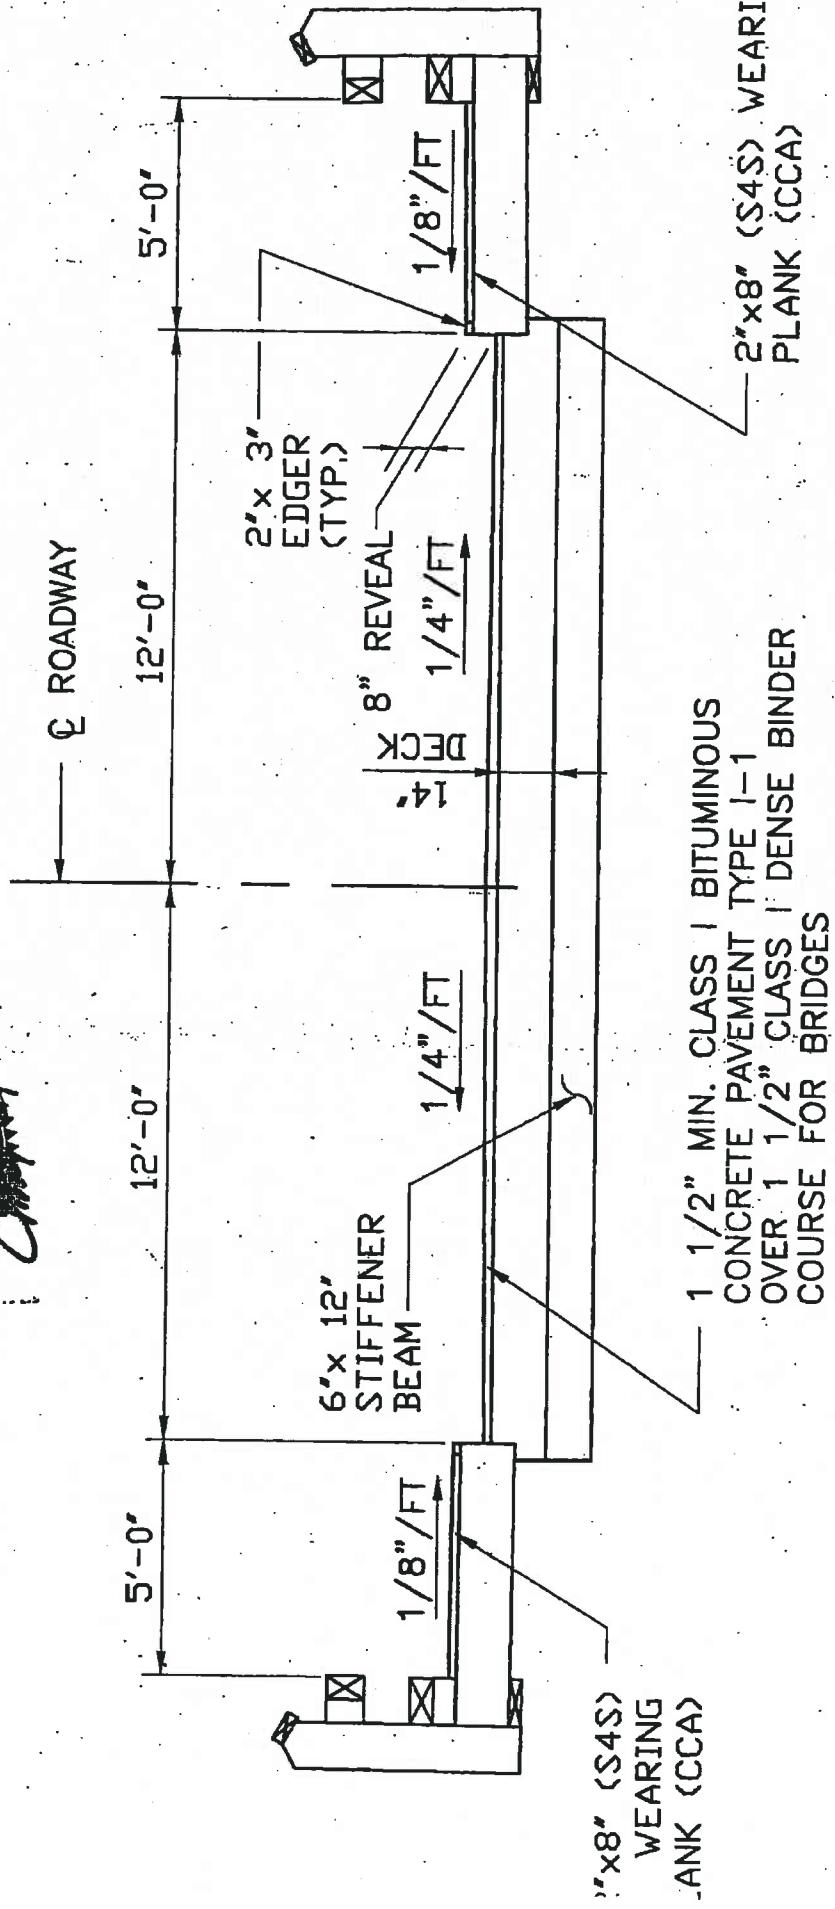
## TYPICAL BRIDGE SECTION AT STIFFENER BEAM

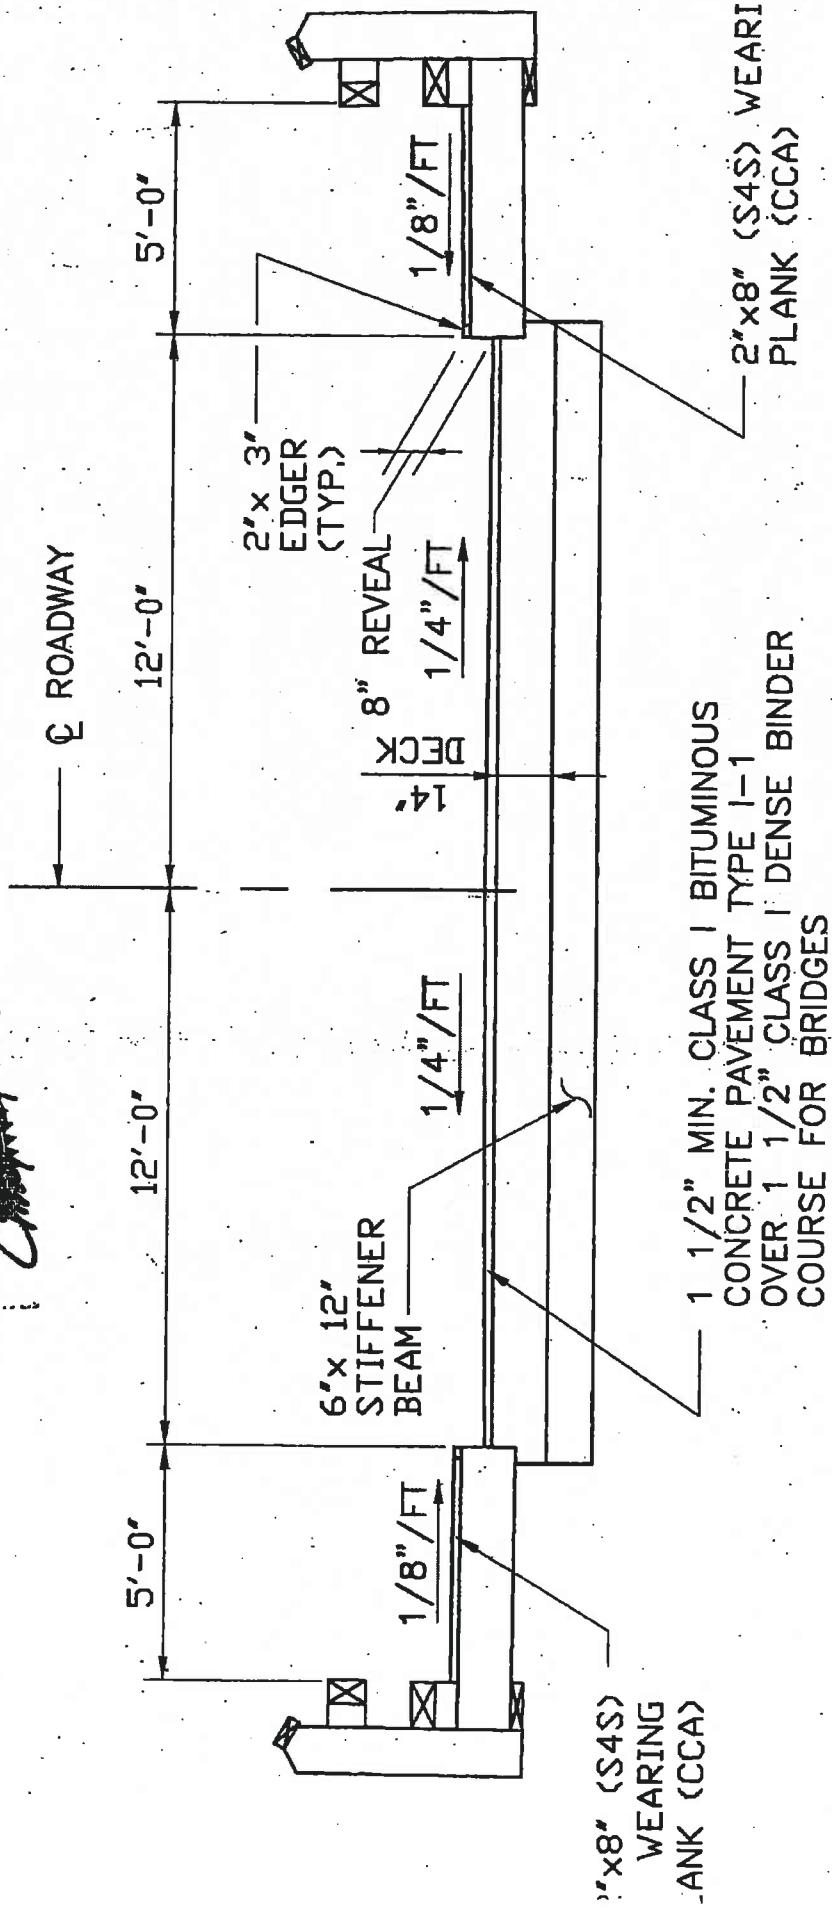
TYPICAL BRIDGE SECTION AT STIFFENER BEAM
