*Massachusetts Coastal Infrastructure  
Inventory and Assessment Project*  
*Massachusetts Department of Conservation and Recreation*  
*Office of Waterways*

## Middle Cape Cod

Barnstable  
Yarmouth  
Dennis

**MASSACHUSETTS COASTAL INFRASTRUCTURE INVENTORY AND ASSESSMENT PROJECT**

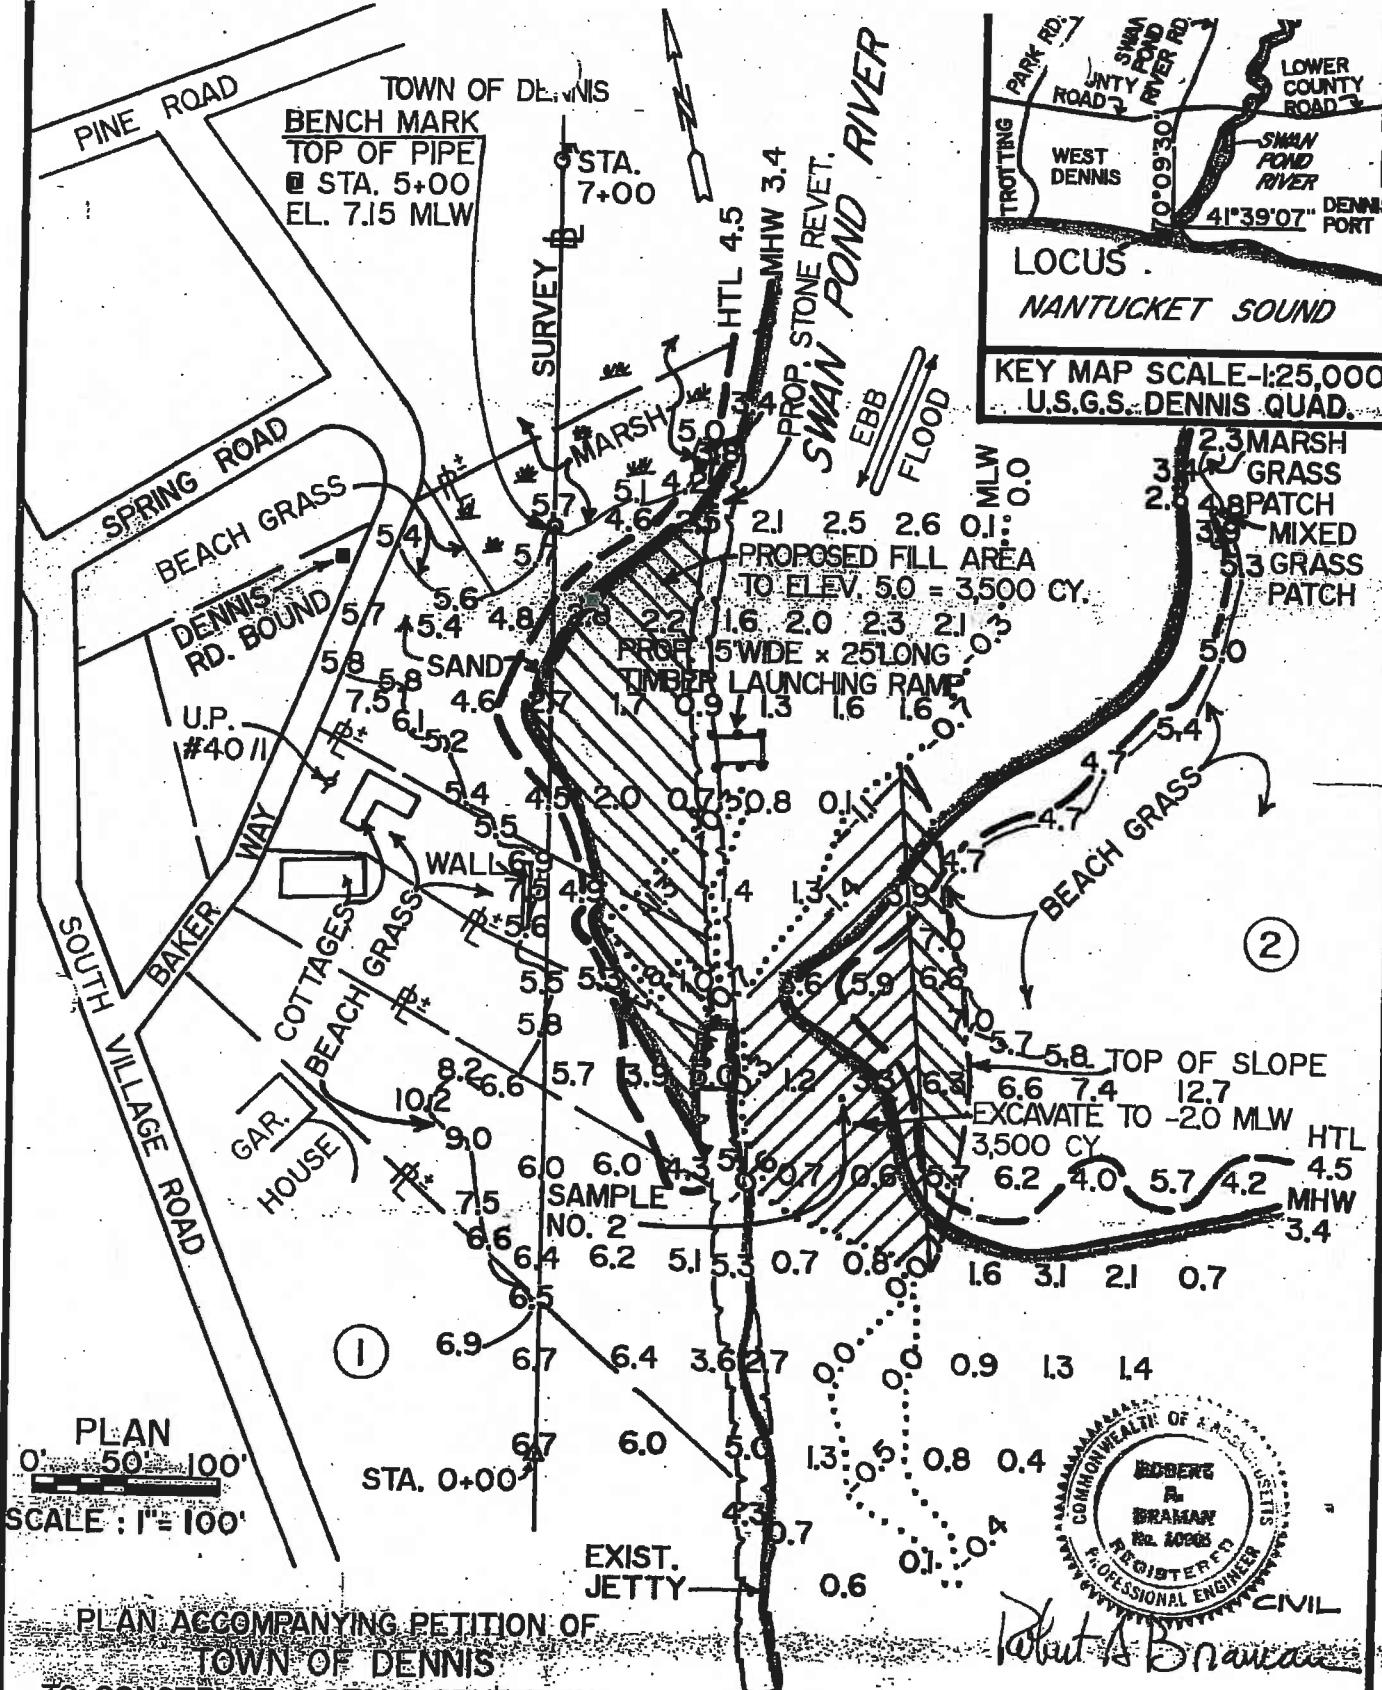
PLAN ACCOMPANYING PETITION OF  
TOWN OF DENNIS  
TO CONSTRUCT A STONE REVETMENT,  
CHANNEL EXCAVATION, &  
TIMBER LAUNCHING RAMP

SWAN POND RIVER  
WEST DENNIS, BARNSTABLE CO., MA.  
AUGUST 1, 1989 SHEET 1 OF 3  
BRAMAN ENGINEERING COMPANY, LTD.  
CIVIL ENGINEERS AND SURVEYORS  
200 MAIN ST. BURTONS BAY MA

016-015-000-045-100	016-015-000-045-100-LIC1A	2423	DEP	Dennis	September 19, 1990	Plan Accompanying Petition of Town of Dennis to Construct A Stone Revetment, Channel Excavation, and Timber Launching Ramp	3	Swan Pond River/ Swan Pond River Road	Stone Groin/Jetty
016-021-000-059-100	016-021-000-059-100-LIC1A	770	DEP	Dennis	July 1981	Plan Accompanying Petition of Town of Dennis to Reconstruct an Existing Groin and Portion of Beach - Nantucket Sound - Dennis, Massachusetts	2	Sea Street Beach	Groin and Revetment
016-021-000-059-200	016-021-000-059-200-LIC2A	770	DEP	Dennis	July 1981	Plan Accompanying Petition of Town of Dennis to Reconstruct an Existing Groin and Portion of Beach - Nantucket Sound - Dennis, Massachusetts	2	Sea Street Beach	Groin and Revetment
016-043-000-014-100	016-043-000-014-100-LIC1A	9270	DEP	Dennis	May 10, 2002	Plan To Accompany Petition of Town of Dennis to License, Reconstruct and Maintain an Existing Boat Launch Facility in Bass River	5	Bass River, Uncle Freeman's Road	Wood Bulkhead/Seawall

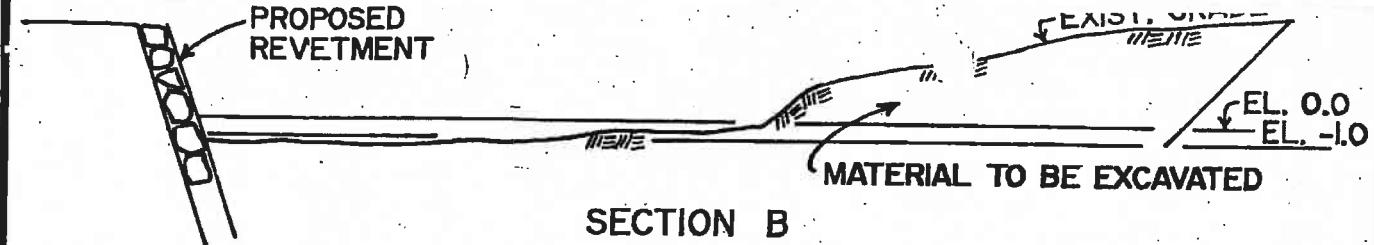
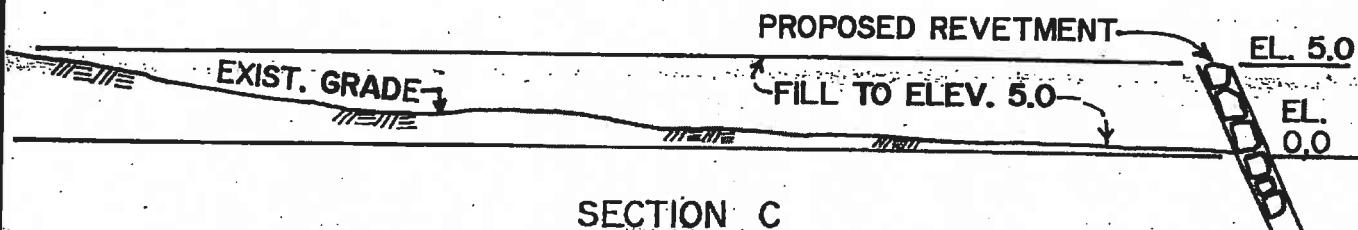
SECTION C  
NOT TO SCALE

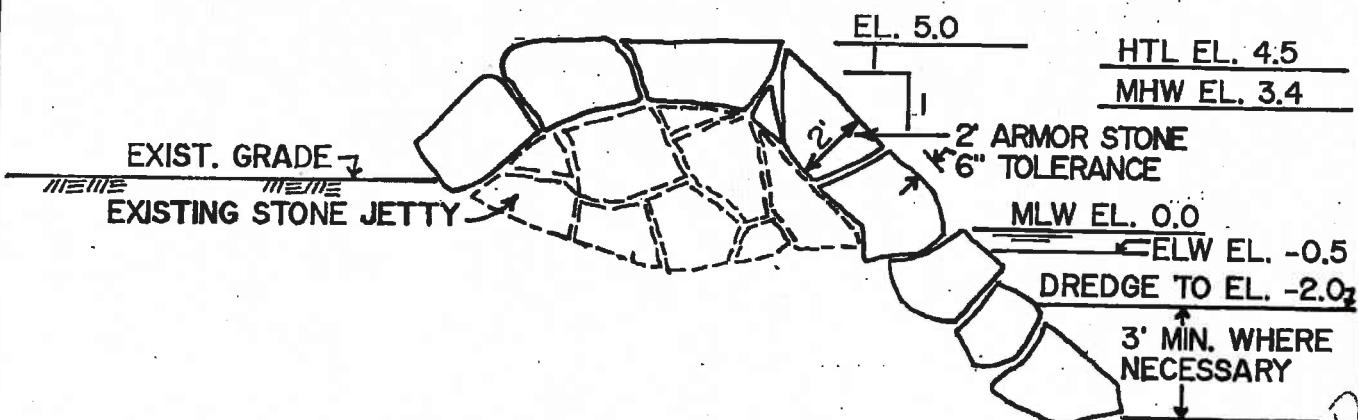
SECTION D  
SCALE : 1" = 5'

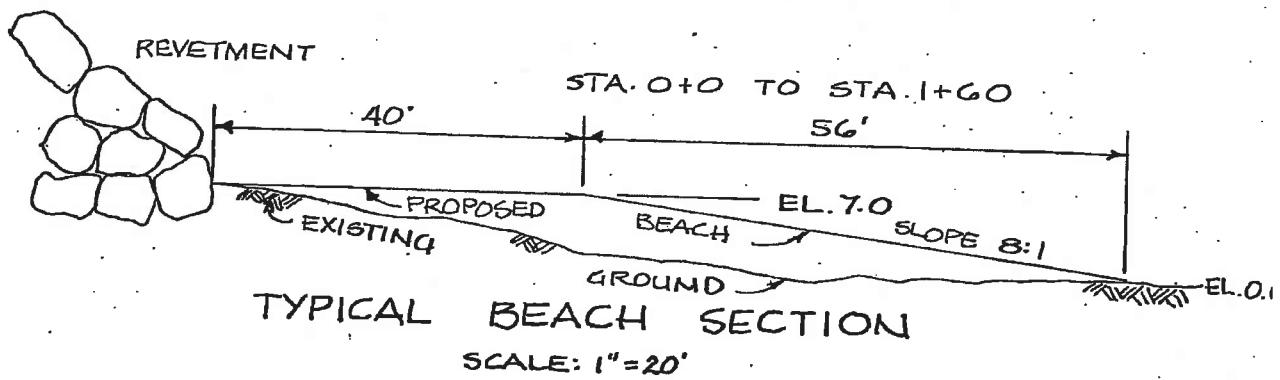
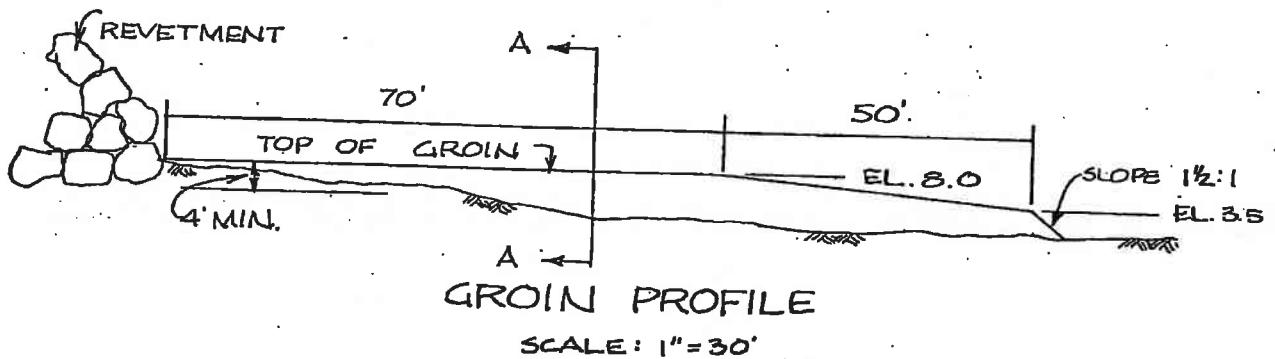
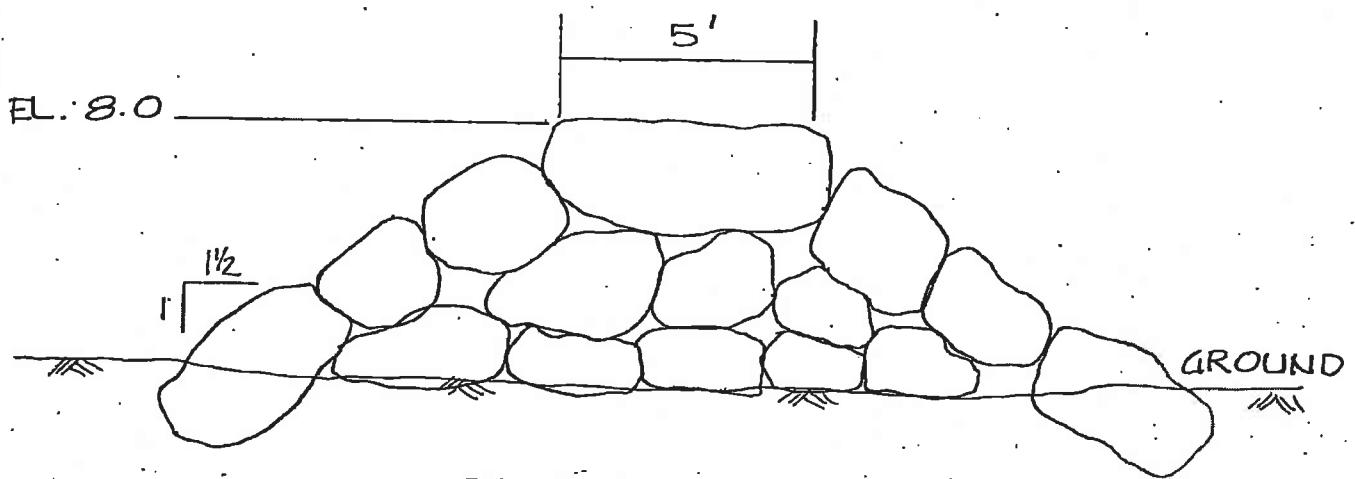
LICENSE PLAN NO. 770

SECTION A-A  
GROIN SECTION - TYPICAL  
SCALE: 1"=4'

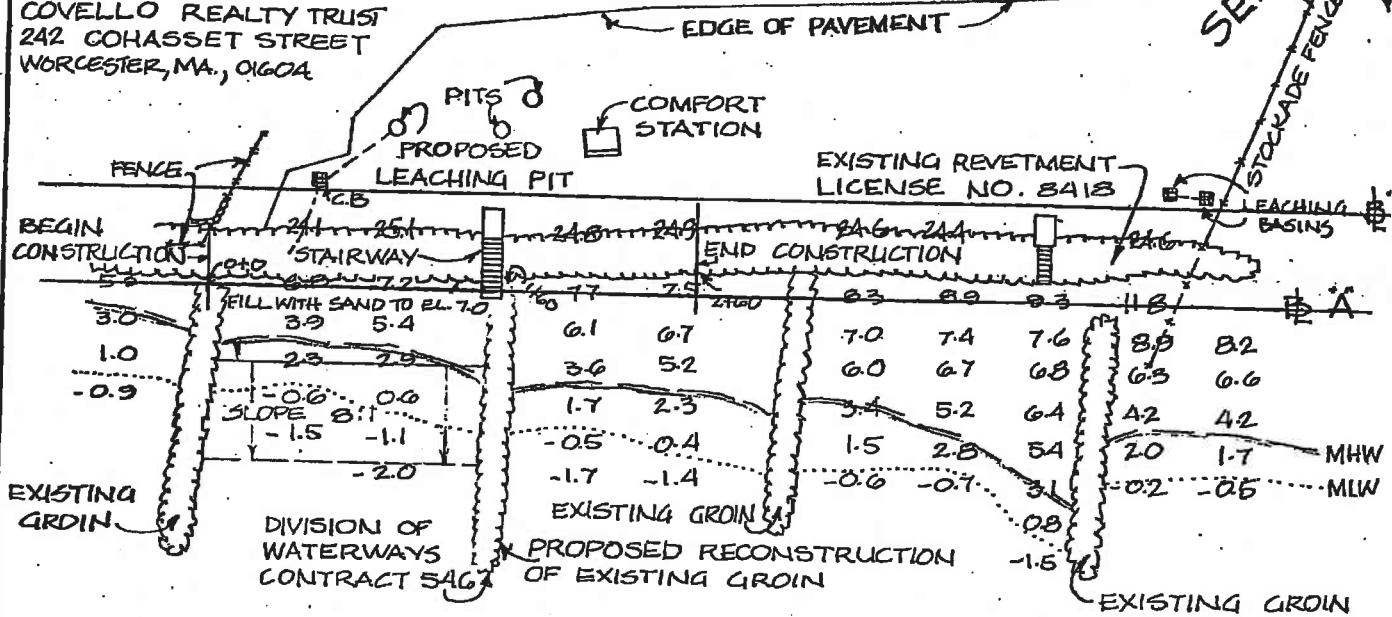
### PLAN

ELEVATIONS ARE IN FEET AND TENTHS  
ON THE PLANE OF MEAN LOW WATER  
MINUS FIGURES REPRESENT ELEVATIONS  
BELOW THAT PLANE.

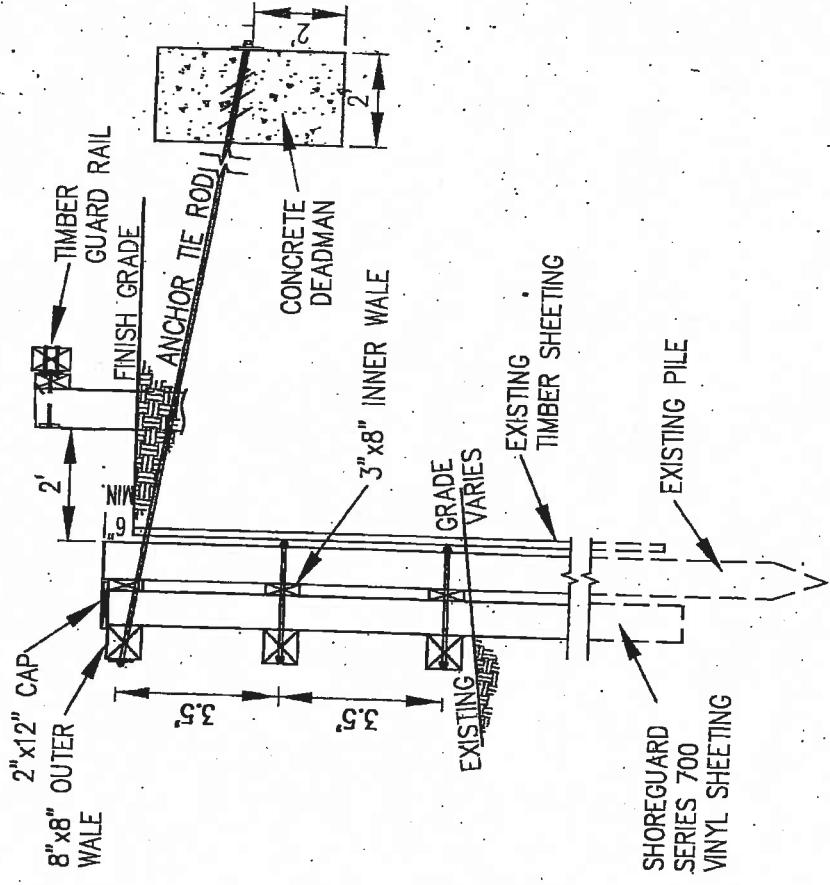
BULKHEAD-SECTION

SCALE 1" = 4'

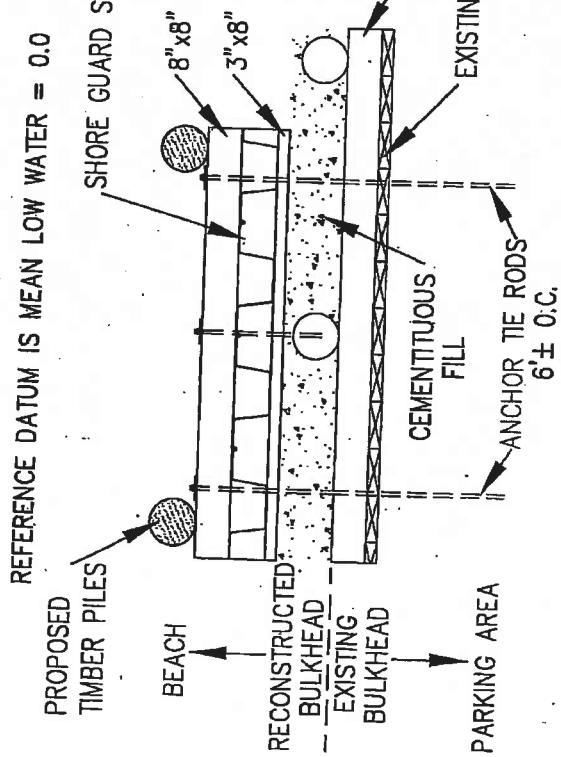
BULKHEAD-PLAN VIEW

SCALE 1" = 4'

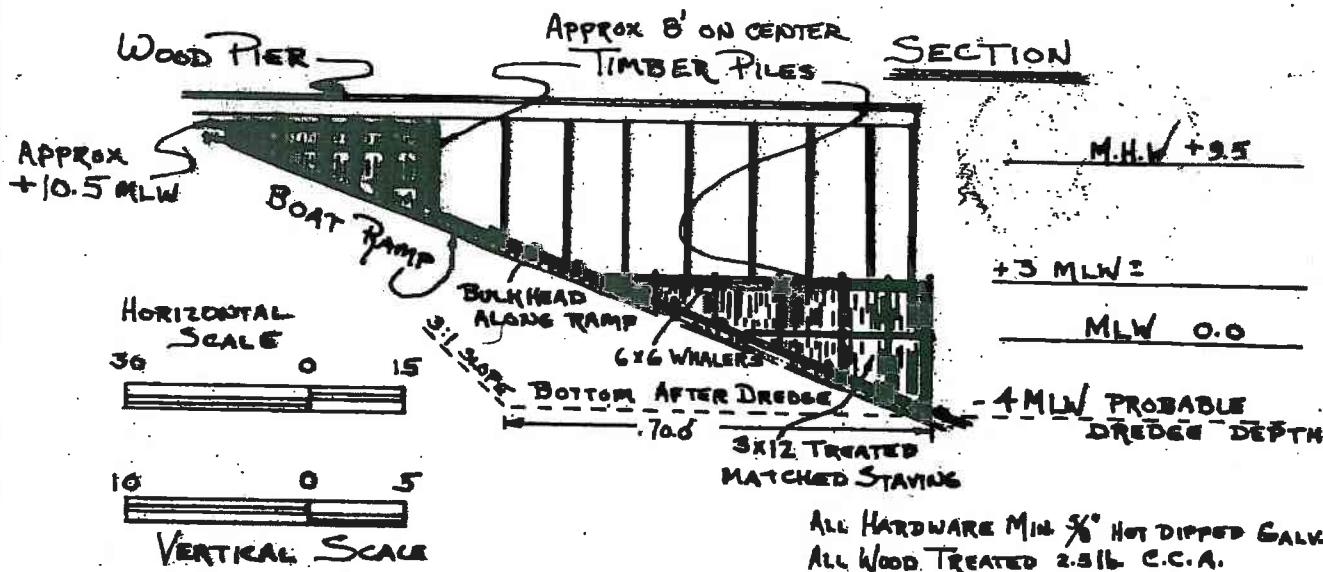
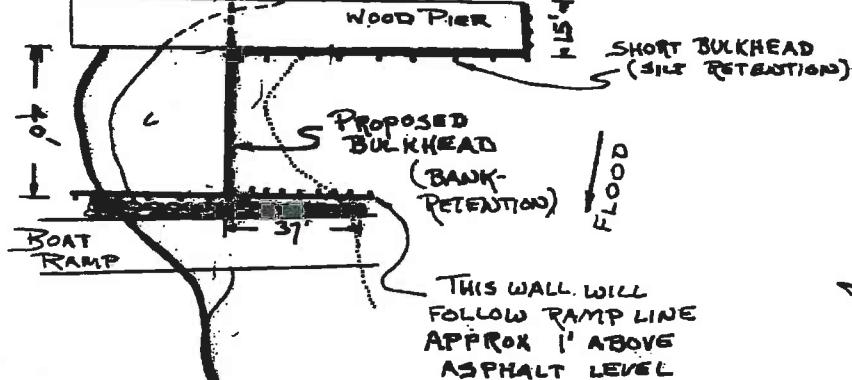
PURPOSE: TO KEEP DOCKING FACILITY FROM SILTING & BANK AROUND PIER  
FROM ERODING

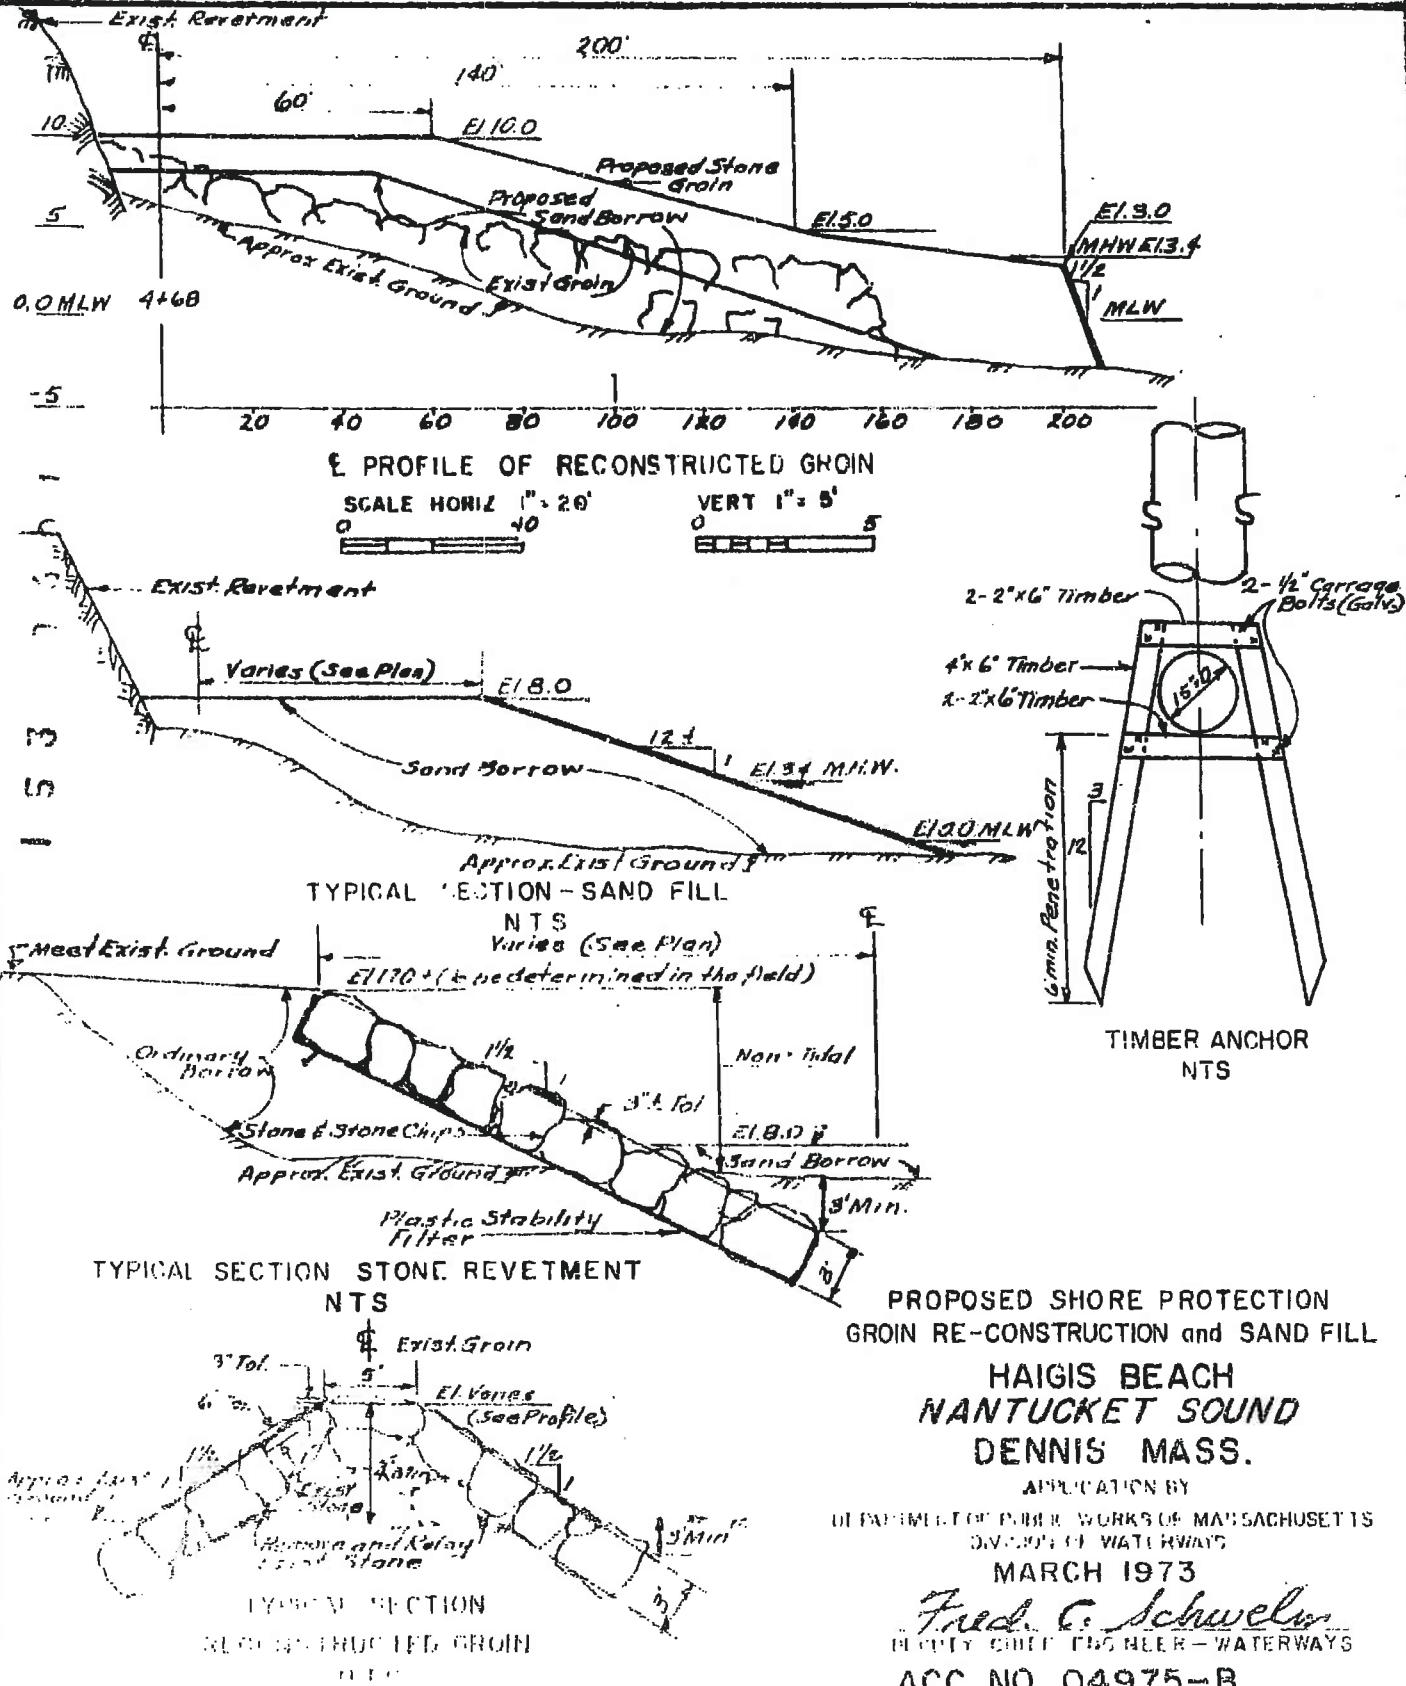
PROPOSED SHORE PROTECTION  
GROIN RE-CONSTRUCTION and SAND FILL

HAIGIS BEACH  
NANTUCKET SOUND  
DENNIS MASS.

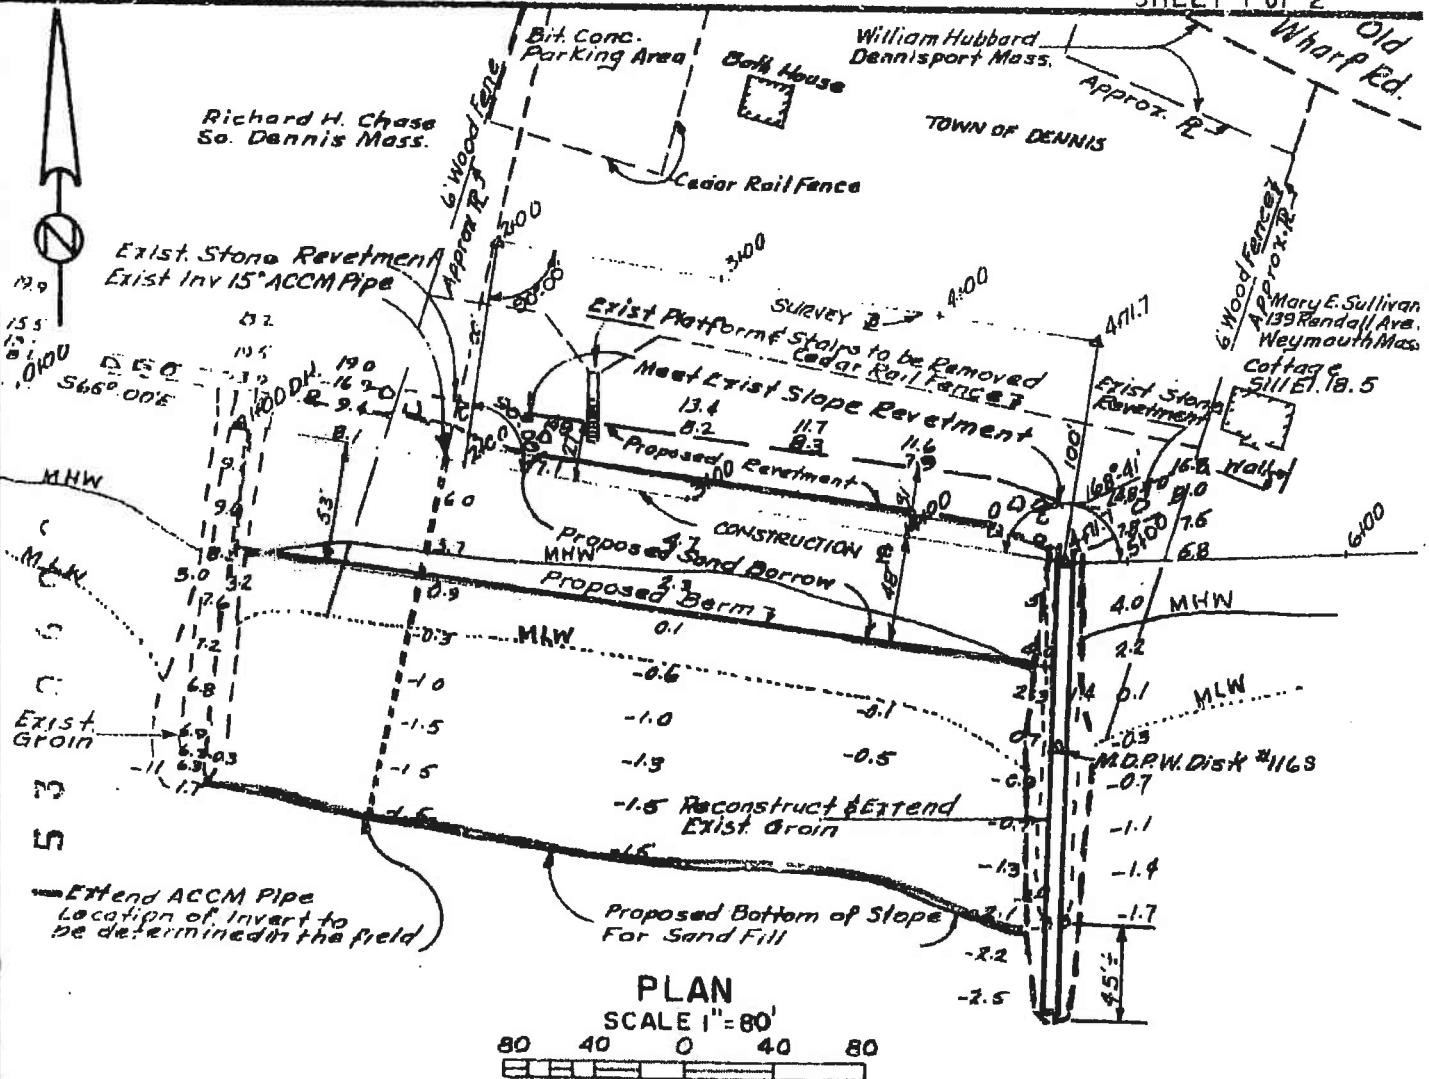
SHEET 1 of 2

**NOTE:** Elevations are in feet and tenths and refer to the plane of Mean Low Water, minus figures denote depths below that plane.  
TBM Elev.15.17 MLW iron collar oil fill pipe of bath house.  
Date of Survey April 1972

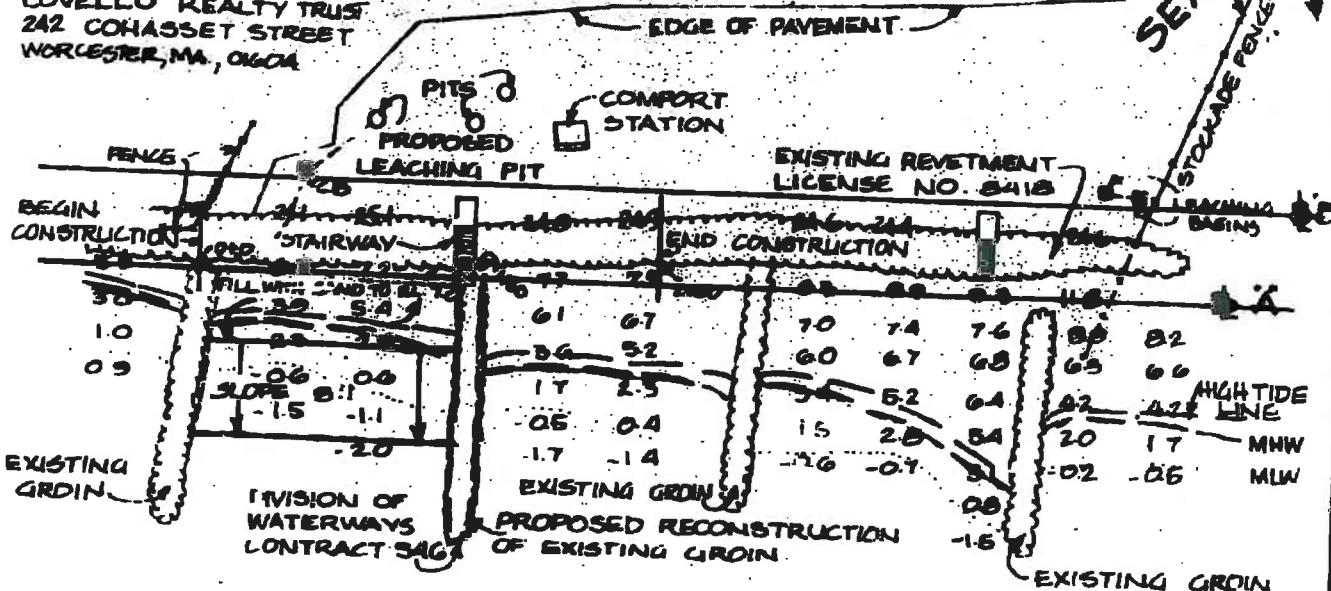
### PLAN

700 C.Y. OF SAND BELOW HIGH TIDE LINE.  
200 C.Y. OF CRUSHED STONE BELOW HIGH TIDE LINE.

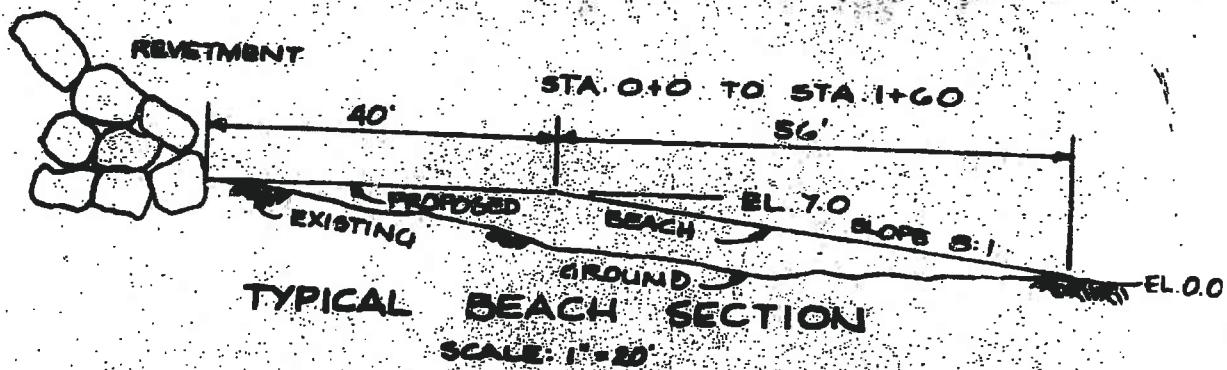
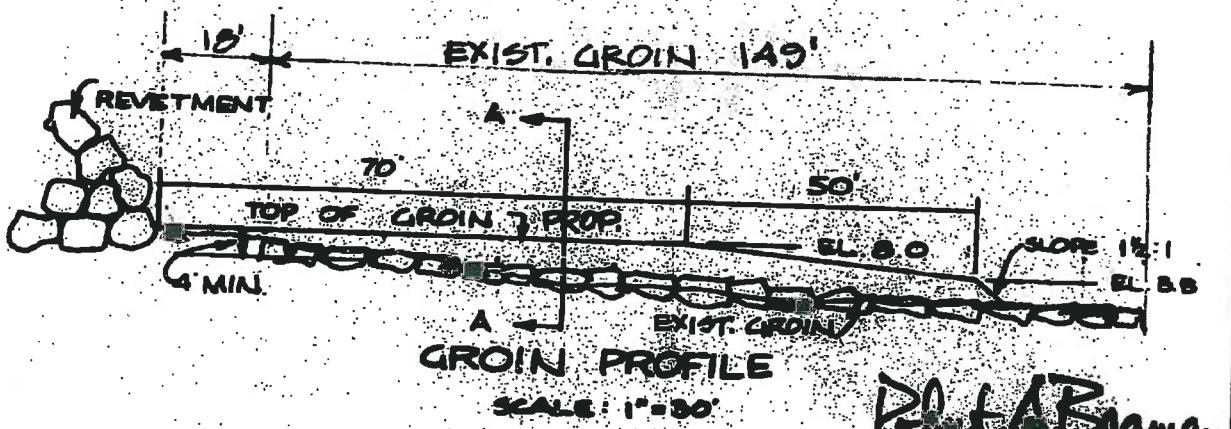
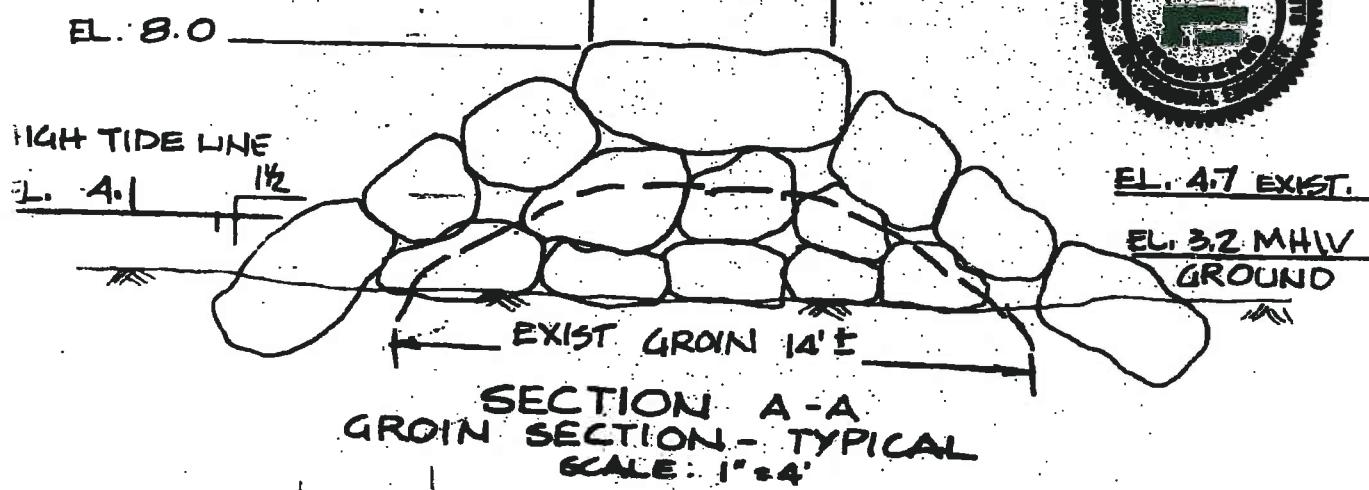
SIDE AND END SLOPES OF GROINS ARE 1/3:1  
APPROX. EXISTING GROUND SHOWN THUS ITTIN  
LOCATION OF PROPOSED WORK SHOWN IN RED.

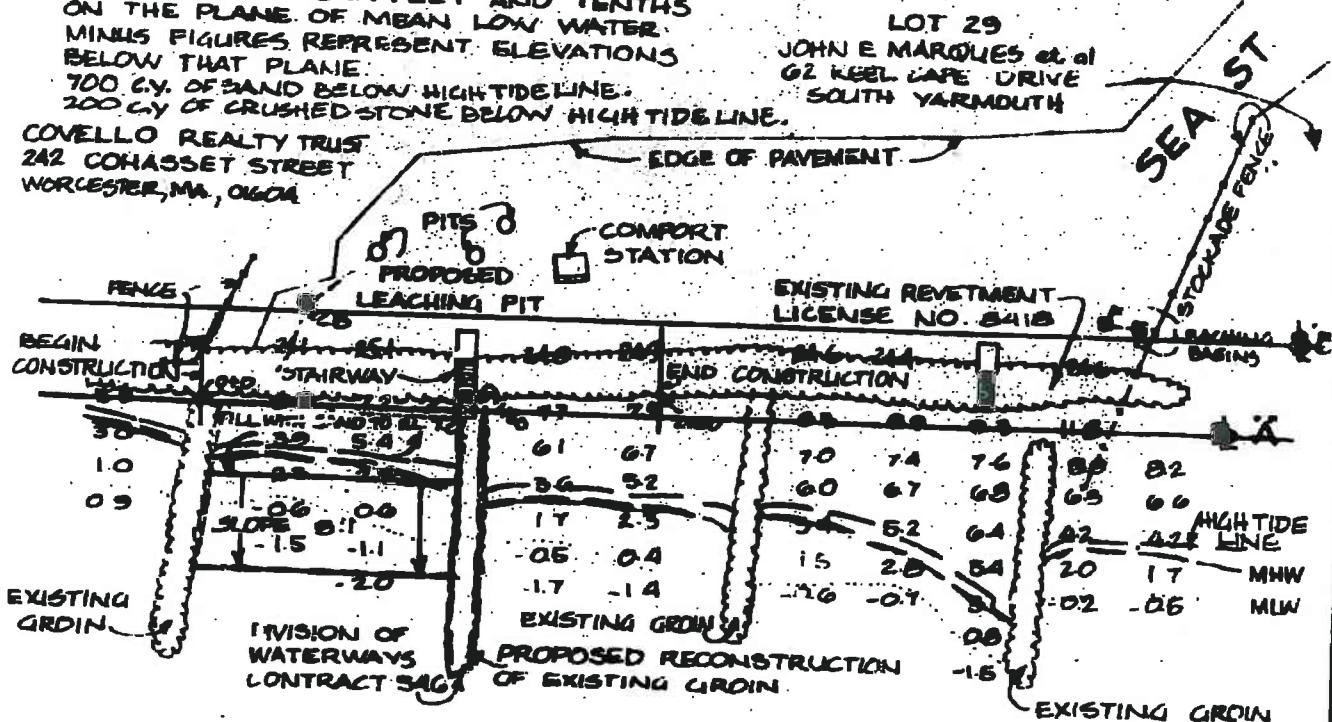
### PLAN

ELEVATIONS ARE IN FEET AND TENTHS  
ON THE PLANE OF MEAN LOW WATER.  
MINUS FIGURES REPRESENT ELEVATIONS  
BELOW THAT PLANE.  
700 C.Y. OF SAND BELOW HIGH TIDE LINE.  
200 C.Y. OF CRUSHED STONE BELOW HIGH TIDE LINE.

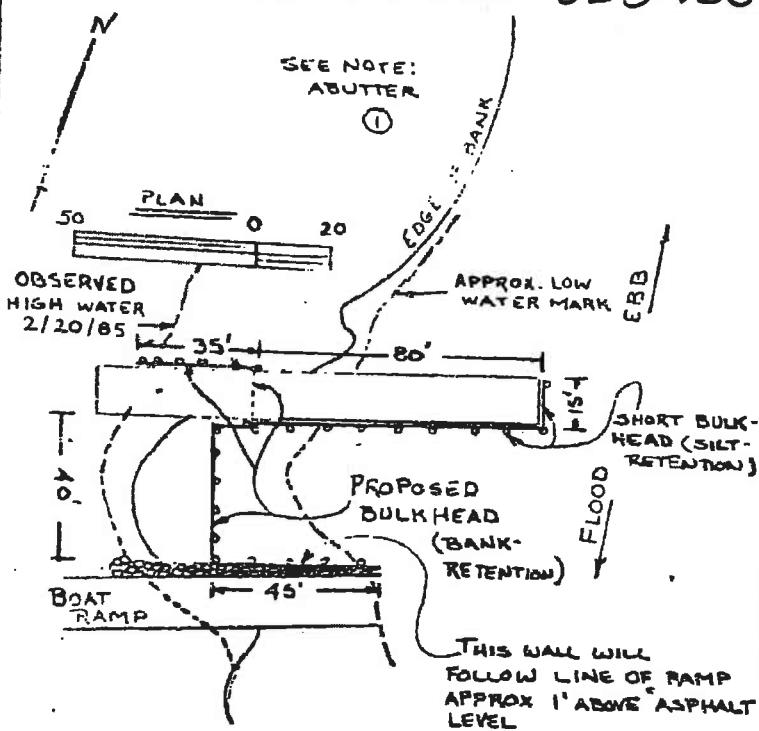
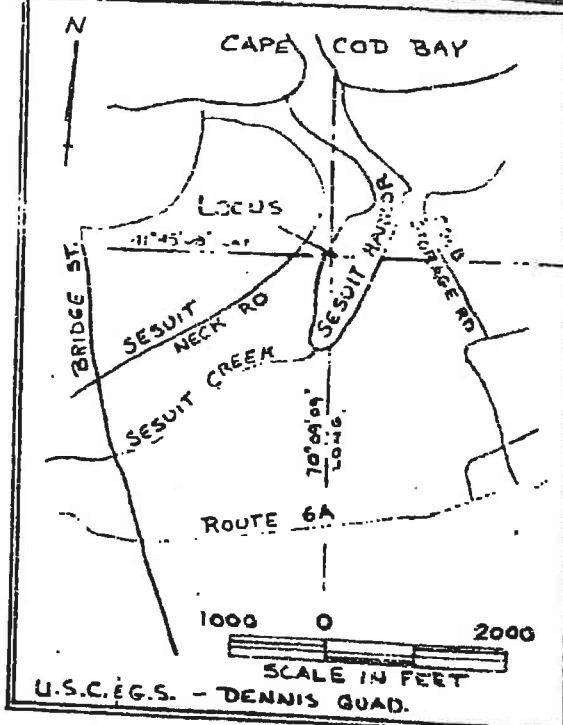
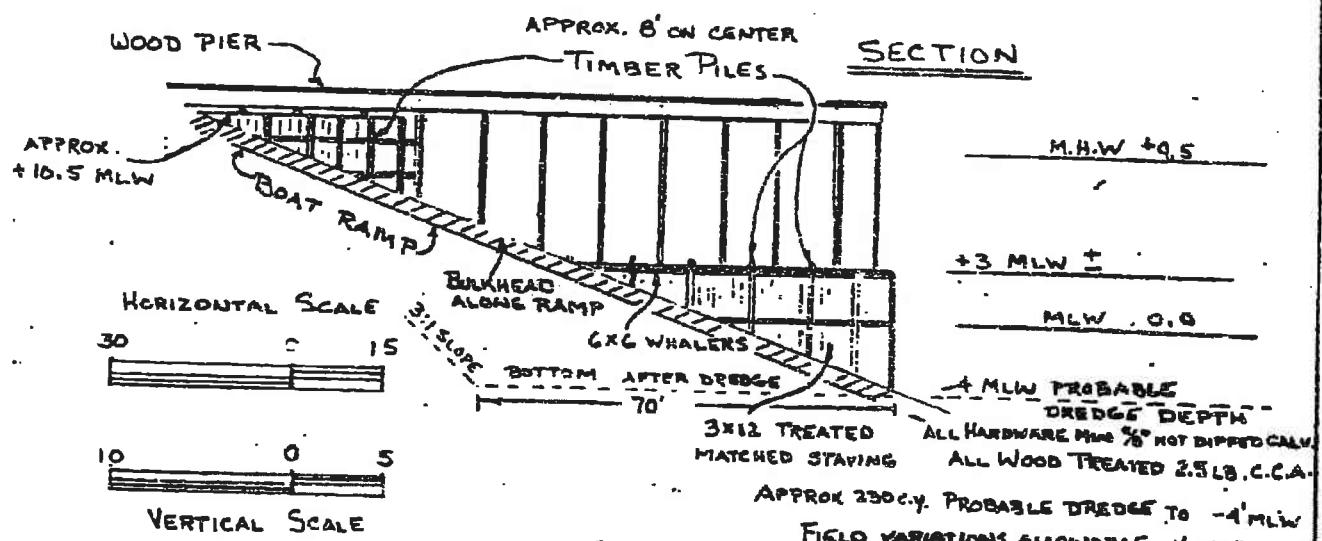
016-410-000-023-100

PURPOSE: TO KEEP DOCKING FACILITY  
FROM SILTING & BANK AROUND PIER FROM  
ERODING.

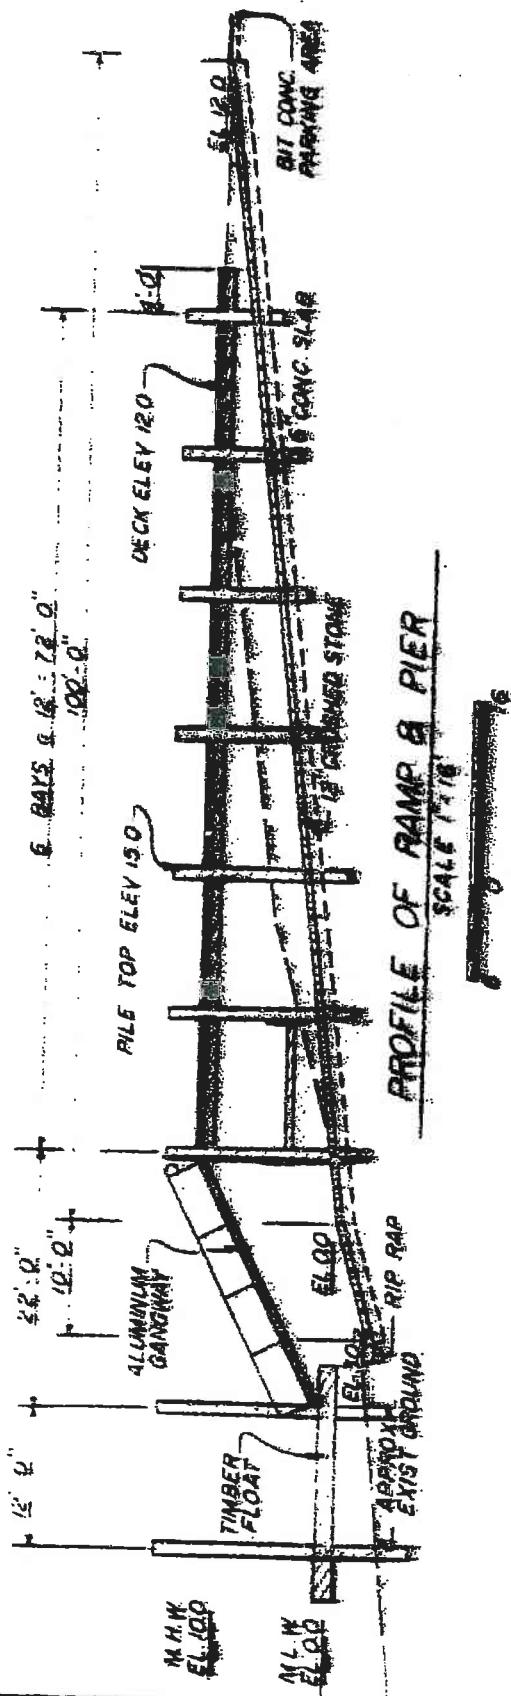
PROFILE OF RAMP & PIER  
SCALE 1:16

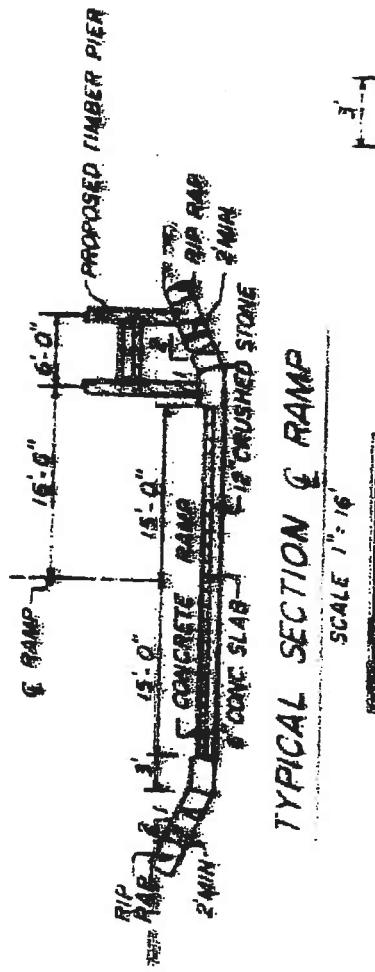
TYPICAL SECTION & RAMP  
SCALE 1:16

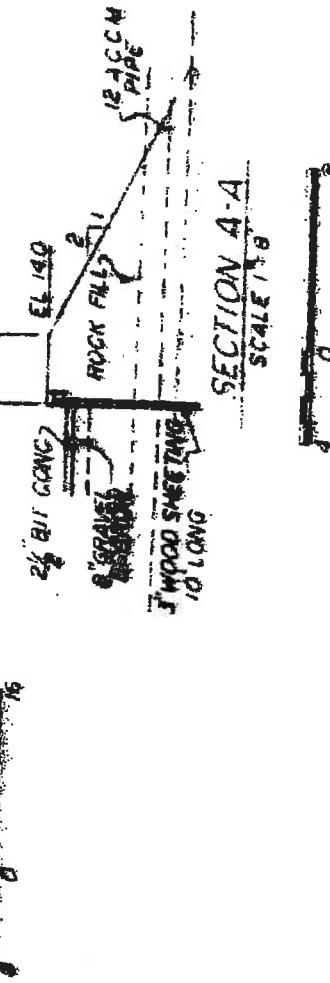
SECTION A-A  
SCALE 1:16

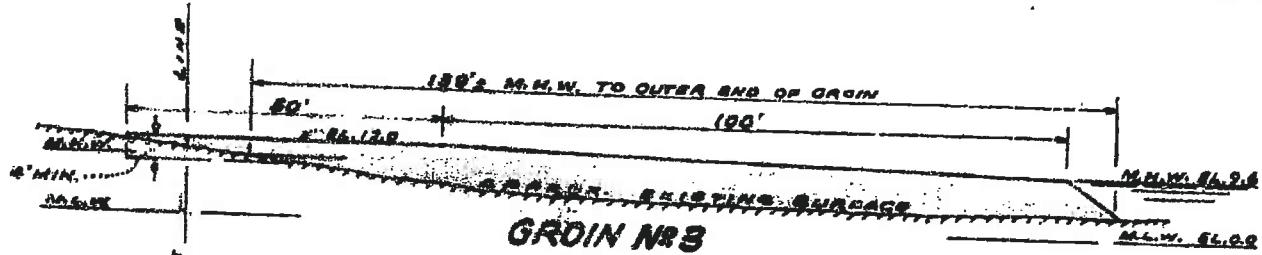
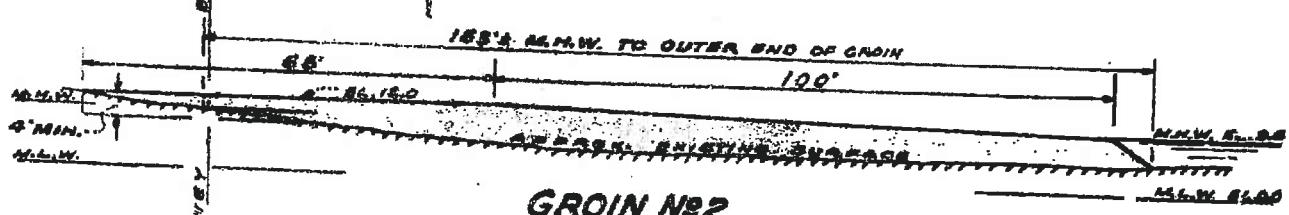
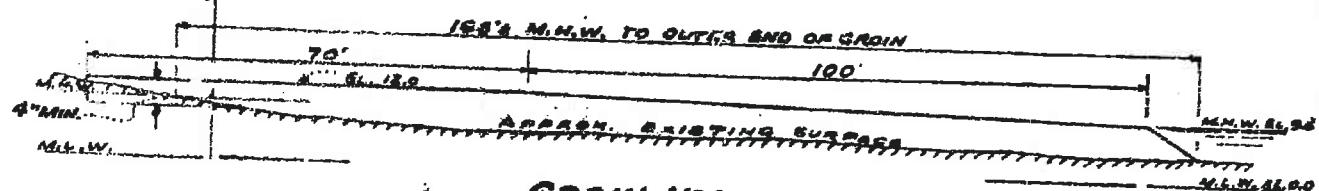
**PROFILES - PROPOSED GROINS**

SCALE - FEET  
1" = 30'

PROPOSED JETTY AND GROIN CONSTRUCTION  
**SEQUIT HARBOR**  
DENNIS MASS.  
APPLICATION BY  
DEPARTMENT OF PUBLIC WORKS OF MASSACHUSETTS  
DIVISION OF WATERWAYS  
JUNE 1954  
SCALES SHOWN

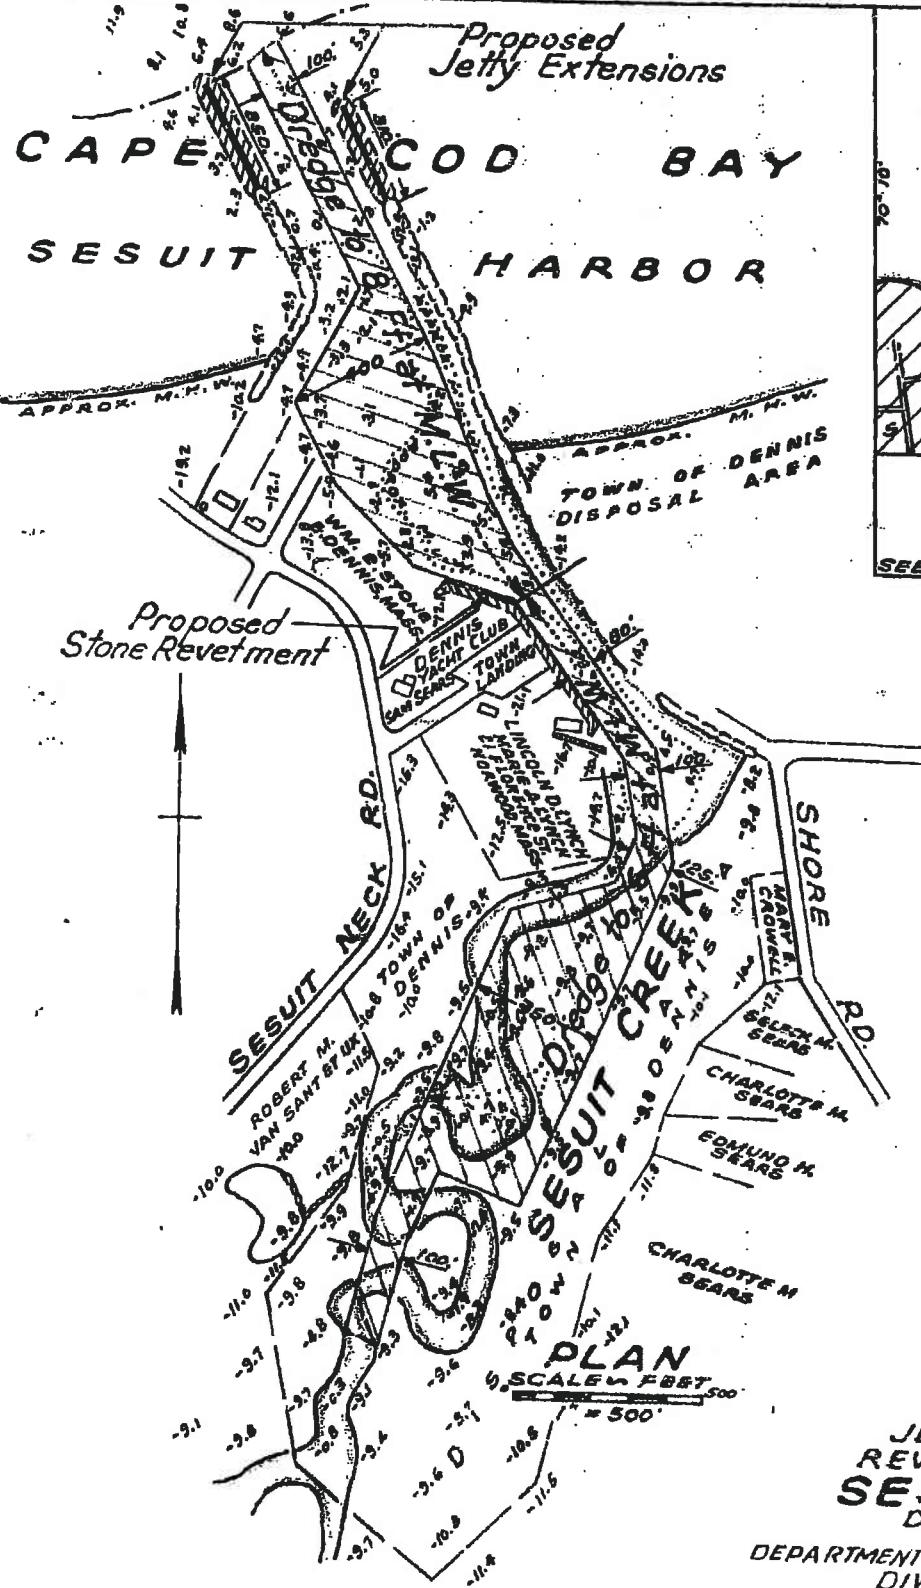
**NOTE**  
SOUNDINGS ARE IN FEET AND TENTHS  
AND REFER TO PLANE OF MEAN LOW  
WATER. MINUS FIGURES SHOW ELEVATIONS  
ABOVE THE SAME PLANE.  
HYDRAULICALLY DREDGED MATERIAL  
APPROX. 870,000 CUBIC YARDS TO BE DISPOSED  
OF ON ADJACENT TOWN OF DENNIS PROPERTY  
IN SUCH MANNER THAT IT WILL  
NOT RE ENTER TIDEWATER AND WITH  
THE FINAL TOP AREA NEATLY GRADED  
TO AN ELEVATION NOT EXCEEDING 16 FT.  
ABOVE MEAN LOW WATER.  
LOCATION PROPOSED DREDGING IN R.D.  
SEE SHEET 2 FOR JETTY EXTENSION AND  
REVESTMENT DETAILS.

**PROPOSED  
JETTY EXTENSIONS  
REVESTMENT AND DREDGING  
SESUIT HARBOR  
DENNIS - MASS.  
APPLICATION BY  
DEPARTMENT OF PUBLIC WORKS - MASSACHUSETTS  
DIVISION OF WATERWAYS  
MAY - 1958**
