*Massachusetts Coastal Infrastructure  
Inventory and Assessment Project*  
*Massachusetts Department of Conservation and Recreation*  
*Office of Waterways*

## Middle Cape Cod

Barnstable  
Yarmouth  
Dennis

**MASSACHUSETTS COASTAL INFRASTRUCTURE INVENTORY AND ASSESSMENT PROJECT**

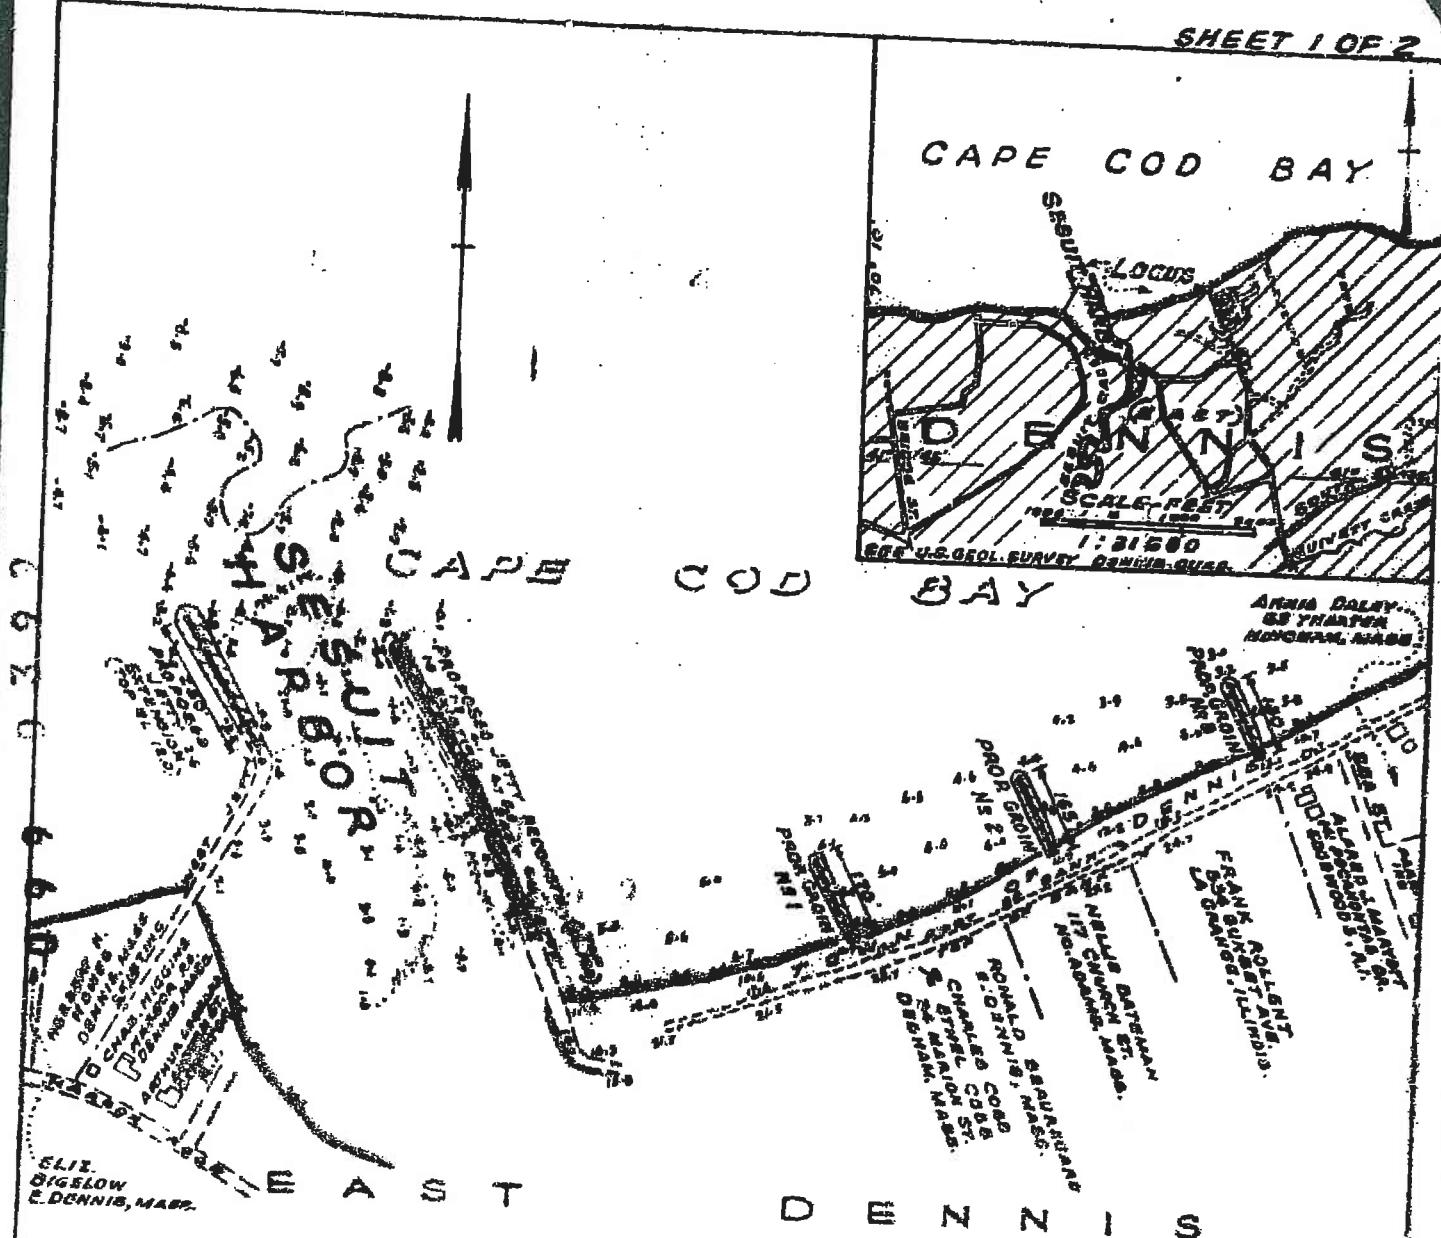
ELEVATIONS ARE IN FEET AND TENTHS ABOVE  
THE PLANE OF MEAN LOW WATER. MINUS  
FIGURES SHOW DEPTHS BELOW SAME PLANE.  
LOCATIONS OF PROPOSED WORK ARE SHOWN  
IN RED.

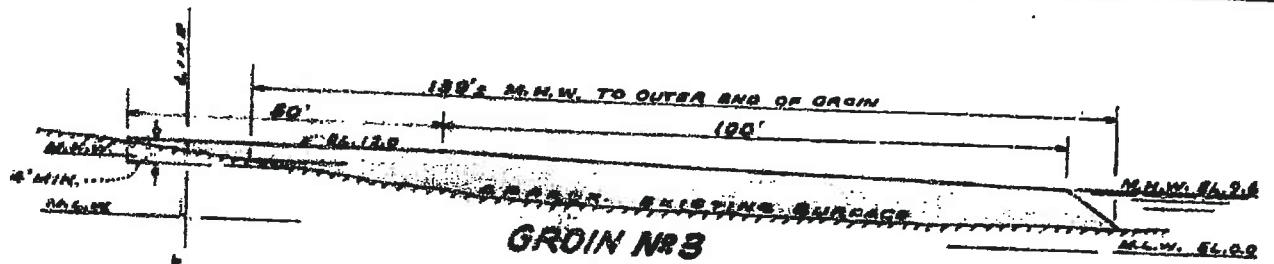
GROIN NO. 3

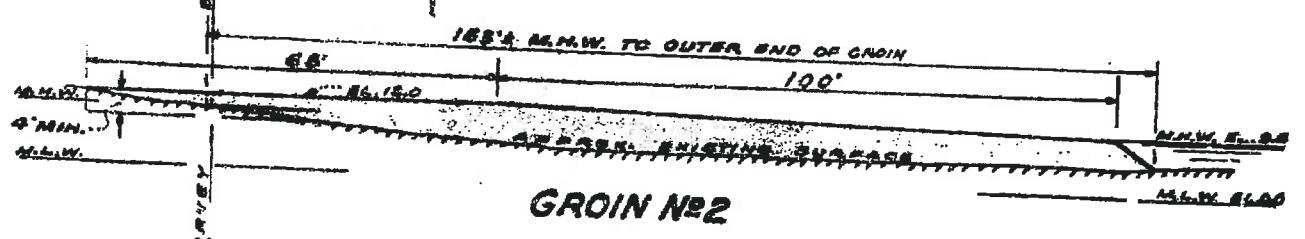
GROIN NO. 2

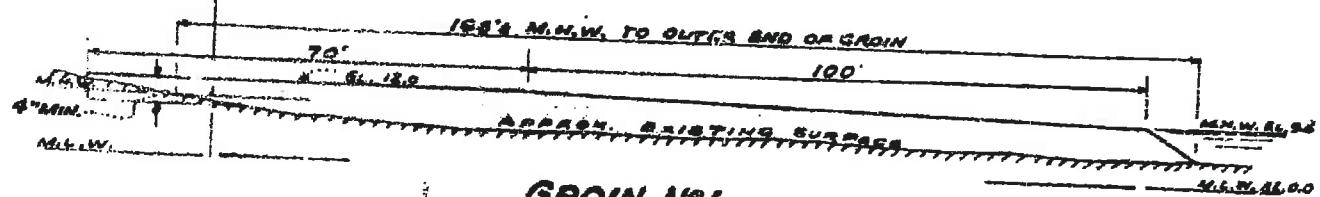
GROIN NO. 1  
PROFILES - PROPOSED GROINS

SCALE - FEET  
1" = 30'

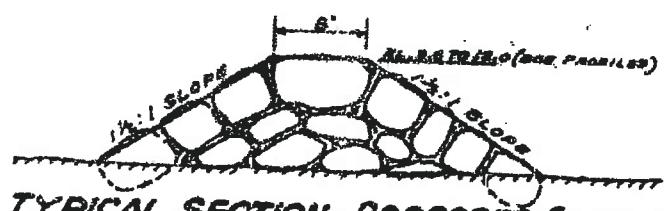
TYPICAL SECTION - PROPOSED GROINS

SCALE - FEET  
1" = 10'

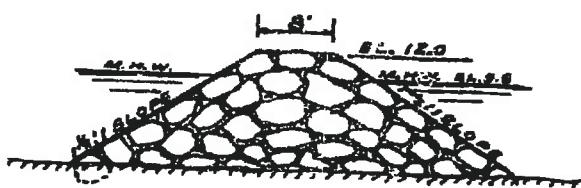
SECTION - WESTERLY JETTY

SCALE - FEET  
1" = 20'

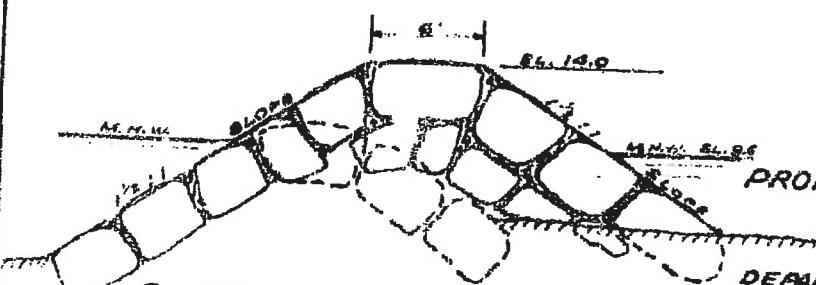
SECTION - EASTERLY JETTY

SCALE - FEET  
1" = 10'

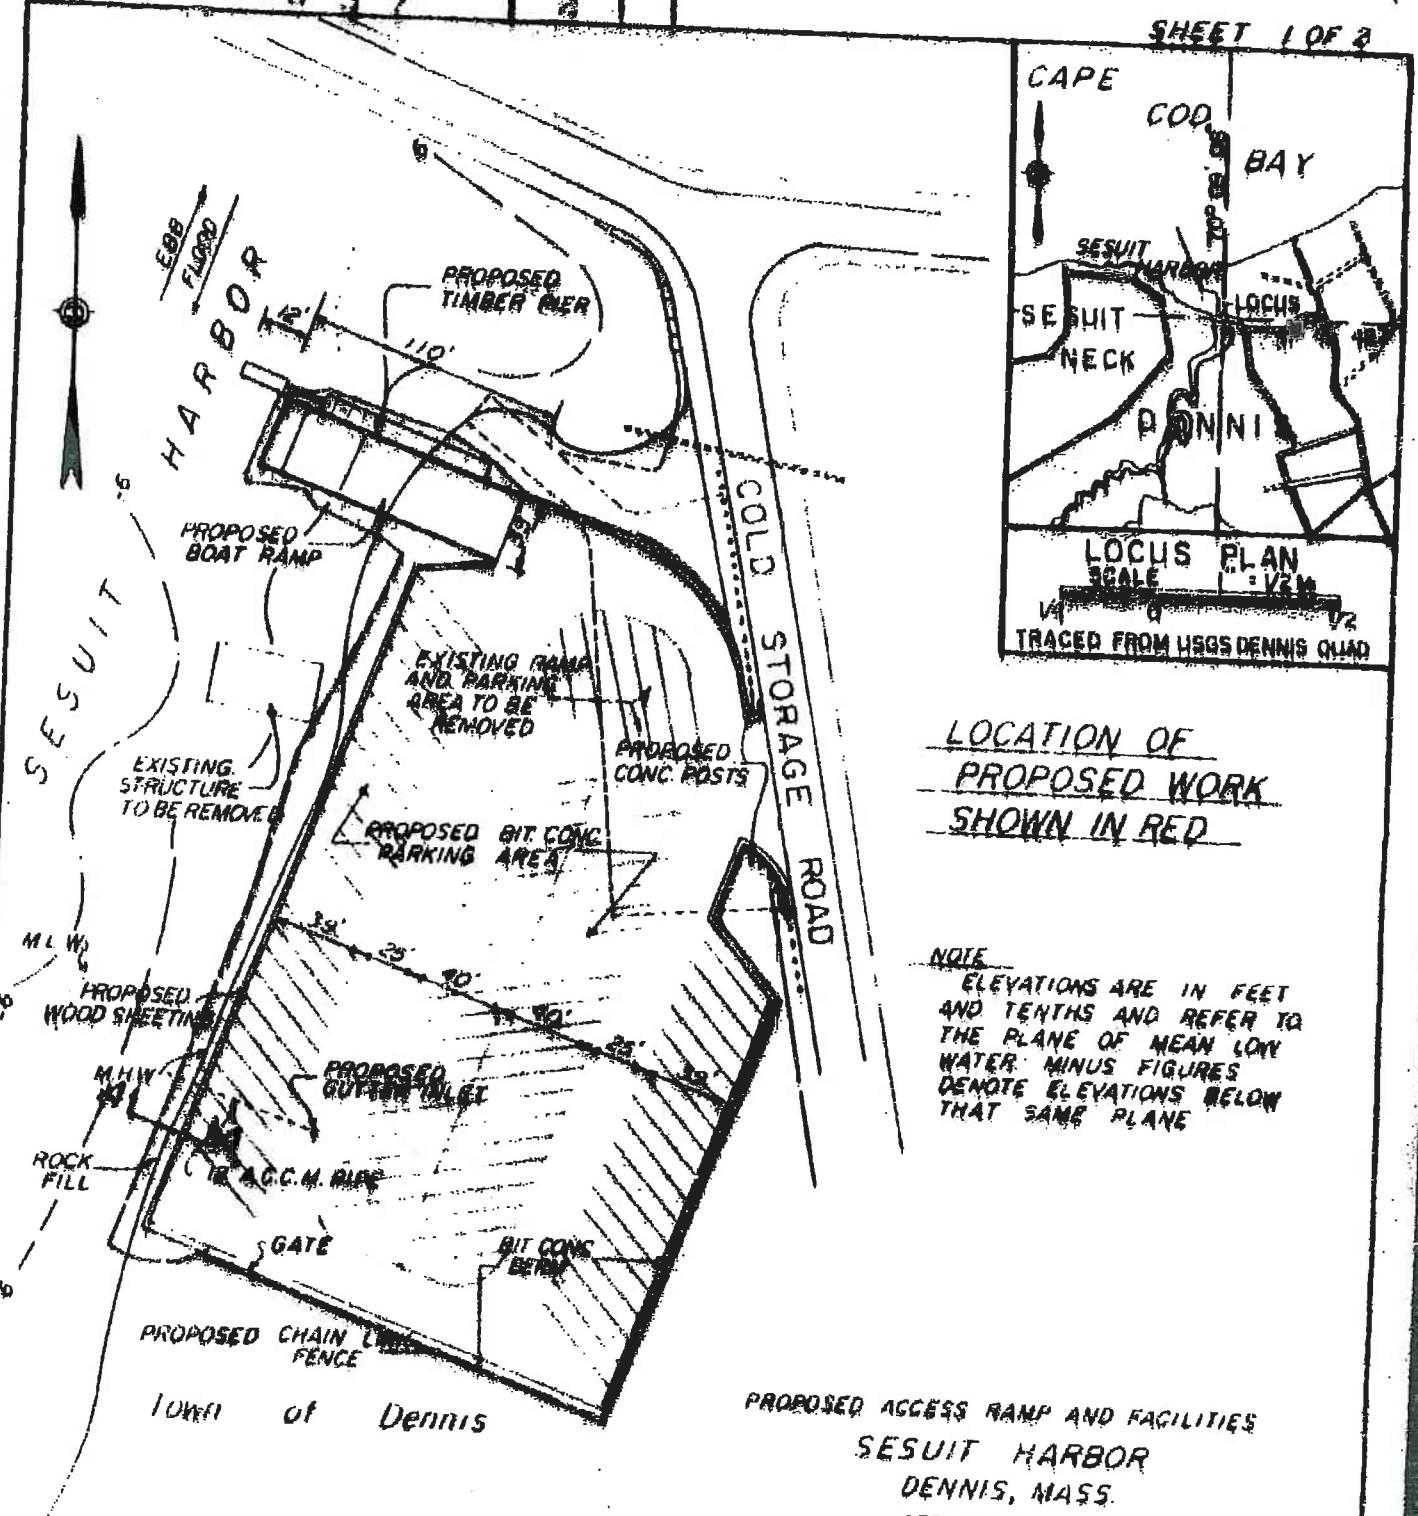
LOCATION OF  
PROPOSED WORK  
SHOWN IN RED

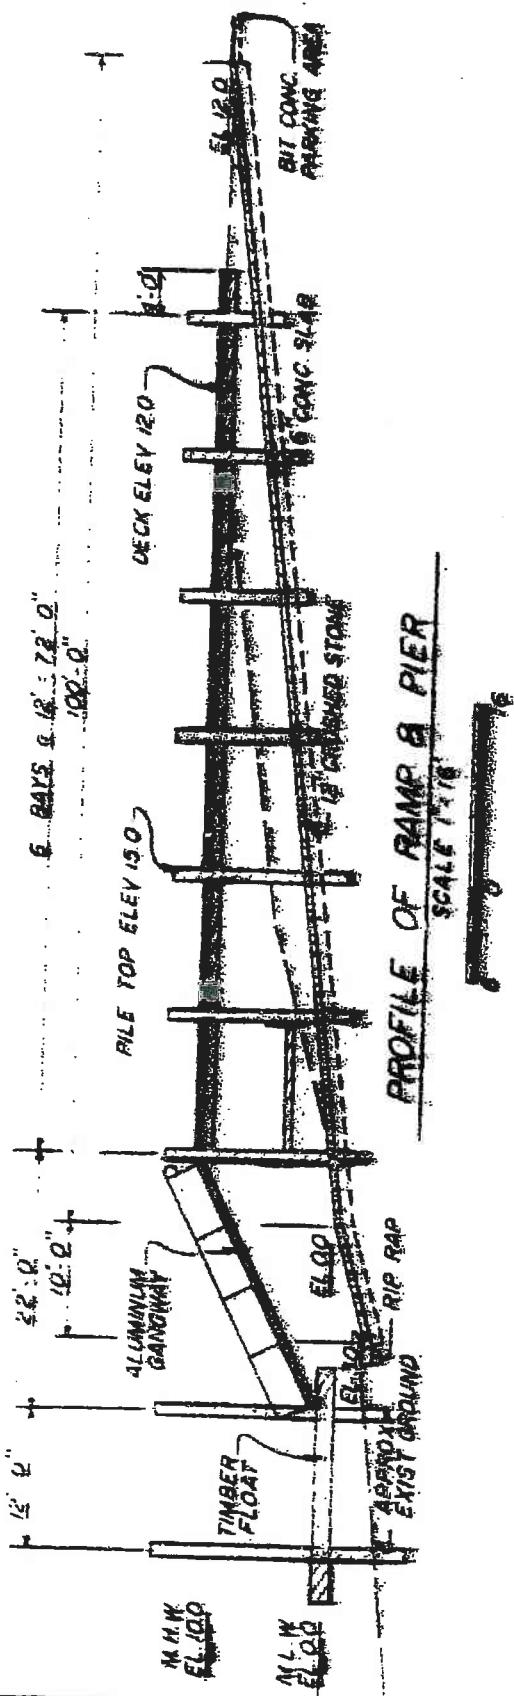
PROFILE OF RAMPS & PIER

SCALE 1:16

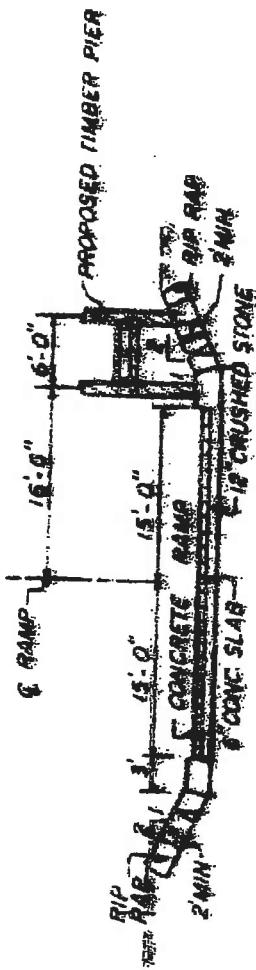
TYPICAL SECTION & RAMPS

SCALE 1:16

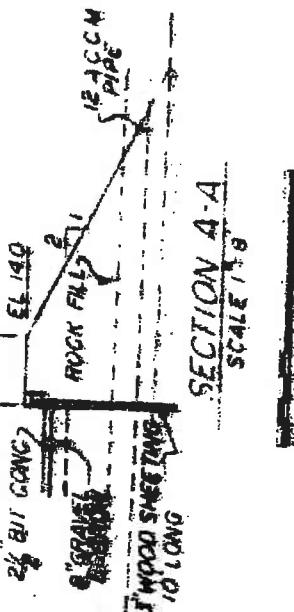
SECTION A-A  
SCALE 1:16
