# Raised Crosswalks on Cross Street – Belmont, MA

### Site and Treatment Description

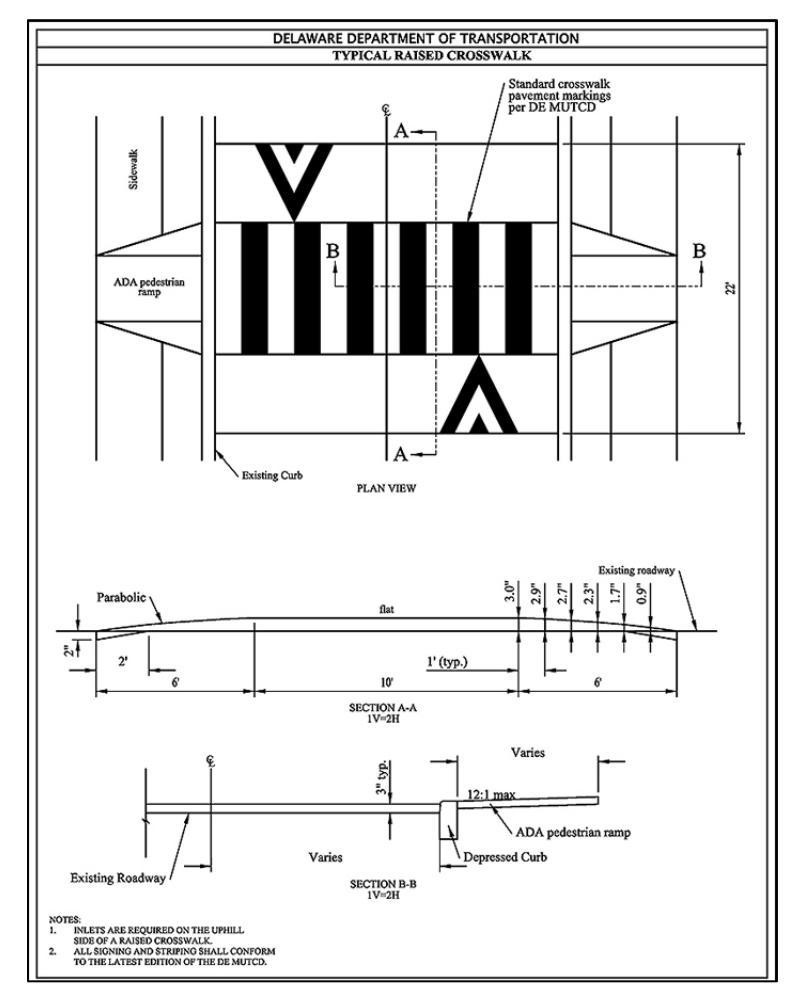
# Appendix A - Raised Crosswalk Specification

The raised crosswalk design referenced the FHWA specification (see <u>FHWA Traffic Calming</u> <u>ePrimer</u>), which highlights roughly 6ft rises on each side and table of about 10ft in depth. As a result the raised crosswalk itself sits roughly 3 to 3.5 inches above the roadway, with adequate ADA compliant ramps connecting to the sidewalk on each side. This design specification can be found in the Appendix of this case study.

Source: Delaware DOT
