# EAST BROOKFIELD DISTRICT COURT HVAC SYSTEM EVALUATION SUMMARY

East Brookfield District Court East Brookfield, MA

# HVAC SYSTEM EVALUATIONS COVID-19

April 8, 2021

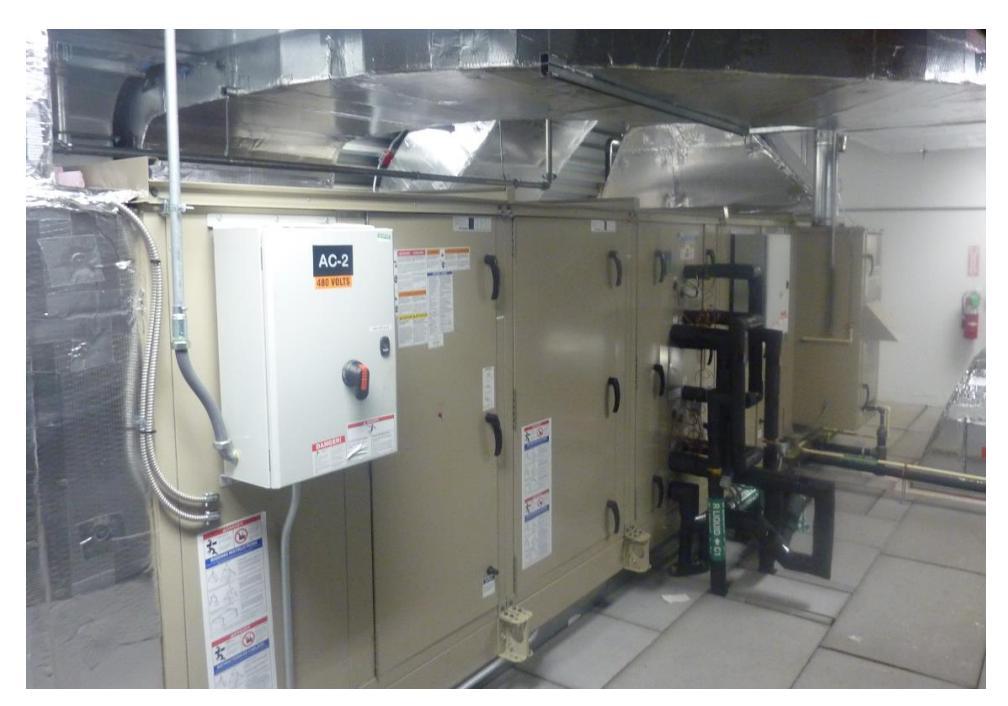
Photo 1 – Typical air handling unit

AC-1 and AC-2 have integral return fans, mixed air dampers capable of full economizer, MERV-13 filters, a direct expansion (DX) cooling coil, gas-fired furnace, and supply fan in a draw-through configuration. AC-3 and AC-4 have dedicated return fans that are East Brookfield District Courthouse HVAC System Evaluation COVID-19 external to the unit. These units also have full airside economizer capability. The units include a supply fan in a blow-through configuration, MERV-13 filters, DX cooling coil, and gas-fired furnace. Each of the four packaged DX air handling units has an air-cooled condenser mounted on the roof of the building. Supply air is distributed to each zone via VAV boxes, which were also replaced in 2019.

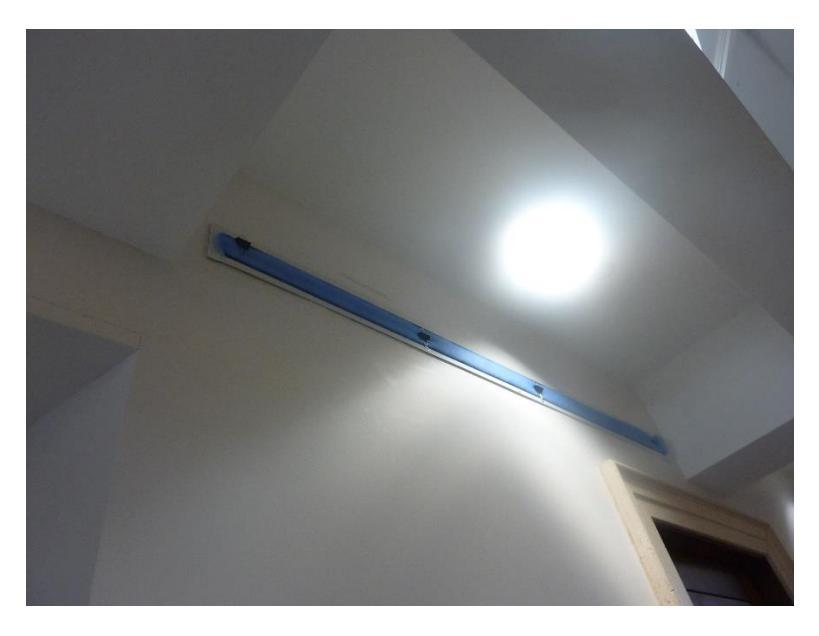
The ductwork serving these systems and all the occupied areas is original to the 1992 construction. The supply ductwork is 100% internally lined with fiberglass and is reported to be in poor condition according to a 2020 report. The report suggest that the liner has detached from the walls and may be restricting airflow. Filter fabric has been placed over the supply diffusers to address indoor air quality (IAQ) concerns from loose fibers in the supply air stream.

Photo 2 – Linear slot diffuser with filter fabric

It should be noted that during the work to replace these units in 2019, it was discovered that the duct liner in the ductwork throughout the building has become detached and the ducts appeared to be in poor condition. A ductwork remediation study was performed by Habeeb & Associates and a report dated October 2020 details these deficiencies with the ductwork. The report also presents several solutions including complete replacement of the ductwork throughout the building. Typically we recommend adjusting all airflow rates to recommended levels but, given that the building was recently balanced and extensive work is planned to remedy the duct issues, Tighe & Bond recommends performing the more comprehensive TAB work (measures RTB-2 and RTB-4) after the duct remediation work is complete.

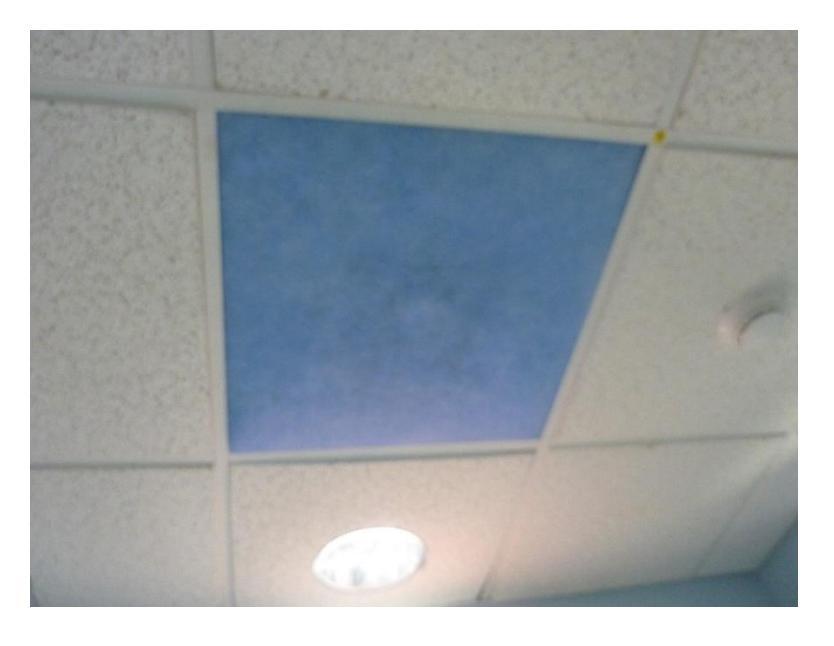
#### Photo 3 – Typical ceiling diffuser with filter fabric
