Marlborough District Court Marlborough, MA

HVAC SYSTEM EVALUATIONS COVID-19

Office of Court Management

April 6, 2021

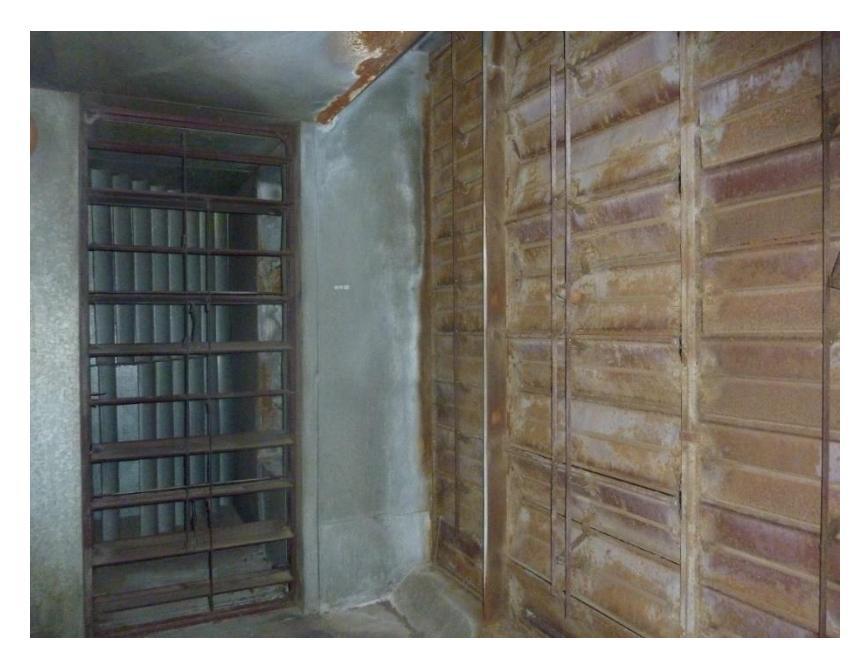
Photo 1 -RA (left) and OA (right) Dampers in AHU

At the time of the site visit, the AHU had its OA dampers nearly shut and RA damper 100% open. The preheat coil was actively heating, and the chilled water valve was closed.

The AHU is original to the building and in poor condition. Courthouse staff cycled the pneumatic actuators for the OA dampers, and the blades moved only a few degrees.

RE-1: Test existing air handling system dampers and actuators for proper operation.

Repair or replace the dampers and actuators that are not opening and closing fully, or not going to the position commanded by the controls.

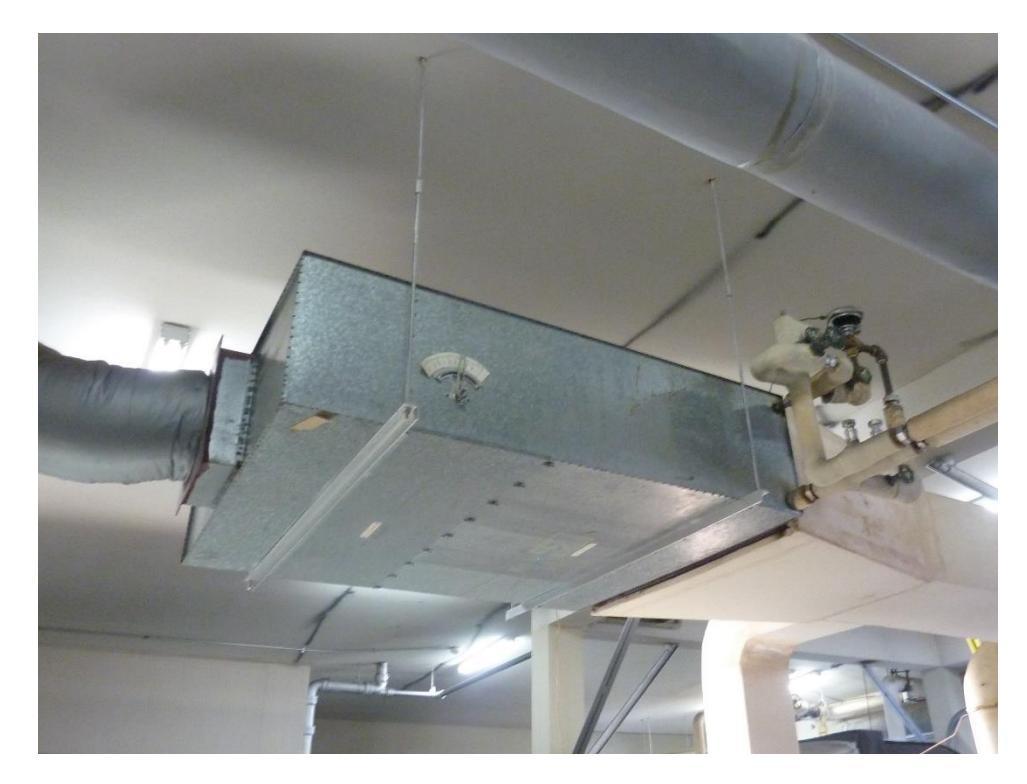
Photo 2 – Representative Terminal Reheat Box (Courtroom 103)

Air distribution throughout the building is constant volume, through 34 terminal reheat boxes. Each box has a fixed supply air volume damper and a hydronic reheat coil with a two-way control valve modulated by a pneumatic thermostat in the space.

RTB-4: Test and balance terminal reheat box airflow rates.

To ensure the proper quantity of supply air is delivered to each zone, we recommend benchmark testing and rebalancing all terminal reheat boxes to their original airflow rates. The boxes are over 50 years old and may have fallen out of calibration.

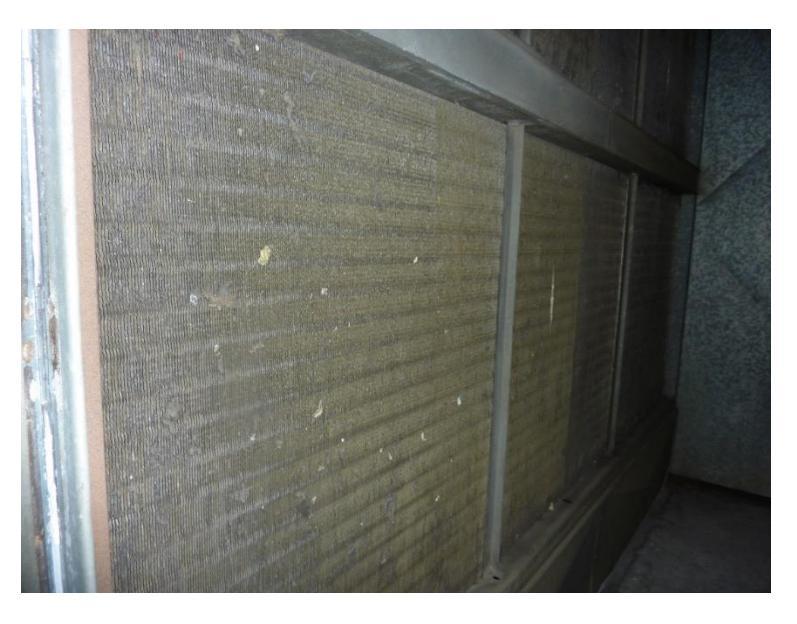
Photo 3 – Representative Coil Condition

The coils in air handlers and terminal reheat boxes are over 50 years old, and Tighe & Bond does not know how regularly they have been cleaned. There was a visible accumulation of dust and debris on the AHU preheat coil.

RE-2: Clean Heating and Cooling Coils and Drain Pans

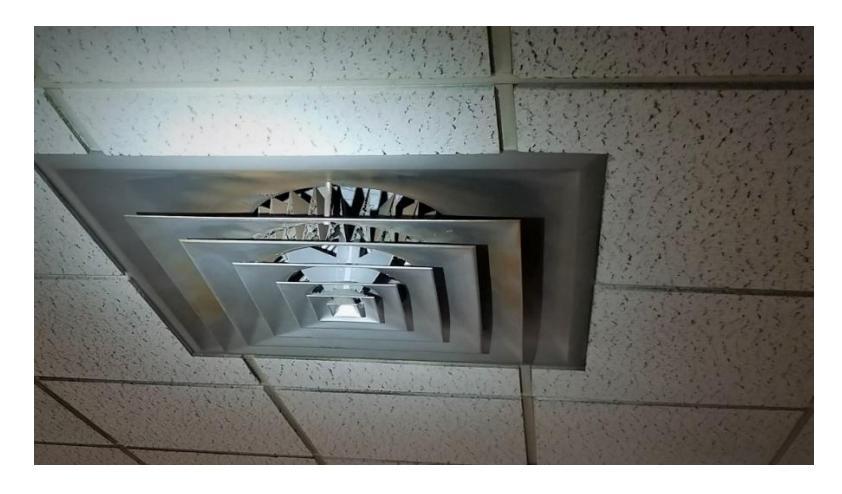
Photo 4 – Representative Supply Diffuser

We noted a visible accumulation of dust on several ceiling supply diffusers and lowmounted return air grilles. According to the EPA, duct cleaning has not been shown to prevent health problems, and studies have not conclusively shown that dust levels in spaces increase because of dirty air ducts or terminals. However, they do recommend cleaning if there is an excessive buildup of dust or debris.

2.7.2 Clean supply diffusers and return grilles

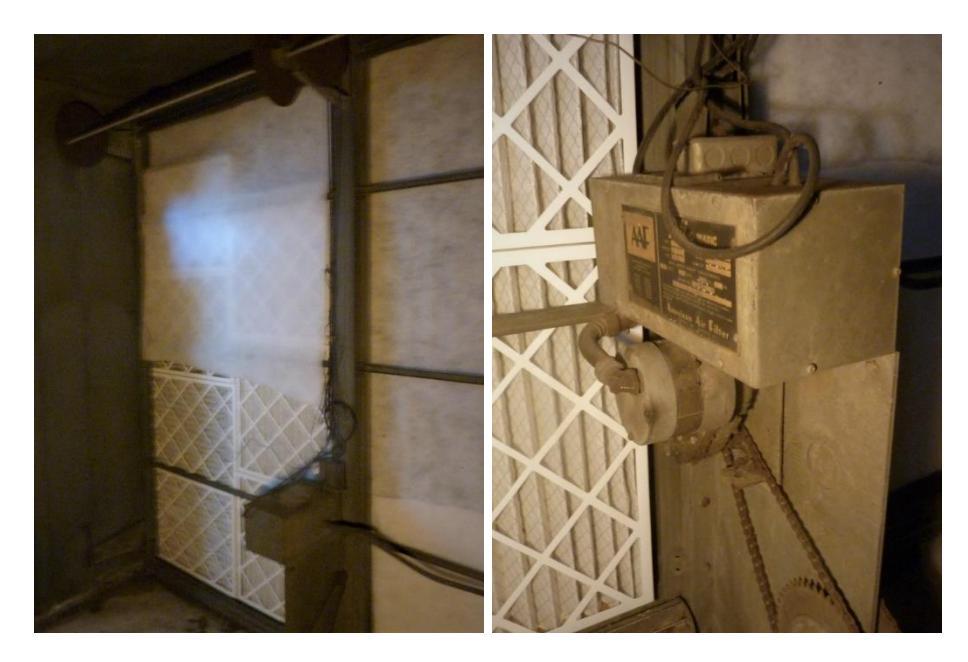
Photos 6 and 7 – AHU Prefilter and Roll Dispenser

The AHU was modified recently to add a row of 2" thick pleated-type cartridge filters. The original filter, which uses non-woven MERV-5 roll media, is now used as a prefilter. However, the roll dispenser no longer works which requires facilities personnel to manually cut and place the roll media. During our site visit we noted large gaps in the media and a visible accumulation of dust on the upstream face of the preheat coil. We recommend repairing or replacing the roll dispenser, so that the prefilter media will fit properly and be more easily replaced as needed.

2.7.3 Repair or Replace Roll Dispenser for Prefilter

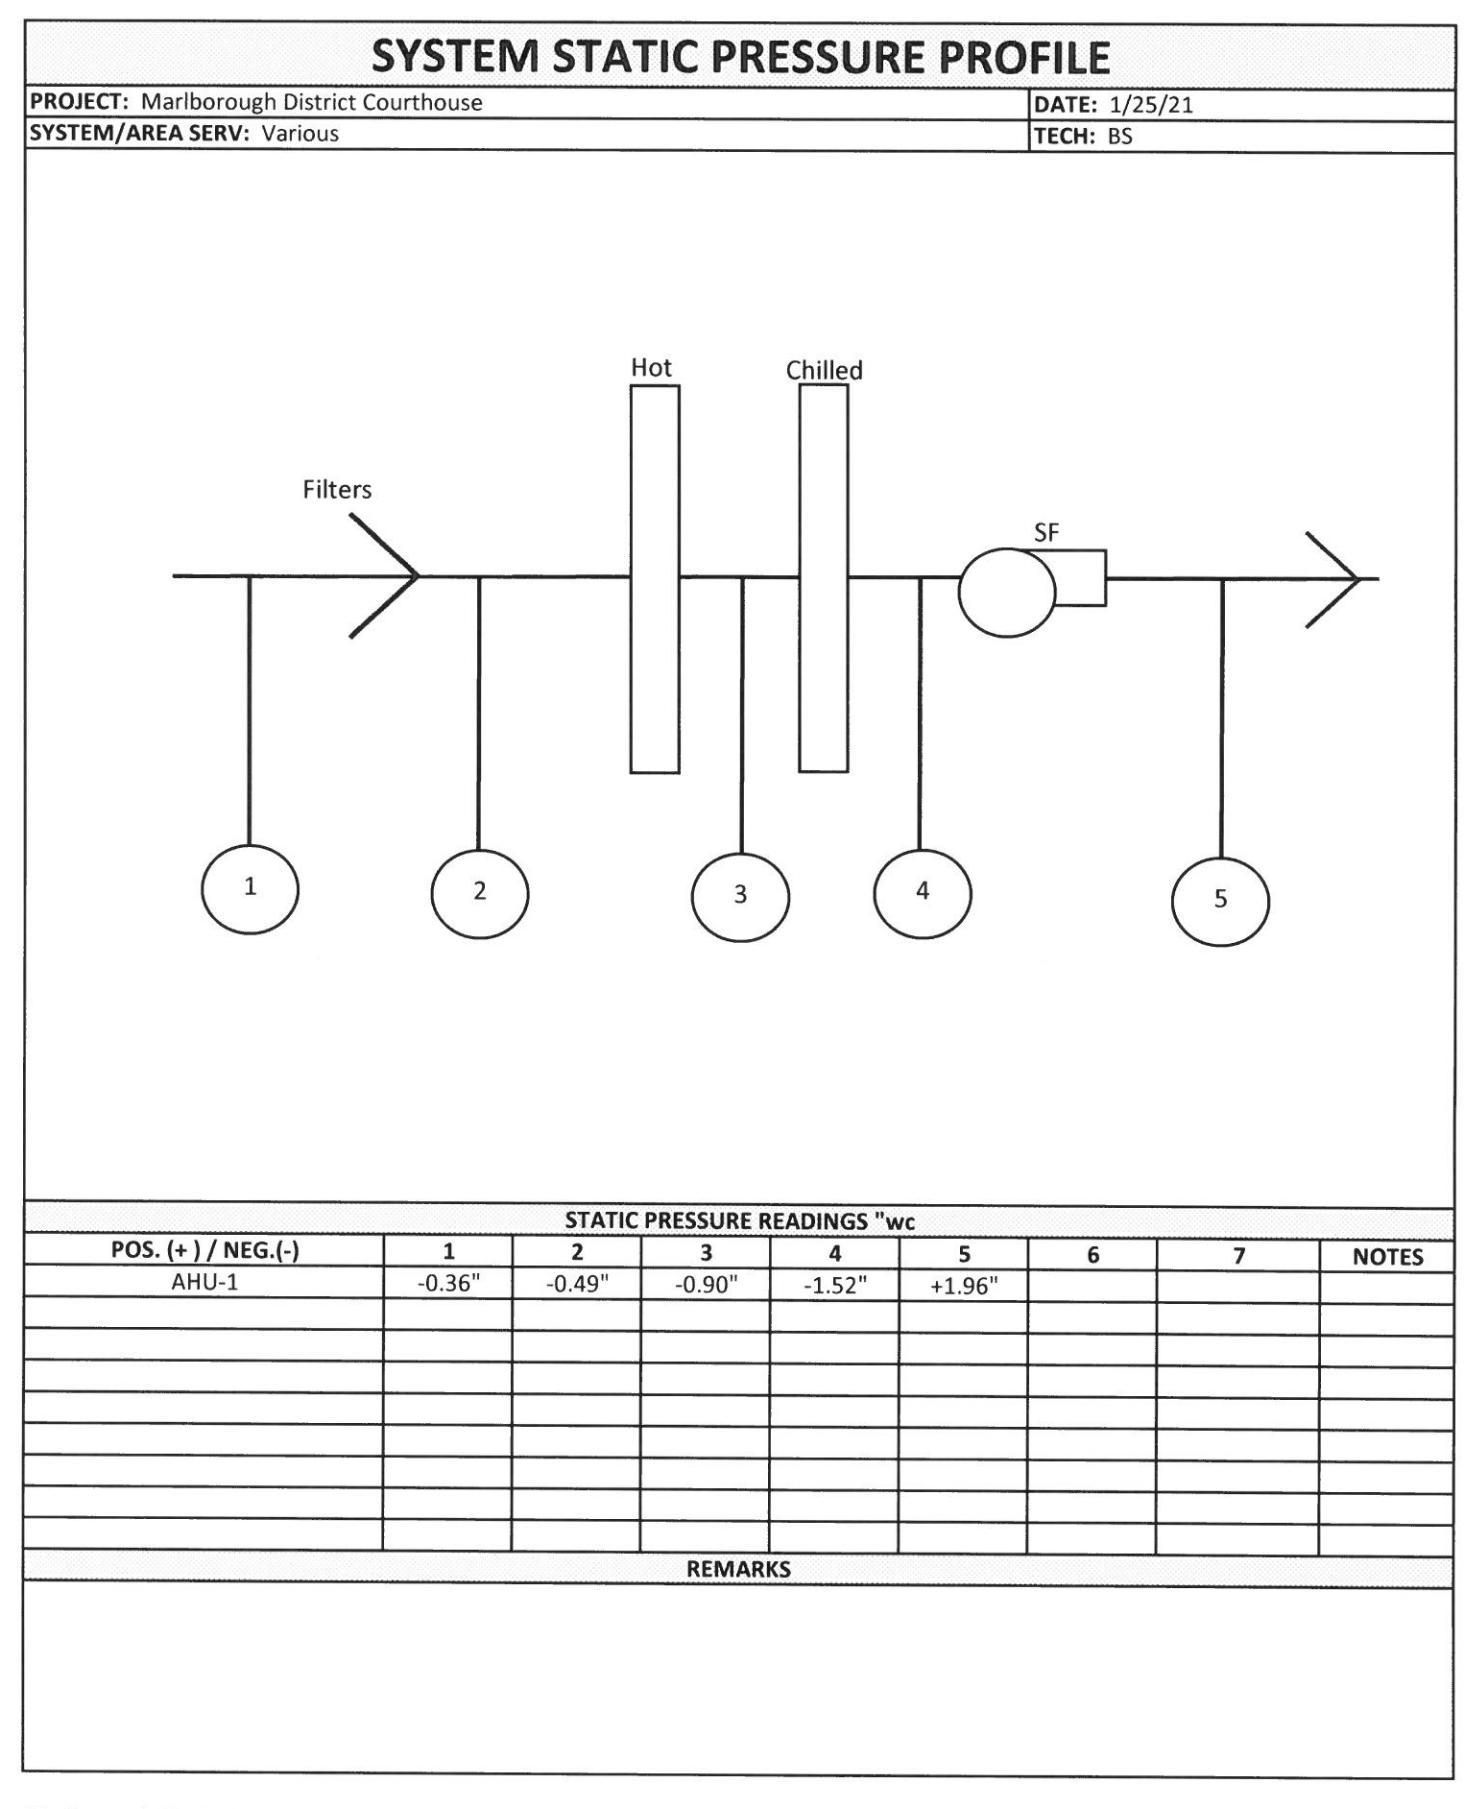
1	/ELOCI [®]	TY PRE	SSURE I	READINGS			
PROJECT: Marlborough	District Courthouse					DATE: 1/25/2	21	
TRAVERSE	DUCT		DE		051175011115	TECH: BS		
LOCATIONS	SIZE "	AREA SO ET	EDM	CEM	CENTERLINE		EST	NOTES
Locations	JILL	30.11.	FFIVI	Crivi	STATIC PRES.	FPIVI	CFM	
AHU-1								
Total	74" x 105"	53.96		27,000	w/velgrid	604	27,196	
OA	108" x 105"	78.75		5400	w/velgrid	64	5040	(1)
Lock Up Exhaust Fan	14" x 8"	0.78	ND	ND	+0.32	992	772	
			RE	MARKS				
(1) The outside dampers a	re pneumatic and a	re not functio	nal
