Quabbin Reservoir Elevation

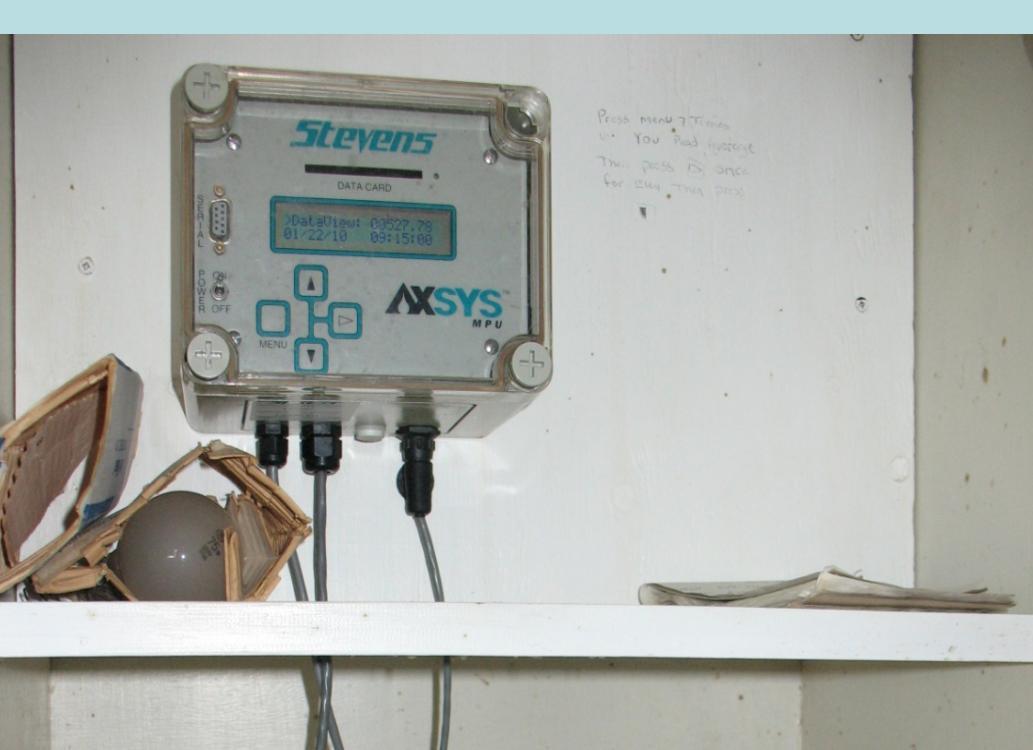
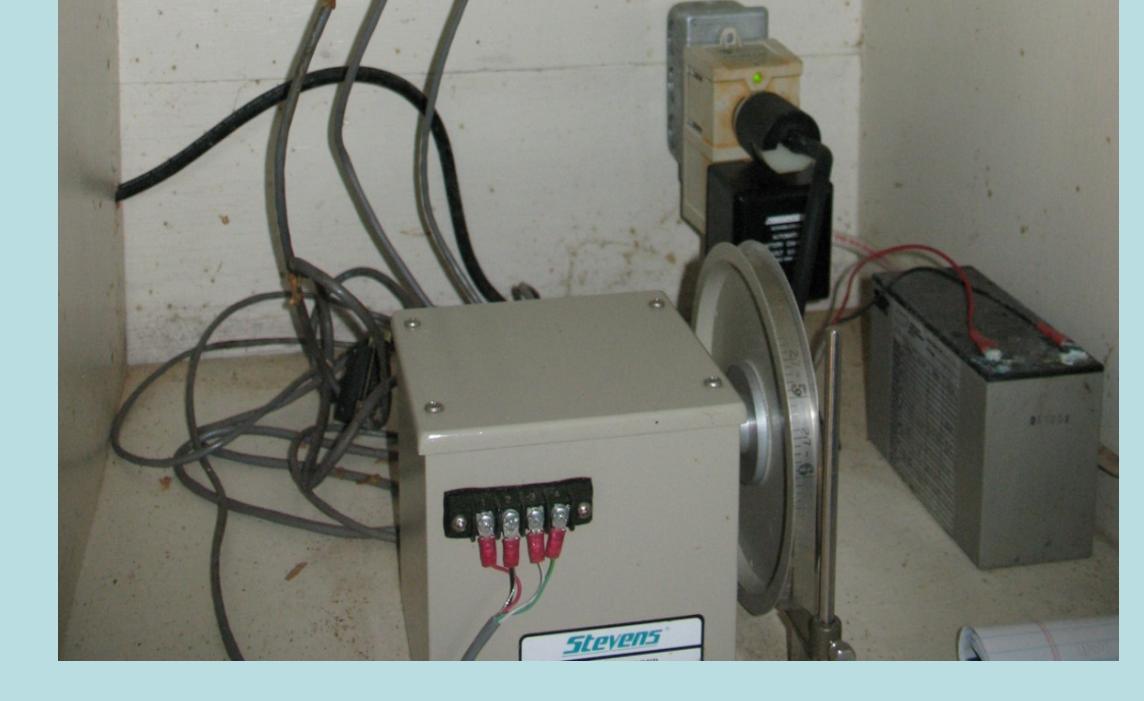
DCR engineers use an elevation gauge and observation well to record the daily elevation. The

elevation

gauge is

the

steel

attached to

observation

well by a

measuring

tape. Daily information is available at the following website .

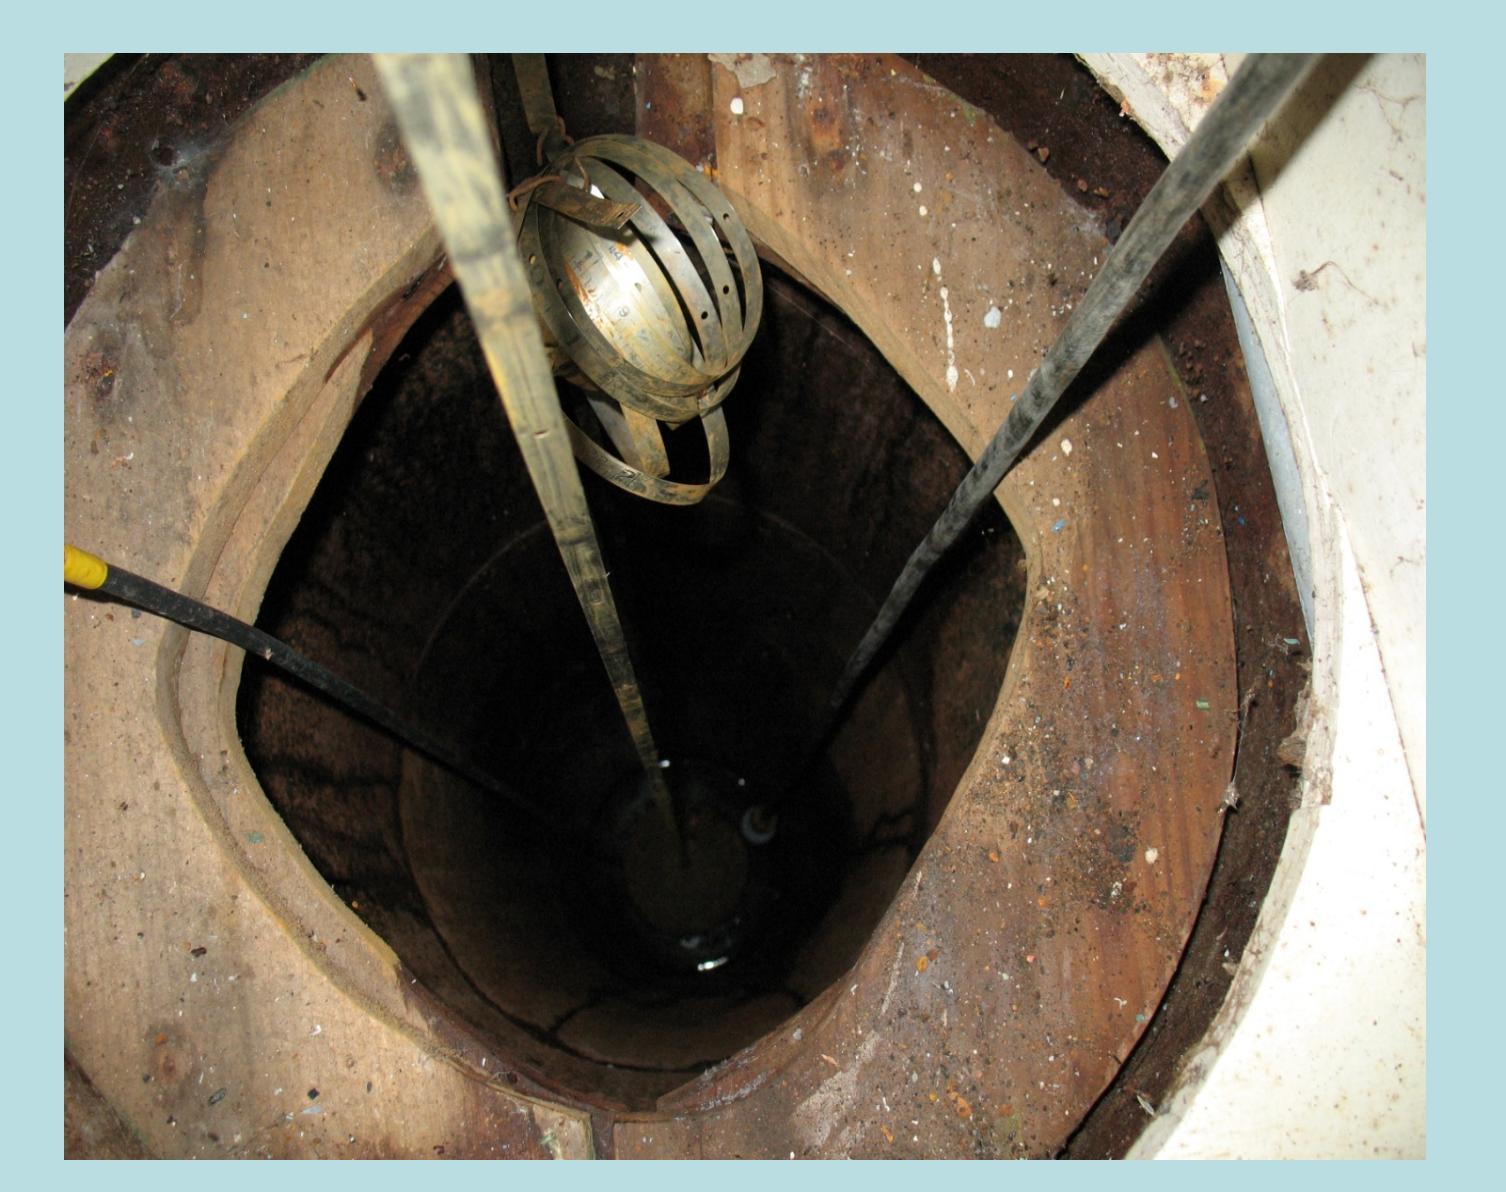
The Quabbin Reservoir Elevations and Capacities chart illustrates the annual levels of the reservoir for the past several years. On the left the levels are recorded in feet above BCB. On the right are indicated the number of gallons of water and what those gallons represent in percentage. As a benchmark, 1984 was included to show the highest elevation of the reservoir ever recorded; 531.82 feet BCB, 420,800.0 billion gallons, or 103% of capacity in June of 1984. This may seem to be a small amount, a mere foot and a half above capacity, but when the reservoir is full the top inch alone equals 750 million gallons of water. When Quabbin Reservoir is at capacity it holds 412 billion gallons of water. However, from the viewpoint of drinking water standards, if a reservoir declines below a certain percent of capacity the water quality may deteriorate as physical, chemical and biological conditions change and the water may no longer be considered safe for consumption. This is called the minimum pool level theory. At Quabbin, the minimum pool level is 38% capacity or 159 billion gallons of water. According to

The current chart records the past several years of elevation. Until 2016 reservoir elevations were higher than the historic average. Due to modernization of the water distribution system, which included repairs of leaky pipes and a restructuring of water rates as well as an emphasis on water conservation, daily water usage dropped to an average of about 200 million gallons, much lower then the 300 million gallon usage that is the safe yield of the system.

However in 2016 Massachusetts experienced a severe drought which caused reservoir levels to drop to 79.0% at the end of the year. By the end of 2017 with sufficient rain and snow the reservoir had recovered to 85.3% . Transfer of water from the Ware River also helped raise the reservoir levels. On November 29, 2018 the reservoir reached full capacity for the first time since January of 2012. ...through the channel...

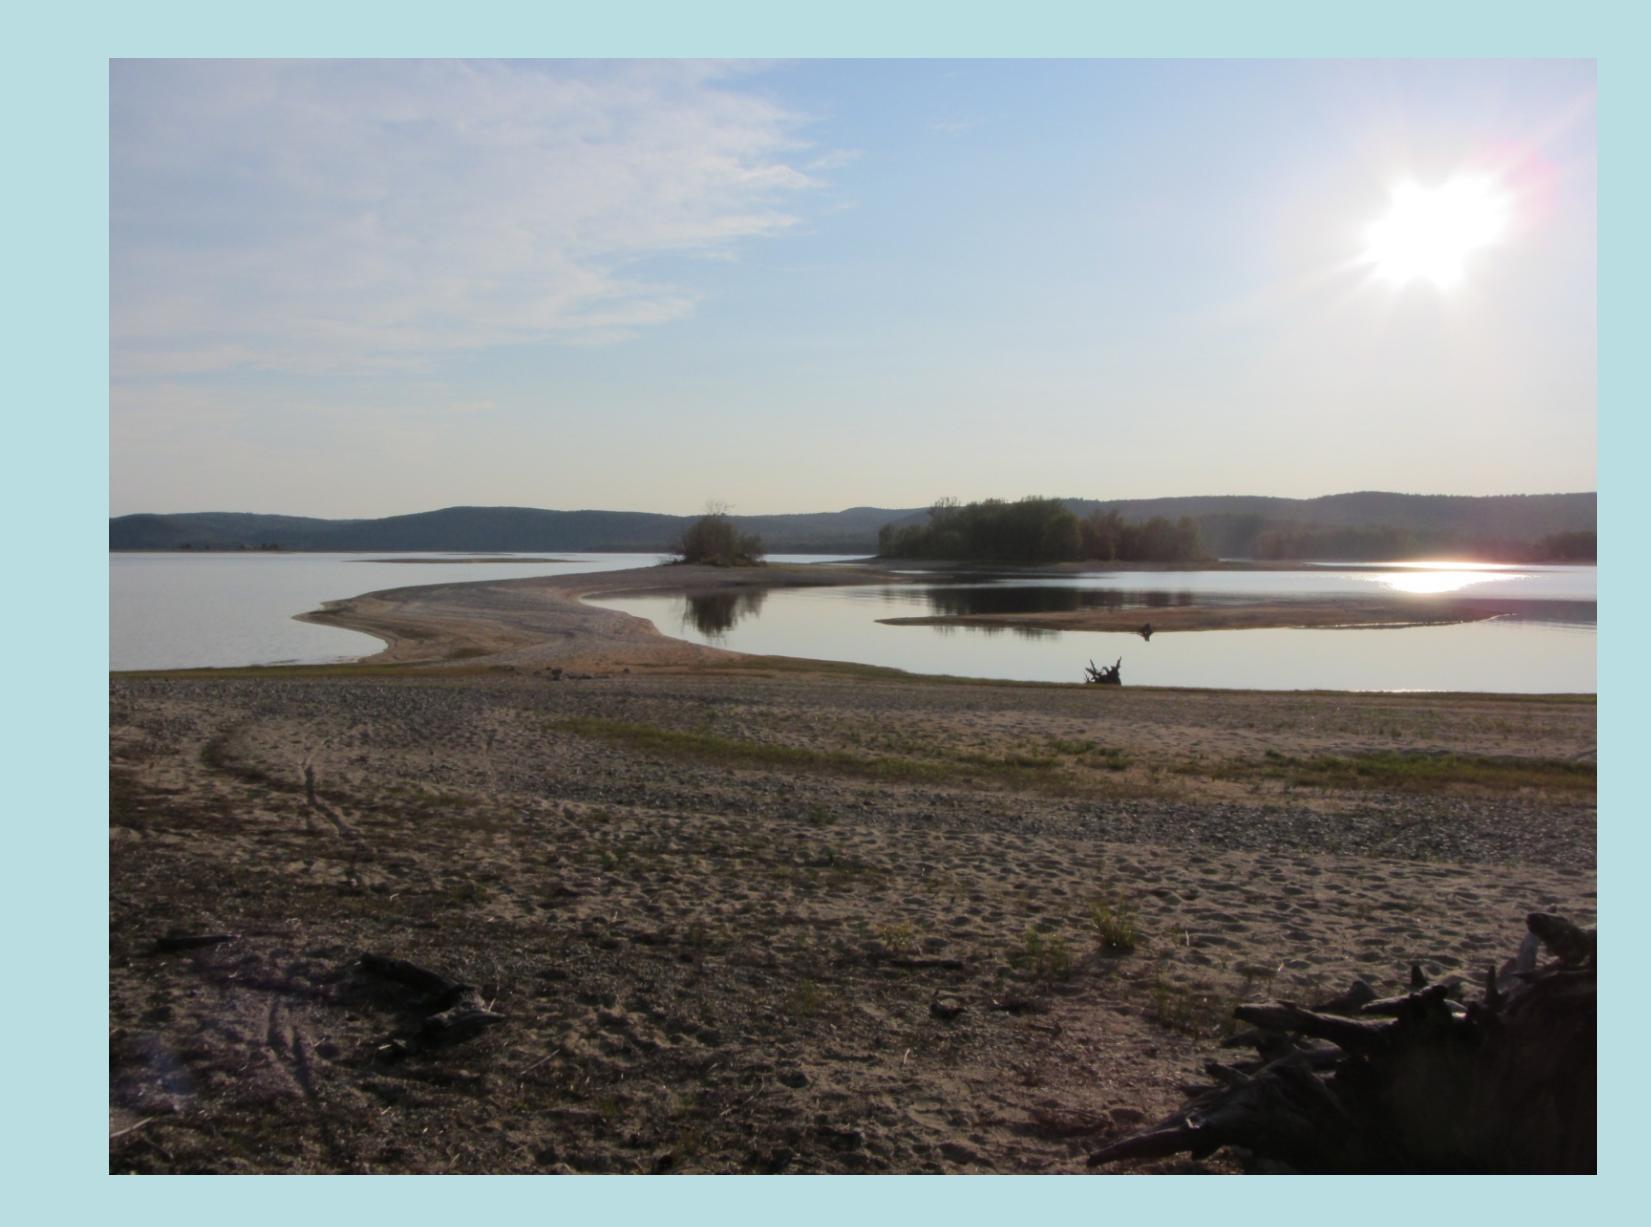
In dry years, old roads that ran through the Valley are often visible. This photo from 2016 shows a part of a road that once ran from Dana Center to North Dana.

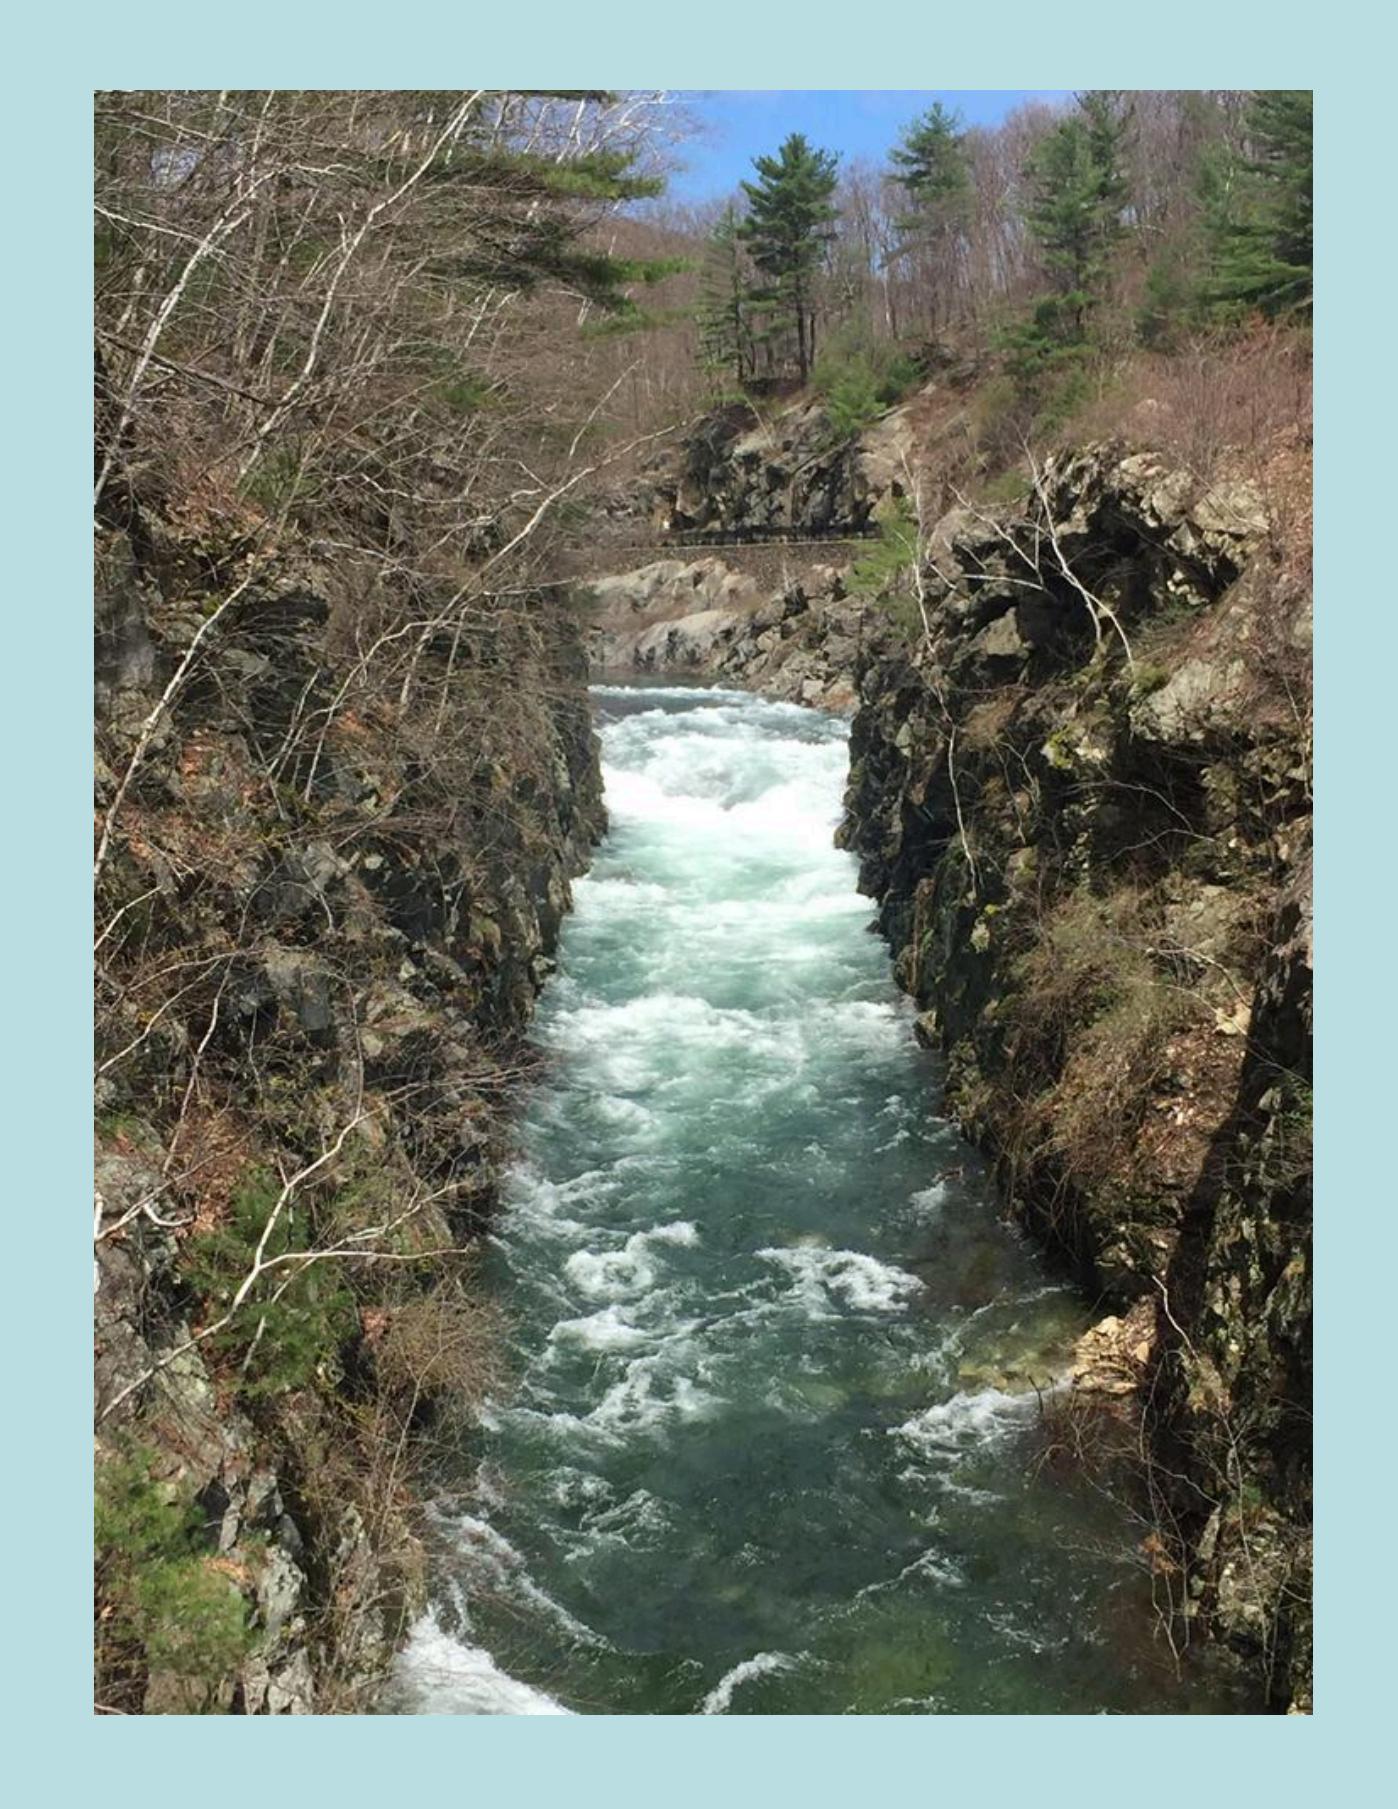
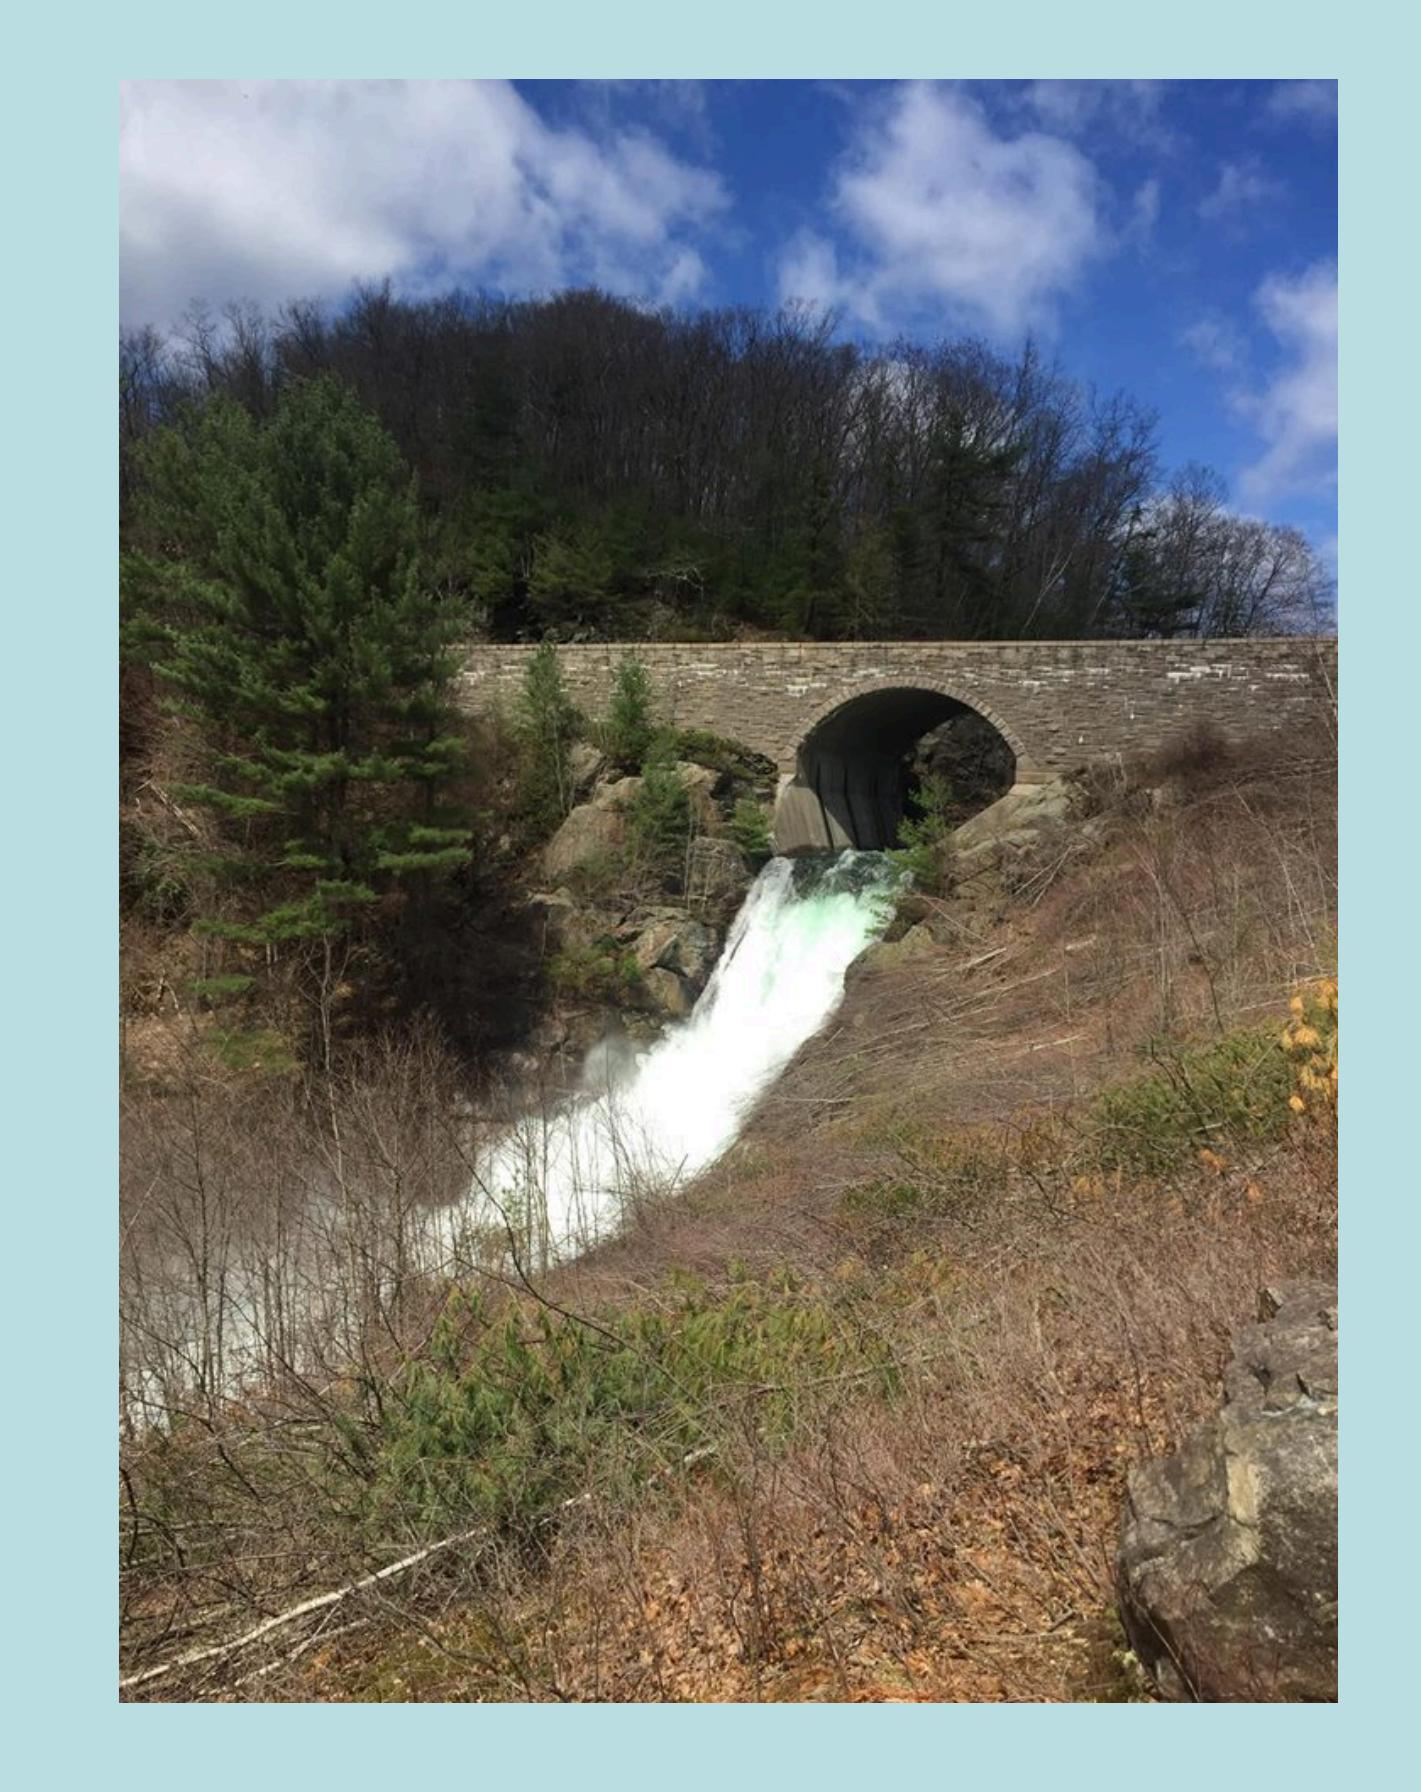
Looking at the graph, it is easy to see seasonal fluctuations in the water level. Spring is the traditional time for the reservoir to be replenished, or recharged, through snow melt and spring rains. Tracking the reservoir elevation through the year shows that by summer the reservoir level is dropping. Trees are in full leaf in summer, drawing more water from the ground to produce food. As well, water evaporates more quickly in the strong sun of a summer day. However, the major contributor to the drop in elevation is from water users watering lawns, gardens and filling pools while they enjoy the warmer months. When the reservoir reaches capacity, water flows over the spillway wall...

...and down an 80-foot drop until it joins with the Swift River.

To many visitors the most striking feature of the Winsor Dam is its spillway. Designed to allow water to be released from the reservoir when needed, the spillway creates a spectacular waterfall when in use. Located on the east side of the Winsor Dam, the spillway is activated when the reservoir reaches capacity. Water pours over the wall and plunges dramatically down an 80-foot cascade under the arched spillway bridge. It then travels a half mile through an excavated channel to the original stream bed of the Swift River. There are times, generally to prevent flooding downstream, when the spillway is deliberately activated. When the reservoir is within two feet of capacity, stop logs are removed from a 30-foot section of the spillway wall, and water is allowed to flow freely through the channel.
