# MATFIELD RIVER SUBWATERSHED

The Matfield River and its tributaries drain 77 square miles of the northeast portion of the Taunton River Basin. This subwatershed contains some of the most densely developed areas of the state. The following segments are included in the Matfield River subwatershed (Figure 9):

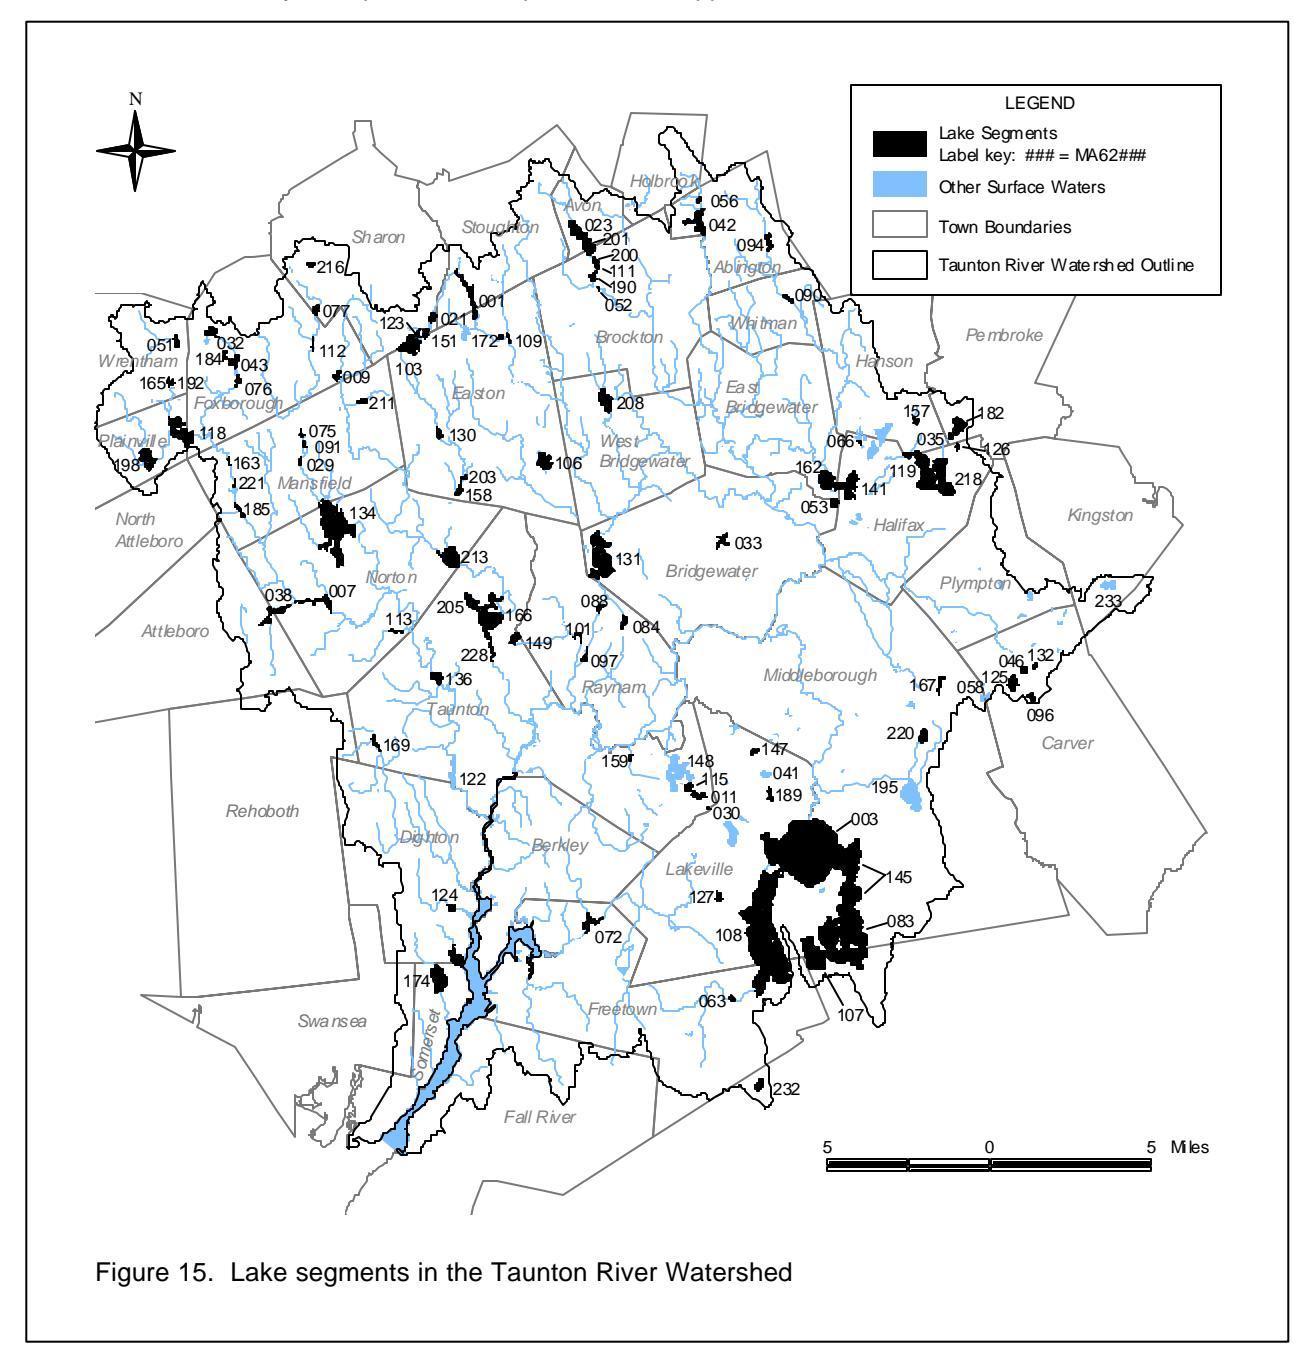
The 98 lakes assessed in this report represent 11,059 of the 12,517, or 88% of the acreage, in the Taunton River Watershed (Figure 15). Fourteen lakes are designated water supplies (i.e., Class A), which accounts for 54% (or 6,715 acres) of the assessed acreage. Additionally, another nine lakes are proposed Class A waterbodies, since they are upstream from public water supplies.
