INSPECTION HISTORY

Woodworking Shop

The Department of Labor Standards conducted a safety inspection at a state agency in November, 2015. The following conditions were found which required corrective action. Use this "Inspection History" as a self-audit checklist in your own Woodworking Shop. Per 454 CMR 25.00, executive branch state agencies are required to comply with OSHA standards.

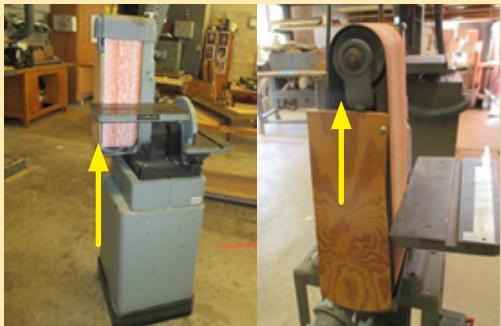
Condition Observed	Photo	OSHA Regulation	Corrective Action
Band Saw: The machine guard could become loose during operation because the closure mechanism was broken.

29 CFR 1910.213(i)(1) Woodworking machinery	Repair or replace the closure mechanism. Ensure that a machine guard covers unused portions of the blade. Ensure the guard cannot unintentionally open during operation.
Belt Sander: Machine guard is missing. Pinch points are exposed.

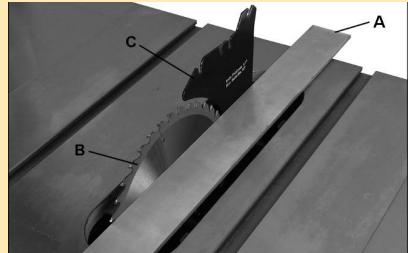
Circular hand-fed rip saw: A spreader was not used on a hand-fed circular rip saw to prevent material from squeezing the saw blade or being thrown back on the operator.

29 CFR 1910.213(c)(2) Woodworking machinery	Install a spreader to prevent kickbacks, and to keep chips and slivers away from the back of the saw blade, where they might get caught by the saw teeth and thrown toward the operator.

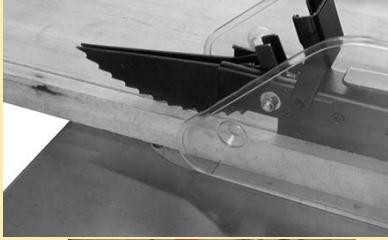
Condition Observed	Photo	OSHA Regulation	Corrective Action
Circular hand-fed rip saw: Anti-kickback fingers or dogs were not located to oppose the thrust or tendency of a hand-fed circular rip saw to pick up the material or throw it back toward the operator.

29 CFR 1910.219(c)(3) Mechanical power-transmission	Install an anti-kickback device for the saw operator during ripping operation.
Drill Press: An exposed part of rotating vertical shafting was not protected by a guard.

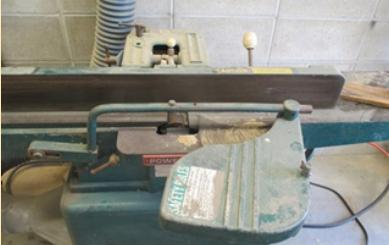
29 CFR 1910.219(c)(3) Mechanical power-transmission	Enclose the rotating shaft with a self-adjusting guard or a non-rotating shaft. Also enclose the drill bit chuck attached to shaft.
Jointer: A hand-fed jointer with a horizontal cutting had a broken guard. The Spring was broken so it no longer retracted to cover the revolving knives.

29 CFR 1910.213(j)(3) Woodworking machinery	Repair the existing guard so that it automatically retracts to adjust to cover the unused portion of the revolving knives

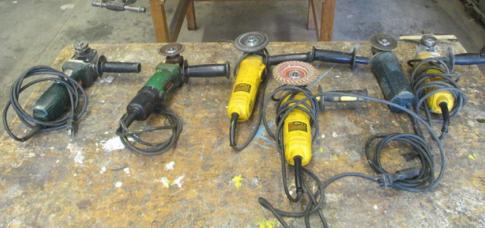
Portable Grinder An abrasive wheel used on a vertical portable grinder (right angle head grinder) was not provided with a safety guard.

29 CFR 1910.243(c)(3) Guarding of portable powered tools	Provide a safety guard so that the maximum exposed angle is 180°. The intent of the standard is to ensure that pieces of a disintegrating wheel will be deflected away from the operator.
Push sticks: Only one push stick was available. Different sizes of push sticks/push blocks are required dependent upon size of wood to be cut.
