INDOOR AIR QUALITY ASSESSMENT INCIDENT RESPONSE

**Newman Elementary School
1155 Central Street
Needham, Massachusetts 02492**

Prepared by:
Massachusetts Department of Public Health
Bureau of Environmental Health
Indoor Air Quality Program
October 2008

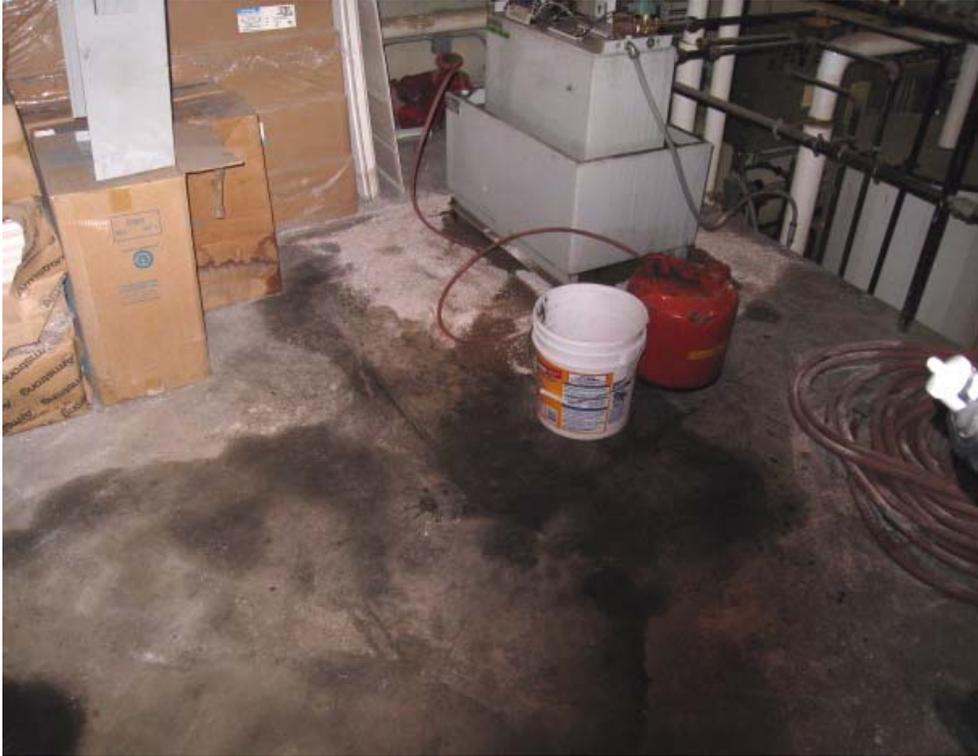
Picture 1

On the morning of September 22, 2008, the Massachusetts Department of Public Health (MDPH) Bureau of Environmental Health (BEH) was asked to provide immediate assistance regarding an indoor air quality incident related to an oil spill in the boiler room at the Newman Elementary School (NES) in Needham, Massachusetts. MDPH has been working with parents, schools, and health officials in addressing unrelated indoor air quality issues at the NES for the past year. Sometime between 3:30 PM Sunday September 21, 2008 and 7:30 AM Monday September 22, 2008, a switch reportedly failed in a hot water heater pump leading to excessive amounts of oil overflowing a containment reservoir. As a result, a small amount of #2 fuel oil seeped onto the concrete floor of the boiler room (Picture 1).

Water Heater Pump and Overflow Reservoir, Note Oil-Stained Concrete Floor in Foreground

1. Continue to keep floor drain covered until further cleaning is conducted. Seal rubber membrane “cover” with duct tape to create an airtight seal.
2. Clean floor drain and residual staining on concrete floor with an appropriate detergent/emulsifier and nylon bristle brush. Clean, rinse and repeat as necessary.
3. Clean residual oil from surface of switch pump and overflow reservoir.

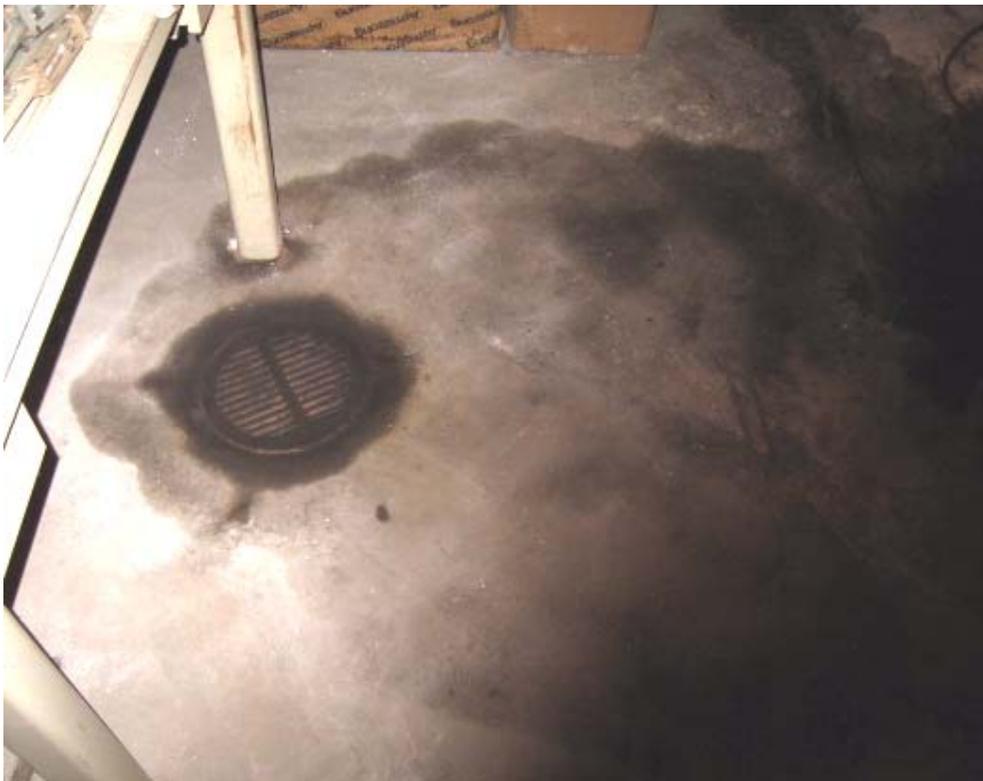
Picture 2

Floor Drain and Oil-Stained Concrete

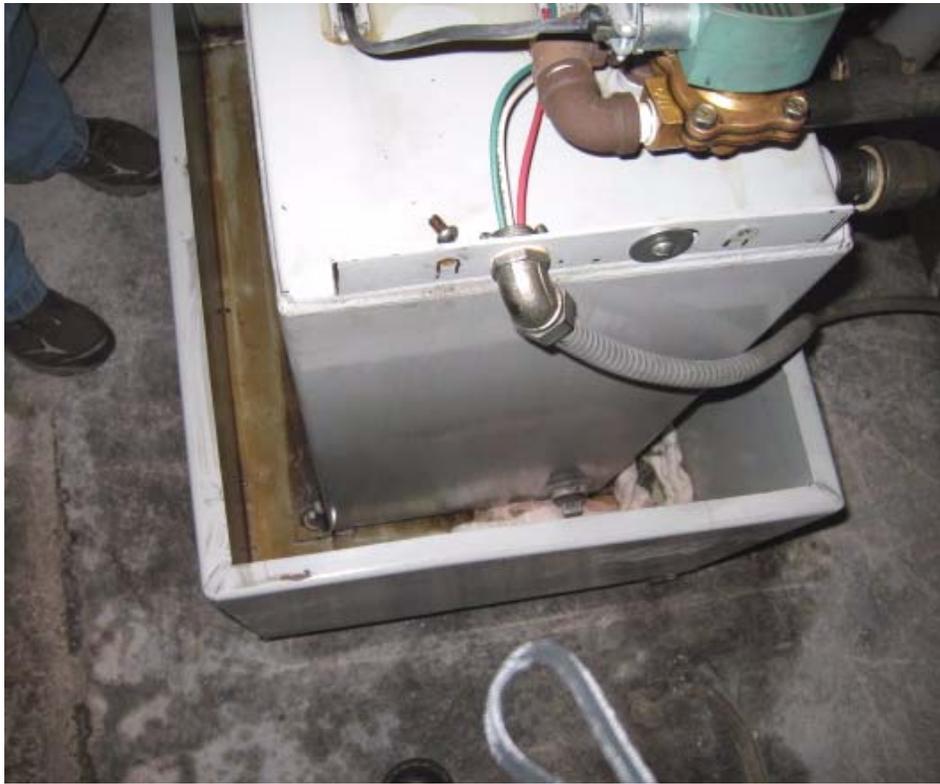
Picture 3

Needham maintenance staff conducted cleaning and remediation of affected areas overnight. The next morning, an inspection of the affected areas the next morning showed that all of the oil collected in the reservoir had been drained and the spillage and absorbent material on the boiler room floor was removed (Pictures 3 to 5). Efforts to remove oil from the saturated

Overflow Reservoir Drained of Oil, Note Residual Staining on Concrete Floor

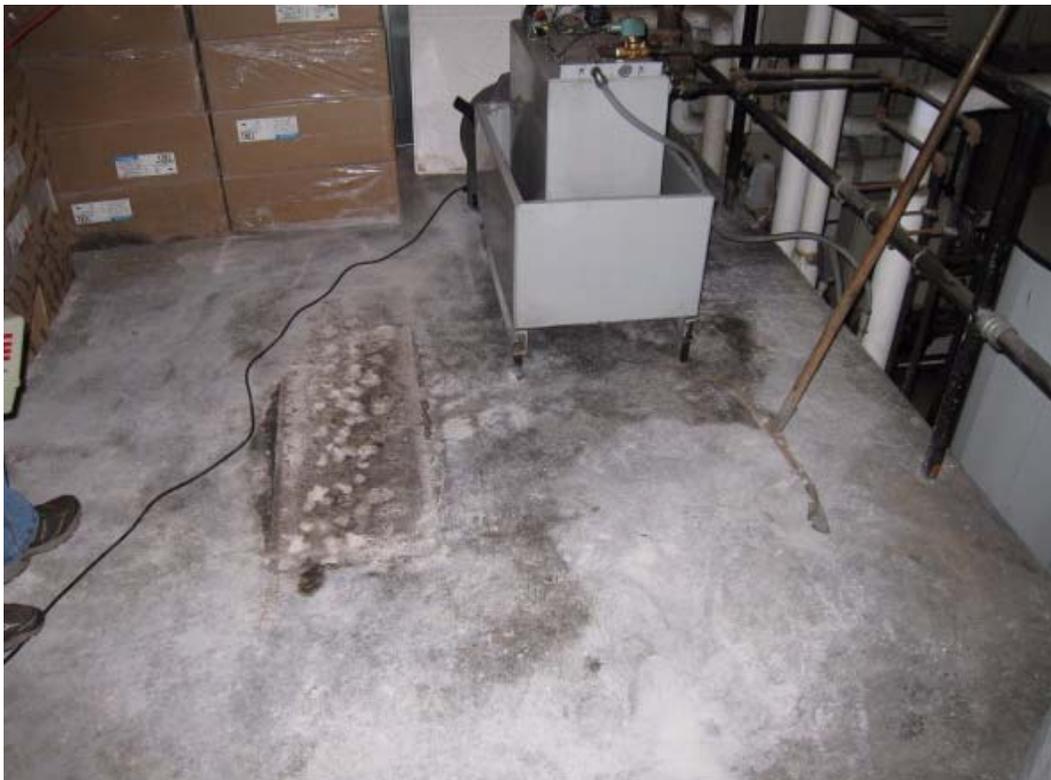
Picture 4

Boiler Room Floor Post Clean-up, Note Residual Staining

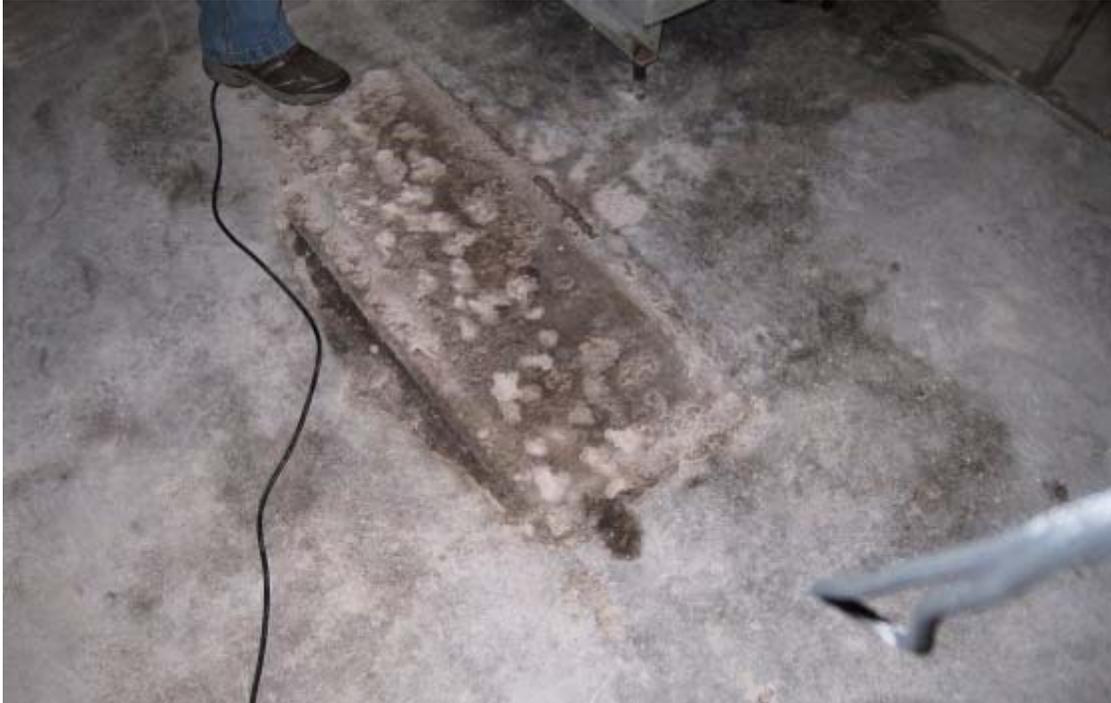
Picture 5

Close-Up of Residual Staining on Concrete Floor

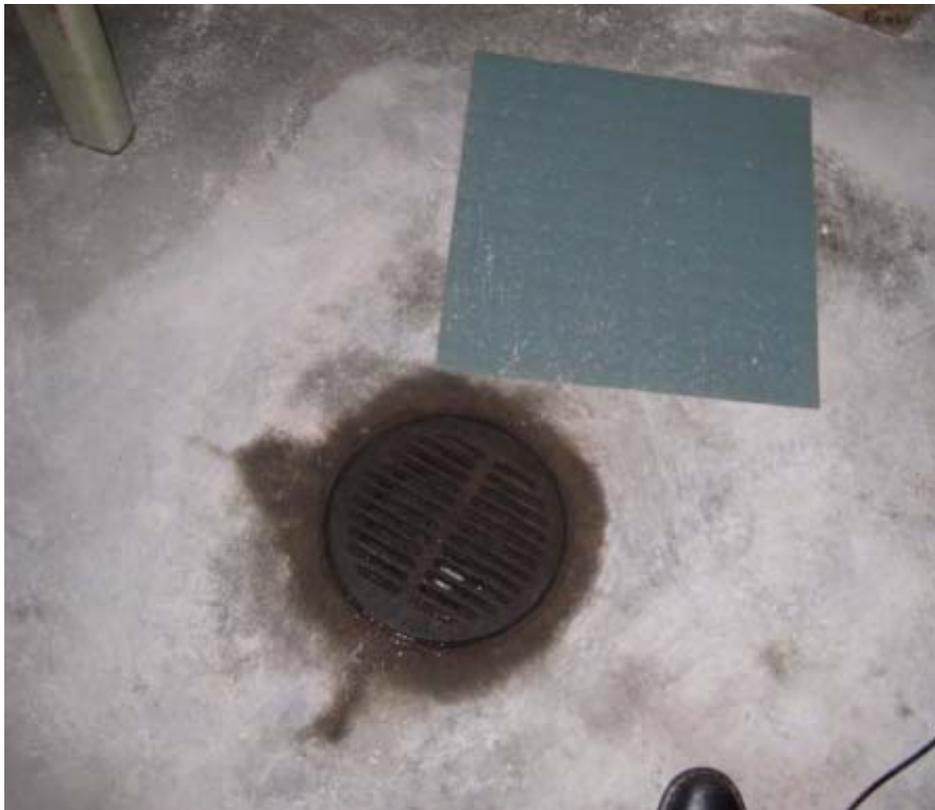
Picture 6

concrete floor were largely successful. Outdoor TVOC concentrations on September 23, 2008, were ND (Table 2). Follow-up testing inside the building indicated that no measurable levels of TVOCs were detected in any areas outside the boiler room. A TVOC measurement of 16 ppm was detected at floor level near an area with residual staining (Pictures 4 and 5). Finally, an elevated TVOC measurement of 112 ppm was detected at the floor drain when the rubber mat covering the drain was removed (Picture 6). This measurement was reduced in half compared to the previous day (285 ppm). However, the drain will continue to provide a source of odors and VOCs until further cleaning can be conducted.

Oil-Stained Concrete around Floor Drain
