ODOR INVESTIGATION FOLLOW-UP

**Major Edwards Elementary School
70 Crescent Street
West Boylston, Massachusetts**

Prepared by:
Massachusetts Department of Public Health
Bureau of Environmental Health
Indoor Air Quality Program
April 2008

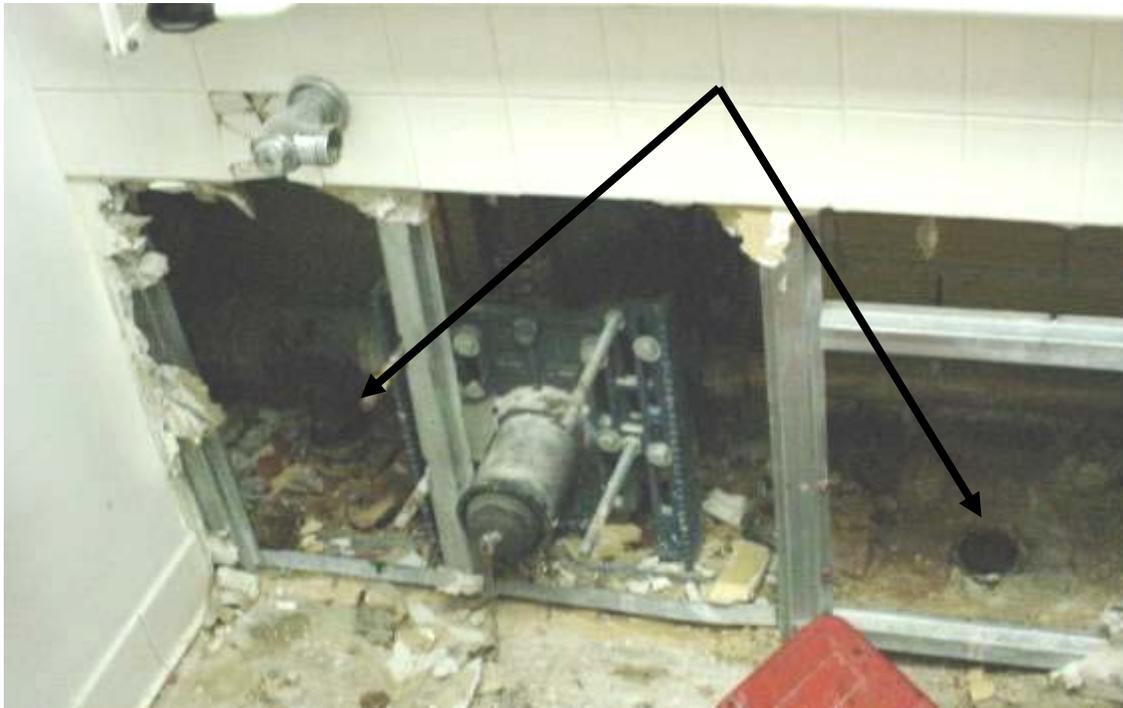
Picture 1

Concurrent with BEH follow up visit, the WBPSD had contracted a plumbing company (Eagan Plumbing) to identify the source of the odor and make repairs. On the day of the BEH follow up visit, Eagan Plumbing work had already begun. Eagan Plumbing had removed gypsum wallboard and bored holes into cement block to open a wall cavity that contained a significant amount of abandoned plumbing. According to Eagan Plumbing, floor drains had been sealed with construction debris (Picture 1). With the increased rain during the 2007-2008 winter, combined with the school using a septic system, it is likely that water forced air back up the drain lines subsequently forcing sewage odor through the construction debris and into the wall cavity. From that point the schools heating, ventilating, and air-conditioning system would draw this odor into the classrooms.

Abandoned Floor Drains in Basement Wall Cavity between Restrooms

1. In the event of future odors/concerns, continue working with plumbing contractor to identify/eliminate any additional abandoned plumbing fixtures that serve as sources/pathways for odors.
2. Continue to implement all applicable recommendations listed in previous MDPH reports.

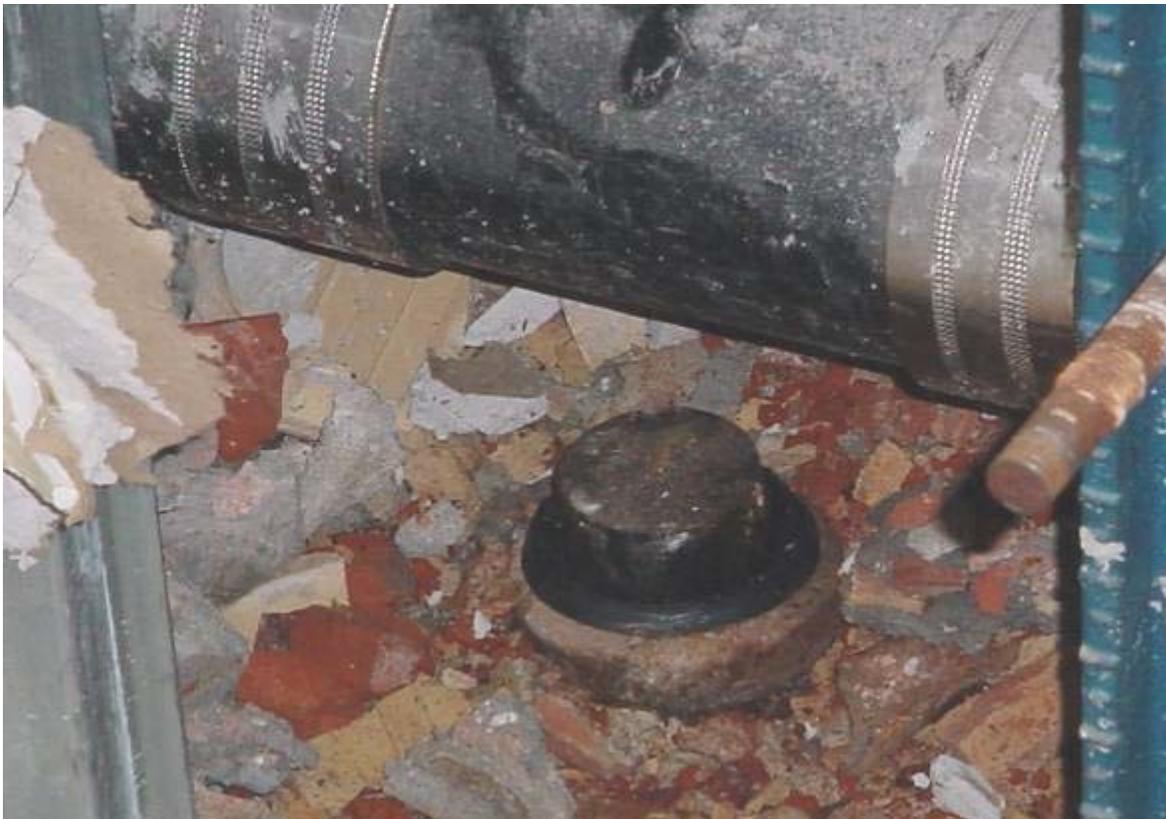
Picture 2

Close-Up of Capped Floor Drain in Basement Wall Cavity between Restrooms

These newly discovered open drains were capped by Eagan (Pictures 2 and 3) which resulted in the immediate dissipation of odors. In a telephone conversation with Principal Caruso after this visit, he reported that Eagan Plumbing had located and capped 14 different pipes, drains, and vents in this area of the school. The local plumbing inspector had also inspected and approved the sealing of these open drains. Principal Caruso reported that no further odors had been reported and that occupants would be relocated back to their respective rooms.

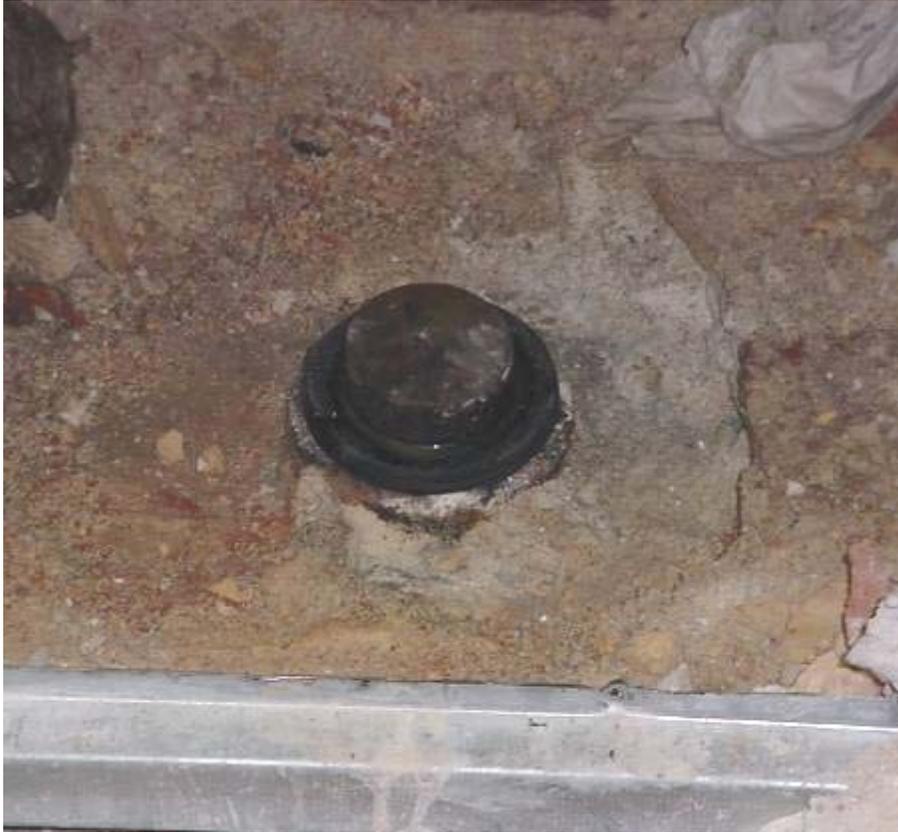
Picture 3

Close-Up of Capped Floor Drain in Basement Wall Cavity between Restrooms
