INDOOR AIR QUALITY ASSESSMENT

**Old Post Road Elementary School
99 Old Post Road
Walpole, MA**

Prepared by:
The Massachusetts Department of Public Health
Bureau of Environmental Health
Indoor Air Quality Program
June 2013

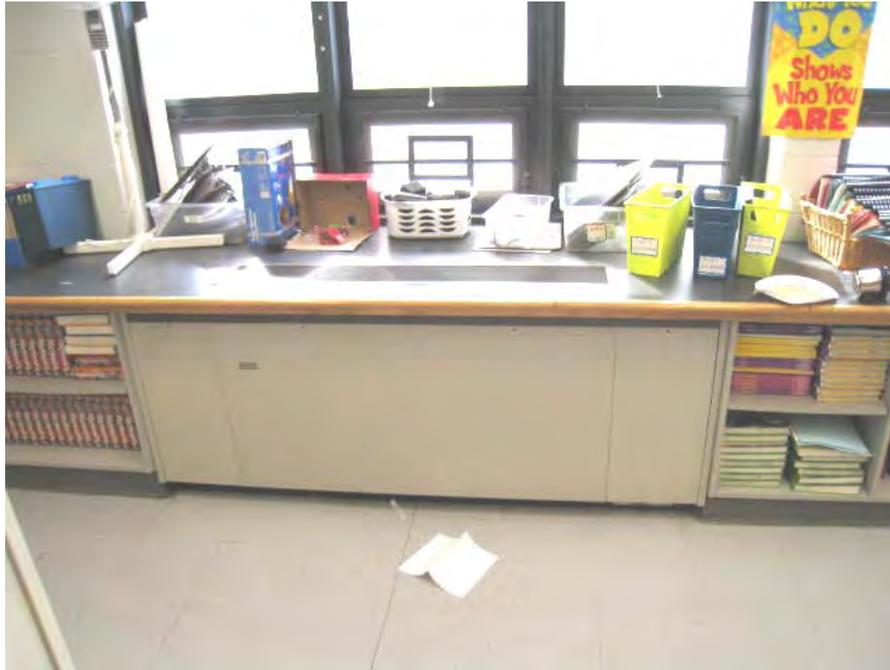
Picture 1

It can be seen from Table 1 that carbon dioxide levels were below 800 parts per million (ppm) in both classrooms 14 and 15. These results indicate adequate air exchange at the time of assessment. Fresh air in classrooms is supplied by unit ventilator (univent) systems (Picture 1). A univent draws air from the outdoors through a fresh air intake located on the exterior wall of the building (Picture 2) and returns air through an air intake located at the base of the unit. Fresh and return air are mixed, filtered, heated and provided to classrooms through an air diffuser located in the top of the unit ([Figure 1](#)). Univents have fan settings of “low” and “high” (Picture 3). At the time of assessment the univent in classroom 15 was operating on the “low” setting.

Classroom univent

1. Continue to operate ventilation systems (e.g., univents and exhaust vents) continuously during periods of occupancy.
2. Close classroom doors to maximize exhaust capabilities and air exchange as designed.
3. If an increase in fresh airflow/exchange is desired, consider operating univents in the fan “high” mode.

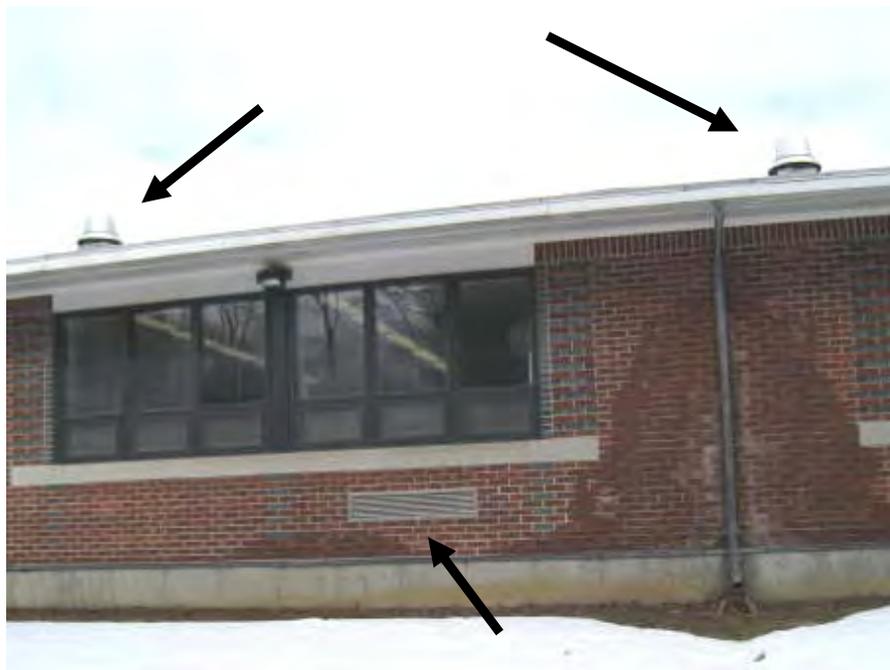
Picture 2

Exhaust ventilation is provided by ceiling-mounted vents that are ducted to rooftop motors (Pictures 2 and 4). During the assessment, the exhaust vents were operating and were found to have a good draw of air. However, the exhaust grills were observed to have accumulated dust/debris (Picture 4). Exhaust vents should be periodically cleaned of accumulated dust/debris to prevent re-aerosolization of these materials under conditions where exhaust vents are deactivated or not functioning as designed and cause backdrafting. It is also important to note that exhaust vents are located near hallway doors, which are generally left open (Picture 5). With the hallway doors open however, the exhaust vent will tend to draw air from the hallway *into* the classroom, instead of drawing stale air *from* the classroom. Therefore it is recommended that classroom doors remain shut while exhaust vents are operating to function as designed.

Univent fresh air intake (bottom arrow) and rooftop exhaust motors (top arrows)

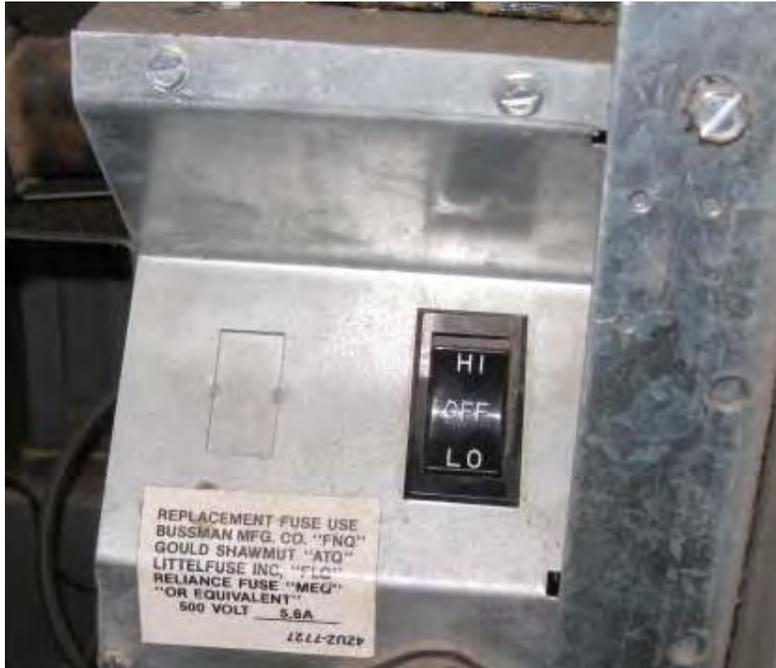
Picture 3

Univent fan control set to “low”

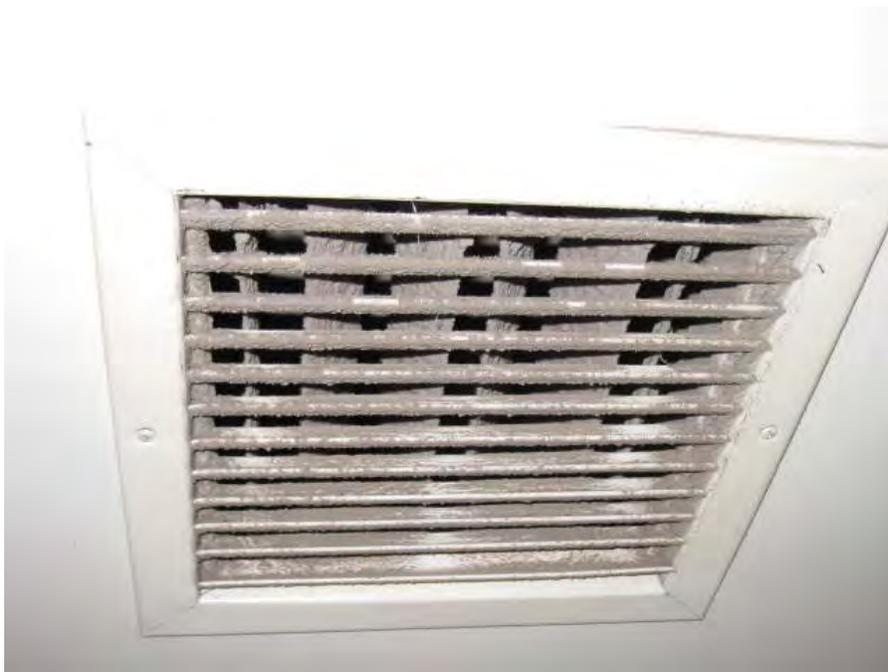
Picture 4

Other conditions that can affect indoor air quality were observed during the assessment. As previously mentioned, dust was observed accumulated on the surface of exhaust vents (Picture 4); dust/debris accumulation was also observed in the interior of univents (Picture 7). Univents and exhaust vents should be cleaned periodically (e.g., during regular filter changes) in order to prevent them from serving as a source of aerosolized particulates.

Ceiling-mounted exhaust grill, note dust/debris accumulation

4. Use openable windows where available in conjunction with classroom univents and exhaust vents to facilitate air exchange.
5. Ensure exhaust vents and the interiors of univent cabinets are thoroughly cleaned of dirt, dust and loose debris on a regular basis (e.g., during regular filter changes).

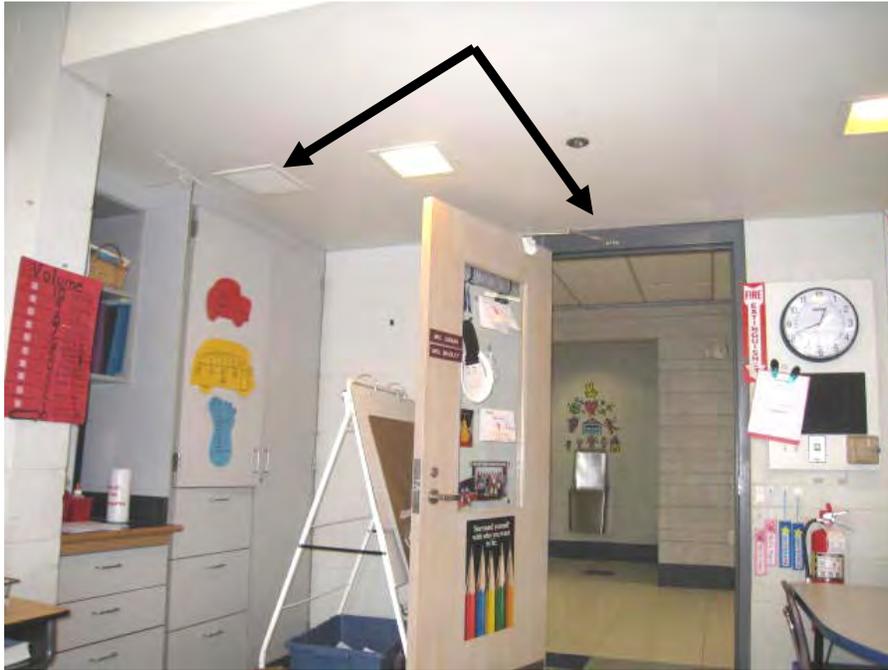
Picture 5

Proximity of ceiling-mounted exhaust vent to open classroom door (arrows)

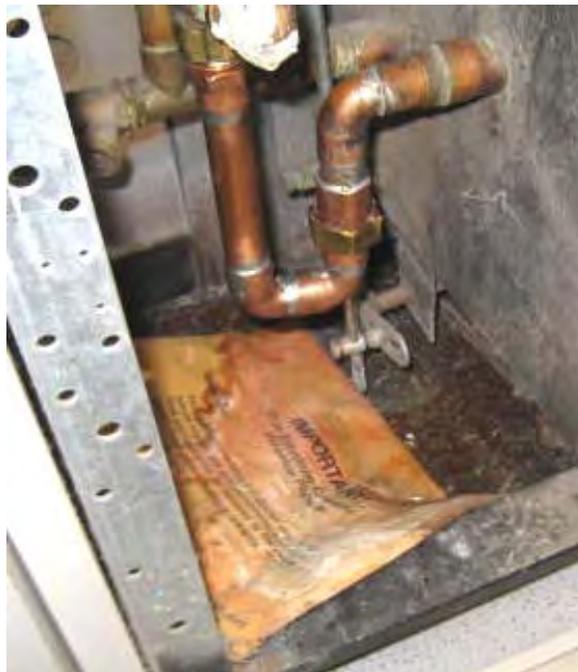
Picture 6

In order for building materials to support mold growth, a source of water exposure is necessary. Identification and elimination of the source of water moistening porous materials is necessary to control mold growth. As part of the assessment, BEH/IAQ staff opened the univent in classroom 15 to observe conditions inside for possible sources of irritants. Inside the univent cabinet wet/mold-colonized paper materials were found beneath a leaking pipe (Picture 6). At

the time of discovery of this material, BEH/IAQ staff recommended that the wet/moldy materials be discarded and the interior of the univent cabinet be cleaned and disinfected. No obvious leaks from the univent or sources of mold were observed in classroom 14.

Wet/mold-colonized paper materials in univent cabinet below pipe leak

7. If not done yet, ensure pipe leak in classroom 15 is fixed. Clean interior of univent cabinet with an appropriate antimicrobial. Paper materials (e.g., equipment manuals) should not be stored within univents. Univents in other classrooms should be inspected to ensure similar conditions do not exist.

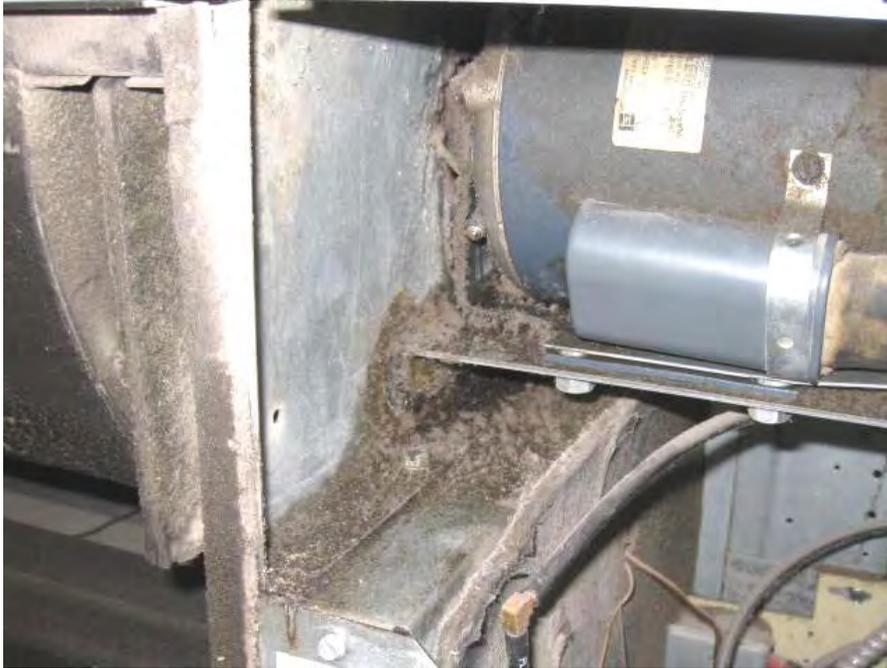
Picture 7

Accumulated dust and debris inside univent cabinet

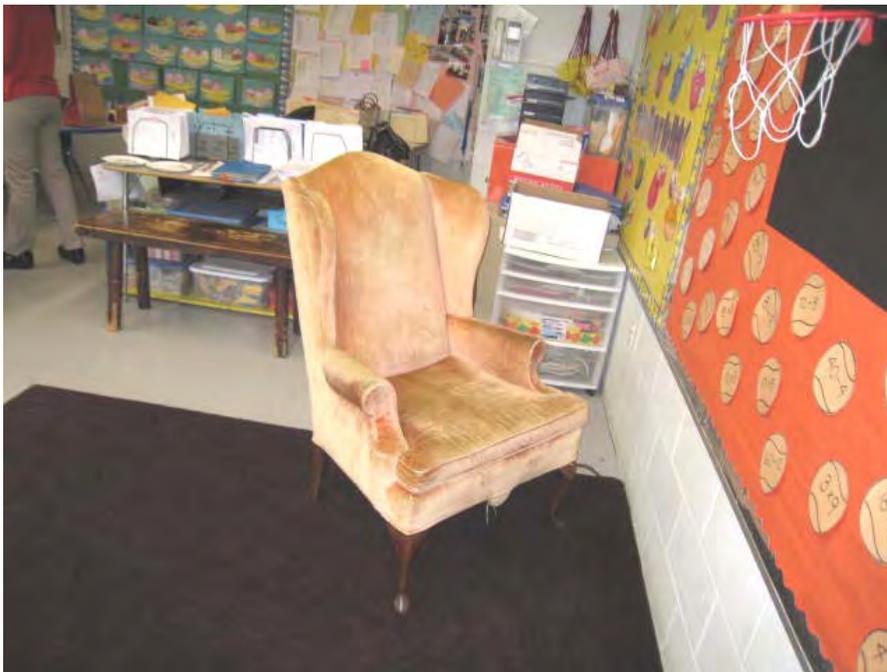
Picture 8

Upholstered furniture and pillows/cushions were seen in classrooms 14 and 15 (Picture 8). Upholstered furniture, pillows and cushions are covered with fabric that comes in contact with human skin. This type of contact can leave oils, perspiration, hair and skin cells. Dust mites feed upon human skin cells and excrete waste products that contain allergens. In addition, if relative humidity levels increase above 60 percent, dust mites tend to proliferate (US EPA, 1992). In order to remove dust mites and other pollutants, frequent vacuuming of upholstered furniture is recommended (Berry, M.A., 1994). It is also recommended that upholstered furniture (if present in schools), be professionally cleaned on an annual basis. If outdoor conditions or indoor activities (e.g., renovations) create an excessively dusty environment, cleaning frequency should be increased (every six months) (IICRC, 2000).

Finally, both classrooms also contained area carpets (Picture 8). The Institute of Inspection, Cleaning and Restoration Certification (IICRC), recommends that carpeting be

Upholstered chair and area rug in classroom 15

8. Clean upholstered furniture, stuffed animals and pillows on a regular schedule. If not possible/practical, consider removing from classrooms.
9. Continue to clean carpeting annually or semi-annually in soiled high traffic areas as per the recommendations of the Institute of Inspection, Cleaning and Restoration Certification (IICRC). Copies of the IICRC fact sheet can be downloaded at: http://www.cleancareseminars.com/carpet_cleaning_faq4.htm (IICRC, 2005).
