# **INDOOR AIR QUALITY ASSESSMENT**

**Quinsigamond Community College  
Suprenant Building  
670 West Boylston Street  
Worcester, Massachusetts**

Prepared by:  
Massachusetts Department of Public Health  
Bureau of Environmental Health  
Indoor Air Quality Program  
February 2014

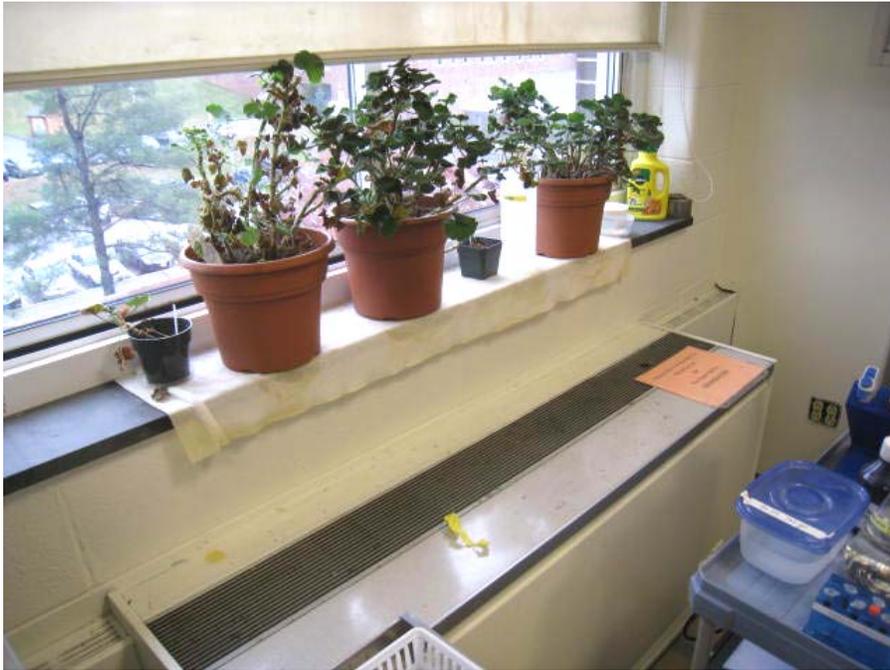
**Picture 1**

It can be seen from Table 1 that carbon dioxide levels were above 800 parts per million (ppm) in nine of forty-one areas, indicating a lack of air exchange in about a quarter of the areas examined. Fresh air in the majority of classrooms is supplied by unit ventilators (univents) (Picture 1). A univent is designed to draw air from outdoors through a fresh air intake located on the exterior wall of the building (Picture 2). Return air is drawn through an air intake located at the base of each unit where fresh and return air are mixed, filtered, heated or cooled and provided to classrooms through an air diffuser located in the top of the unit ([Figure 1](#)). Univents were found deactivated in some classrooms. In order for univents to provide fresh air as designed, intakes/returns must remain free of obstructions. Importantly, these units must remain “on” and be allowed to operate while rooms are occupied.

Plants were noted in some classrooms (Picture 1). Plants can be a source of pollen and mold which can be respiratory irritants to some individuals. Plants should be properly maintained and equipped with drip pans and should be located away from univents to prevent the aerosolization of dirt, pollen and mold. An aquarium was observed in an office. Aquariums should be properly maintained to prevent microbial/algal growth, which can emit unpleasant odors.

**Univent, note plants on sill on top of towel**

1. Operate univents and AHUs continuously during periods of occupancy to maximize air exchange.
2. Remove all blockages/items from the surface of univent air diffusers and return vents (along front/bottom) to ensure adequate airflow.

8. Ensure indoor plants are equipped with drip pans. Examine drip pans periodically for mold growth and disinfect with an appropriate antimicrobial, as needed. Move plants away from the air stream of mechanical ventilation equipment.

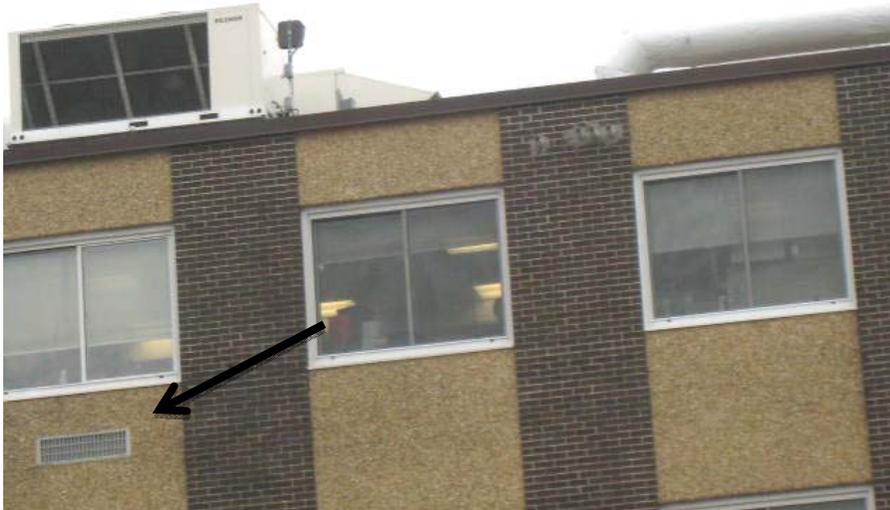
**Picture 2**

**Univent fresh air intake**
