WATERSHED-BASED PLAN

Abbey Brook and Lower Chicopee
River Watershed within the
City of Chicopee, MA

October 18, 2019

City of Chicopee
Geosyntec Consultants

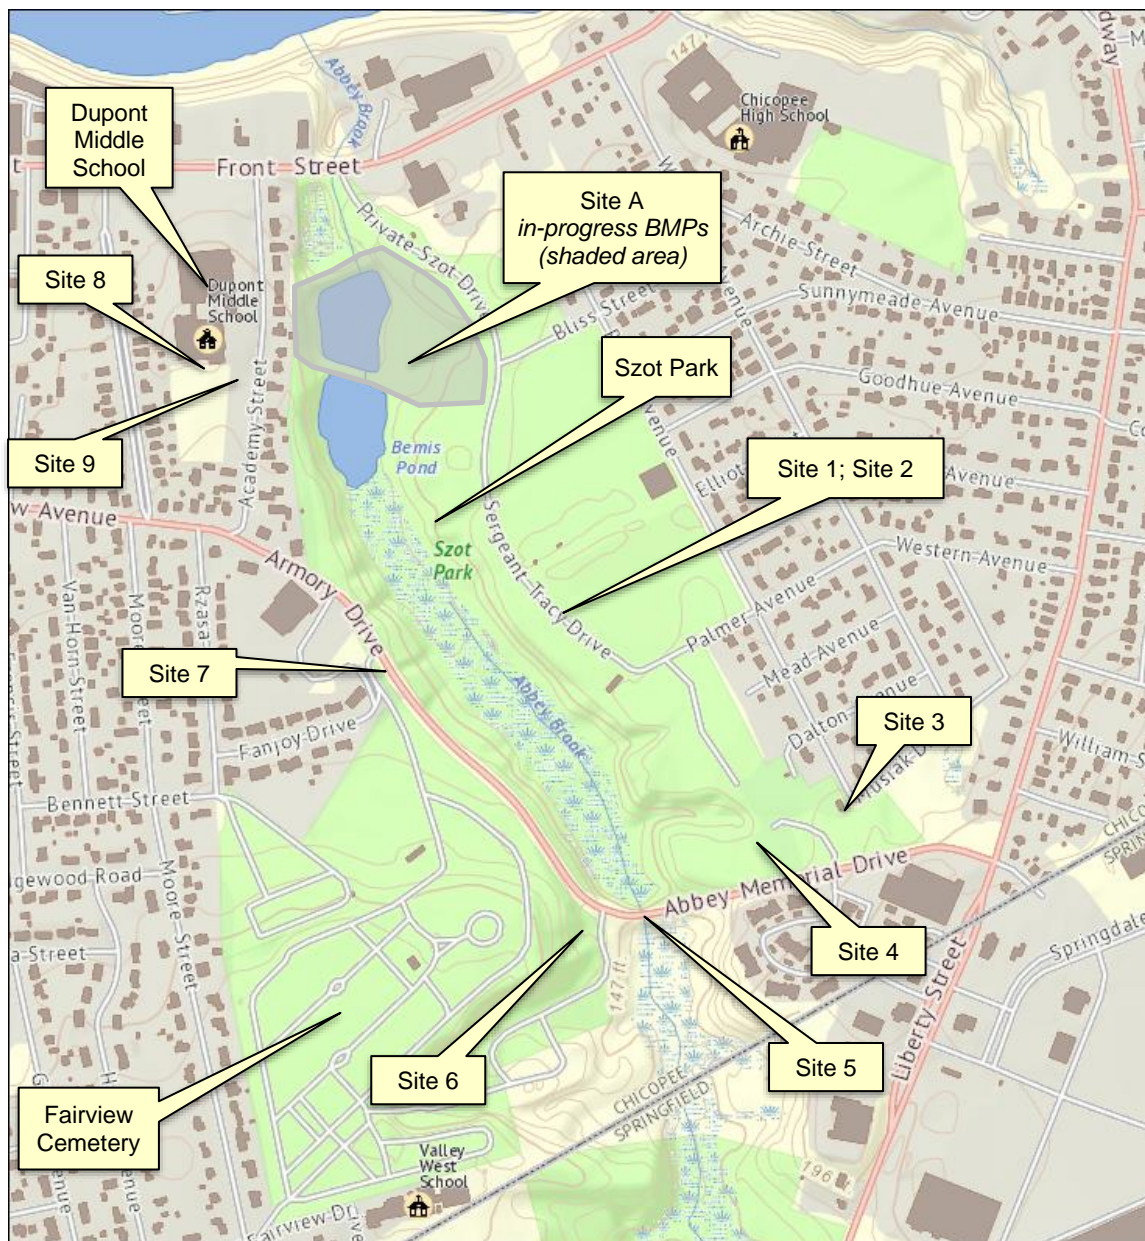
Figure C-1. BMP Opportunity Sites (See Appendix C for site descriptions)
 (Map source: MassGIS OLIVER viewer, standard basemap)

Refer to **Figure C-1** for a location map of proposed BMPs and to **Table D-1** for a summary of BMP characteristics and estimated costs.

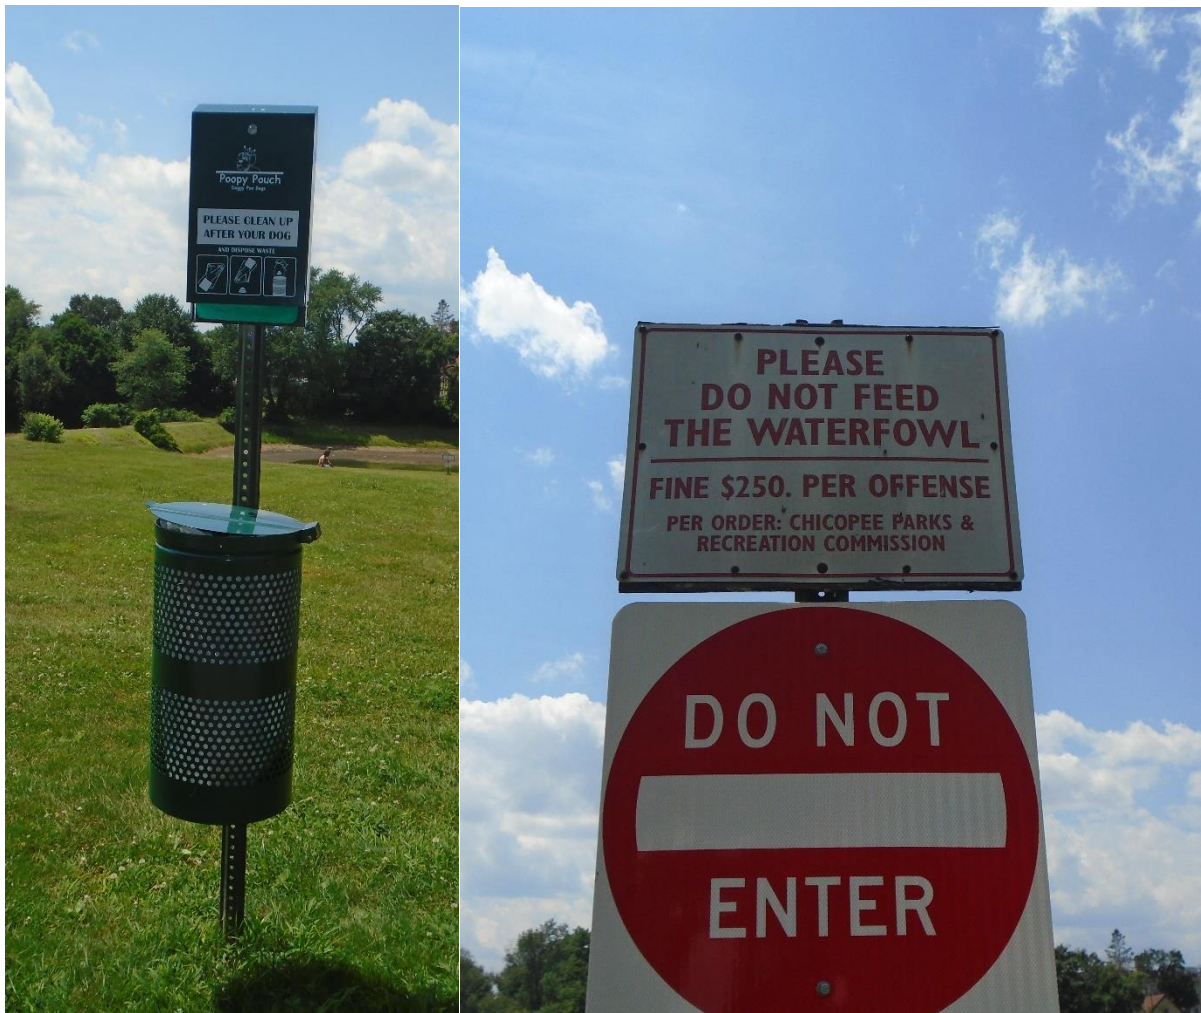
Figure E-1: Existing Examples of Public Education and Outreach in the Abbey Brook Watershed

1. Pet waste stations installed in Szot Park (existing – **Figure E-1**).
2. Develop a fifth grade-level learning module about watershed management and present the module at three Chicopee elementary schools. Students will prepare a project based on the module to be displayed publicly.
3. Hold a local event to extend information and learning to the public.
4. Post this watershed-based plan and project information on the City of Chicopee website.
5. Create additional information signage to highlight BMPs that are installed throughout the watershed on public land.
6. Implement community process planned as part of the Lower Bemis Pond Dam removal project.
7. Implement S.319 grant education programs.

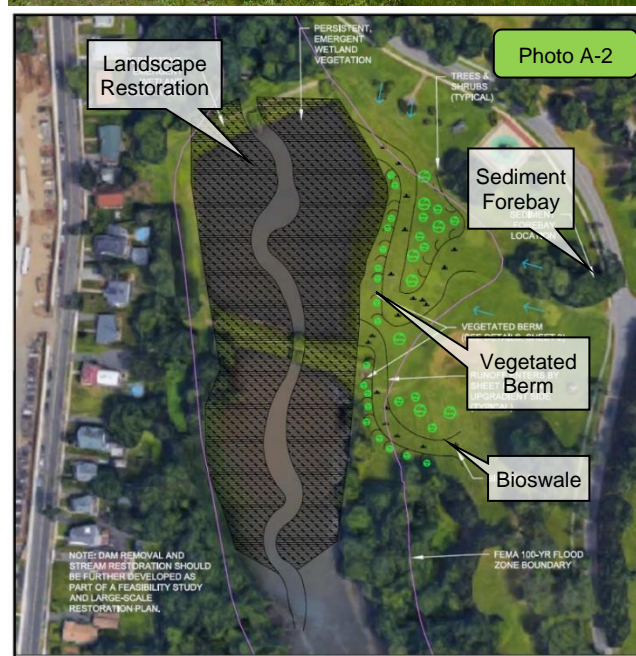
Sizing Characteristics ¹	
BMP Drainage Area (acres)	15.1
Estimated Pollutant Load Reduction ¹	
<i>E. coli</i> (billion colonies/yr.)	11.2
TSS (lbs./yr.)	1,178
Estimated Cost ¹	
Planning-level Capital Cost	\$203,400

1. The sizing characteristics, estimated pollutant load reductions, and estimated cost were obtained from the Stormwater Management and Stream Restoration for Water Quality in Lower Abbey Brook, Chicopee Section 319 Nonpoint Source Pollution Grant Program application (City of Chicopee, 2018).
