**August 2024**  
**Report No. 24-060**

# Accessible Bus Stop Design in the Presence of Bike Lanes

**University of Massachusetts Amherst**  
**Northeastern University**

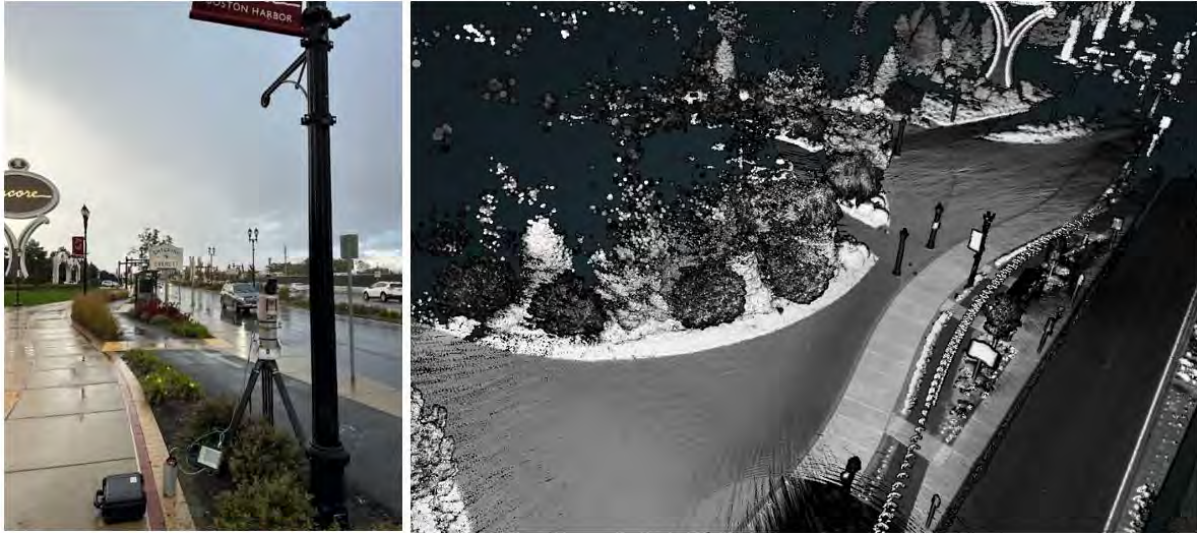
**Figure 2.1: LiDAR scanning set up and corresponding cloud point data (Broadway at Horizon Way Street.)**

In addition to the comprehensive inventory using publicly available data, e.g., Google Maps and Streetview imagery, and field observations, the research team collected detailed terrestrial LiDAR scan data using the Riegl VZ-2000 scanner for the five study sites identified in the following section. Besides the abovementioned information, the point cloud data derived from the terrestrial LiDAR scan can provide detailed geometry with more accurate measurements, such as the platform's width, bike lane's width, etc. Figure 2.1 shows a picture of when the LiDAR was scanning the testing site at Broadway at Horizon Way Street and the corresponding point cloud data.

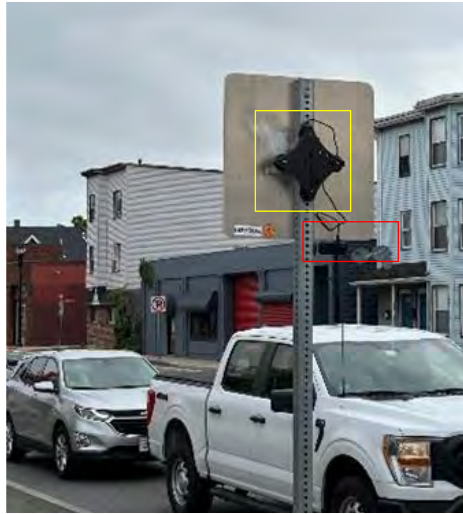
**Figure 2.9: Configuration of the 360° video camera (with battery and the camera magnetically mounted on the sign post as shown in the yellow and red boxes)**

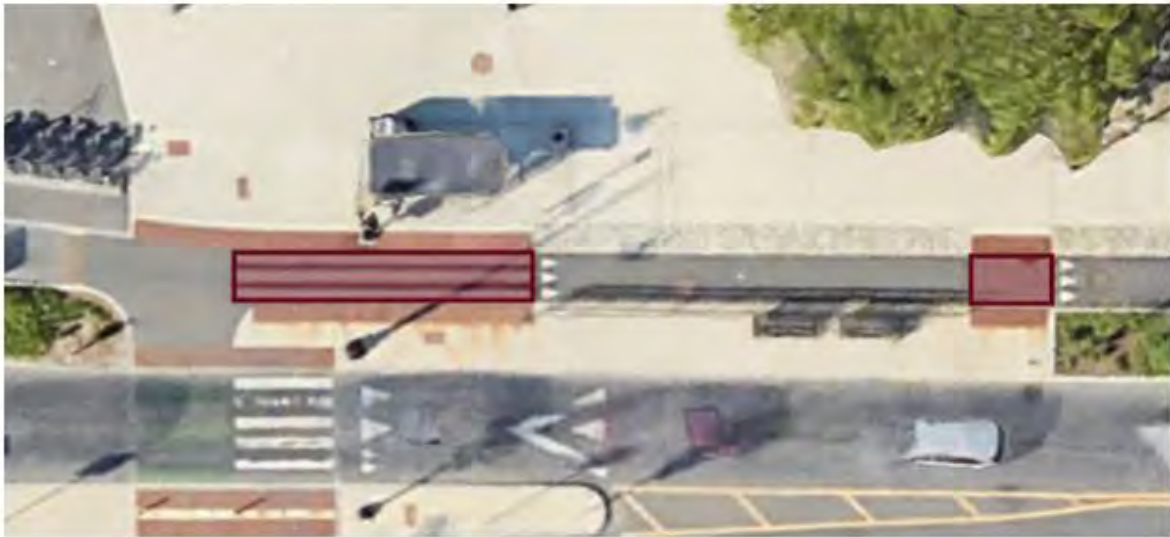
(b) Somerville Avenue at Stone Avenue

**Figure 2.21: Detection zone for assessing the percentage of transit riders that use crosswalks versus crossing elsewhere (Question 4) (continued on next page)**

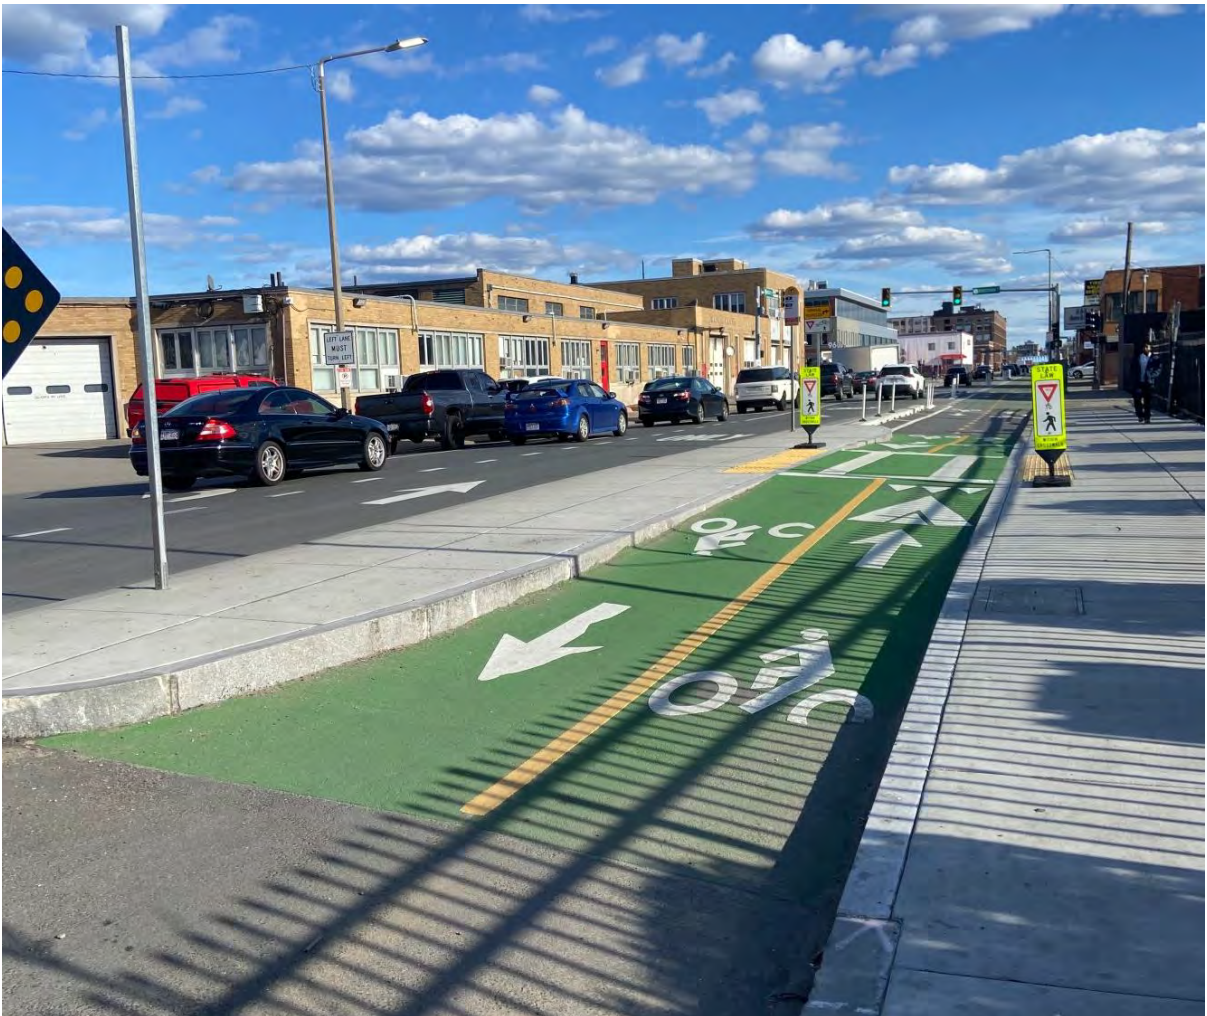
**Figure 3.9 Vertical curve along the adjacent bike lane (Massachusetts Ave at Island St, Boston, MA)**

Having a vertical or horizontal curve for bike lanes is an effective way to manage bicyclists' speeds by essentially encouraging them to slow down when they are biking through the floating bus stop area. The percentage of bike lanes featuring vertical curves or horizontal curves by floating bus stop type is shown in Figure 3.7. As the figures illustrate, vertical curves are more common at full-width platform bus stops (48%), while horizontal curves are only found at full-width platform bus stops; 32% of full-width platform bus stops are adjacent to bike lanes that feature a horizontal curve. This might be correlated to the fact that full-width platforms are typically implemented at locations with more space availability. Examples of the vertical/horizontal curves along the bike lanes are presented in Figure 3.8, Figure 3.9, and Figure 3.10.

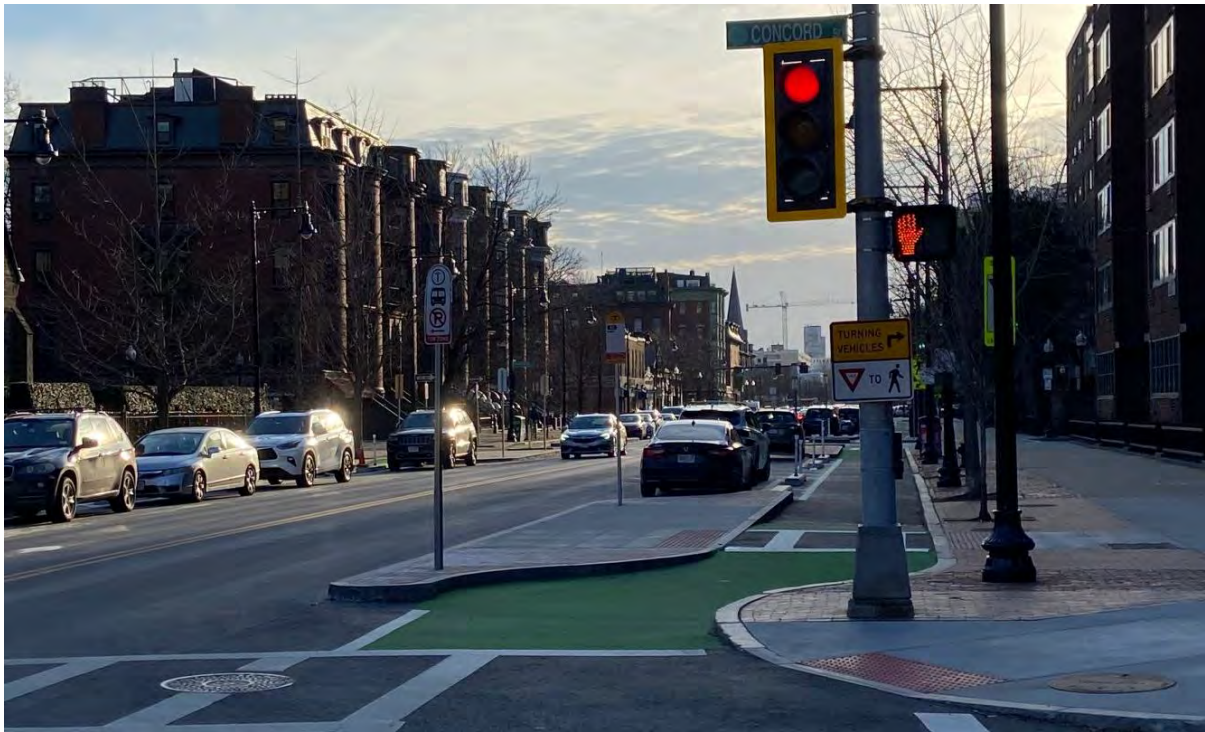
**Figure 3.10 Horizontal and vertical curve along the adjacent bike lane (Tremont St at Concord Sq, Boston, MA)**

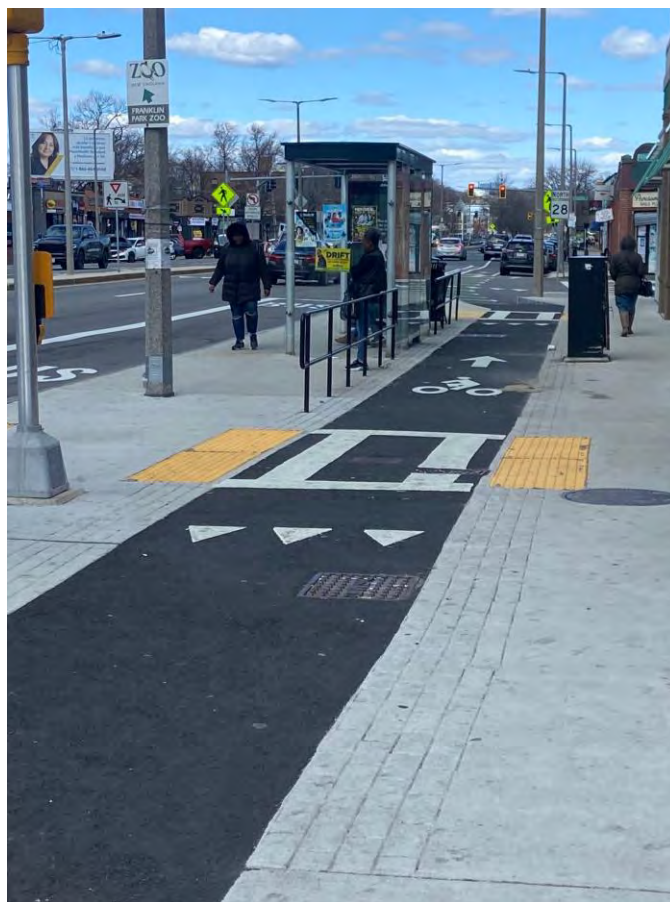
**Figure 3.20: Floating bus stop with fencing (Morton St at Blue Hill Ave, Boston, MA)**

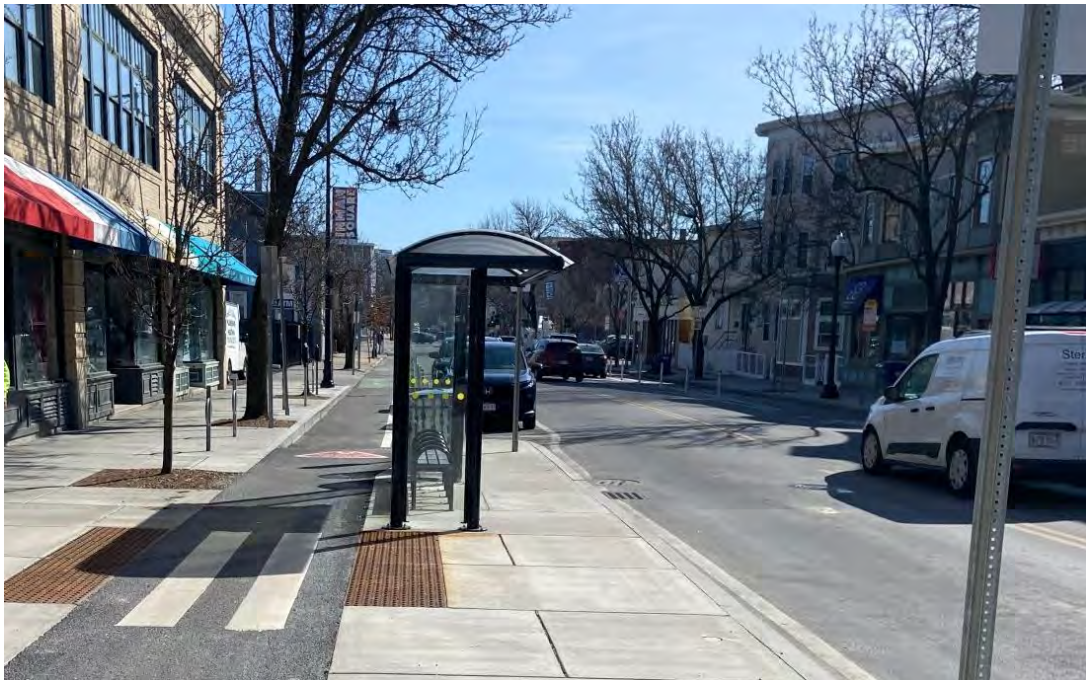
**Figure 3.22: Floating bus stop with tactile pavement (Hampshire St. at Cambridge St., Cambridge, MA)**

Tactile pavement helps visually impaired pedestrians navigate infrastructure and is typically located along sidewalks or to indicate the stops. Example of floating bus stops with tactile pavement is presented in Figure 3.22.

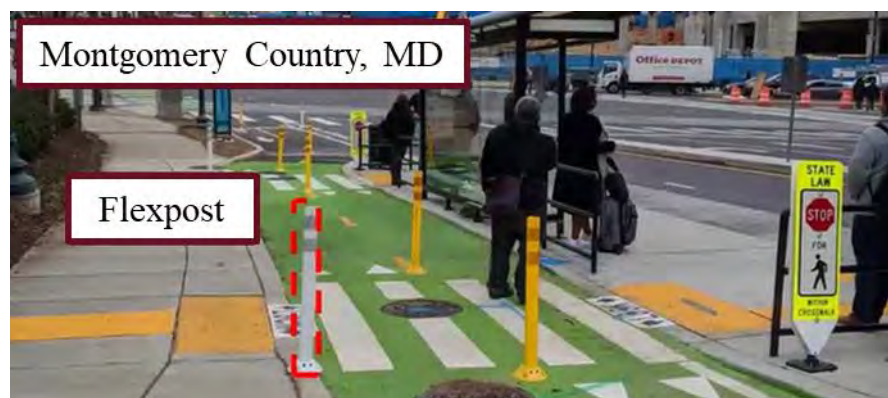
**Figure 4.11: White flexpost for marking the crosswalk location**
