**Cambridge/Malden District Courts
Medford, MA**

**HVAC SYSTEM
EVALUATIONS
COVID-19**

Office of Court Management

April 8, 2021

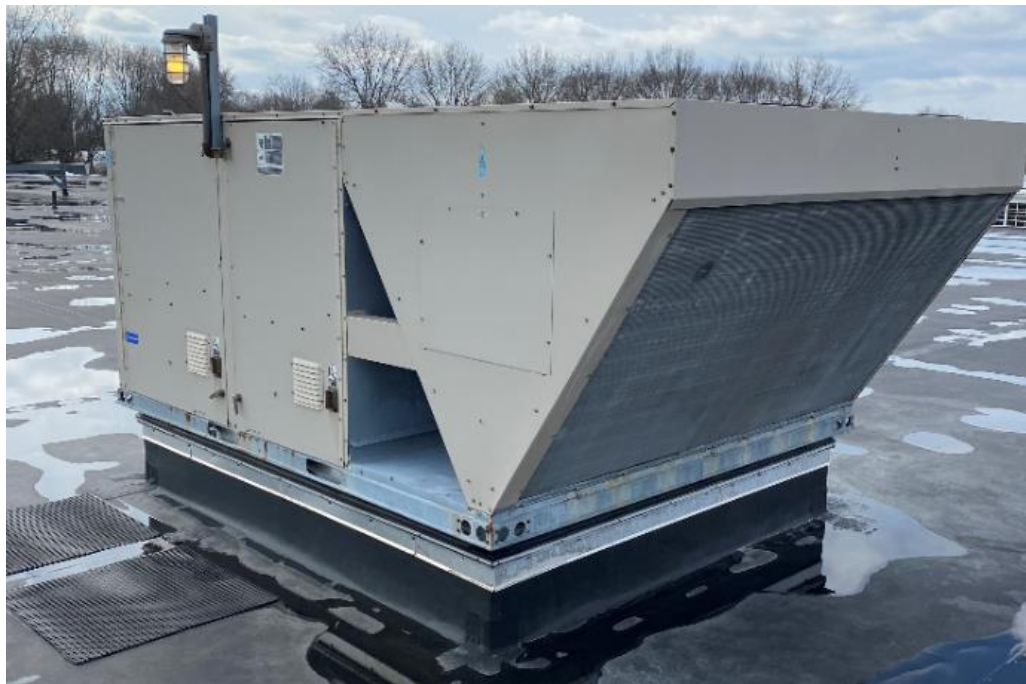
Photo 1 – Representative Air Handler

The two larger units and the ERU were installed as part of a renovation to the building in 2008 and are in good condition, however, the fans in RTU-6 makes a loud noise and the PVC cooling coil condensate drain piping has broken off. The four smaller units serving the Courtrooms and corridor were existing and relocated during the 2008 renovation. Tighe & Bond is unsure of their exact age, but we estimate that they were manufactured ~2005 based on information found on unit nameplates. ASHRAE data indicates that the median useful life expectancy for Rooftop Units like these are 15 Years, however, these unit appear to be in good condition and with proper maintenance, likely have several years of useful life remaining.
