Case Study: Route 181 Culvert Replacement Permitting & Culvert Infrastructure Assessment

Project Title: RT 181 Culvert Replacement Permitting & Final Design

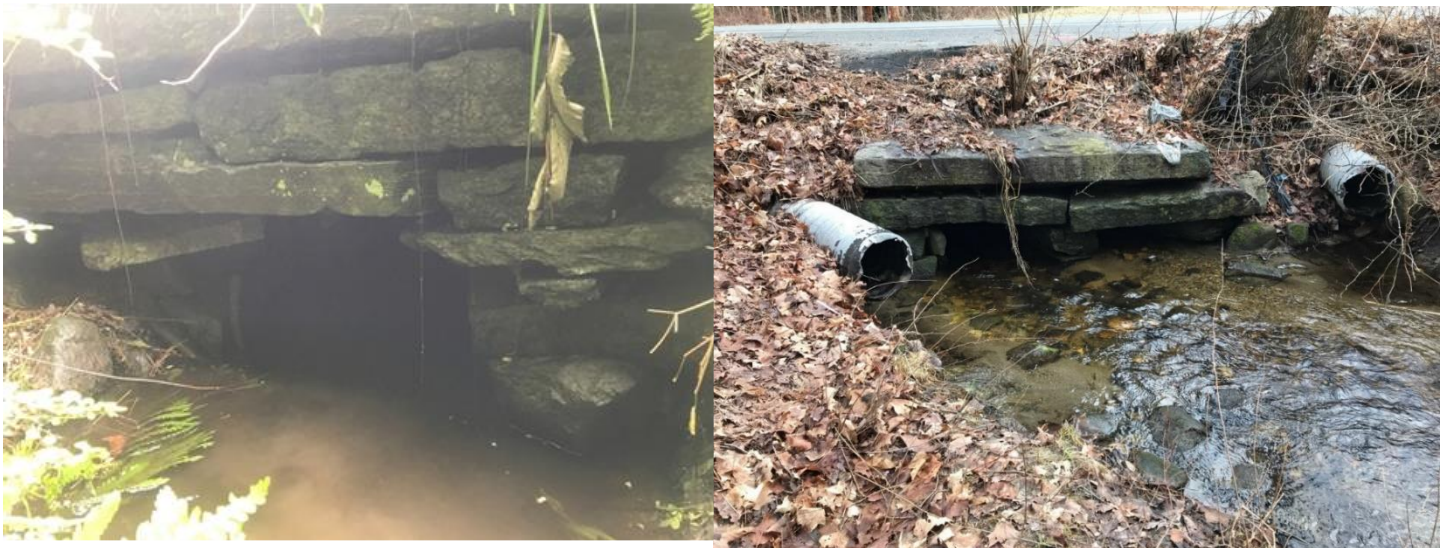
Photos of the inlet and outlet of the Route 181 culvert.

Flooding, including riverine and stormwater flooding, was a top hazard identified at the February 1, 2019 Community Resilience Building (CRB) workshop. The Route 181 culvert, located just north of the intersection of Thorndike Street and MA Route 181 (a major north-south transportation/evacuation route), experiences frequent overtopping by Scott's Brook, a coldwater fisheries resource. By upgrading the culvert to meet MA Stream Crossing Standards, and removing point-source discharges, this project will eliminate the need for road closures and associated travel delays as a result of flooding and/or overall culvert failure by increasing the flood conveyance capacity of the crossing.

The project resulted in the final design of the Route 181 culvert upgrade, which will include a 5-foot tall, 13-foot wide, 60-foot long box culvert embedded 2 feet. The final culvert design complies with the 1.2 bankfull width criteria under the MA Stream Crossing Standards and will have a natural substrate bottom, therefore mimicking the water depth, velocity, channel and substrate conditions found in Scott's brook outside of the influence of the existing, deteriorated, undersized twin culverts. . The channel slope will be 0.5%, and flood conveyance capacity is improved for all events, and there will be no overtopping of the roadway for any event analyzed, which included the 100-year storm. The final design also eliminated point-source discharges by replacing the two existing catch basins with two water quality basins to provide water quality enhancement of stormwater runoff that drains from the low point in the roadway, therefore protecting the primary recharge area for the Three Rivers public water supply and eliminating the discharge of untreated stormwater into a coldwater fisheries stream.
