**East Brookfield District Court  
East Brookfield, MA**

**HVAC SYSTEM  
EVALUATIONS  
COVID-19**

Office of Court Management

July 15, 2022

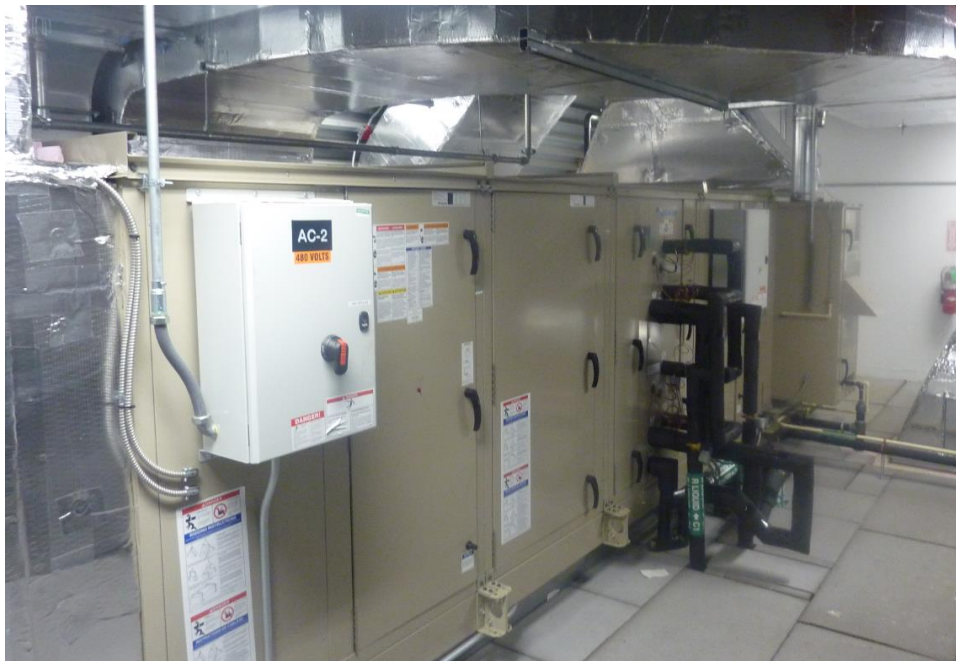
The East Brookfield District Courthouse was constructed in 1992 and is approximately 44,000 square feet in size. There are four variable air volume (VAV) air handling units that provide ventilation air to the occupied portion of the building. These are replacement units, installed in 2019, and are in new condition including all dampers, valves, and controls.

Photo 1 – Typical air handling unit

AC-1 and AC-2 have integral return fans, mixed air dampers capable of full economizer, MERV-13 filters, a direct expansion (DX) cooling coil, gas-fired furnace, and supply fan in a draw-through configuration. AC-3 and AC-4 have dedicated return fans that are

external to the unit. These units also have full airside economizer capability. The units include a supply fan in a blow-through configuration, MERV-13 filters, DX cooling coil, and gas-fired furnace. Each of the four packaged DX air handling units has an air-cooled condenser mounted on the roof of the building. Supply air is distributed to each zone via VAV boxes, which were also replaced in 2019.

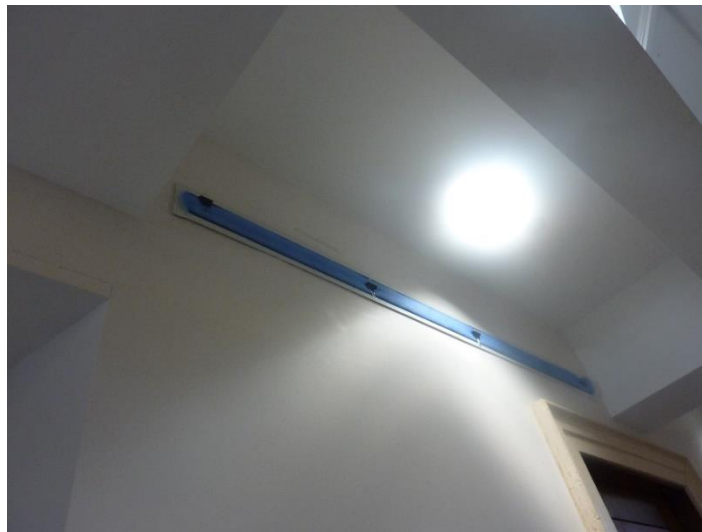
The ductwork serving these systems and all the occupied areas is original to the 1992 construction. The supply ductwork is 100% internally lined with fiberglass and is reported to be in poor condition according to a 2020 report. The report suggest that the liner has detached from the walls and may be restricting airflow. Filter fabric has been placed over the supply diffusers to address indoor air quality (IAQ) concerns from loose fibers in the supply air stream.

Photo 2 – Linear slot diffuser with filter fabric

It should be noted that during the work to replace these units in 2019, it was discovered that the duct liner in the ductwork throughout the building has become detached and the ducts appeared to be in poor condition. A ductwork remediation study was performed by Habeeb & Associates and a report dated October 2020 details these deficiencies with the ductwork. The report also presents several solutions including complete replacement of the ductwork throughout the building. Typically we recommend adjusting all airflow rates to recommended levels but, given that the building was recently balanced and extensive work is planned to remedy the duct issues, Tighe & Bond recommends performing the more comprehensive TAB work (measures RTB-2 and RTB-4) after the duct remediation work is complete.

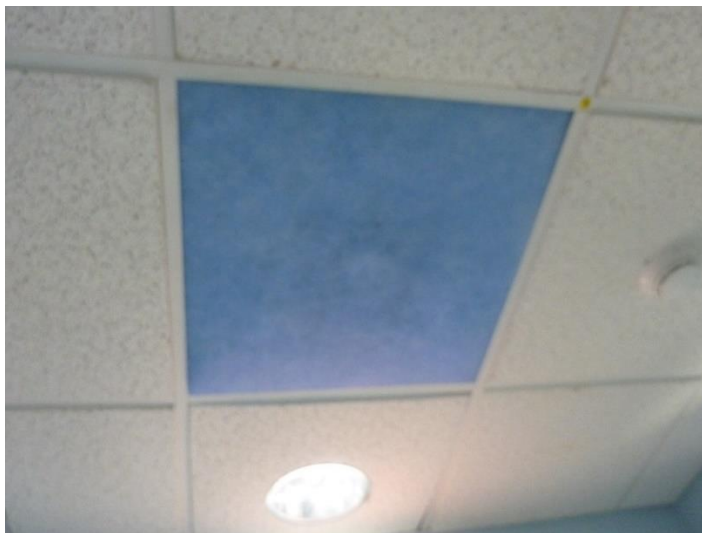
Photo 3 – Typical ceiling diffuser with filter fabric
