**Fenton Judicial Center
Lawrence, MA**

HVAC SYSTEM EVALUATIONS COVID-19

Office of Court Management
September 18, 2024

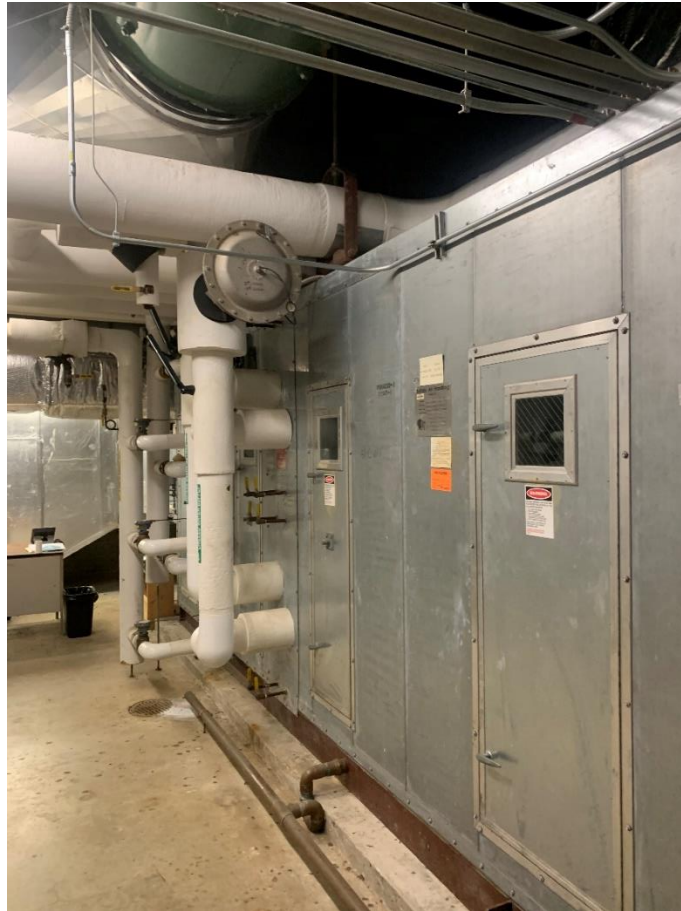
Photo 1 – Representative Air Handler

The Fenton Judicial Center was constructed in 1998 and is approximately 156,000 square feet in size. Six variable air volume (VAV) air handling units (AHU) provide ventilation air to the building. Each unit contains a supply fan, chilled water cooling coils, hot water heating coils, and a single stage 12" MERV 14 filter. Five dedicated return fans serve AHU's 1-5. All six units serve the building through a common supply and return duct system. AHU's 1-5 operate with variable airflow and approximately 25% outdoor air. AHU-6 operates with constant airflow and is a 100 percent outdoor air unit. Supply air is distributed to each zone via VAV boxes. The AHU's are from the original building construction in 1997 and are generally in good condition.

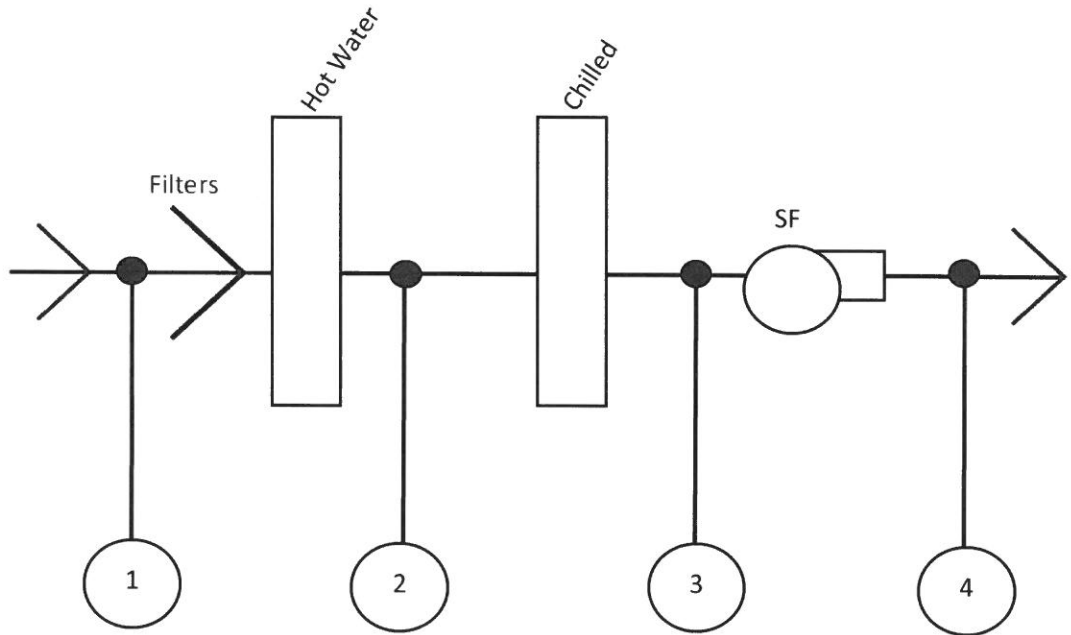
STATIC PRESSURE READINGS "wc

POS. (+) / NEG.(-)	1	2	3	4	5	6	7	NOTES
AHU-1	-0.57"	-1.16"	-1.58"	+2.44"				
AHU-2	-0.54"	-1.20"	-1.69"	+2.42"				
AHU-3	-0.51"	-1.18"	-1.78"	+2.38"				
AHU-4	-0.55"	-1.33"	-1.89"	+2.44"				
AHU-5	-0.77"	-1.33"	-1.83"	+2.31"				
AHU-6	-0.33"	-0.97"	-1.30"	+1.10"
