**Lynn District Court
Lynn, MA**

**HVAC SYSTEM
EVALUATIONS
COVID-19**

Office of Court Management

January 24, 2021

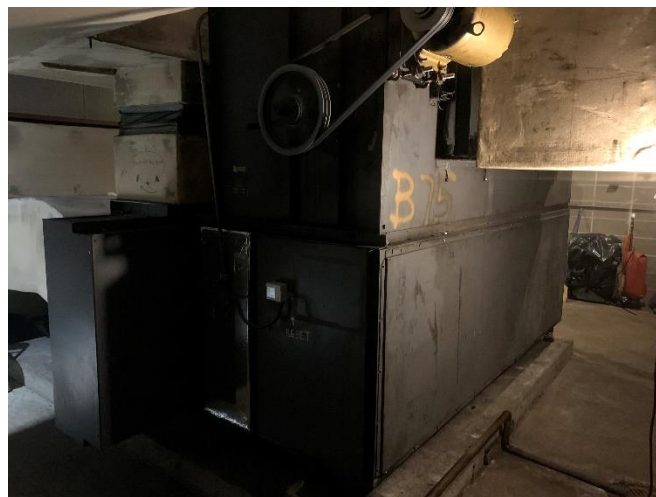
Photo 1 – AHU-1

Air handlers AHU-1 and AHU-2 appear to be from the 1969 renovation and are in fair condition. The outdoor air dampers are rusted, in fair to poor condition. The return air damper for AHU-1 was not accessible and AHU-2 return air damper is rusted. All damper actuators are old and in fair condition. The coils were not accessible, and therefore the condition and cleanliness is unknown. However, we suspect they may be dirty considering only a MERV 6 filter is used. The return fans also appear to be from the 1969 renovation and are in fair condition. The exhaust air dampers downstream of the return fan are in good condition.

We recommend replacing air handling units AHU-1 and AHU-2 within the next three years and to replace AHU-3 within the next five to 10 years. AHU-1 and AHU-2 are 50 years old and are past their expected life span. This recommendation does not affect the indoor air quality of the building, assuming the existing air handling units can deliver the proper quantity of supply and outdoor air and temper the air properly.

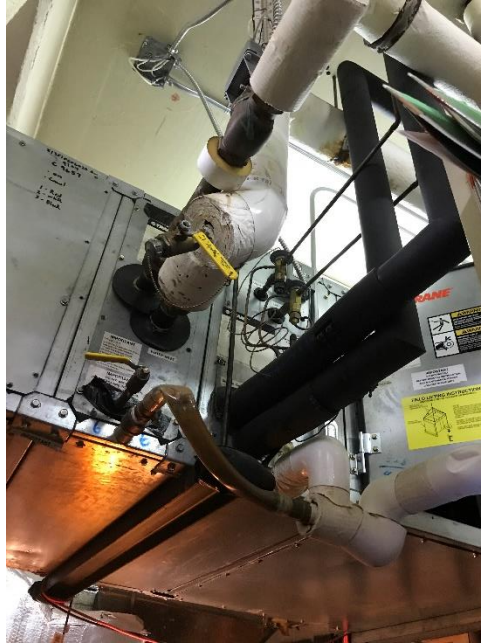
Photo 2 – AHU-3

AHU-3 is located in the basement file room, was installed during a 1996 renovation, and appears to be in good condition. The outdoor air damper is in fair condition, however the outdoor air damper was closed and the linkage was not connected to the actuator. We did not observe a return air damper. The coils appeared to be dusty in some spots.

We recommend replacing the MERV 8 filter in AHU-3 with MERV 13 filters.
