Municipal Vulnerability Preparedness Program Action Grant Case Study

Municipality: Norwood, MA

Project Title: Traphole Brook Flood Prevention and Stream Restoration Project

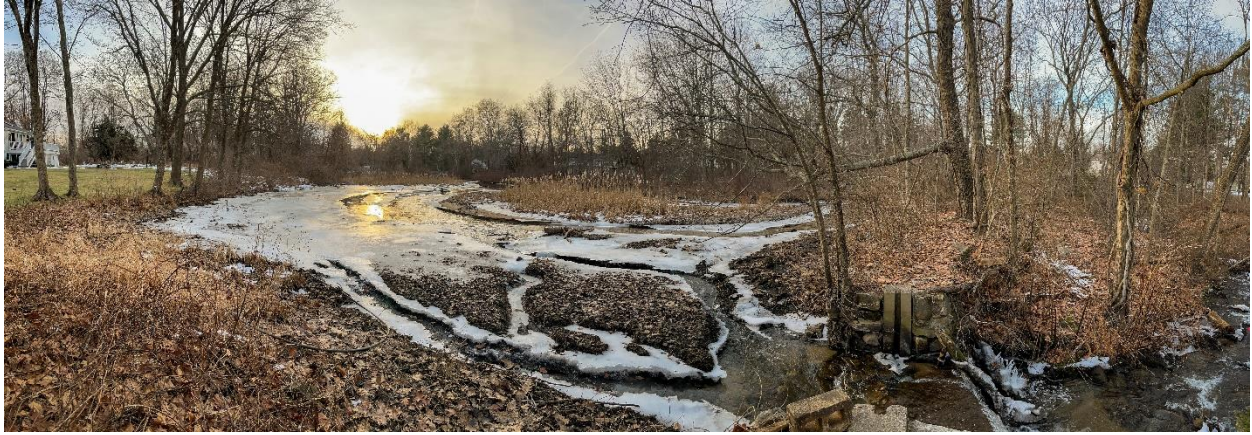
Mill Pond prior to dam removal. January 2022. PC: Sterling Worrell

Mill Pond was an 1.1 acre impoundment on Traphole Brook, a tributary that flows from Moose Hill Sanctuary in Sharon to its confluence with the Neponset River in Norwood. The Mill Pond Dam dated back to the 18th century and remained the primary impediment to fish passage along Traphole Brook. Following years of sedimentation, the former pond became a shallow pool with several thousand tons of sediment held back by the earthen dam.

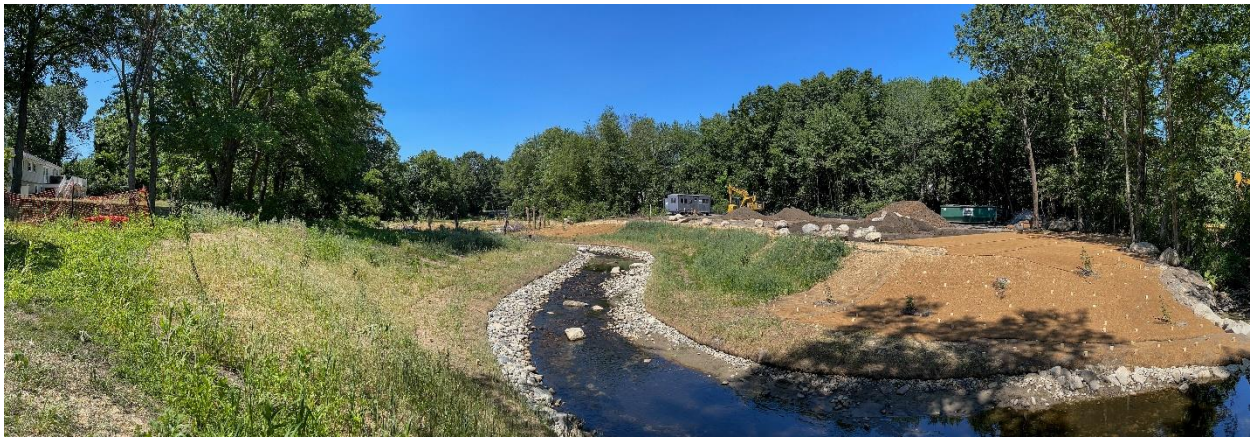
Mill Pond following dam removal and channel reconstruction. June 2022. PC: Sterling Worrell

Given this, the project was designed to remove the Mill Pond Dam and rechannelize the former impoundment to increase flood storage capacity and bolster the culvert at Sumner St while disposing of the impounded sediment to avoid its downstream transport. The removal of the dam, the construction of new channel, and the stabilization and revegetation of banks were all construction tasks set out for this project. Additionally, community members were engaged in voicing their own concerns about the impacts of climate change and the opportunities presented by green infrastructure. Awareness of the brook's biodiversity and methods abutters could use for bank stabilization and restoration through live tree staking were also employed.

The project successfully restored 437 linear feet of stream habitat and provided connectivity between the upstream and downstream Brook Trout populations. Over 5000 tons of impounded sediment was removed to landfills and an additional 1.1 acres was opened for eventual canopy cover as the riparian vegetation grows back. As previously mentioned, the risk of downstream impacts from a dam failure was removed with a newly constructed channel
