## ORLEANS DISTRICT COURT HVAC SYSTEM EVALUATION SUMMARY

**Orleans District Court  
Orleans, MA**

**HVAC SYSTEM  
EVALUATIONS  
COVID-19**

Office of Court Management

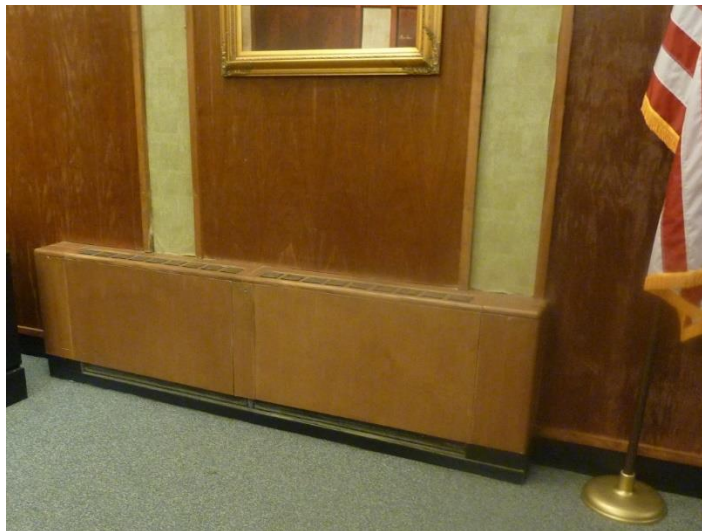
Photo 1 – Representative Unit Ventilator

All units appear to be from the original construction in 1971 and are in poor condition. The OA dampers and actuators do not appear to be functional.

The unit ventilators are well beyond their expected service life of 20 years and are in poor condition. New unit ventilators have more efficient electronically-commutated motors, have much quieter fans, and can use MERV-13 filters. We also recommend providing mechanical ventilation to all interior zones.

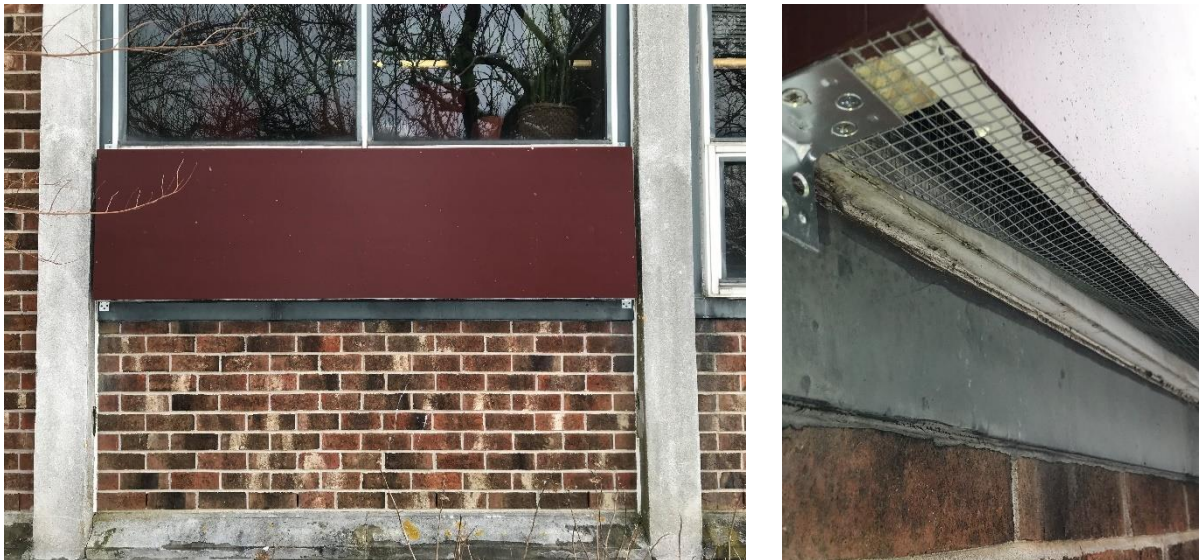
Photos 3 and 4 – Outdoor Air Intakes Boarded Over

A conditions assessment report, dated March 1980, noted that the systems were in “good condition with local temperature control” and noted “no operational problems”. However, it also mentioned that it “may be possible to reduce minimum outside air quantities”. This was a common, but often ill-advised energy conservation measure during that period, and appears to have been implemented. Many of the OA intake louvers are boarded up with plywood, leaving only a small gap at the bottom. We do not know if these intakes were boarded up to address other issues, such as coil freezing, wind-driven rain, or excessive indoor humidity in summer.

We recommend testing and balancing the outdoor air flow rates for all unit ventilators units to the recommended minimum O.A. rates listed in Table 2, or to the O.A. rates on the original design drawings. We also recommend investigating why the outdoor air intakes were covered over to begin with. If it was to address coil freeze or wind-driven rain problems, the solution may be different than if it was simply an energy conservation measure.

In order to achieve the proper amount of outdoor ventilation air for the unit ventilators, it may be necessary to remove some the restrictive covers added to the exterior louvers over the years. We recommend replacing these covers and adding hoods if there has been a problem with wind-driven rain entering the unit ventilators.
