**Quincy District Court
Quincy, MA**

**HVAC SYSTEM
EVALUATIONS
COVID-19**

Office of Court Management

January 14, 2022

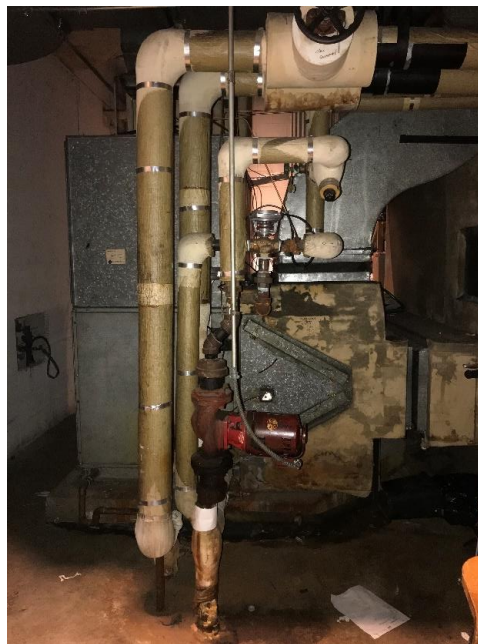
Photo 1 – Representative Air Handler

The air handling units appear to be from the original construction in 1972 and are in poor condition. The outdoor air dampers and actuators are in fair to poor condition, and the outdoor air damper in S-1 and S-2 appeared to be closed or mostly closed during our site visit. The heating and cooling coils are dirty. The 3-way hot and chilled water control valves and actuators are in fair condition. S-1 serves most of the basement, S-2 serves the first floor, and S-3 serves the second floor. S-4 serves three small offices in the old vault space. S-4 does not provide any outdoor air to the spaces served.

Indoor air handling units have a life expectancy of 35-45 years. The air handlers are approximately 49 years old and are in poor condition. Consider replacing these units as soon as possible to avoid the risk of failure. If one of the air handling units fails unexpectedly, it will result in significant portions of the building being unventilated, heated, or cooled. Replacing the return fans should also occur in conjunction with the replacement of the air handling units and should be sized correctly to provide an overall positive building pressure to reduce infiltration.
