**Stoughton District Court  
Stoughton, MA**

**HVAC SYSTEM  
EVALUATIONS  
COVID-19**

Office of Court Management

February 3, 2021

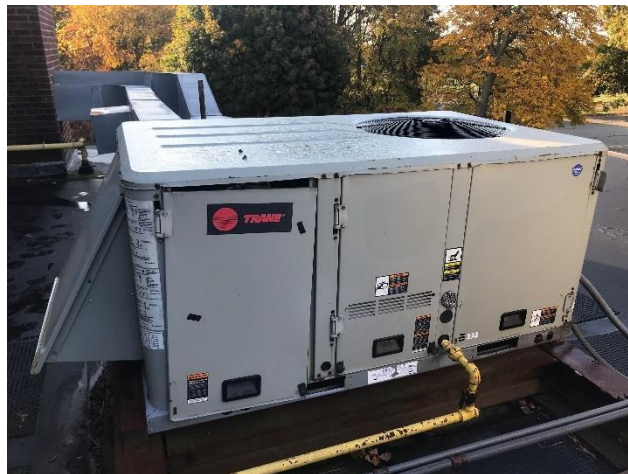
Photo 1 – RTU-2 (Trane)

The two, constant volume Trane rooftop air handling units each contain a supply fan, refrigerant (DX) cooling coil, a natural gas heating coil, and 2" MERV 10 filters. RTU-1 is newer and in excellent condition. According to the name plate tag, RTU-2 was installed in 2002 and is in fair condition. The DX coil is dirty, and the gas heating coil was not accessible. The outdoor air damper section of RTU-2 was sealed shut and a gravity damper was installed in the ductwork located on the roof. It appears the function of the gravity damper is to allow outdoor air to enter the system, however we observed that the damper remained closed while RTU-2 was running. A dedicated return fan serves the two Trane air handling units. The return fan serving RTU-1 had a broken belt during our site visit.

Replace the filters in both Trane rooftop units with MERV 13 filters. The TAB Contractor and/or Engineer shall verify that the air handlers can accommodate a MERV-13 filter per Appendix A in the overview of recommendations report.

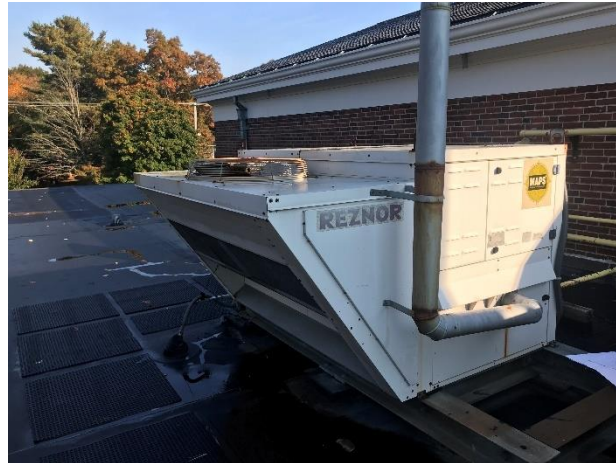
Photo 2 – RTU-2 (Reznor)

The two Reznor units have a supply fan, DX cooling coils, gas fired heating coils, and 2” filters with an unknown MERV rating. They are both in poor condition and according to facilities staff, have not run in several years. The dampers and actuators are in fair condition and the coils are dirty. Since these units are not operational, the spaces they serve are not receiving any ventilation air to our knowledge.

We recommend either repairing or replacing the two non-functional Reznor air handling units. According to the 2003 design drawings, these units were designed to provide 100% outdoor air. 100% outdoor air is typically not required for the office space or the two Courtrooms that these units serve, and these units may be expending more energy than required to deliver supply air. However, if each space supplied by these RTUs are cooled by a mini split system, all that may be required for supply air is code required ventilation air. We recommend evaluating the heating, cooling, and ventilation air requirements for the spaces these units serve to determine how much supply air is required for each space, taking into consideration the ductless mini split systems serving the spaces. It may be viable to replace RTU-2 (Reznor) with a unit that can return air, instead of exhausting it to the outdoors. The existing roof mounted exhaust fan can be removed and the exhaust ductwork in the ceiling can be routed to the return section of the new air handler. A new roof opening may be required to run the return ductwork up through the roof.
