**Massachusetts State Laboratory**

**Facility Condition Assessment Study**

Project Number DPH 0702 ST1

January, 2014

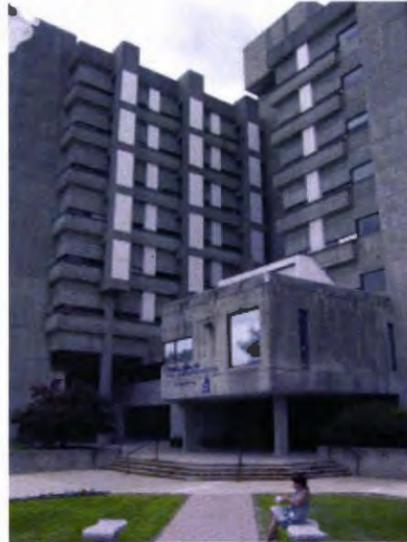
A.001 Tower Building Exterior View

- Sealants are failing at the main entry overhang.
- Hairline cracks are noticeable in some of the concrete wall surfaces. These appear to be shrinkage or stress cracks and are not considered to be a concern for the structural integrity of the concrete wall.

- Entry plaza window heads – the horizontal concrete return to the window frame is cracked at the window head area.
- Rusting reinforcing bars are exposed in several areas of the concrete wall panels and other areas were observed to have the beginning of spalling concrete which is indicative of rusting reinforcing bars behind that fracture the concrete face.

- Sealant deterioration and loss of adherence are observed at several lower block to tower building joints.
- Significant staining to the concrete walls were observed at several areas around the building. Although perhaps not critical to water infiltration, staining of this magnitude may hide potential problems such as retained moisture within the concrete panels.

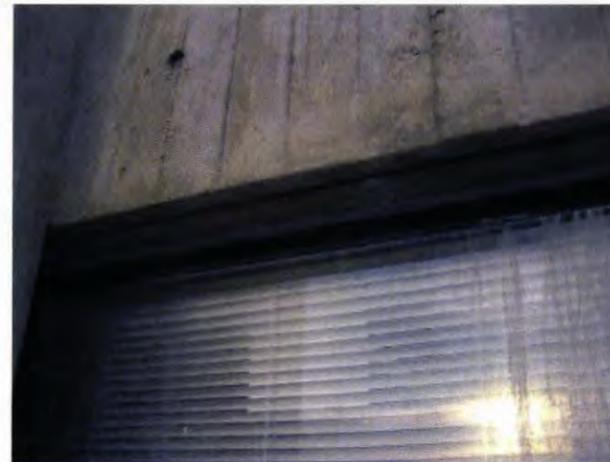
A.017 Tower Building Window Detail

- The metal strip windows at the tower portion are set back from the main building face by approximately 12 to 16 inches. This recessed condition has provided them with protection from severe weathering conditions. Of the windows that could be directly observed up close (a small percentage) perimeter sealants and glazing sealants appeared to be in fair condition.

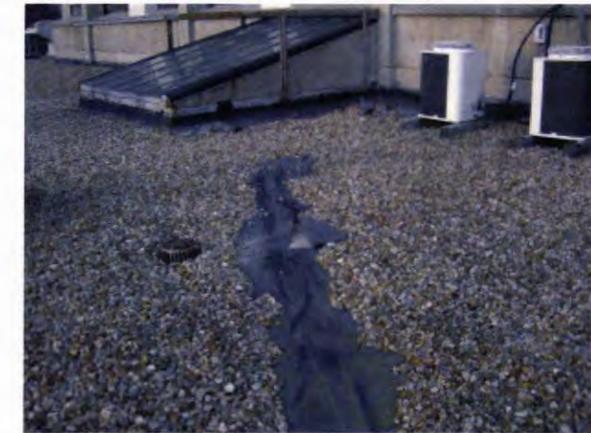
A.018 Tower Building Membrane Roof Detail

- The roof membrane was replaced 20 to 23 years ago with a black EPDM system. In 2010 the electrical room roof was replaced with an off-white TPO system, covered with roofing pavers. The chiller plant roof was replaced in 2011 in conjunction with the Emergency HVAC Project, with an off-white TPO system.
- Water infiltration above the window heads is prevalent on west wing.
- It is not known if sealants around the original steel window frames have been replaced.
- Some sealant repairs/applications have been made on the exterior mechanical exhaust towers.
- Water infiltration has been observed in all four egress stair wells.

8. Replace Tower grease trap	\$ 60,000
9. Replace Tower EPDM roofing system	\$2,700,000
10. Replace Tower exhaust fans	\$ 190,000
11. Replace Stable skylights	\$ 190,000

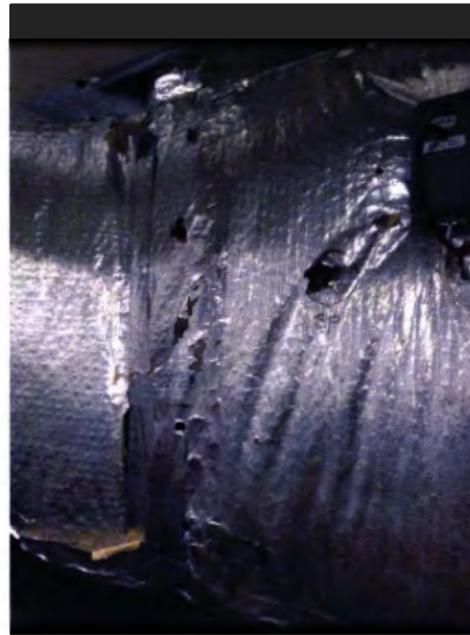
M.014 Stable – Ductwork in mechanical room has holes.

12. Replace Stable ductwork	\$ 700,000
13. Replace Stable AHU	\$ 90,000
14. Provide Stable I/T improvements	\$ 290,000
15. Separate Stable PBX from Biologics	\$ 5,000

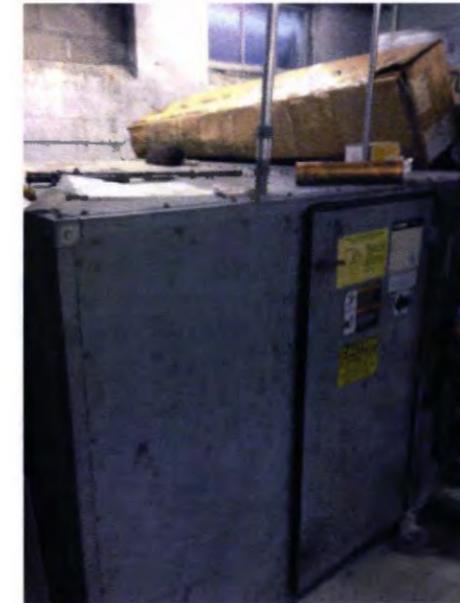
M.015 Stable – AHU

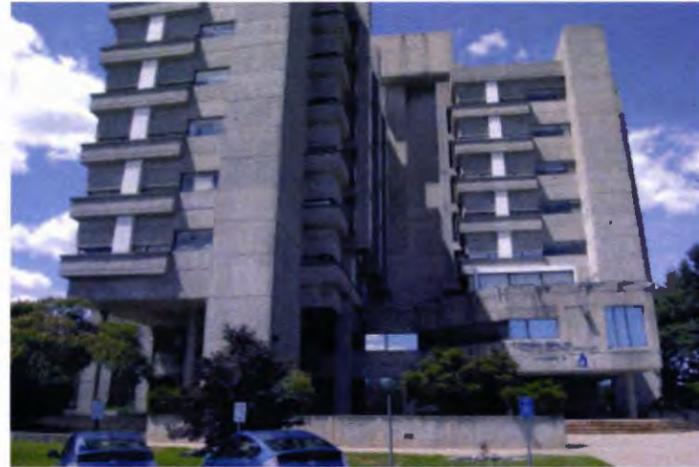
E.001 Tower – Front building with exterior light and security camera.

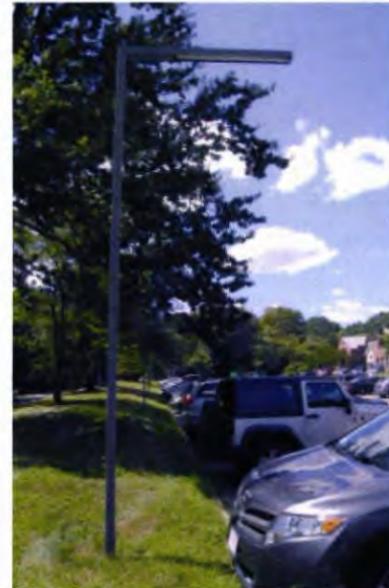
E.002 Tower – Existing exterior light fixture and pole.

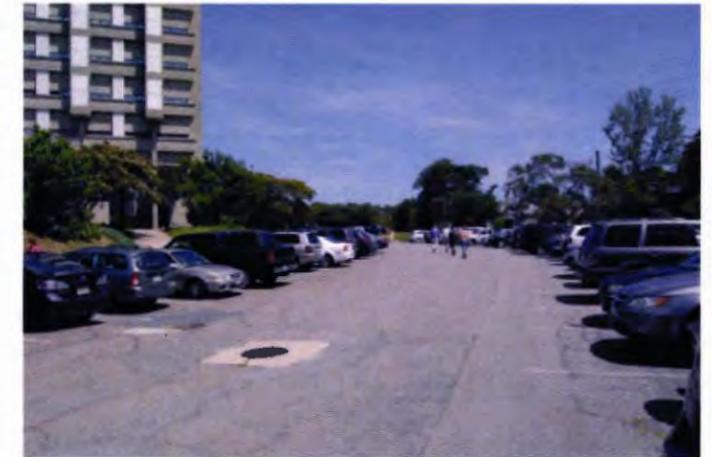
E.003 Tower – Exterior and security camera in parking lot.

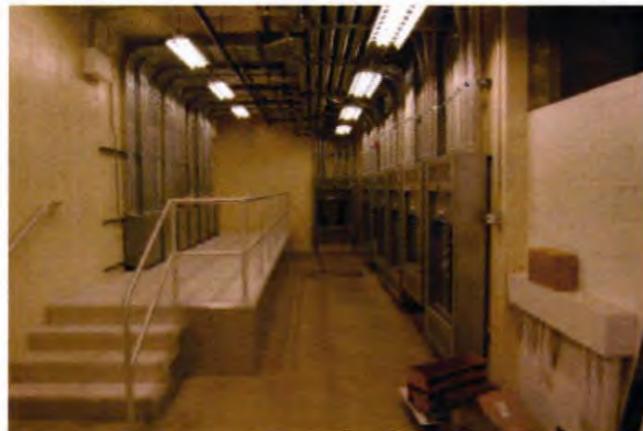
E.004 Tower – Renovated distribution panelboard and splice boxes in Basement electrical room

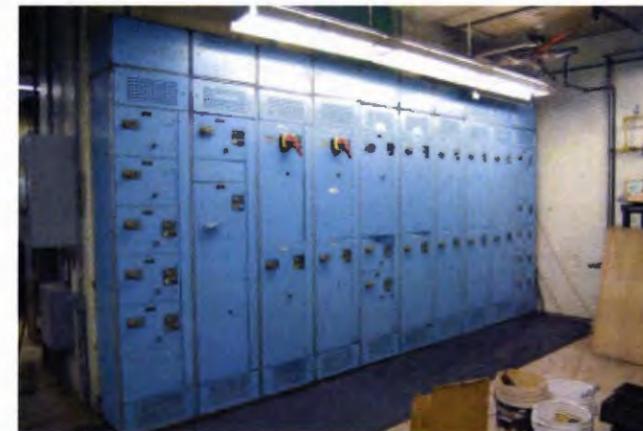
E.005 Tower – Motor Control Center serving power plant

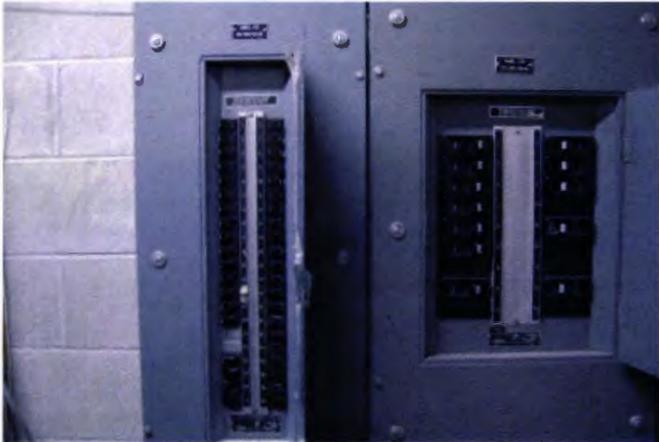
E.008 Tower – Typical panelboard in electrical closet.

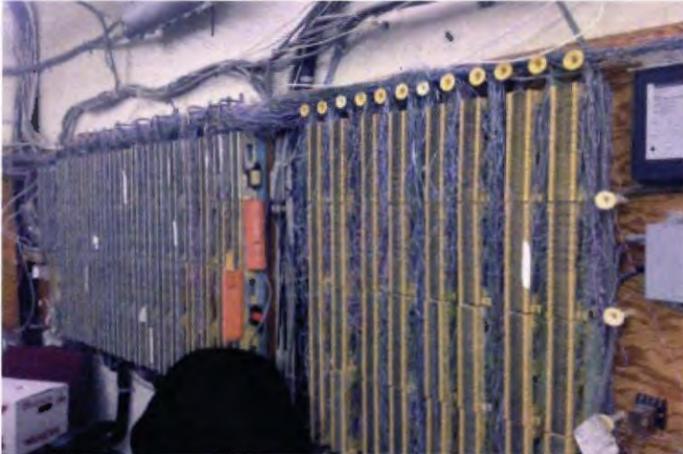
E.009 Tower – Telecom Room

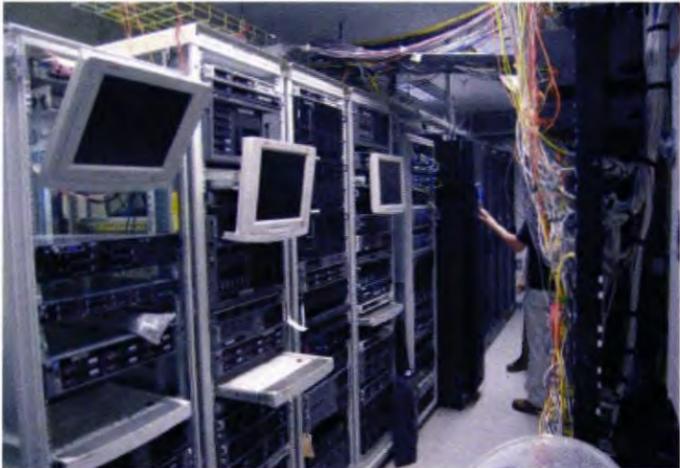
E.010 Tower – IT Room

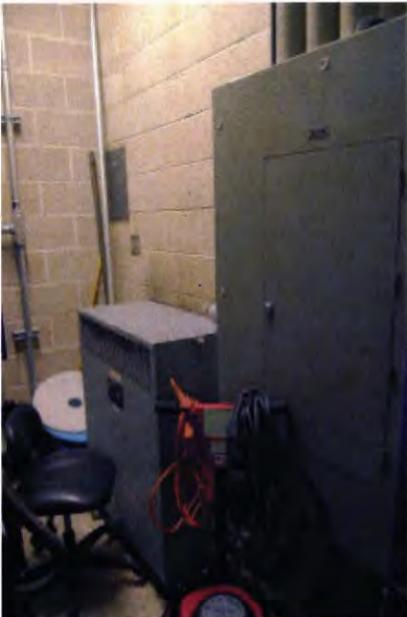
E.013 Tower – Transformer and panel in electrical closet

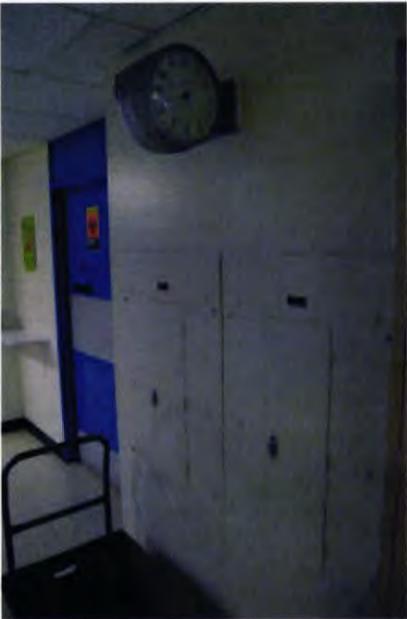
E.014 Tower – Typical non-functioning clock and panelboard in corridor.

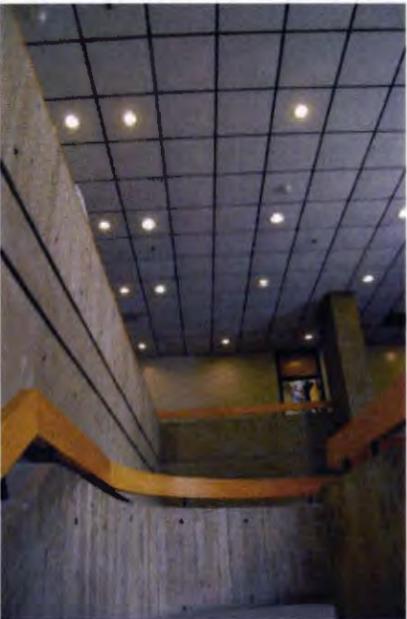
E.015 Tower – Lobby lighting corridor.

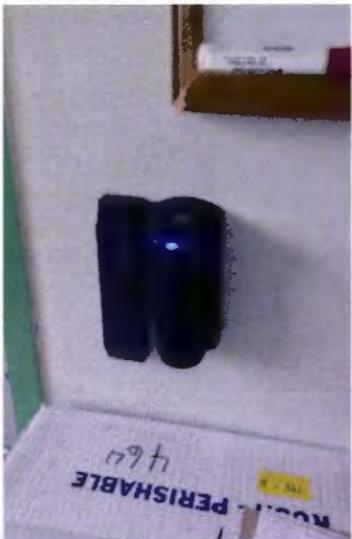
E.016 Tower – Door security device to lab space

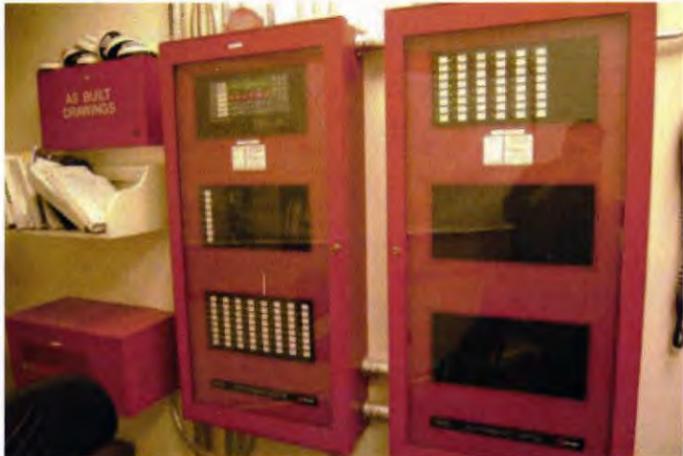
E.018 Tower – Fire Alarm Panel

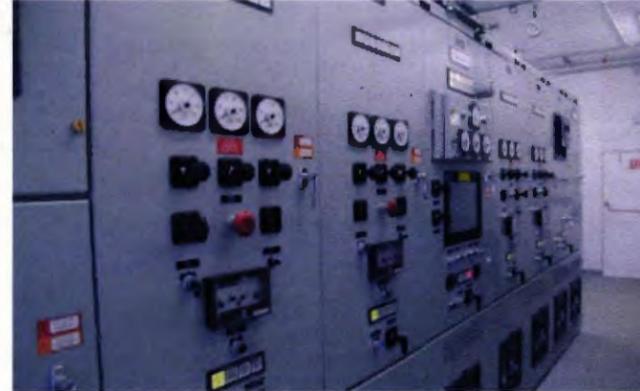
E.020 Outside Grounds – Generator paralleling switch

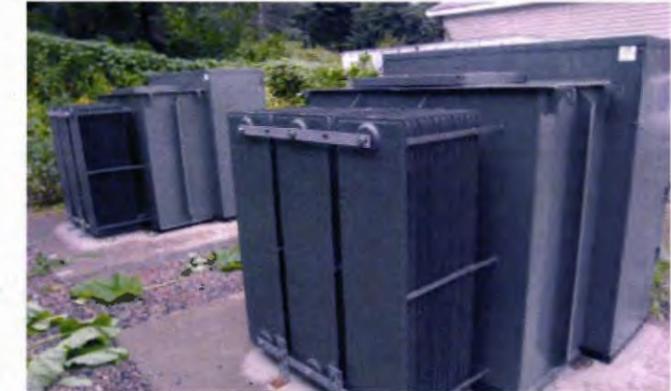
E. 021 Outside Grounds - Transformer

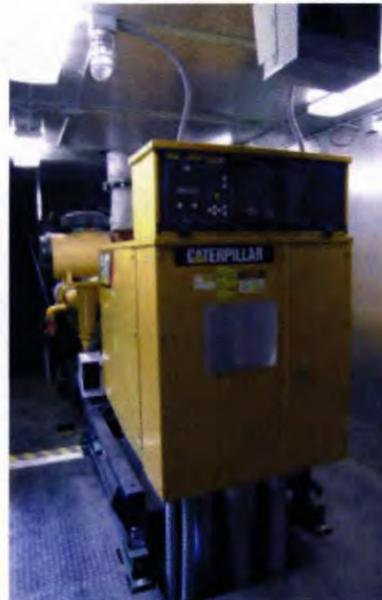
E.022 Outside Grounds – Generator

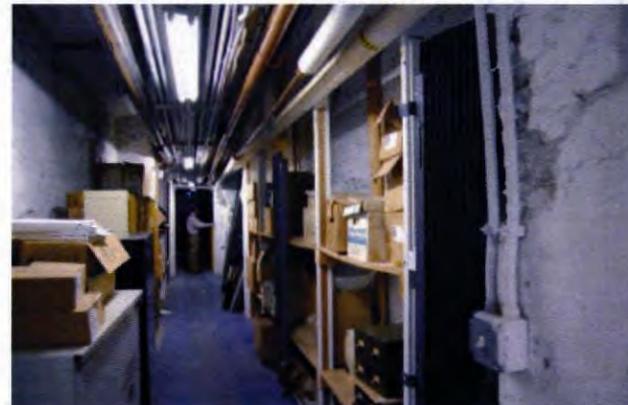
E.023 Stable – Basement Lighting

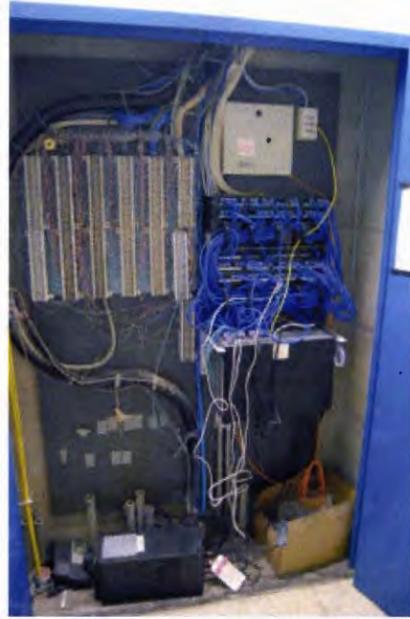
E.025 Stable – Telecom Closet

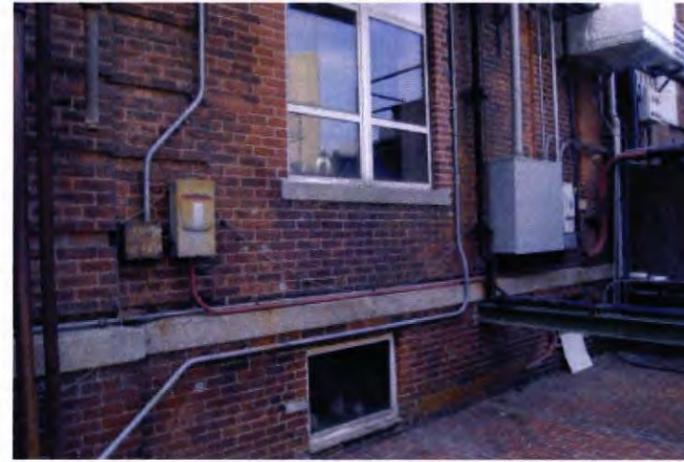
E.026 Stable – Disconnect Switches serving mechanical equipment

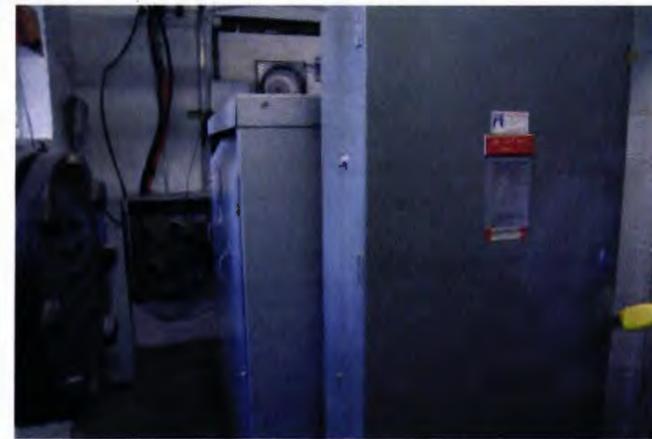
E.029 Biologics – Transformer and disconnect switch

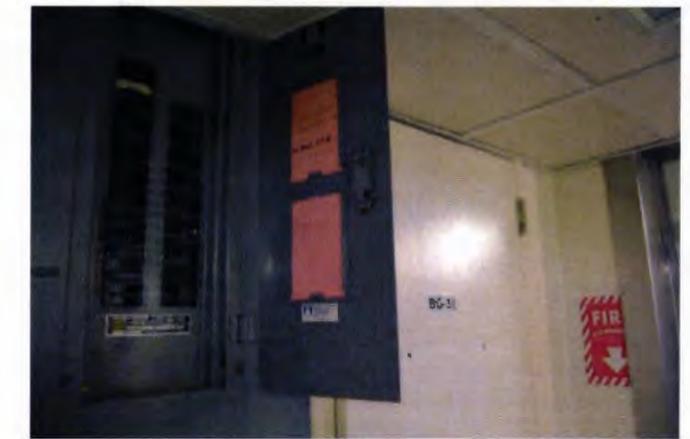
E.030 Biologics – Typical panelboard in corridor

D501005 - Panels		Age / Maintenance	Many are original panelboards. The spare parts are limited.	Age	See Comments in the detailed description	Review and replace individual panelboard, case by case basis.				\$ 50,000			
D501099 - Other Service and Distribution		Corrosion/Age	Disconnect switches serving mechanical and plumbing equipment are not in good condition due to age and corrosion.	Corrosion	See Comments in the detailed description	Replace with new.				\$ 29,000			
D501099 - Other Service and Distribution		Preventive Maintenance	No grounding resistance test, IR scan, periodic house keeping and inspection	Misc.	See Comments in the detailed description	Electrical equipment preventive maintenance plan set up per NFPA70B				By Owner			
D502002 - Lighting Equipment		Energy Saving	High efficient fluorescent lamp should be installed in place of low efficient lamp (incandescent and T12 fluorescent).	Misc.	See Comments in the detailed description	Replace with retrofit unit.				\$ 120,000

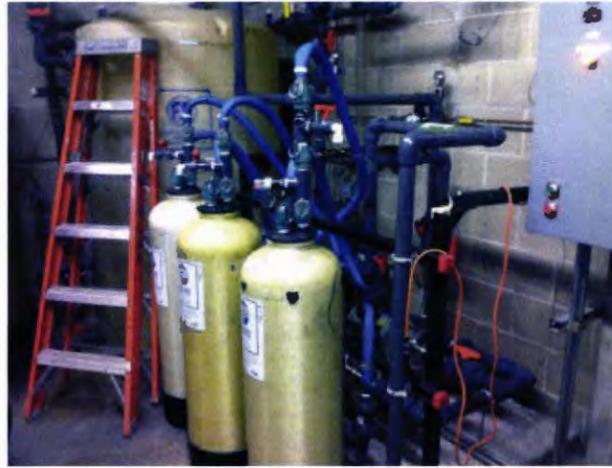
P.002 Tower Building- Existing reverse osmosis system

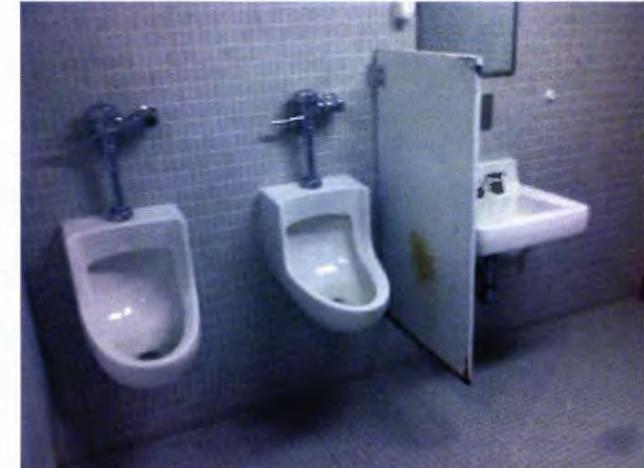
P.003 Tower Building- Existing urinals

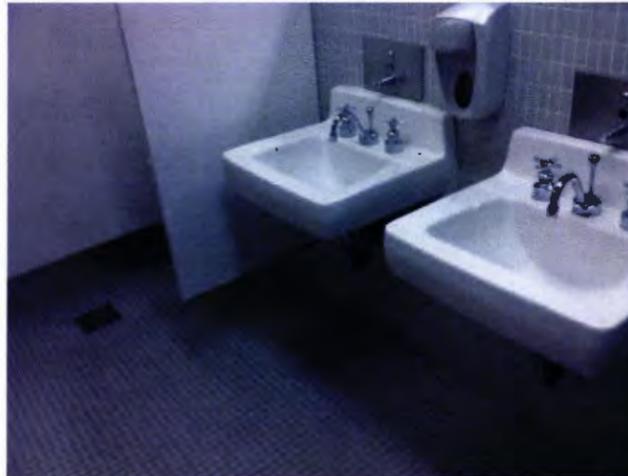
P.004 Tower Building- Existing lavatories

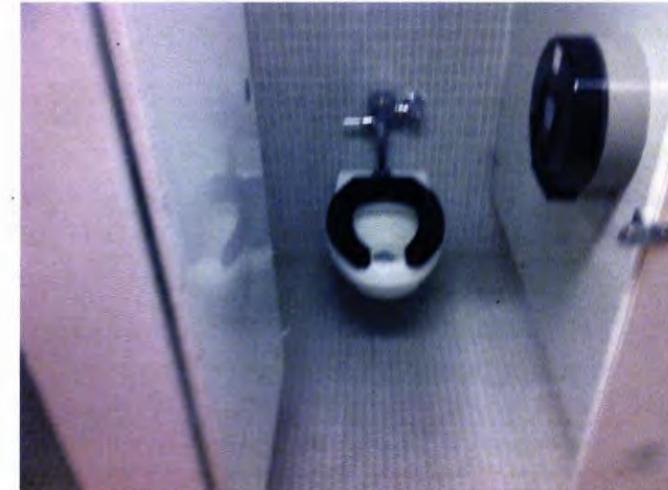
P.005 Tower Building- Existing water closets
