A. Architecture Appendices

1. Existing Building Evaluation

ARCHITECTURE AND INTERIORS

Building Inventory and Evaluation

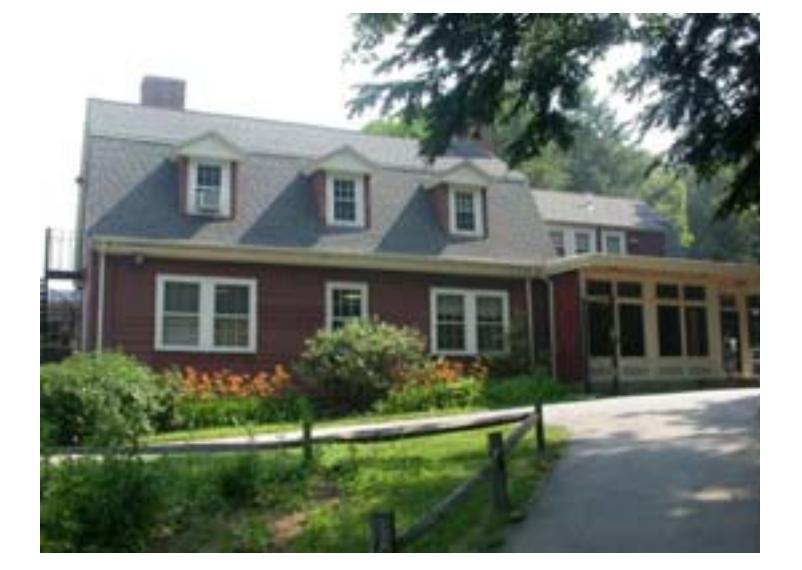
South façade. Trailside Museum Entrance. Staff Vehicles share access road with the visiting pedestrians.

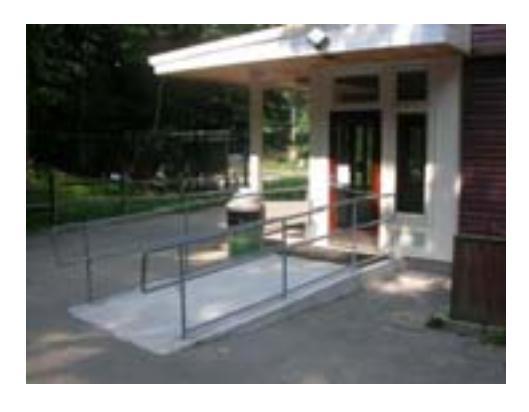
East façade. A new accessible ramp has recently been completed at the entrance. Note perimeter fence gate at left.

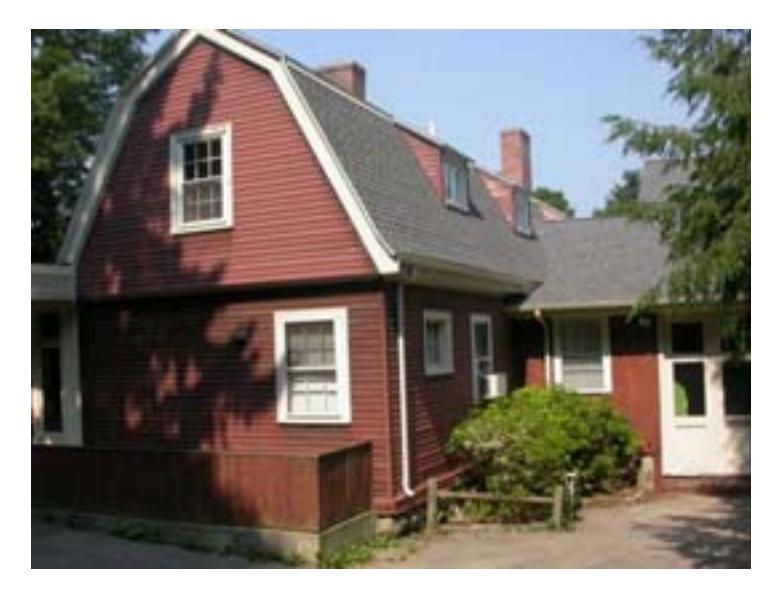
Northeast corner. Exterior stair access to the lower level animal quarantine area is shielded by a low fence.

There are two exits provided and signed at each of the three levels, but some of them are substandard for a museum occupancy. At the second floor, one exit is an exterior metal fire escape and the other is a steep carpeted stair. At the first floor, one exit discharges to an uncovered wood stair. At the basement, one exit discharges to an uncovered stair in an areaway, where snow can accumulate and create a hazard.

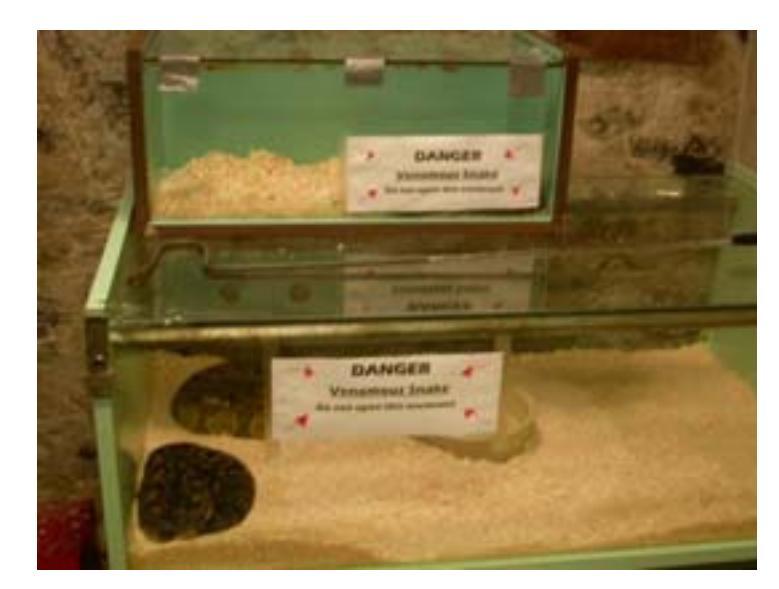
Basement animal care space. Venomous snakes kept in the same room as the boiler.

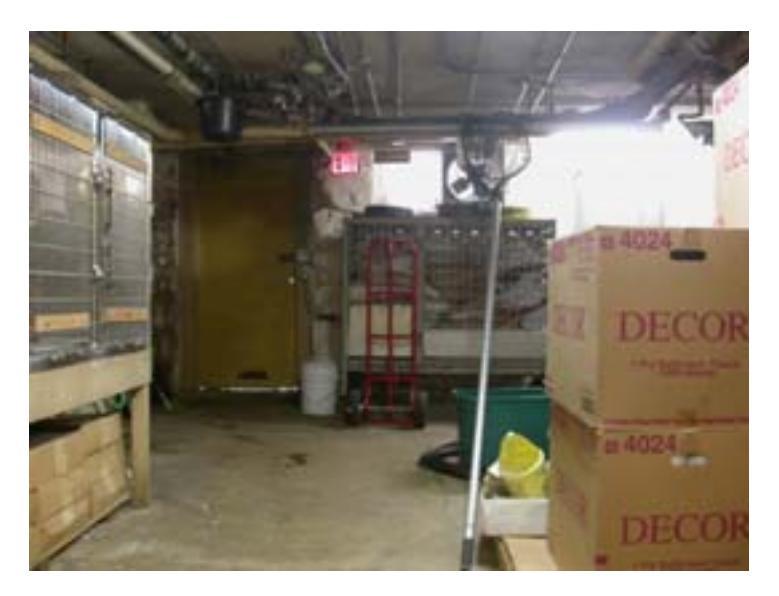
Basement animal quarantine. Unfinished walls and exposed wiring and pipes.

The internal layout and room sizes of this wing contribute to some current operational inadequacies. At the basement, the animal quarantine area is squeezed into a very low-ceilinged space with a change in floor level; many surfaces are not washable and some animals are housed in the boiler room. The second floor offices are accessed through a narrow stair discharging into the vestibule, and are separated from first floor offices by public areas. Ventilation is by operable windows only, except for rooms where window air conditioners have been installed.

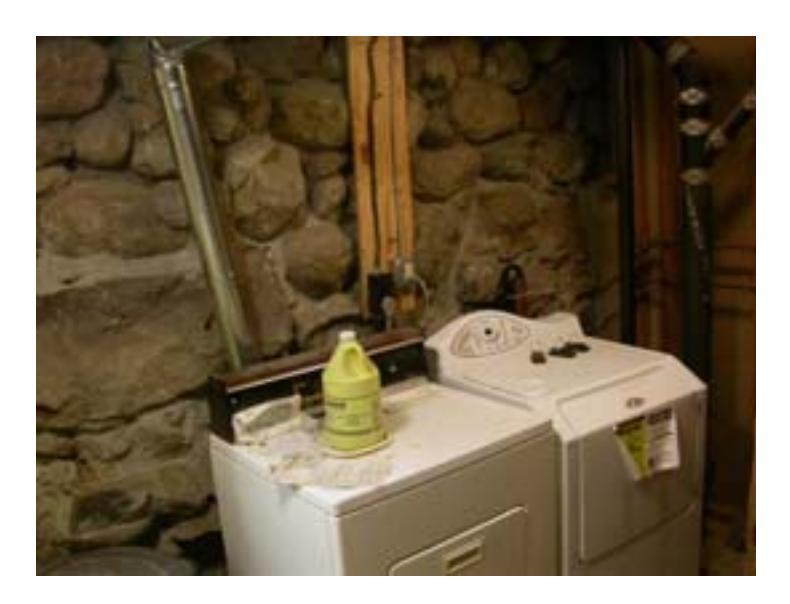
Unfinished basement with stone foundation exposed.

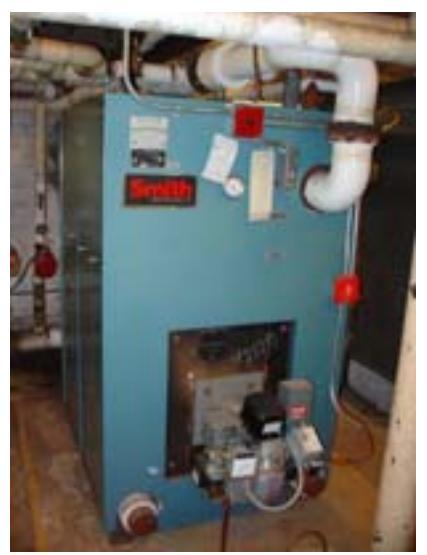
Oil-fired boiler and expansion tank.

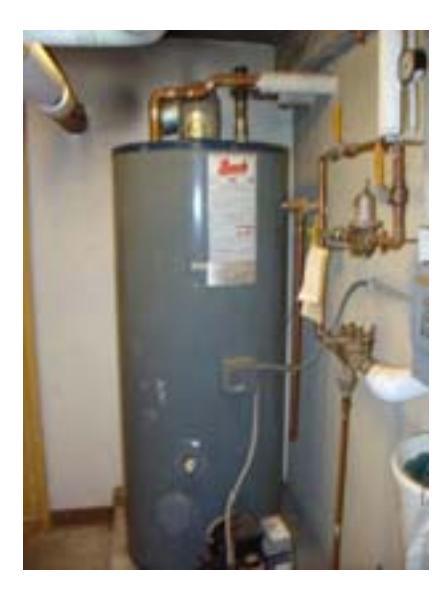
Oil-fired hot water heater.

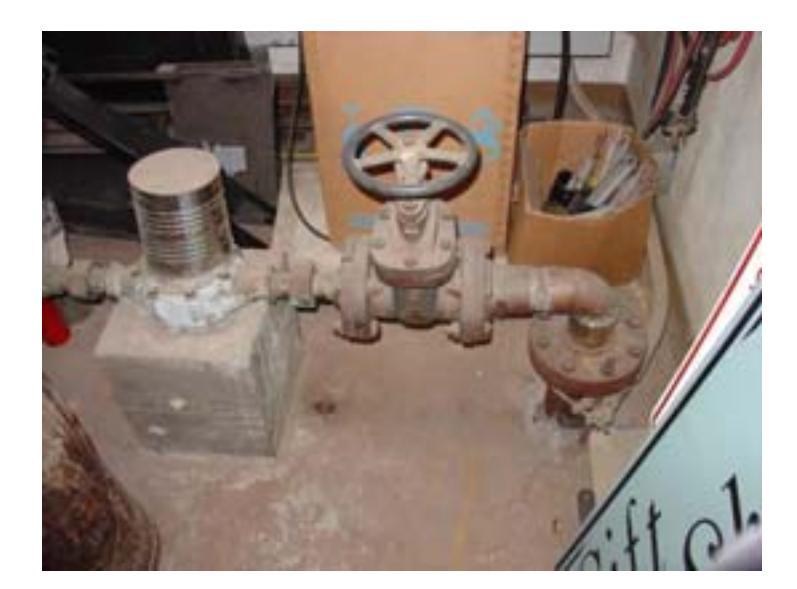
Domestic water.

The copper piping generally appeared in fair condition with a few joints exhibiting excessive corrosion. Plumbing fixtures are in fair condition but should be replaced with modern water-conserving fixtures.

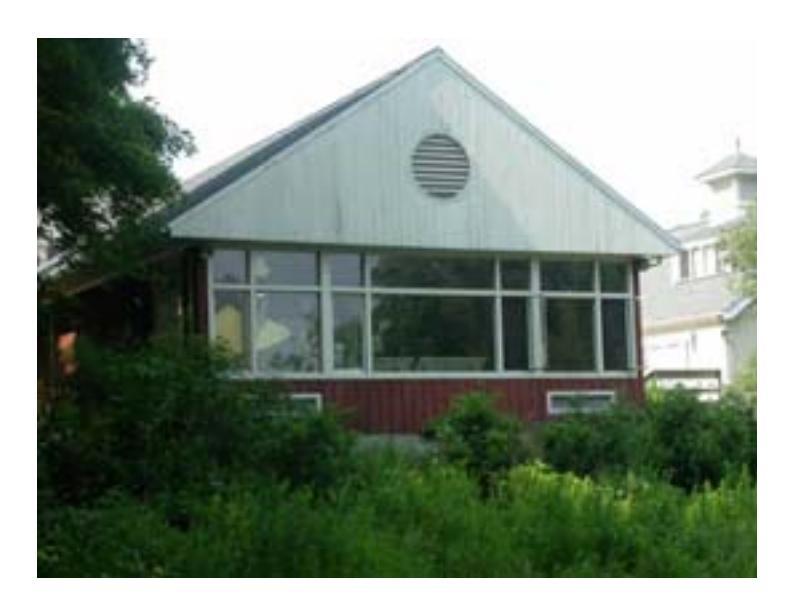
North façade. Windows in exhibit spaces overlook the pond.

The asphalt shingle roof is in good condition but exterior doors, windows, siding and trim appear to be original and are in fair to poor condition. The windows are single-glazed and there is some rot in the frames. It is unknown whether any insulation exists at the roof or walls.

If renovated for educational use this wing would require significant investment, to upgrade mechanical and electrical systems, create an efficient building envelope, and to replace all the doors and windows. A hazardous materials survey should be undertaken to identify potential asbestos-containing materials such as flooring, roofing, sealants, glazing and insulation.

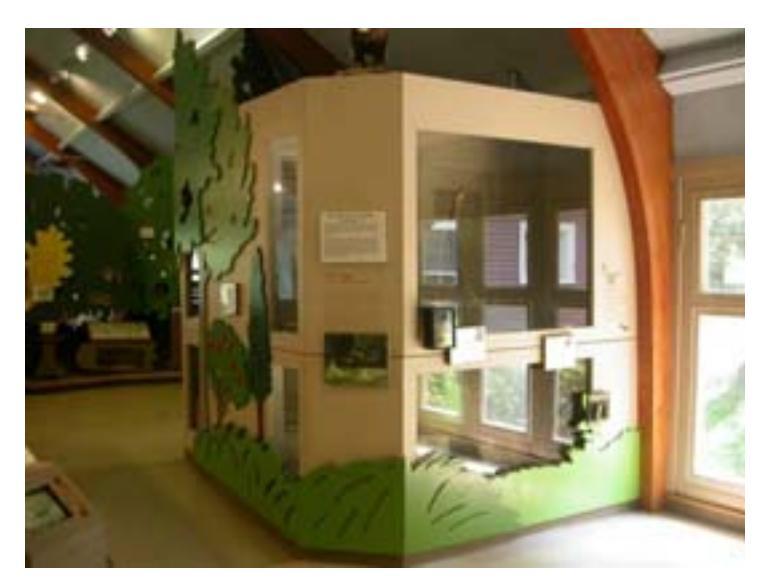
First floor exhibit hall, raised area along east side.

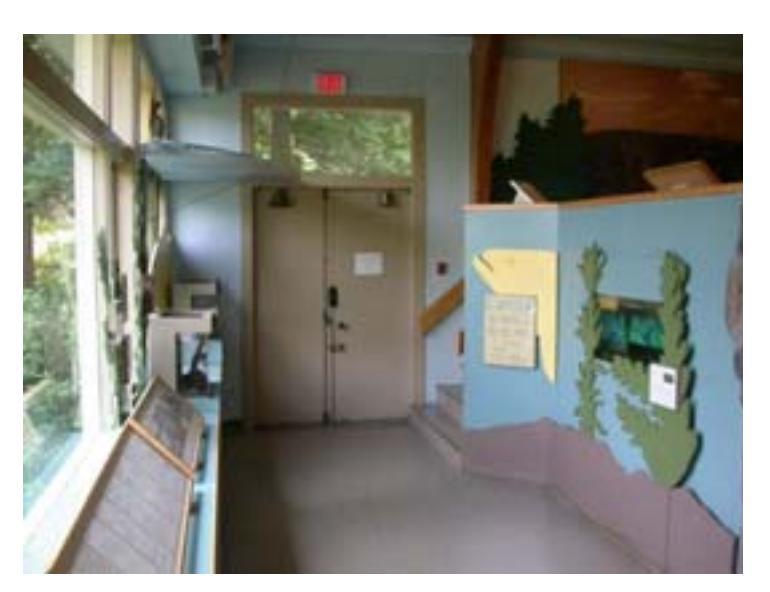
First floor exhibit hall, north end. Note the stairs leading from the raised area; there is no accessible connection..

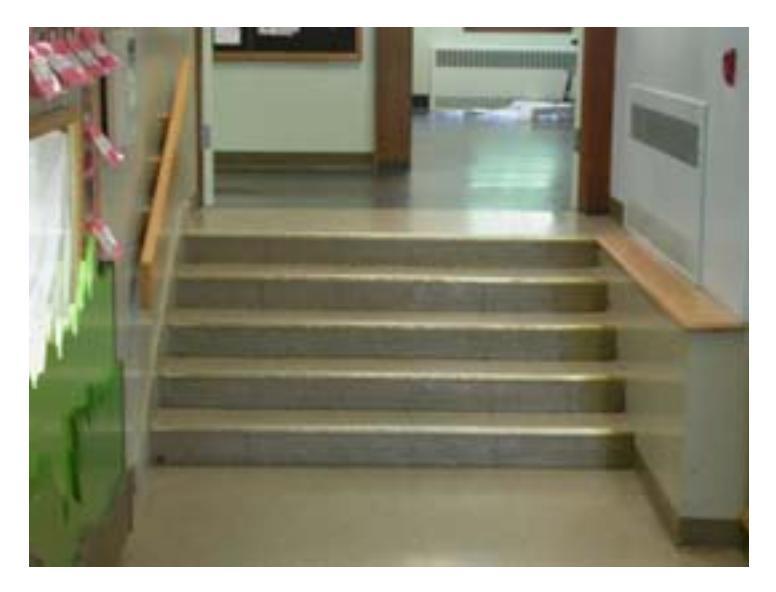
First floor exhibit hall stairs. The circulation in the exhibit hall has numerous stairs and currently is not accessible.

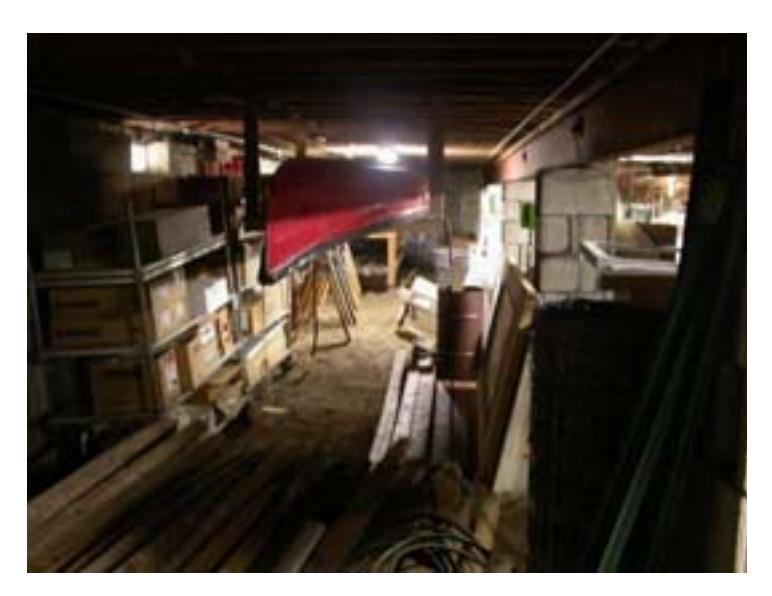
Basement level at exhibit hall. Currently used for general storage. Space is damp and lacks heat and ventilation.

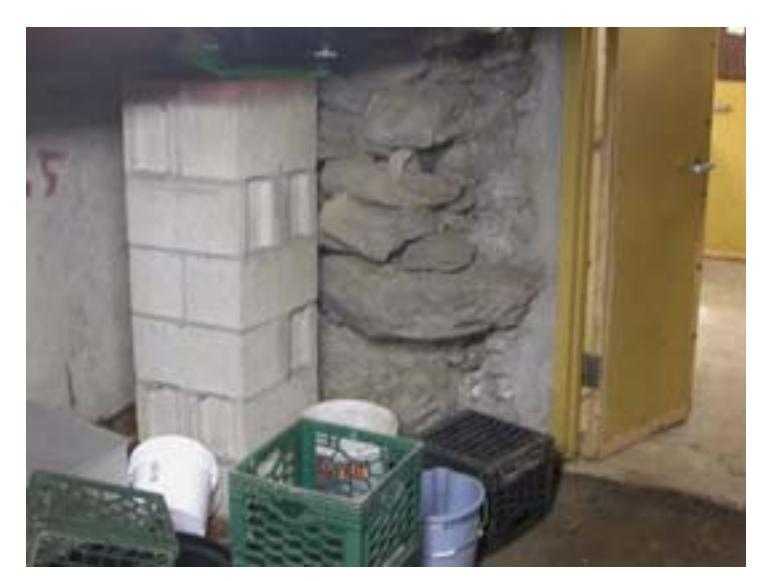
Basement level of the exhibit hall has an earth floor and no damp proofing at walls or floor.

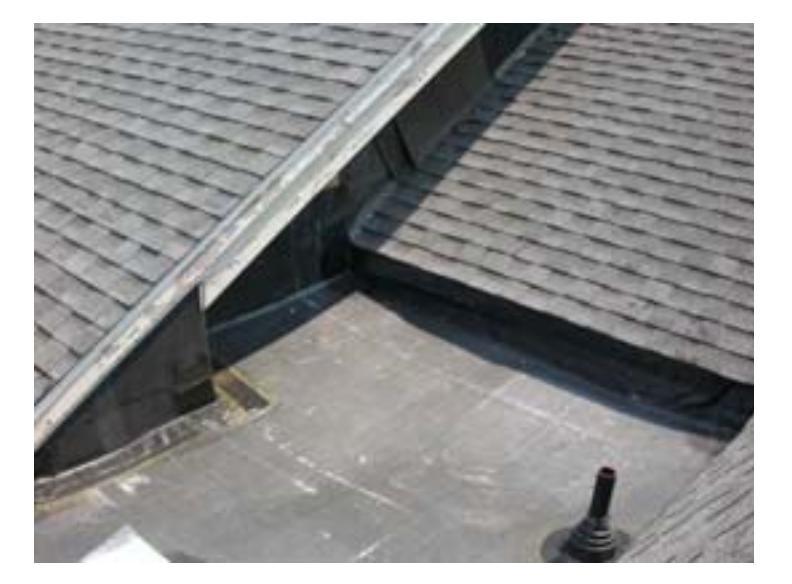
New exhibit wing. Asphalt shingles at sloped roof. New EPDM membrane at flat roofs.

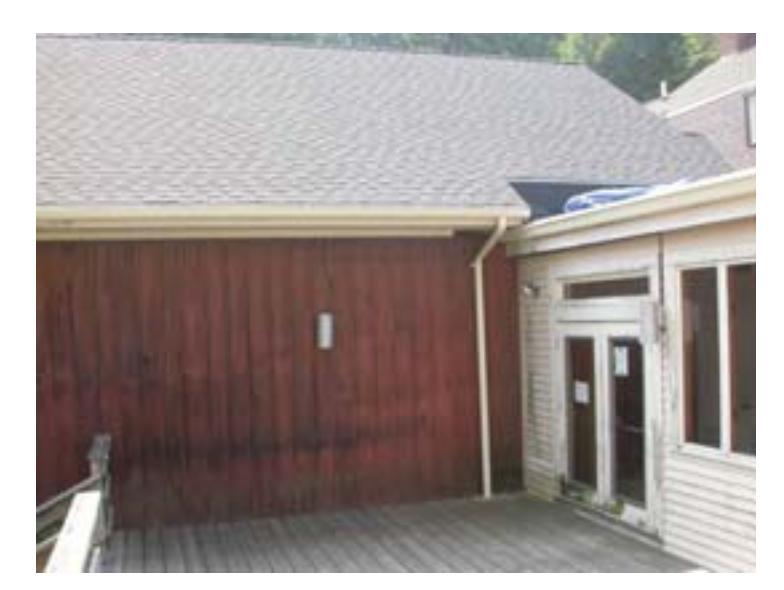
Partial west façade of exhibit wing. New roof and downspout. Vertical wood siding.

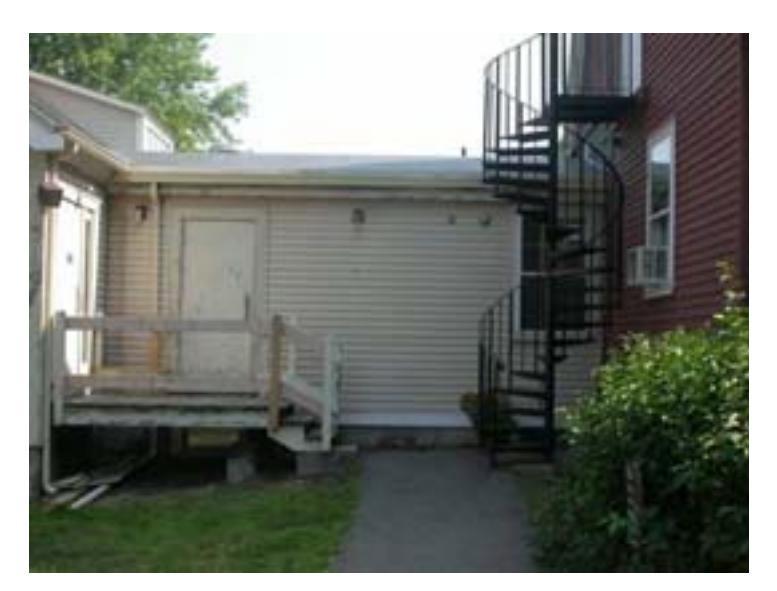
South façade of connector. Note uncovered wood exit stair and metal fire escape.

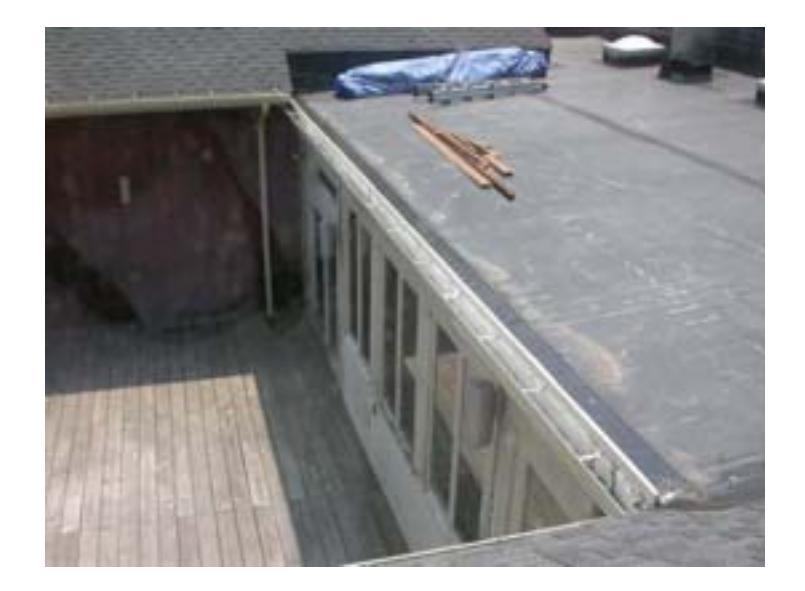
Roof of connector. Wood deck below.

The exterior wood-clapboard siding and asphalt shingle roof are in good condition. Windows include both insulated glass and single-glazing types, with sliding glass doors in several locations. Some of the skylights have leaked. It is unknown whether any insulation exists at the roof or walls. The lightning protection system may be incompletely connected or grounded.

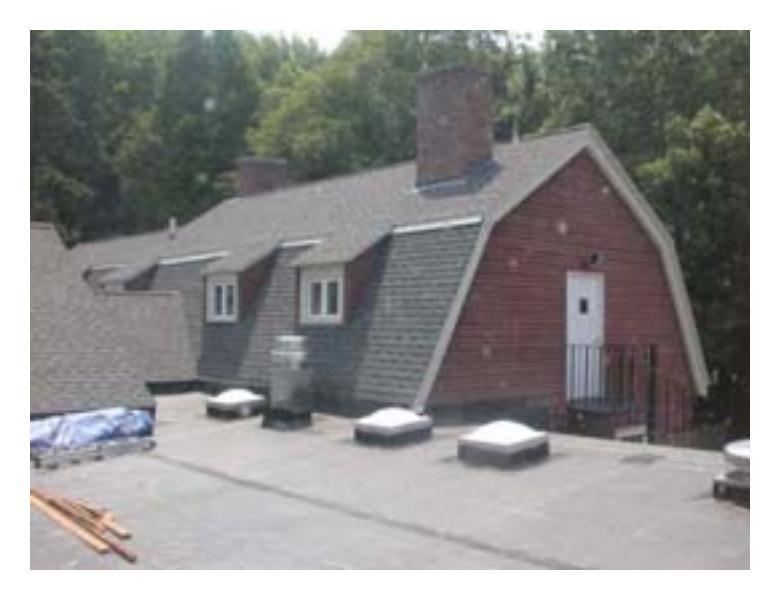
Roof of connector. Visitor wing beyond.

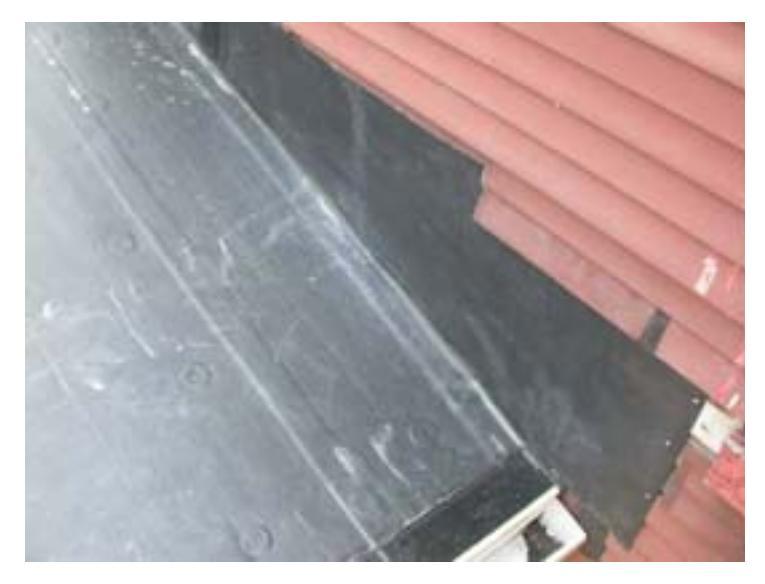
Detail of membrane roofing.

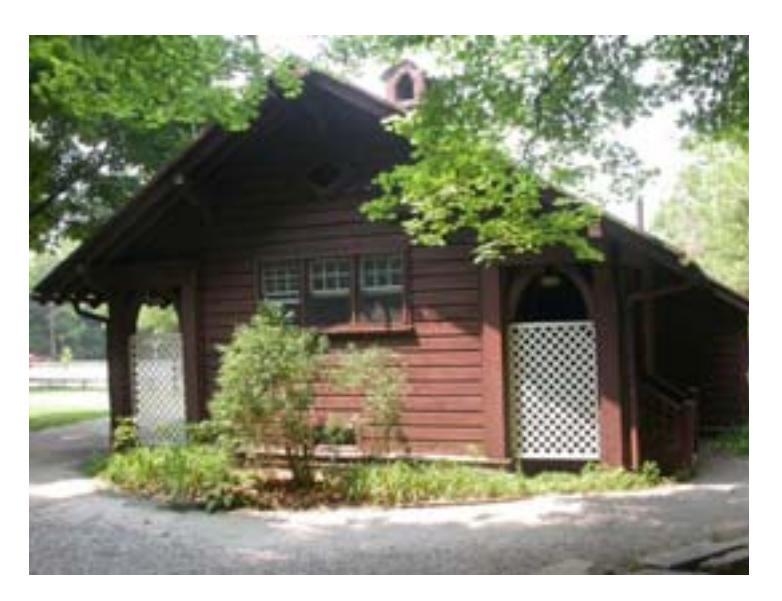
South façade. Lattice panels are not original.

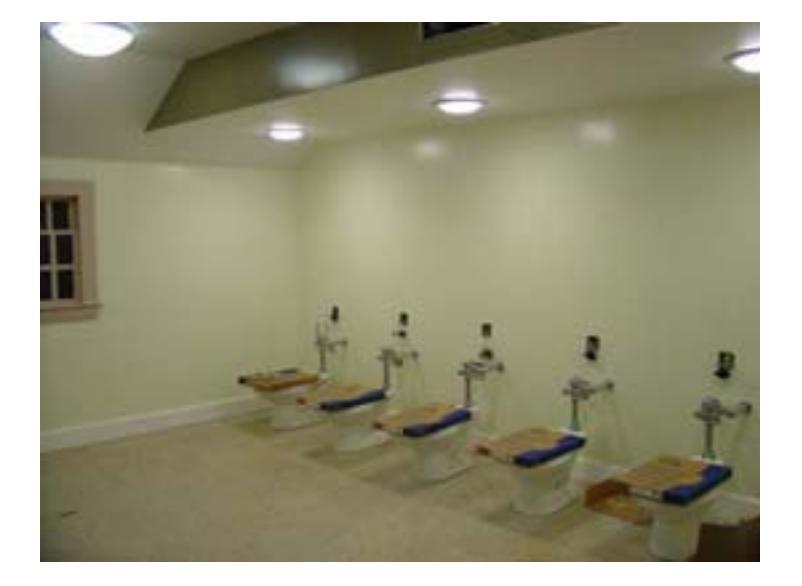
Men's room water closets currently under renovation

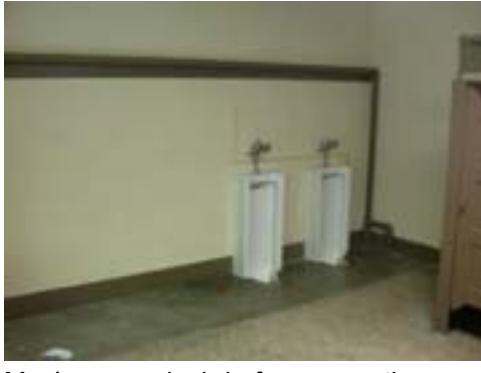
Men's room urinals before renovation

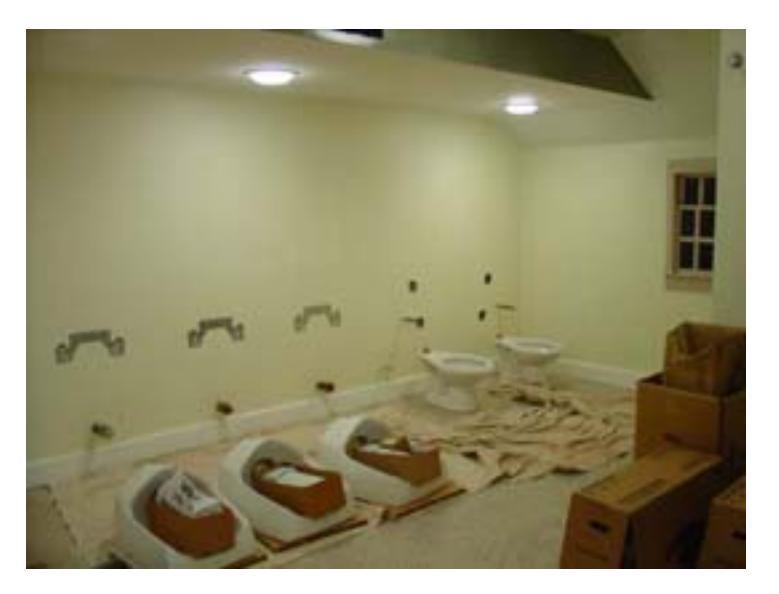
Men's room urinals during renovation

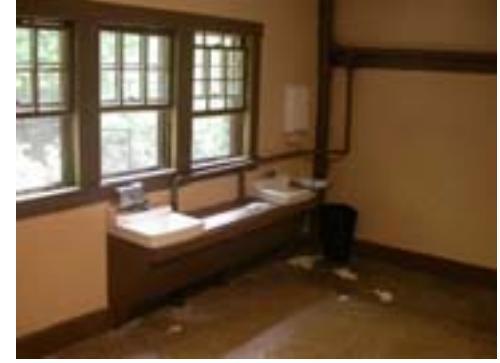
Men's room lavatories before renovation

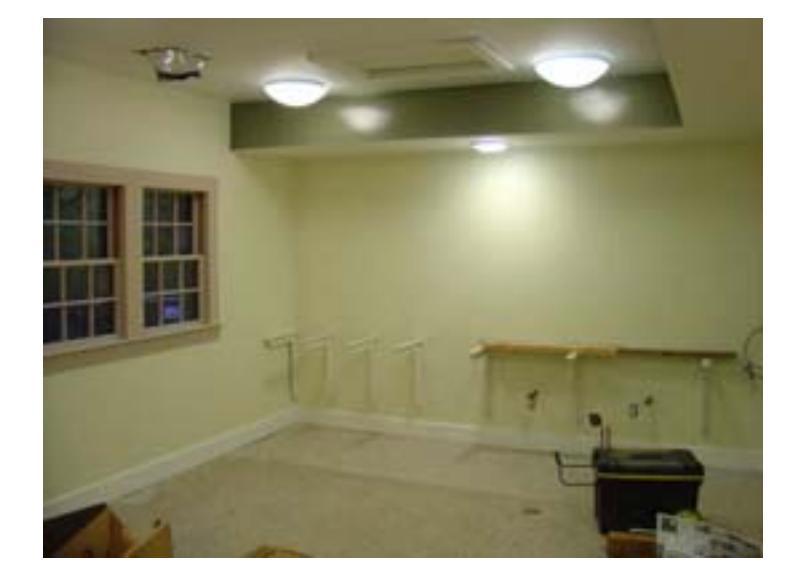
Men's room lavatories during renovation

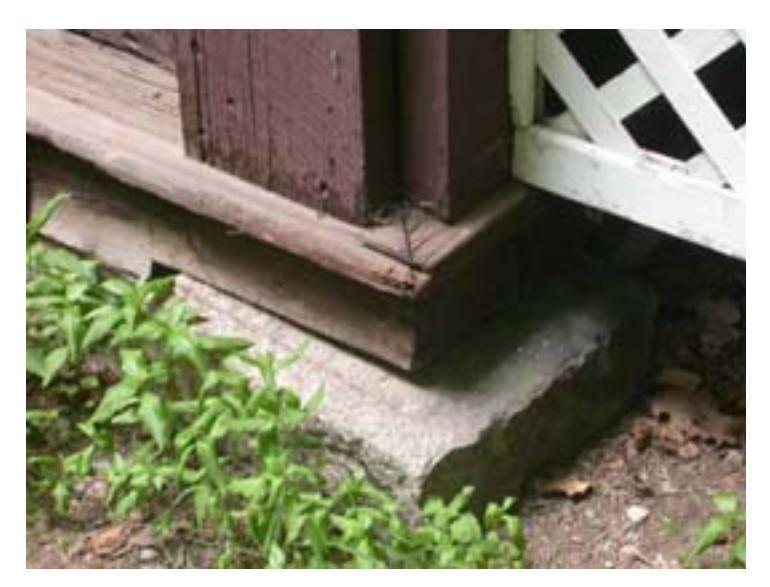
Detail of foundation and building sill.

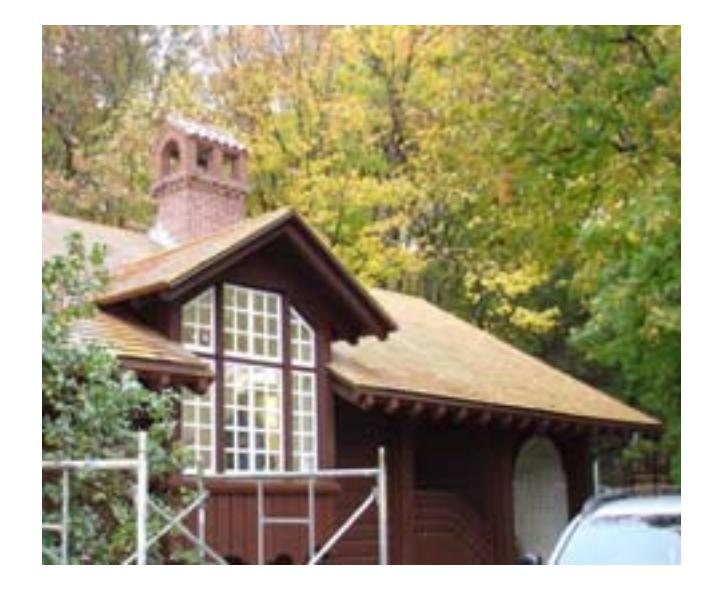
New wood shingle roof.

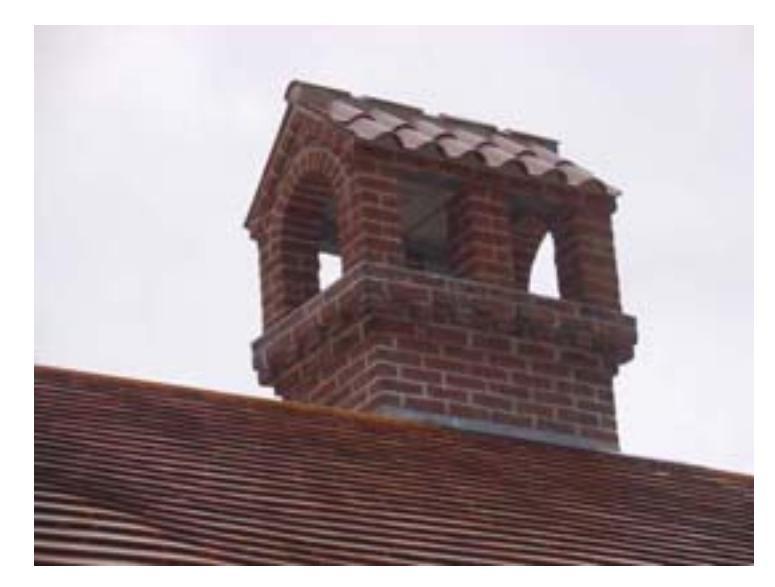
Detail of chimney cap. Recently rebuilt.
