Appendix A: Assessment Summaries for BMPs

HW Site ID#: 1	
Type of BMP: Constructed wetland

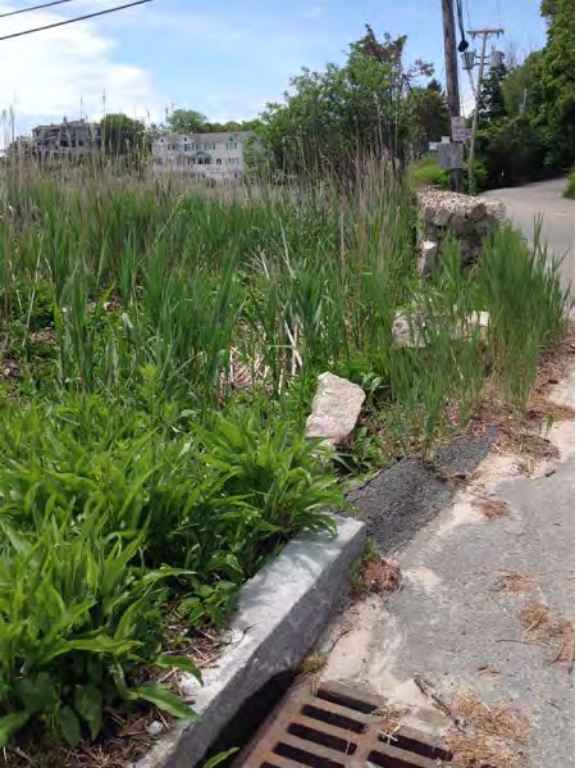
Grant Funding Source/ID Number: 319/07-06	
Year Built: 2010	
Reference Plans: Hand Markup of BMP Location #5, Design Details Nicholas Street at Atlantic Ave. Cohasset, Massachusetts; last revised 12/07/09.	
Address: Nichols Rd and Atlantic Ave	
BMP Condition: Poor condition. Inlet clogged so water cannot enter BMP. Appears that water ponds on street and overflows into BMP.	Potential Retrofit: Add another pretreatment practice (e.g., forebay) to address sand/sediment. Needs vegetation maintenance to address invasive species.
Climate Change Risks: Protected from ocean by a sea wall approximately 5-6 feet high. Exposed to marsh to the east. Functional problem appears to be from lack of maintenance which caused erosion.	
Notes:

GENERAL INFORMATION	Site Visit
Elevation: 5.11 ft.	Weather: Rain Within Past 24 hours
<p>BMP Plant Health: Salt Impacts. Lots of phragmites. Wall collapsed into forebay, possibly undercut by high water. Water in catch basin approx 2 feet below rim. Inlet from diversion manhole completely blocked. Appears that bmp is not functioning and all water is diverted to nearby wetland.</p>	Arrival Time: 12:05 PM
	Nearest Tide: High, 1:28 PM
	Observers: None
<p>Observed Constraints: None</p>	Date Assessed: 6/4/2015
	<p>Outfall Details</p>
	Outfall Observed: No
	<p>Outfall Notes: Did not find outfall structure, but clear indication of discharge.</p>
<p>Direction of Coastal Exposure: North</p>	<p>Outfall Photo:</p>

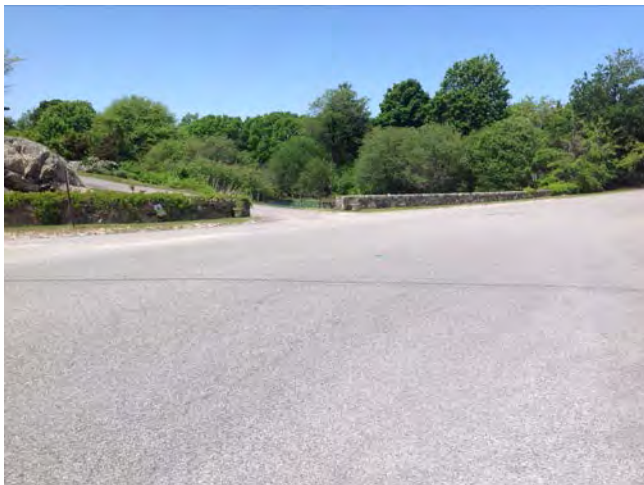
Looking northwest on Atlantic Ave.

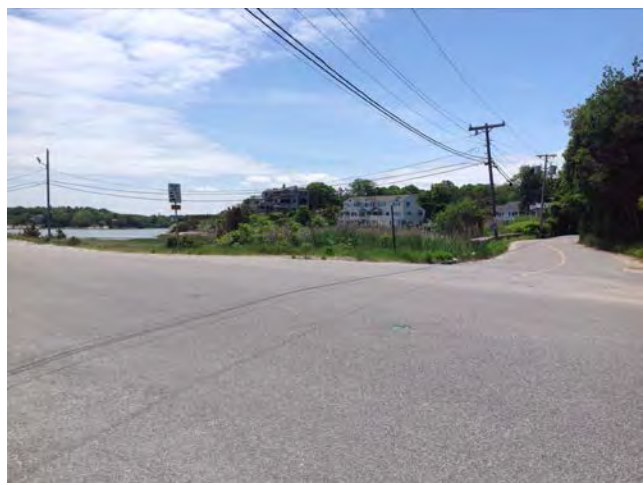
Looking southwest across Atlantic Ave. to the gravel wetland.

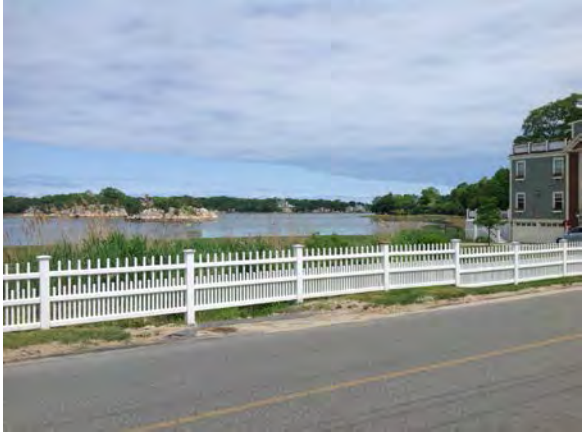
HW Site ID#: 2 Town: Cohasset	
Type of BMP: Rain garden

Grant Funding Source/ID Number: 319/07-06	
Year Built: 2011	
Reference Plans: BMP Location #4, As Built Plan Opposite 37 Beach Street Cohasset, Massachusetts; last revised 09/06/11.	
Address: 44 Beach St	
BMP Condition: Slit in manhole/catch basin that outfalls to rain garden. BMP appears to be in good condition and functioning properly.	
Climate Change Risks: Located at the low point on road and immediately adjacent to wet areas. Seems likely that groundwater will impact rain garden benefits.	Potential Retrofit: Needs vegetation maintenance to address invasive species.
Notes:

GENERAL INFORMATION	Site Visit
Elevation: 9.93 ft.	Weather: Rain Within Past 24 hours
BMP Plant Health: Salt Impacts. Overall good condition. Not clear what the planting scheme is, maybe bayberry. Immediately adjacent to rain garden are phragmites and BVW.	Arrival Time: 10:43 AM
	Nearest Tide: High, 1:28 PM. Tide gate.
	Observers: Sara Grady (MassBays)
Observed Constraints: New Development. New single family home under construction up the street. Adjacent homes appear to be new or recently redone.	Date Assessed: 6/4/2015
	Outfall Details
	Outfall Observed: No
	Outfall Notes: Could not locate outfall.
Direction of Coastal Exposure: Northwest	Outfall Photo:

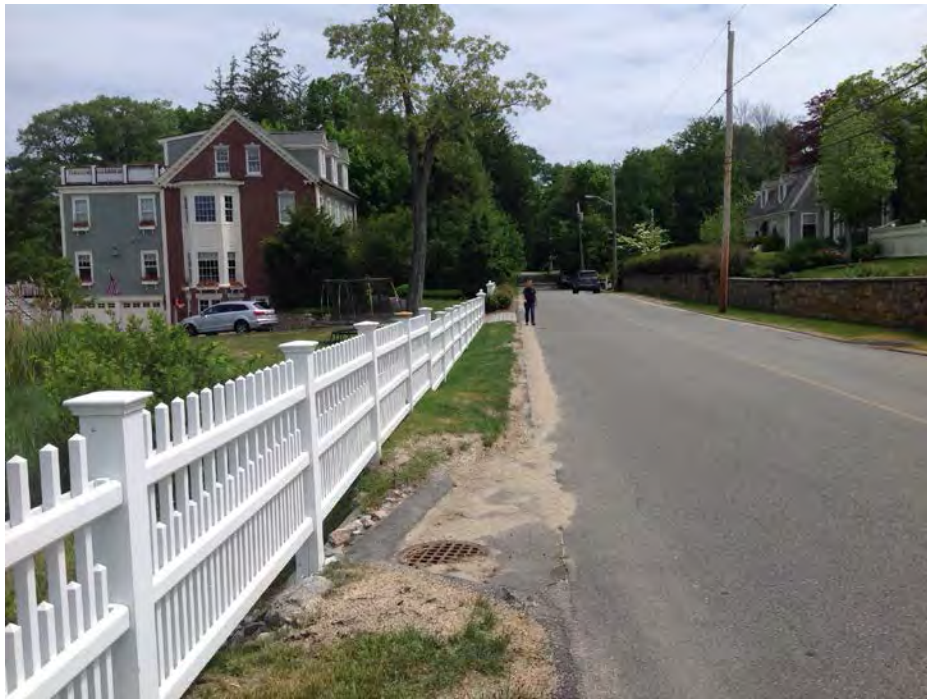
Periwinkle snail paths evident on rock, indicating high water.

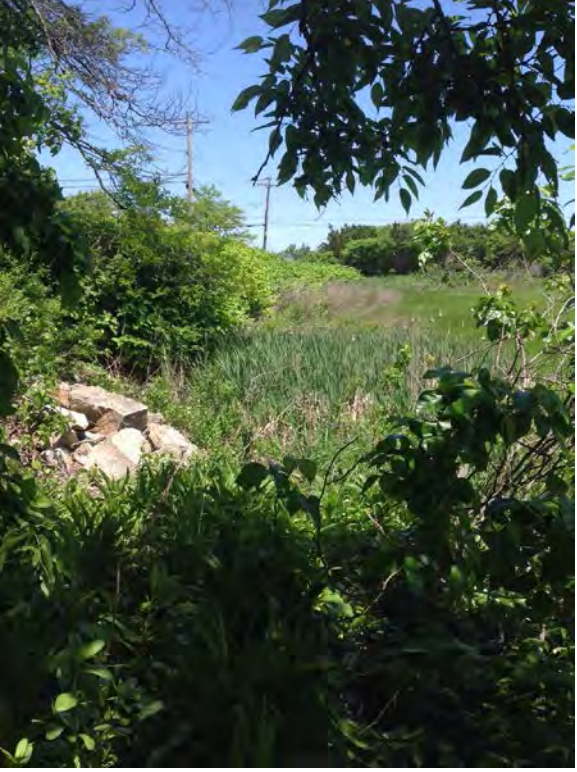
HW Site ID#: 8/9 Town: Cohasset	
Type of BMP: Stormceptor, infiltration basin

Grant Funding Source/ID Number: 319/10-04	
Year Built: 2011	
Reference Plans: Jerusalem Road at Atlantic Ave Drainage Improvements; last revised 10/01/10	
Address: Jerusalem Rd at Atlantic Ave	
BMP Condition: Swale overgrown with knotweed. Hard to see swale.	
Climate Change Risks: Infiltration basin is not a recommended practice here due to high groundwater. Also, significant Japanese Knotweed presence could limit conveyance and available storage in practice.	Potential Retrofit: Possible space for bioretention across the street, at a higher elevation and buffered from the marsh.
Notes: Three catch basins are full of sediment.

GENERAL INFORMATION	Site Visit
Elevation: 8.9.0 ft.	Weather: Rain Within Past 24hours
BMP Plant Health: All knotweed all the time.	Arrival Time: 12:44 PM
	Nearest Tide: High, 1:29 PM
	Observers: None
Observed Constraints: None	Date Assessed: 6/4/2015
	Outfall Details
	Outfall Observed: Yes
	Outfall Notes:
Direction of Coastal Exposure: Southeast	<p data-bbox="813 982 971 1010">Outfall Photo:</p>

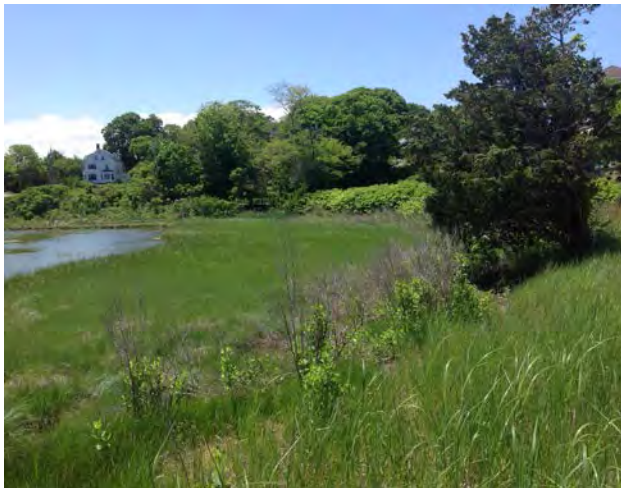
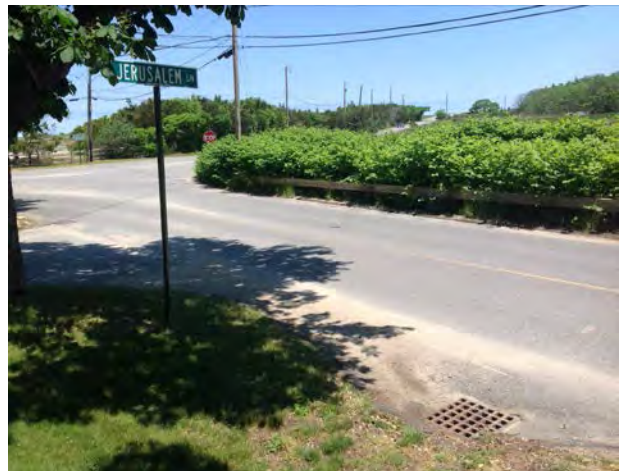
Swale is in the knotweed, upland marsh area is to the left and salt marsh grass to the right.

Three catch basins in the road discharge to swale (in the knotweed) across the street.

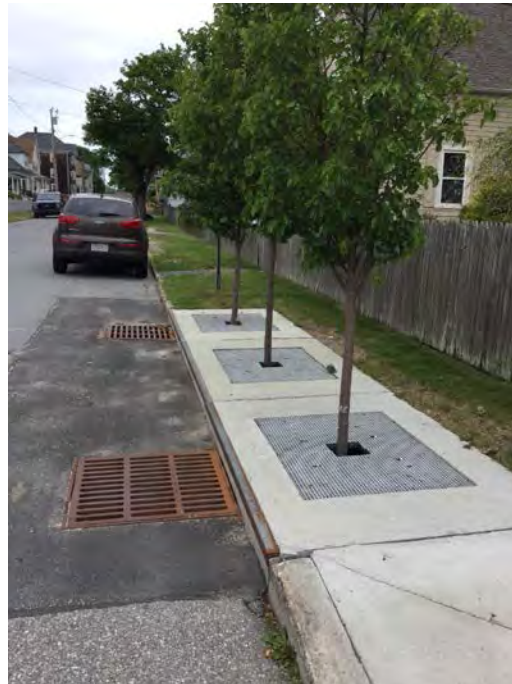
Site 11A, Alpine Avenue. Trees installed.

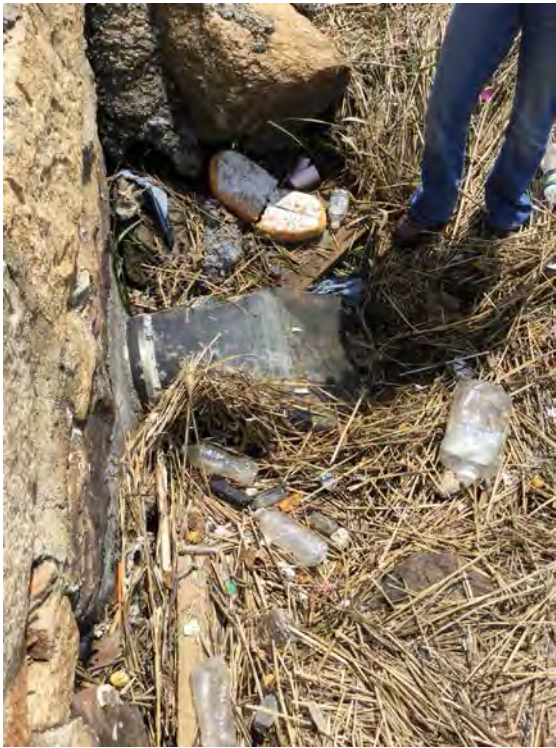
GENERAL INFORMATION	Site Visit
Elevation: 5.00 ft.	Weather: Clear
BMP Plant Health: Sparse	Arrival Time: 11:16 AM
	Nearest Tide: High, 1:20 PM
	Observers: Elise Leduc (Woods Hole Group)
Observed Constraints: None	Date Assessed: 6/8/2015
	Outfall Details
	Outfall Observed: Yes
	Outfall Notes: Duck bill on outfall. Lots of trash near outfall.
Direction of Coastal Exposure: South	<p data-bbox="813 982 971 1010">Outfall Photo:</p>

Coastal Barriers: Sea wall	
Condition of Shoreline: Sea wall in need of repairs/maintenance. Litter and debris.	
Storm Damage/Flooding: No	
High Groundwater: Yes	
Assessed by: ERK/ACK

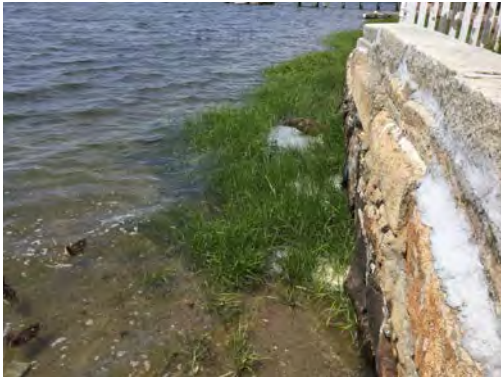
GENERAL INFORMATION	Site Visit
Elevation: 4.00 ft.	Weather: Clear
BMP Plant Health: NA	Arrival Time: 11:16 AM
	Nearest Tide: High, 1:20 PM
	Observers: Elise Leduc (Woods Hole Group)
Observed Constraints: None	Date Assessed: 6/8/2015
	Outfall Details
	Outfall Observed: Yes
	Outfall Notes: No duck bill on outfall. Lots of trash near outfall.
Direction of Coastal Exposure: South	<p data-bbox="813 982 971 1010">Outfall Photo:</p>

Coastal Barriers: Sea wall	
Condition of Shoreline: Sea wall in need of repairs/maintenance. Litter and debris.	
Storm Damage/Flooding: No	
High Groundwater: Yes	
Assessed by: ERK/ACK

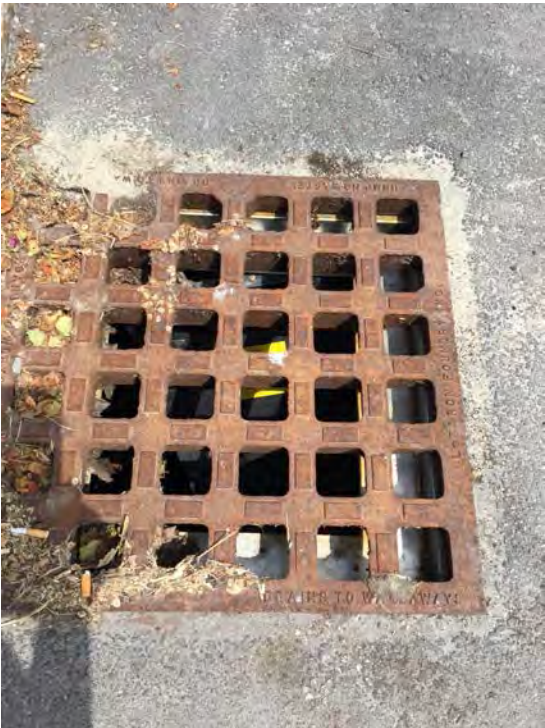
Needs maintenance.

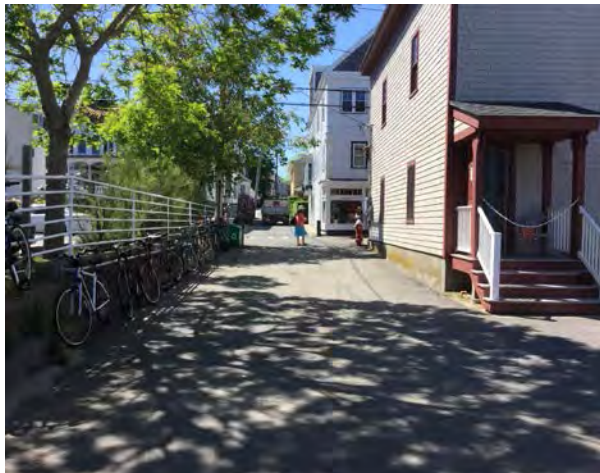
looking up the drainage area from the BMP

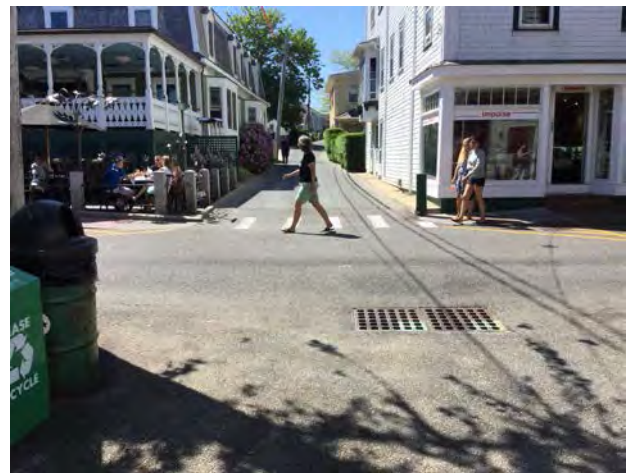
Inlet not built per design. Commercial Street is now porous asphalt. DMH is under trash can.

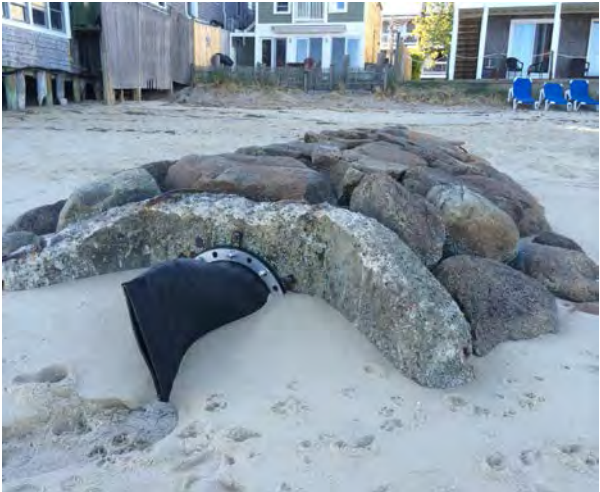
GENERAL INFORMATION	Site Visit
Elevation: 1.59 ft.	Weather: Clear
BMP Plant Health: NA	Arrival Time: 5:22 PM
	Nearest Tide: Low, 3:04 PM
	Observers: None
Observed Constraints: None	Date Assessed: 5/29/2015
	Outfall Details
	Outfall Observed: Yes
	Outfall Notes: Duckbill on outlet pipe. Evidence of discharge.
Direction of Coastal Exposure: Southeast	<p>Outfall Photo:</p>

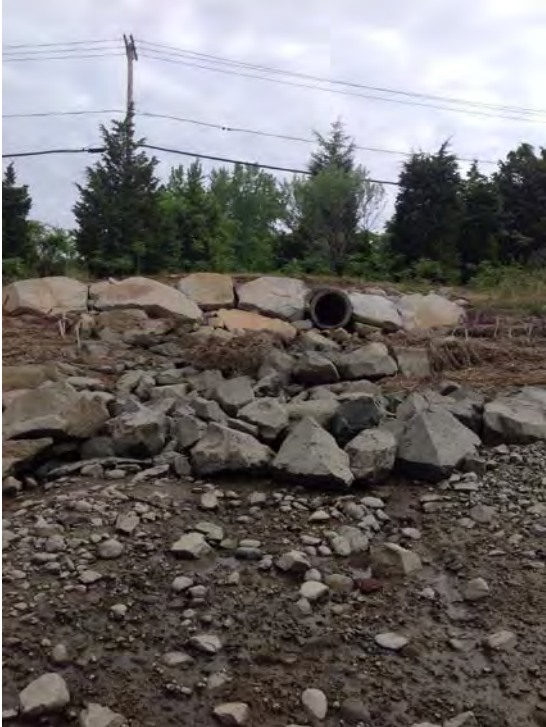
GENERAL INFORMATION	Site Visit
Elevation: 2.58 ft.	Weather: Rain Within Past 24hours
BMP Plant Health: Erosion Impacts. Logs established. Vegetation surrounding appears to be in good condition.	Arrival Time: 9:04 AM
	Nearest Tide: High, 1:44 PM
	Observers: Sara Grady (MassBays)
Observed Constraints: None	Date Assessed: 6/4/2015
	Outfall Details
	Outfall Observed: Yes
	Outfall Notes:
Direction of Coastal Exposure: Southwest	<p data-bbox="813 982 971 1010">Outfall Photo:</p>

Coastal Barriers: Marsh	
Condition of Shoreline: Some erosion present.	
Storm Damage/Flooding: Yes	
High Groundwater: No	
Assessed by: JER/ESB

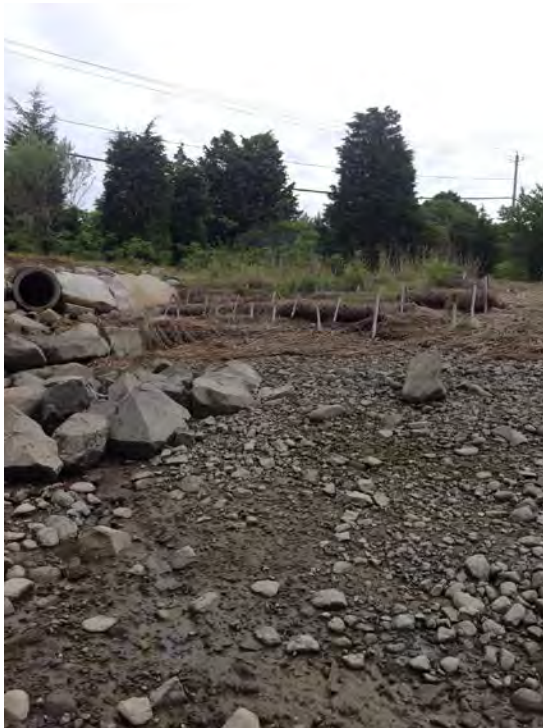
Vegetation.

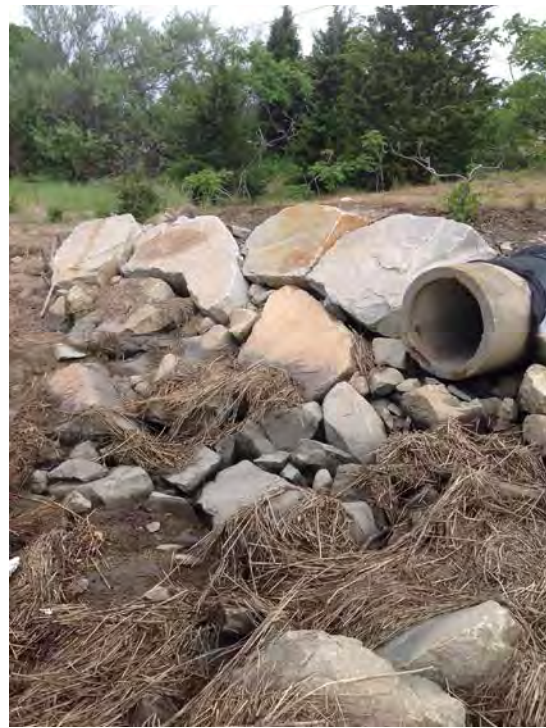
Sedimentation.

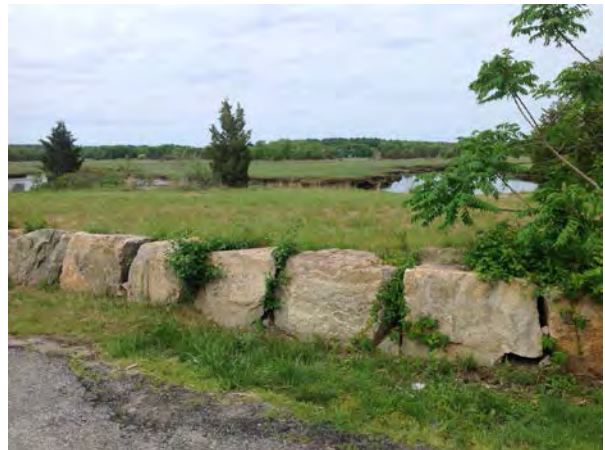
Retaining wall between BMP and marsh.

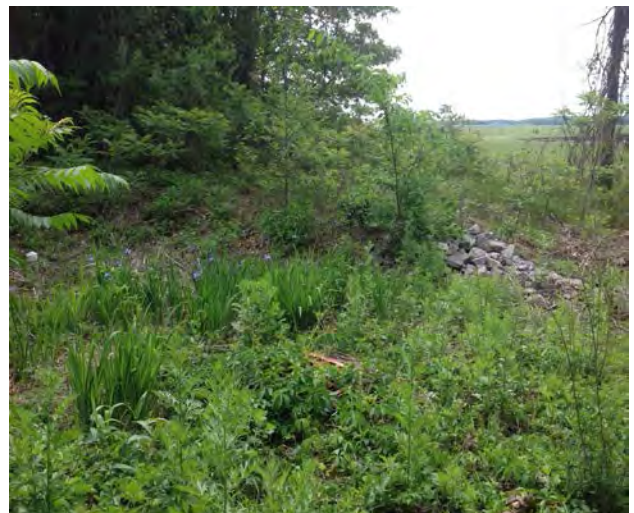
Note the vegetation.

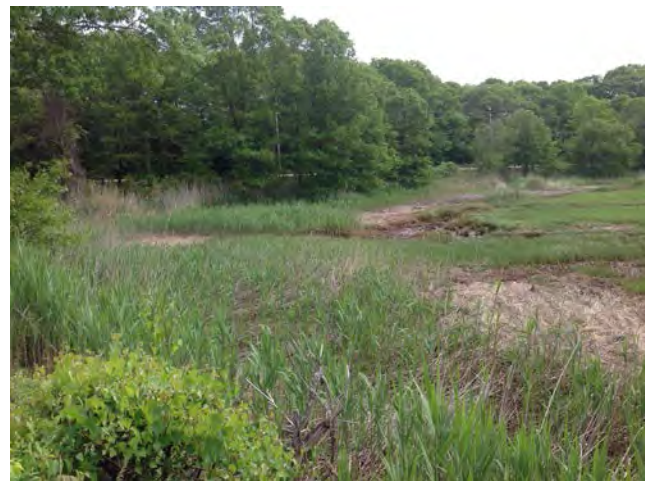
Marsh where the BMP discharges.

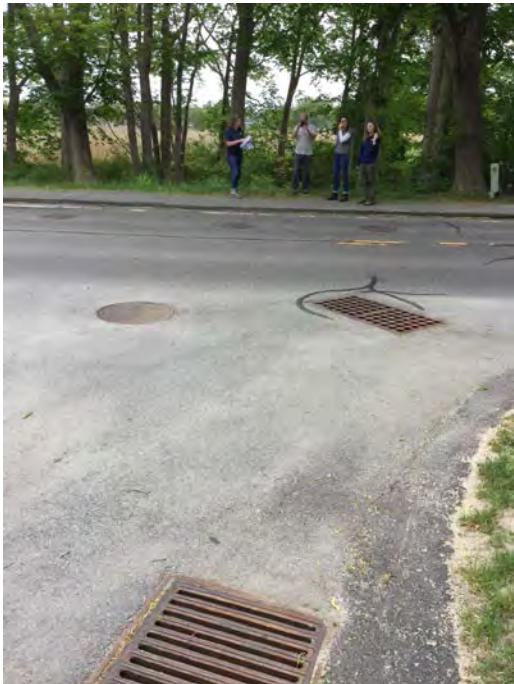
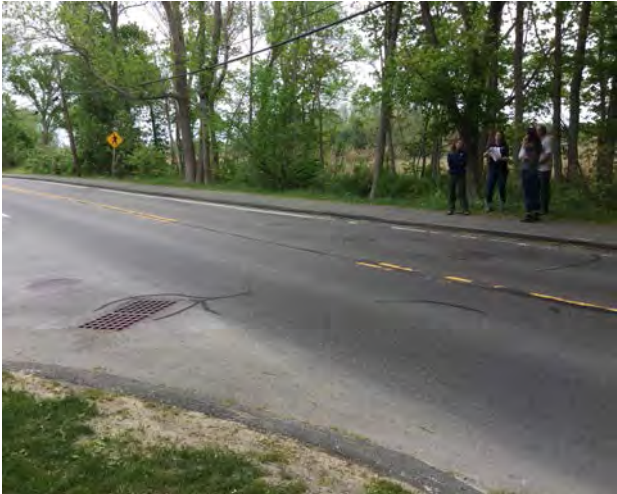
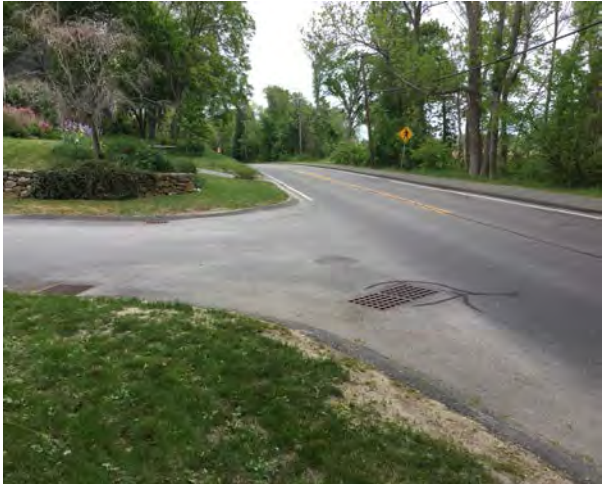
Grant Funding Source/ID Number: 319/02-13	
Year Built: 2011	
Reference Plans: Mill Creek Estuary Stormwater Mitigation As-Builts; dated June 15, 2012	
Address: Tupper Rd and Captain Ellis Way	
BMP Condition: Needs maintenance. Catch basin is full of sediment / grass clippings. Underground structures in middle of road not accessible.	
Climate Change Risks: Underground infiltration may not be a good choice at sites that have high ground water.	Potential Retrofit: Swales with checkdams along Captain Ellis Way could be an alternative.
Notes:

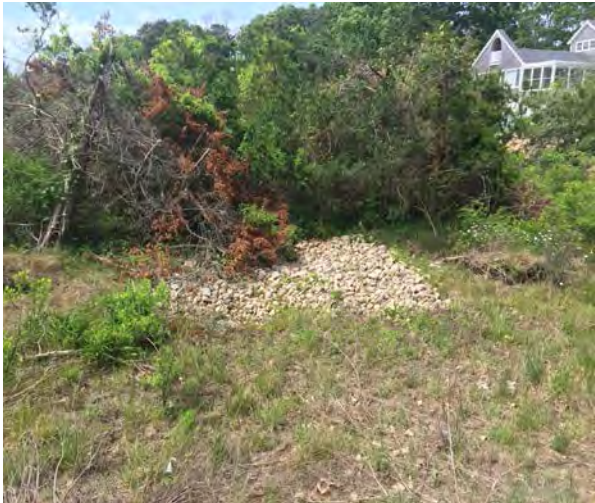
GENERAL INFORMATION	Site Visit
Elevation: -1.65 ft.	Weather: Clear
BMP Plant Health: Plant trimming required but otherwise healthy. Some sediment damage. Weeding necessary and some invasive control required.	Arrival Time: 10:38 AM
	Nearest Tide: High, 10:36 AM
	Observers: None
Observed Constraints: None	Date Assessed: 6/14/2015
	Outfall Details
	Outfall Observed: Yes
	Outfall Notes:
Direction of Coastal Exposure: Southeast	<p data-bbox="813 984 971 1010">Outfall Photo:</p>

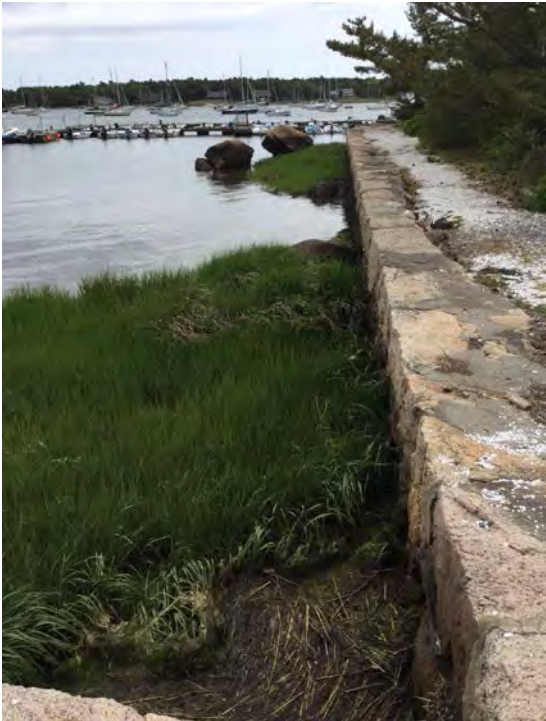
Coastal Barriers: Sea wall	
Condition of Shoreline: Minor erosion at back face of seawall	
Storm Damage/Flooding: Yes	
High Groundwater: Yes	
Assessed by: ERK/ACK

Grant Funding Source/ID Number: CPR/05-01		
Year Built: 2005		
Reference Plans: Record Plan Island Wharf; dated 11/15/06		
Address: Parking lot north/ adjacent to Island Wharf Rd		
BMP Condition: Bioretention in good condition.		
Climate Change Risks: Raise outfall in outlet structure.	Potential Retrofit:	
Notes:

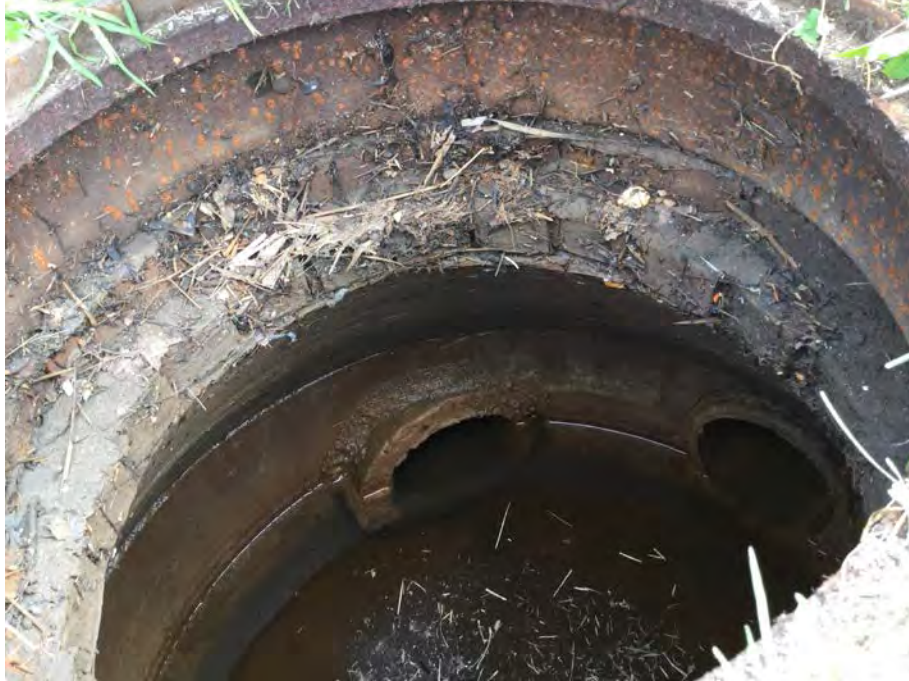
Manhole.

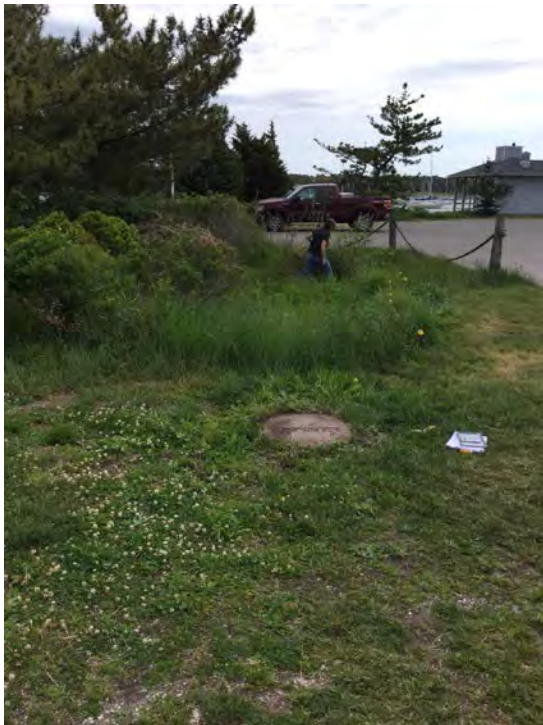
Bioretention.

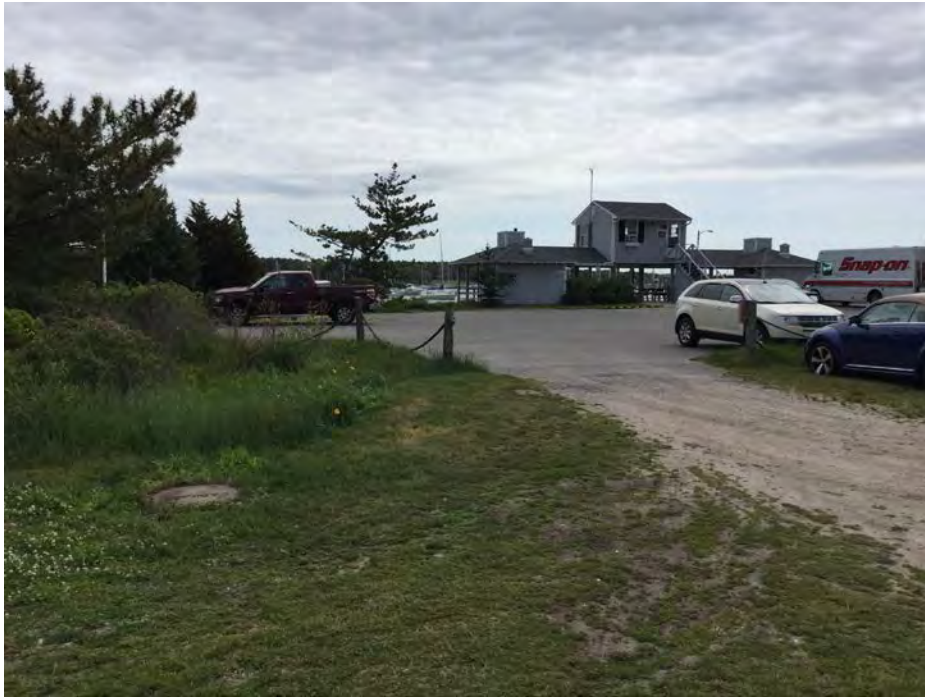
Bioretention and parking area.

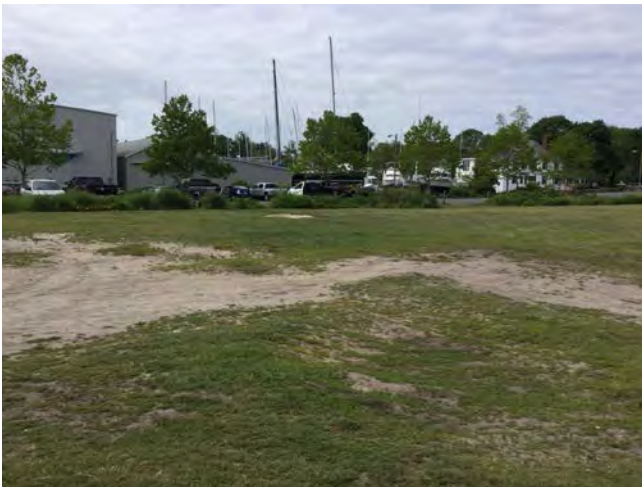
GENERAL INFORMATION	Site Visit
Elevation: 0.33 ft.	Weather: Clear
BMP Plant Health: Good maintenance. Cutting out woody. Some erosion on vegetated berm but otherwise okay.	Arrival Time: 10:02 AM
	Nearest Tide: Low, 6:21 AM
	Observers: Kirk Bosma, Elise Leduc (Woods Hole Group)
Observed Constraints: None	Date Assessed: 6/8/2015
	Outfall Details
	Outfall Observed: Submerged
	Outfall Notes: Outfall underwater at mean high tide.
Direction of Coastal Exposure: Southeast	<p data-bbox="813 982 971 1010">Outfall Photo:</p>

Eroded grass.

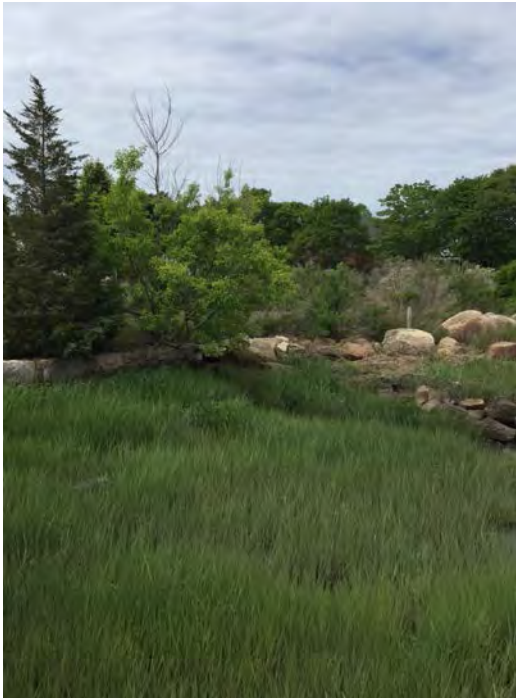
GENERAL INFORMATION	Site Visit
Elevation: 0.98 ft.	Weather: Clear
BMP Plant Health: Plants are doing well	Arrival Time: 10:11 AM
	Nearest Tide: Low, 6:21 AM
	Observers: Kirk Bosma, Elise Leduc (Woods Hole Group)
Observed Constraints: None	Date Assessed: 6/8/2015
	Outfall Details
	Outfall Observed: Yes
	Outfall Notes: Eroded channel at outfall. Observed some flow.
Direction of Coastal Exposure: Southeast	<p data-bbox="813 982 971 1010">Outfall Photo:</p>

Coastal Barriers: Sea wall	
Condition of Shoreline: Needs stabilization. Some evidence of overflow	
Storm Damage/Flooding: No	
High Groundwater: Yes	
Assessed by: ERK/ACK

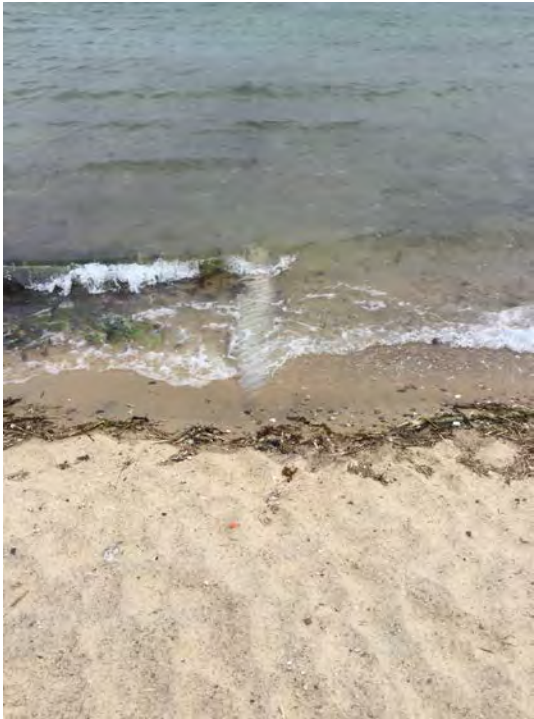
GENERAL INFORMATION	Site Visit
Elevation: 2.37 ft.	Weather: Raining
BMP Plant Health: NA	Arrival Time: 1:18 PM
	Nearest Tide: High, 2:25 PM
	Observers: Elise Leduc (Woods Hole Group)
Observed Constraints: None	Date Assessed: 6/8/2015
	Outfall Details
	Outfall Observed: Submerged
	Outfall Notes: Submerged. No duck bill.
Direction of Coastal Exposure: Southwest	<p data-bbox="813 982 971 1010">Outfall Photo:</p>

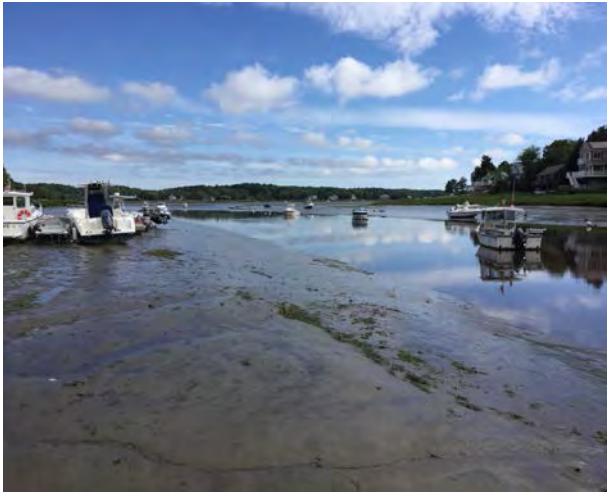
GENERAL INFORMATION	Site Visit
Elevation: 3.45 ft.	Weather: Clear
BMP Plant Health: NA	Arrival Time: 8:39 AM
	Nearest Tide: Low, 8:33 AM
	Observers: None
Observed Constraints: None	Date Assessed: 6/5/2015
	Outfall Details
	Outfall Observed: Yes
	Outfall Notes: Iron floc staining.
Direction of Coastal Exposure: East	<p data-bbox="813 982 971 1014">Outfall Photo:</p>

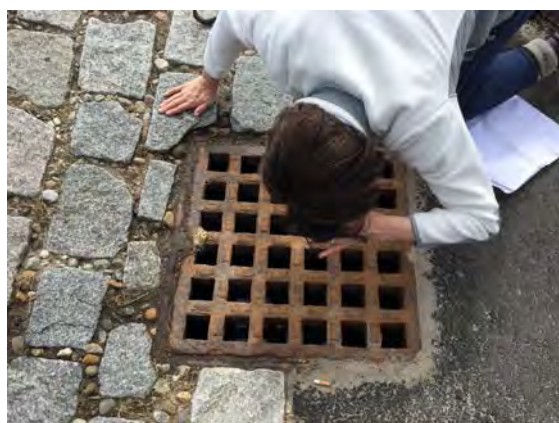
Hooded outlet pipe.

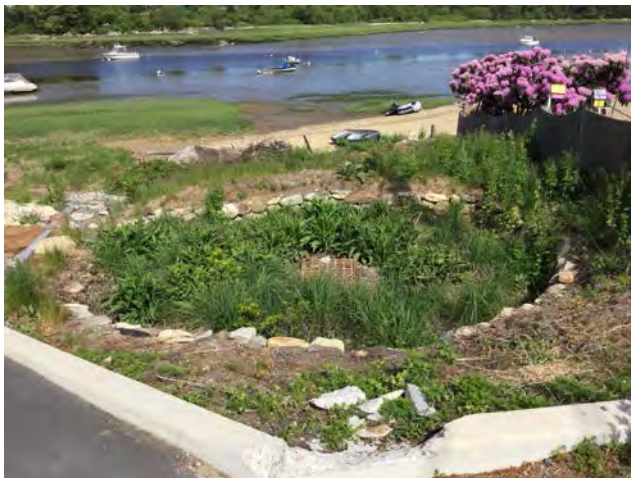
Rain garden immediately downgradient of Delano. Broken concrete curb.

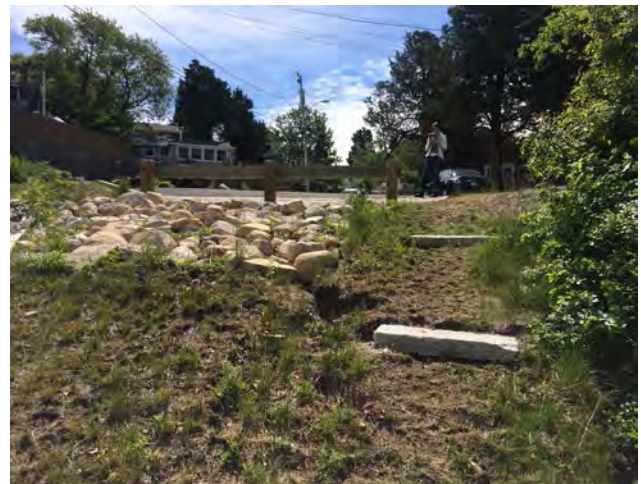
Second rain garden.

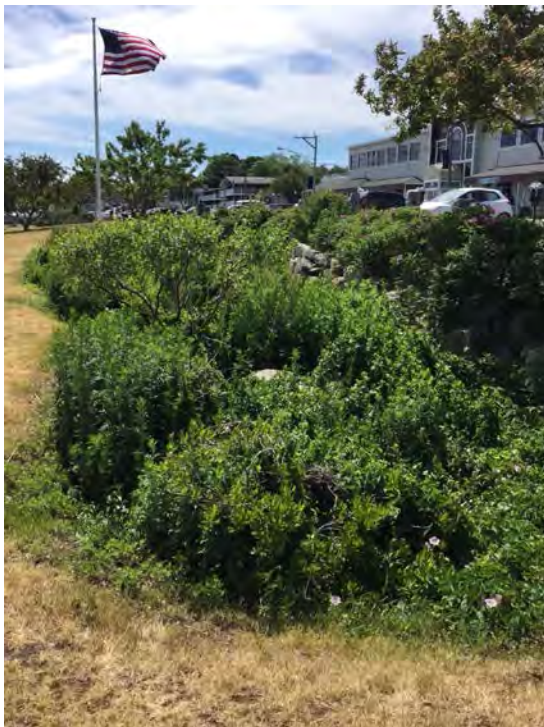
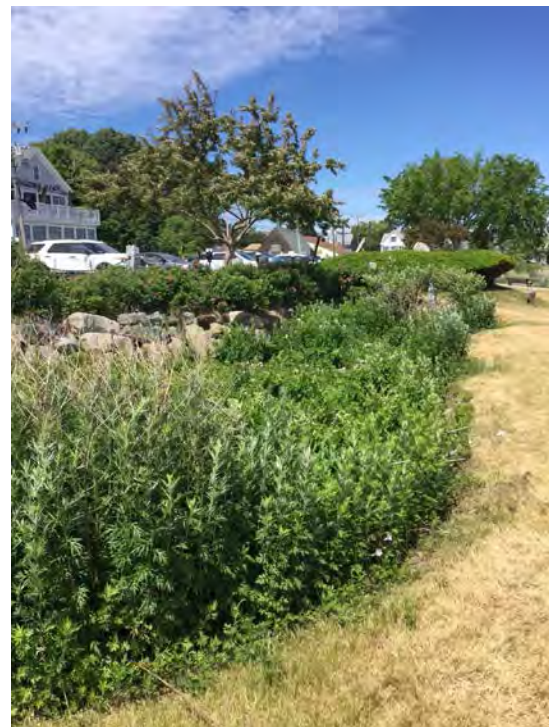
Overgrown, vines.

GENERAL INFORMATION	Site Visit
Elevation: 4.63 ft.	Weather: Clear
BMP Plant Health: Plants in good condition, good coverage. Vines in bio should be removed. Slightly overgrown. Detritus should be removed.	Arrival Time: 10:46 AM
	Nearest Tide: High, 2:15 PM
	Observers: None
Observed Constraints: Other	Date Assessed: 6/5/2015
	Outfall Details
	Outfall Observed: Yes
	Outfall Notes: Rock and debris in outfall pipe.
Direction of Coastal Exposure: Northeast	<p data-bbox="813 982 971 1010">Outfall Photo:</p>

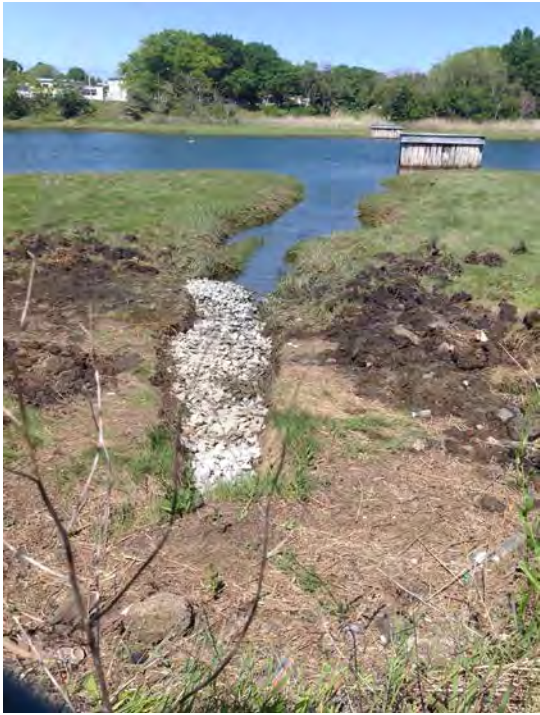
GENERAL INFORMATION	Site Visit
Elevation: 5.89 ft.	Weather: Rain Within Past 24hours
BMP Plant Health: Plants had been dying initially after installation but look healthy now.	Arrival Time: 2:50 PM
	Nearest Tide: High, 1:24 PM
	Observers: Julie Simpson (MIT Sea Grant)
Observed Constraints: None	Date Assessed: 6/4/2015
	Outfall Details
	Outfall Observed: Yes
	Outfall Notes: Outfall ditch has recently been riprapped for stabilization. Unclear if outfall is at near end or far end of riprapp.
Direction of Coastal Exposure: Northeast	Outfall Photo:

Coastal Barriers: Marsh	
Condition of Shoreline: Highlight impacted marsh edge. Chain link fence along marsh edge. Vegetated buffer between lower practice and salt marsh grass is only a few feet. Outfall pipe discharges to marsh; Ditch has recently been stabilized with riprapp.	
Storm Damage/Flooding: No	
High Groundwater: Yes	
Assessed by: JER/ESB

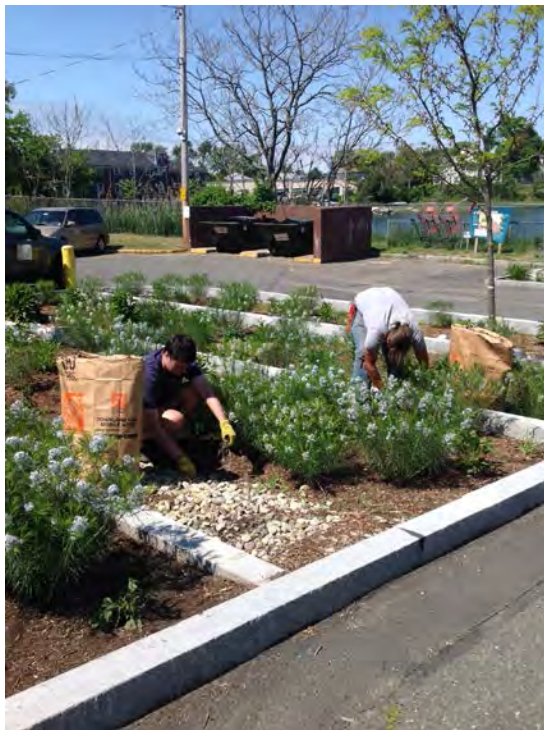
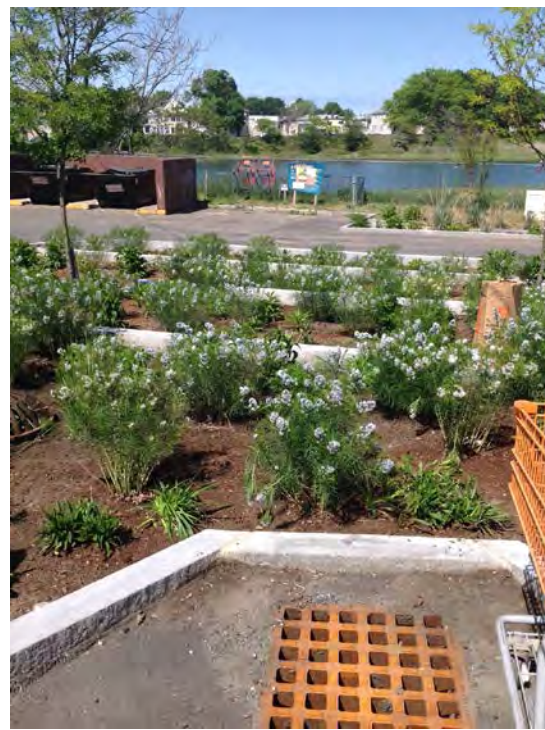
HW Site ID#: 41 Town: Chelsea	
<p>Type of BMP: Two biofilter systems</p>	 
<p>Grant Funding Source/ID Number: MET/</p>	
<p>Year Built: 2013</p>	
<p>Reference Plans: Stormwater System Retrofits MACE Public Housing Chelsea, Massachusetts; 12/18/13; Sheet C-1</p>	
<p>Address: Clinton St and Mill Court, Mace Housing Complex, Chelsea</p>	
<p>BMP Condition: Maintenance observed during our visit. Landscapers suggest mulch is deep and should be removed, replaced to lower elevation. Water is flowing over berms and carrying mulch into gravel spillways. Catch basin into lower basin is ponding, clogged.</p>	
<p>Climate Change Risks: Outfall elevation is very low in the marsh. Salt from snow piles dumped into bioretentions was likely a problem with plant survival.</p>	<p>Potential Retrofit:</p>
<p>Notes:</p>

Maintenance underway.

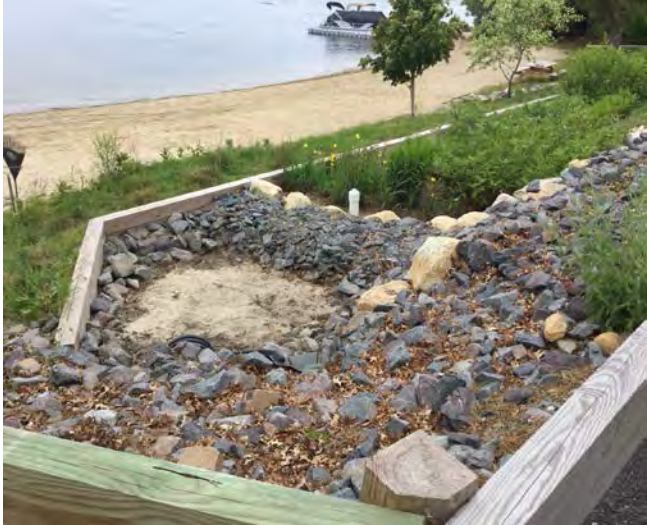
HW Site ID#: 44 Town: Plymouth	
Type of BMP: Bioretention, Subsurface infiltration

Grant Funding Source/ID Number: CPR/2011	
Year Built: 2011	
Reference Plans: Pond Road Stormwater Improvements, dated March 2012	
Address: Pond Road, Plymouth	
BMP Condition: Bioretention in very good condition. Some sediment build-up on trench drain grate.	
Climate Change Risks: No recommendations. This practice is quite a bit higher than the adjacent water elevation.	Potential Retrofit:
Notes: Sediment fore bay needs to be cleaned out. Pretreat tanks do not have access manholes

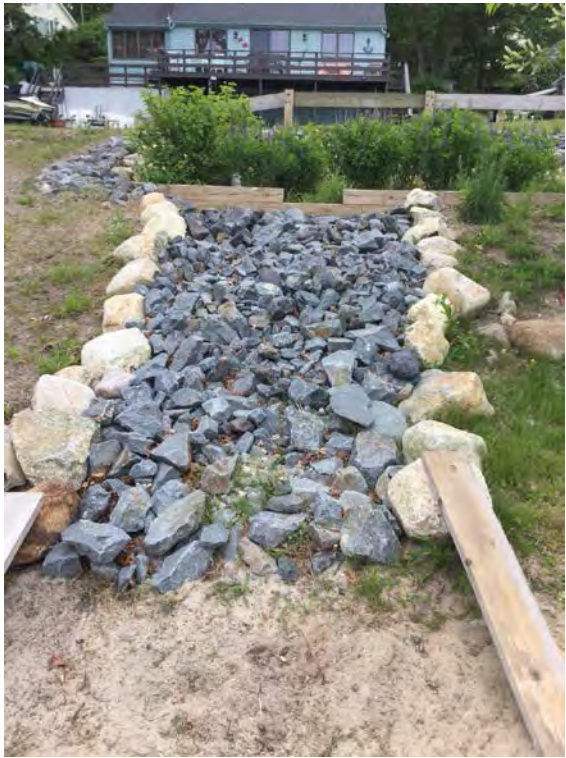
GENERAL INFORMATION	Site Visit
Elevation: 16.77 ft.	Weather: Overcast
BMP Plant Health: Good	Arrival Time: 2:30 PM
	Nearest Tide: High, 4:45 PM
	Observers: None
Observed Constraints: None	Date Assessed: 6/8/2015
	Outfall Details
	Outfall Observed: Yes
	Outfall Notes: Overflow in good condition
Direction of Coastal Exposure: Northeast	<p data-bbox="813 982 971 1010">Outfall Photo:</p>

Coastal Barriers: Ret. Wall	
Condition of Shoreline: Great condition; local neighborhood association is responsible for beach maintenance.	
Storm Damage/Flooding: No	
High Groundwater: No	
Assessed by: ERK/ACK
