Appendix A: Assessment Summaries for BMPs

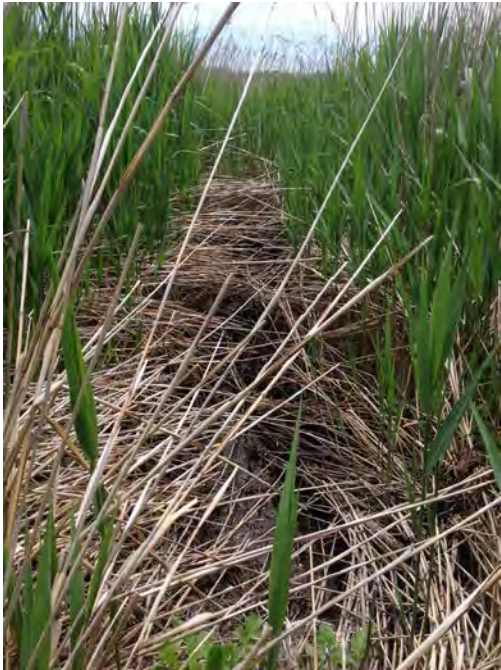
GENERAL INFORMATION	Site Visit
Elevation: 5.11 ft.	Weather: Rain Within Past 24 hours
BMP Plant Health: Salt Impacts. Lots of phragmites. Wall collapsed into forebay, possibly undercut by high water. Water in catch basin approx 2 feet below rim. Inlet from diversion manhole completely blocked. Appears that bmp is not functioning and all water is diverted to nearby wetland.	Arrival Time: 12:05 PM
	Nearest Tide: High, 1:28 PM
	Observers: None
Observed Constraints: None	Date Assessed: 6/4/2015
	Outfall Details
	Outfall Observed: No
	Outfall Notes: Did not find outfall structure, but clear indication of discharge.
Direction of Coastal Exposure: North	Outfall Photo:

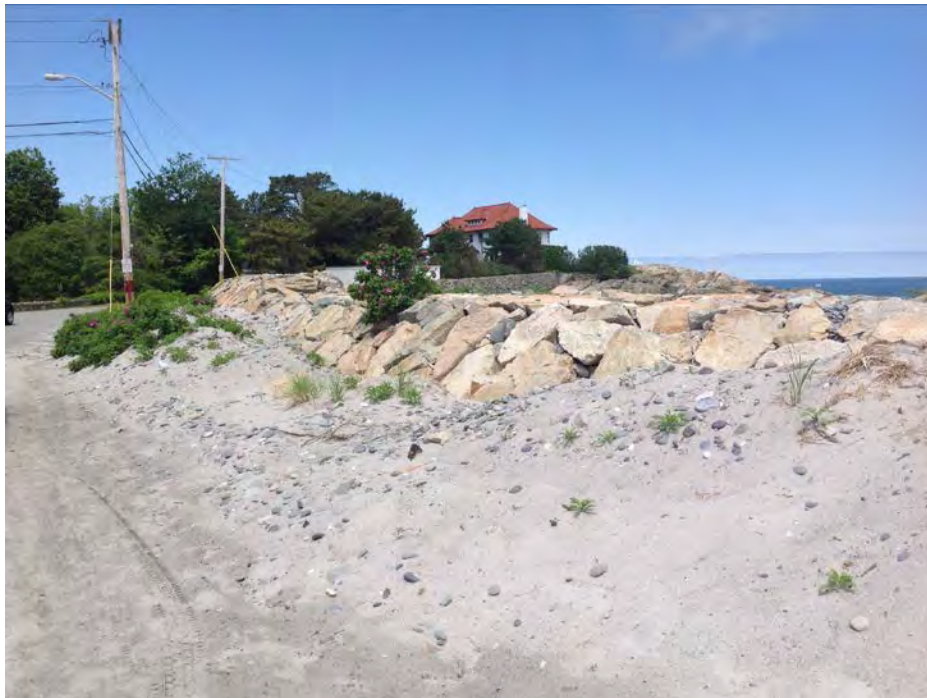
Sand appears to wash over lower section of sea wall, across Atlantic Ave. from BMP.

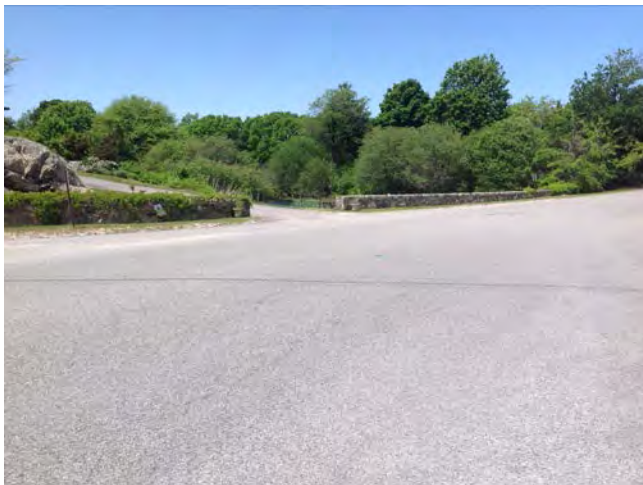
Looking northwest on Atlantic Ave.

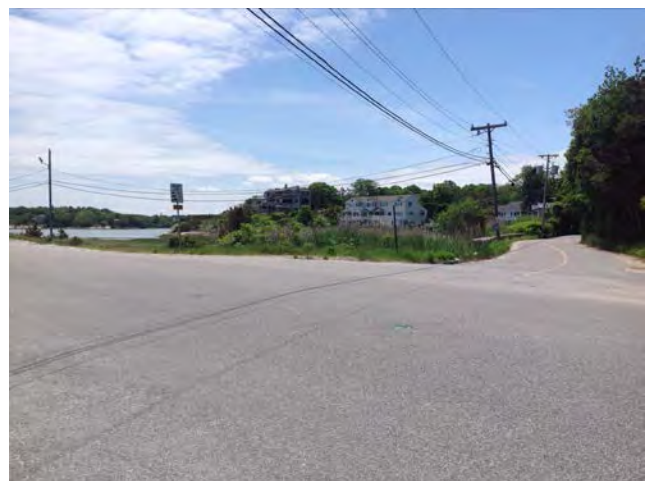
Looking southwest across Atlantic Ave. to the gravel wetland.

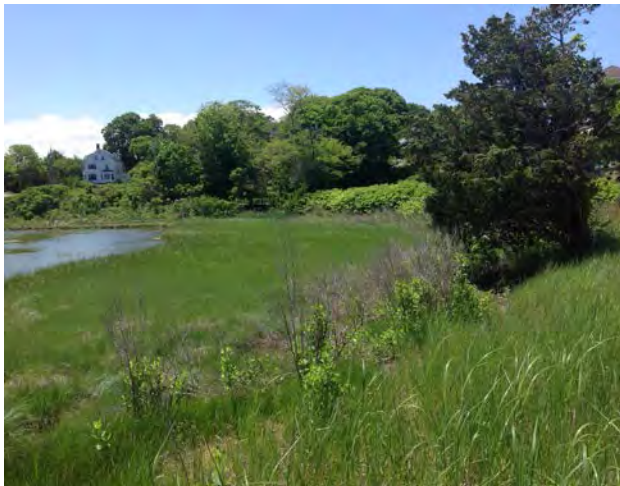
HW Site ID#: 8/9		Town: Cohasset
Type of BMP: Stormceptor, infiltration basin	 	
Grant Funding Source/ID Number: 319/10-04		
Year Built: 2011		
Reference Plans: Jerusalem Road at Atlantic Ave Drainage Improvements; last revised 10/01/10		
Address: Jerusalem Rd at Atlantic Ave		
BMP Condition: Swale overgrown with knotweed. Hard to see swale.		
Climate Change Risks: Infiltration basin is not a recommended practice here due to high groundwater. Also, significant Japanese Knotweed presence could limit conveyance and available storage in practice.		
	Potential Retrofit: Possible space for bioretention across the street, at a higher elevation and buffered from the marsh.	
Notes: Three catch basins are full of sediment.

Swale is in the knotweed, upland marsh area is to the left and salt marsh grass to the right.

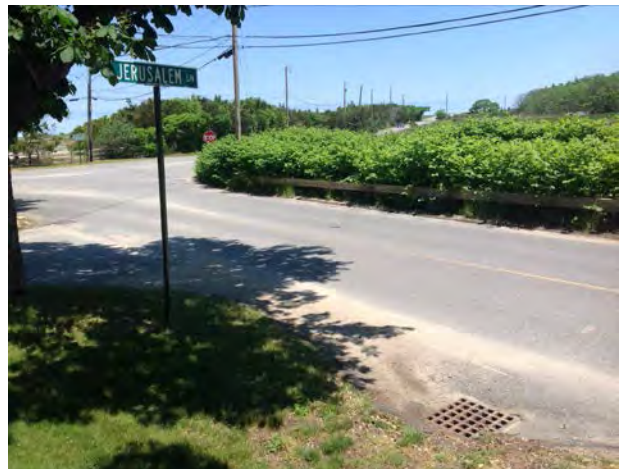
Three catch basins in the road discharge to swale (in the knotweed) across the street.

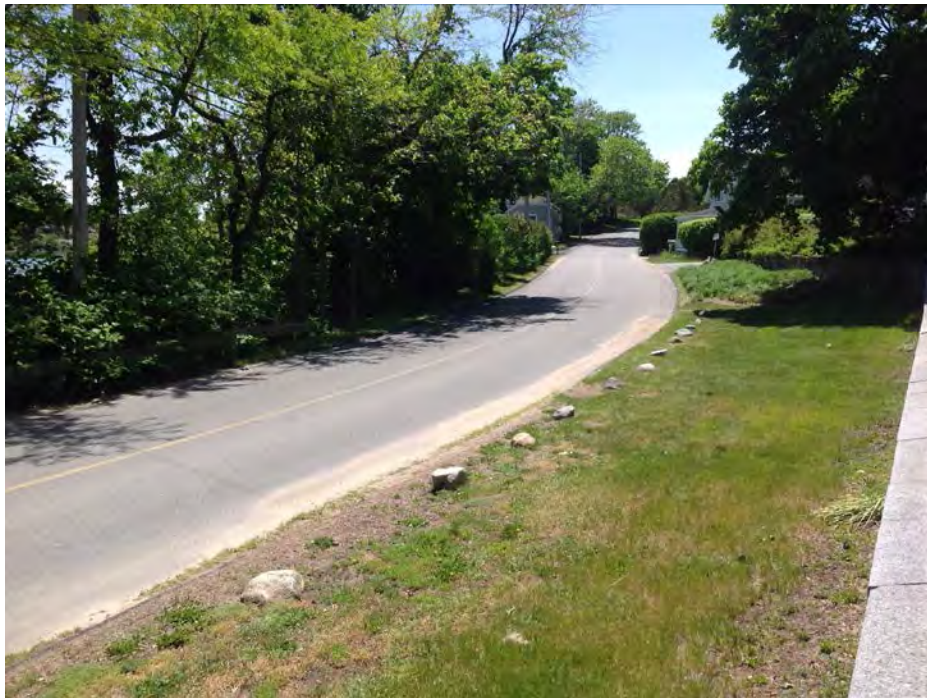
Opposite side of the street. Potential retrofit location.

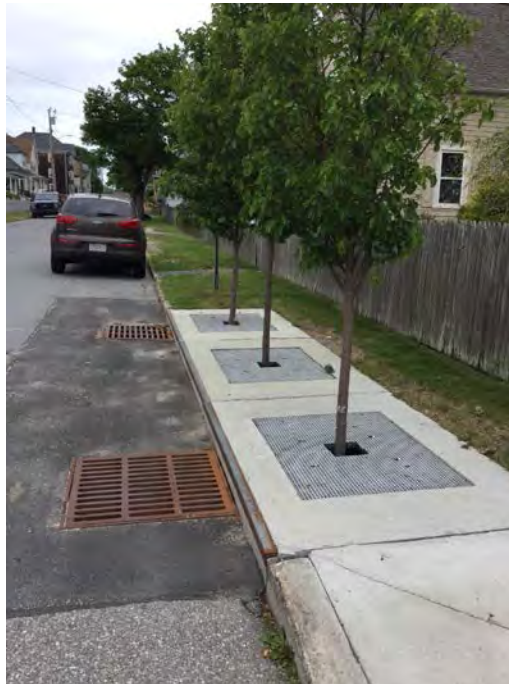
Site 11A, Alpine Avenue. Trees installed.

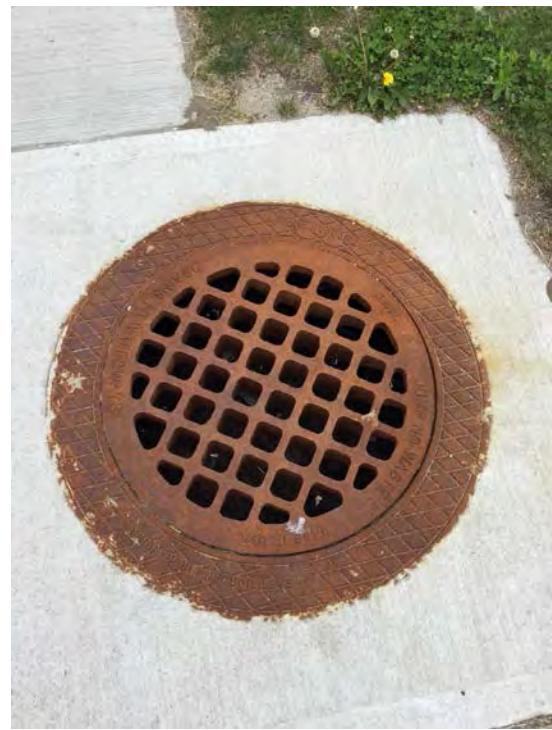
Site 11C, Morgan Street. Trees not installed.

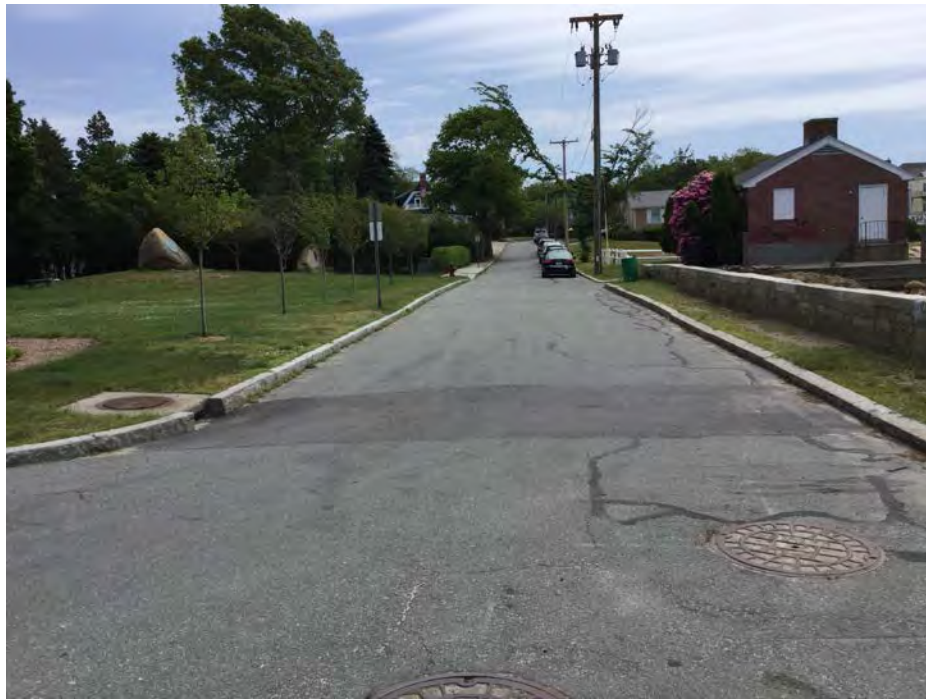
Drains to catchbasin at rain garden outlet.

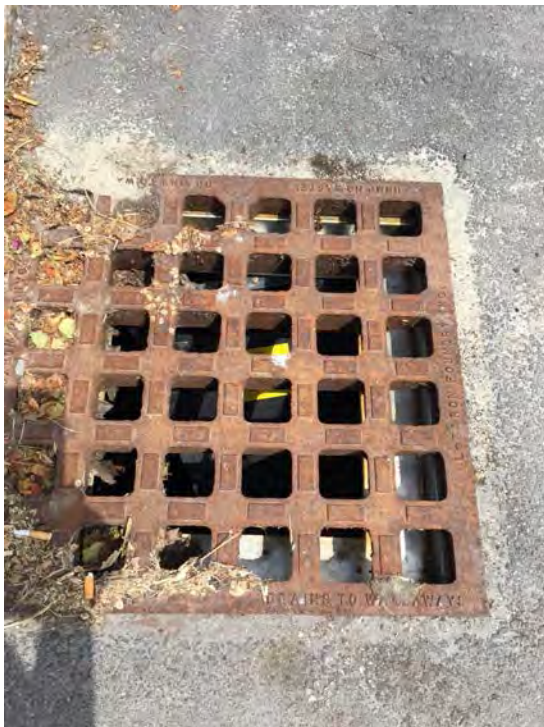
Needs maintenance.

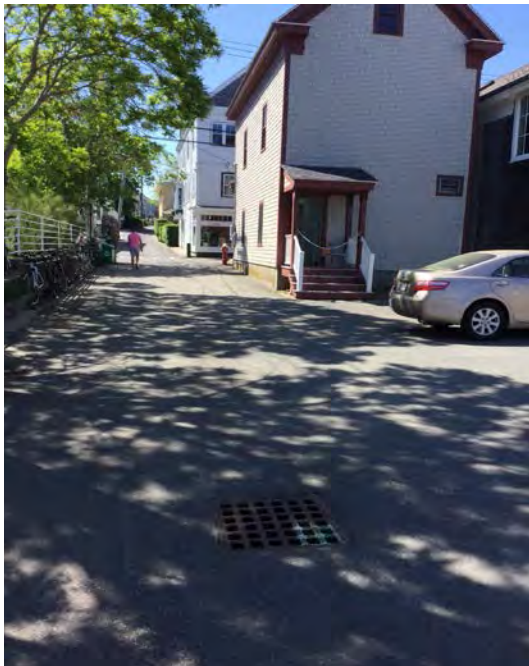
Drainage area is only the road between Commercial Street and the beach, as well as two roofs.

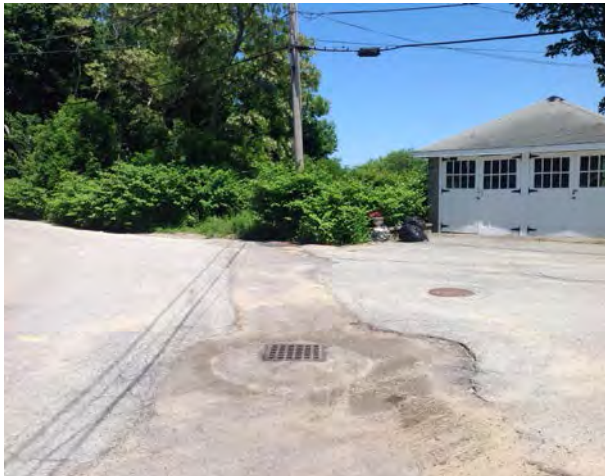
Grant Funding Source/ID Number: 319/08-06		
Year Built: 2012		
Reference Plans: Project Final Report - Stormwater BMPs at Straits Pond, Project Number 09-06/319		
Address: Richards Rd at Pond St		
BMP Condition: Disturbed area above chambers lacks stabilized veg. Covered by rocks and invasives.		
Climate Change Risks: The underground system is likely to address local flooding (area is a low point). Likely high groundwater, so subsurface infiltration is not ideal here. Need to size appropriately to account for lack of infiltration and/or assume detention only.	Potential Retrofit:	
Notes:

Surface of practice area.

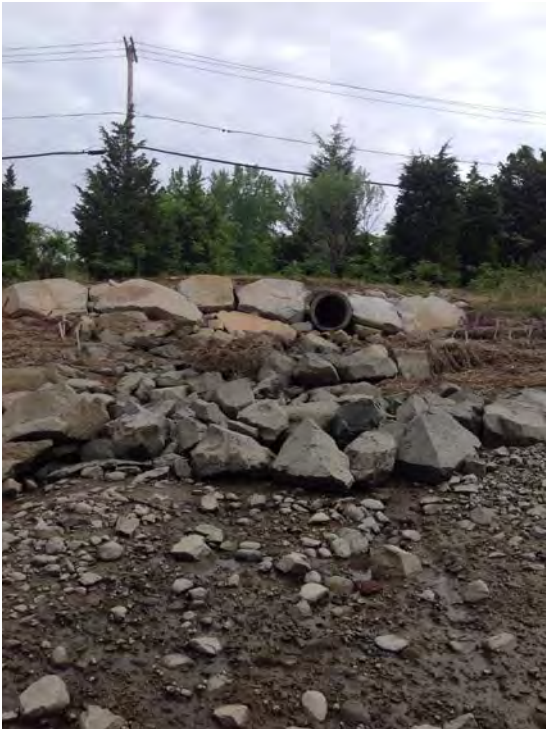
Grant Funding Source/ID Number: 319/06-06		
Year Built: 2009		
Reference Plans: Project Final Report - Herring River Coastal Low Impact Development Project, DEP Project #06-06/319		
Address: Parking lot across from golf course on Driftway		
BMP Condition: Appears to be in good condition. Erosion occurring to the right hand side of the outfall. Sediment deposits throughout BMP.		
Climate Change Risks: Erosion at outfall as a result of increased runoff in drainage area and/or coastal inundation.	Potential Retrofit:	
Notes: Road and large parking lot. Bike path along road.

Erosion.

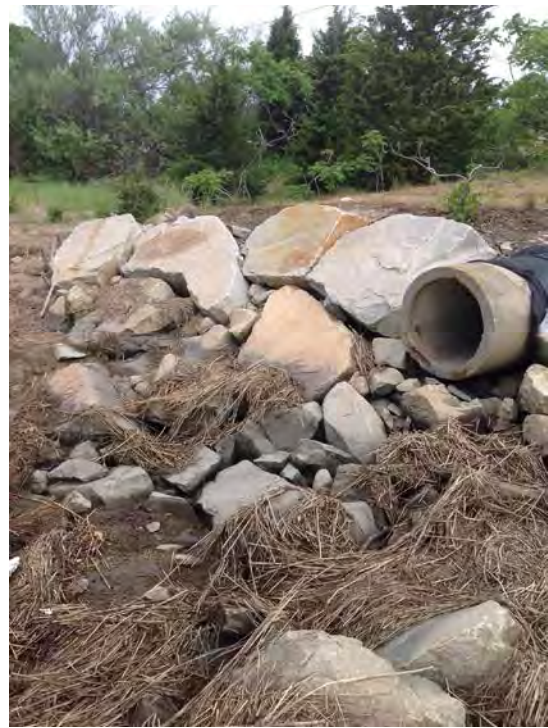
Sedimentation.

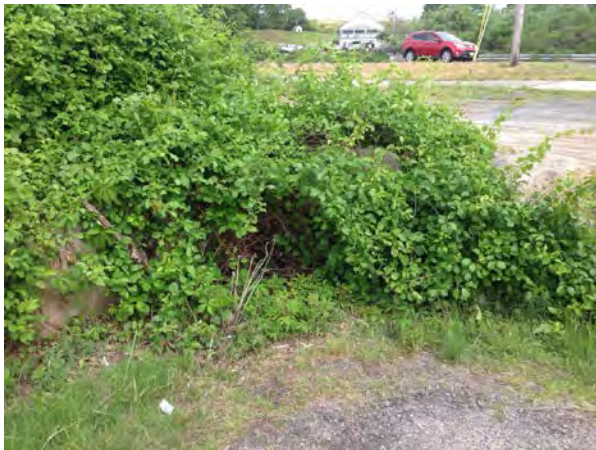
Looking towards driftway.

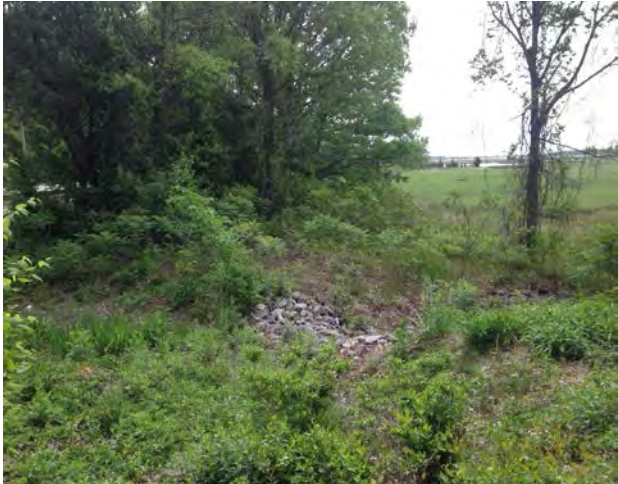
HW Site ID#: 22c		Town: Scituate
Type of BMP: Bioretention

Grant Funding Source/ID Number: 319/06-06		
Year Built: 2009		
Reference Plans: Project Final Report - Herring River Coastal Low Impact Development Project, DEP Project #06-06/319		
Address: Adjacent to Driftway, east of Ladds Way development		
BMP Condition: Overgrown. Not maintained well. Still appears to be functioning. Forebay has significant sediment and debris. Overgrown outfall structure. Flared end of pipe has significant sediment. Needs cleaning,		
Climate Change Risks: Adjacent to marsh. Discharge is slightly above marsh, but no apparent high water issues. Water observed in base of overflow structure, at least 2 feet below grate.	Potential Retrofit:	
Notes: Structure appears to be functioning well but needs maintenance. Forebay full and spillway riprap embedded with sediment.

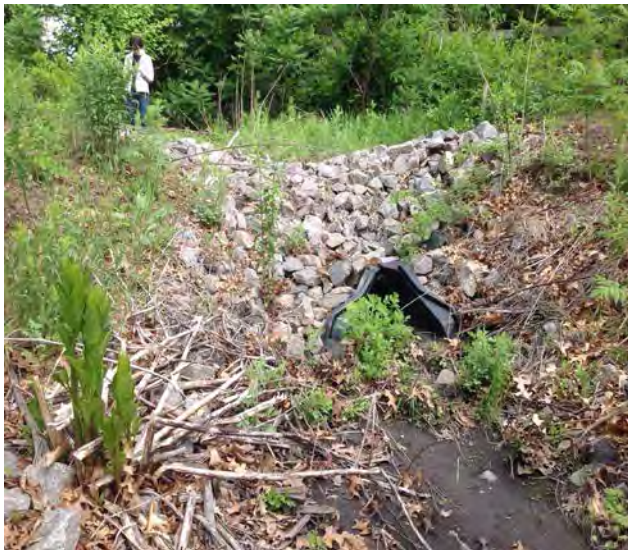
GENERAL INFORMATION	Site Visit
Elevation: 10.55 ft.	Weather: Rain Within Past 24 hours
BMP Plant Health: Good health.	Arrival Time: 9:56 AM
	Nearest Tide: High, 1:44 PM
	Observers: Sara Grady (Massbays)
Observed Constraints: None	Date Assessed: 6/4/2015
	Outfall Details
	Outfall Observed: Yes
	Outfall Notes: Note edge of spillway riprap on left and edge of marsh wrack in center right, indicating high tide.
	Outfall Photo:
Direction of Coastal Exposure: Southeast

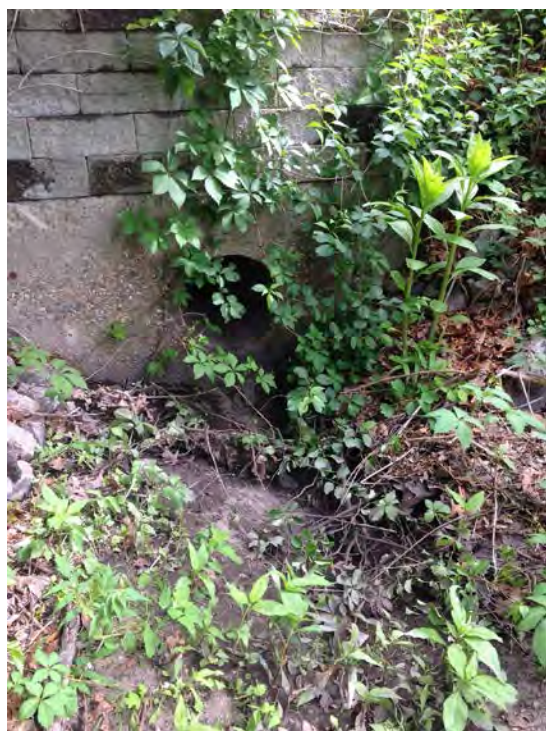
Forebay full of sediment.

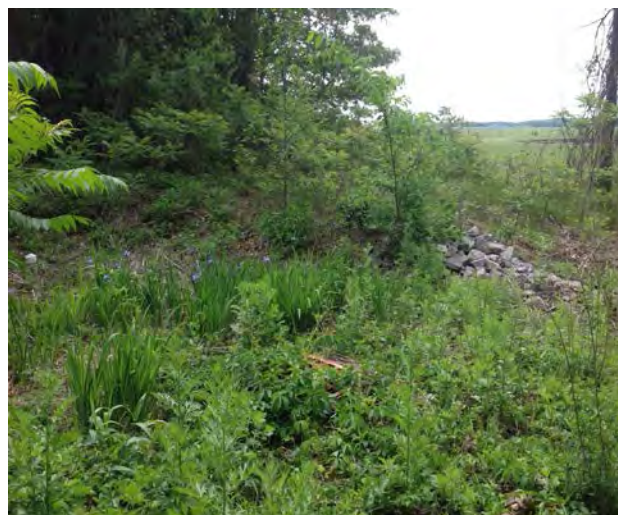
Note the vegetation.

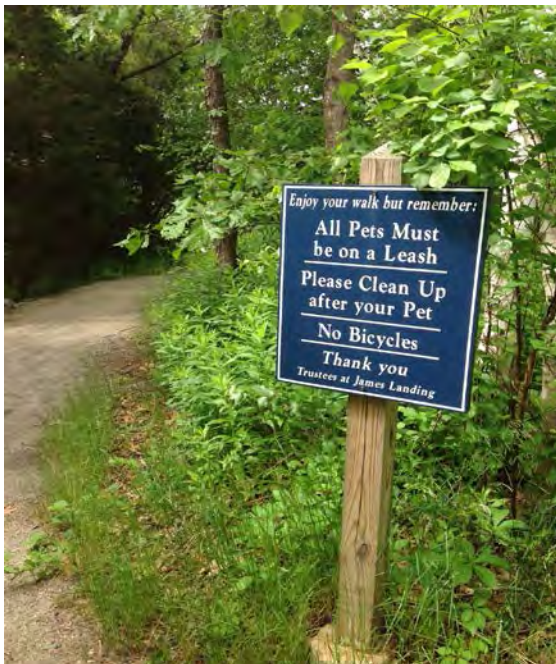
Sign on pathway adjacent to BMP along marsh edge and nearby housing complex.

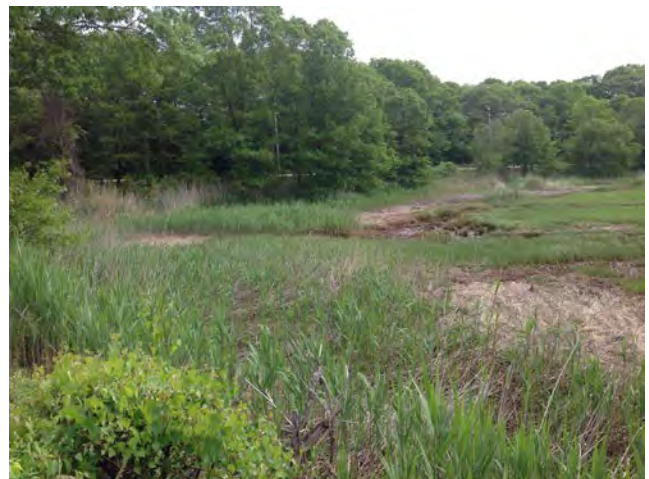
Marsh where the BMP discharges.

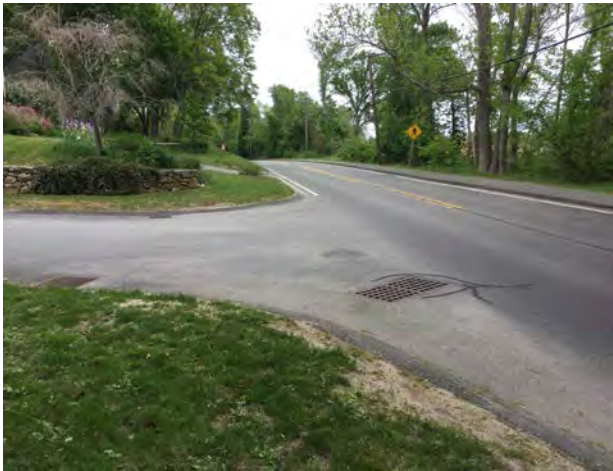
HW Site ID#: 28		Town: Sandwich
Type of BMP: Deep sump catch basin / leaching

Grant Funding Source/ID Number: 319/02-13		
Year Built: 2011		
Reference Plans: Mill Creek Estuary Stormwater Mitigation As-Built; dated June 15, 2012		
Address: Tupper Rd and Captain Ellis Way		
BMP Condition: Needs maintenance. Catch basin is full of sediment / grass clippings. Underground structures in middle of road not accessible.		
Climate Change Risks: Underground infiltration may not be a good choice at sites that have high ground water.	Potential Retrofit: Swales with checkdams along Captain Ellis Way could be an alternative.	
Notes:

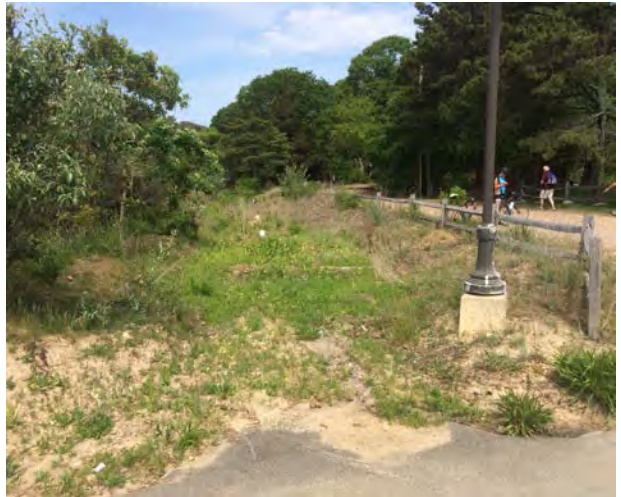
HW Site ID#: 30		Town: Oak Bluffs
Type of BMP: Rain garden/gravel wetland

Grant Funding Source/ID Number: CPR/10-10		
Year Built: 2010		
Reference Plans: East Chop Drive Stormwater Pollution Prevention Construction Plans; dated March 23, 2010		
Address: Approx 64 East Chop Dr on Mill Sq Rd and East Chop Dr		
BMP Condition: BMP is in good working condition. In need of maintenance of plants and sediment removal. Outlet structure partially clogged with debris. Abutting large trees have died from root damage.		
Climate Change Risks: This practice may be subject to coastal over wash in an extreme event, but is moderately protected in the harbor from direct coastal storm influences. The site is highly influenced by tides as the bottom of the practice is below the high tide elevation. But the practice is lined so is not directly influenced by the tide.	Potential Retrofit: Possible improvements may include additional plantings along the top of slope to expand the buffer between the roadway and the practice. An alternative to the paved flume for pretreatment may improve sedimentation concerns.

GENERAL INFORMATION	Site Visit
Elevation: -1.65 ft.	Weather: Clear
BMP Plant Health: Plant trimming required but otherwise healthy. Some sediment damage. Weeding necessary and some invasive control required.	Arrival Time: 10:38 AM
	Nearest Tide: High, 10:36 AM
	Observers: None
Observed Constraints: None	Date Assessed: 6/14/2015
	Outfall Details
	Outfall Observed: Yes
	Outfall Notes:
	Outfall Photo:
Direction of Coastal Exposure: Southeast

Notes: Overall, this site is performing well but requires maintenance.

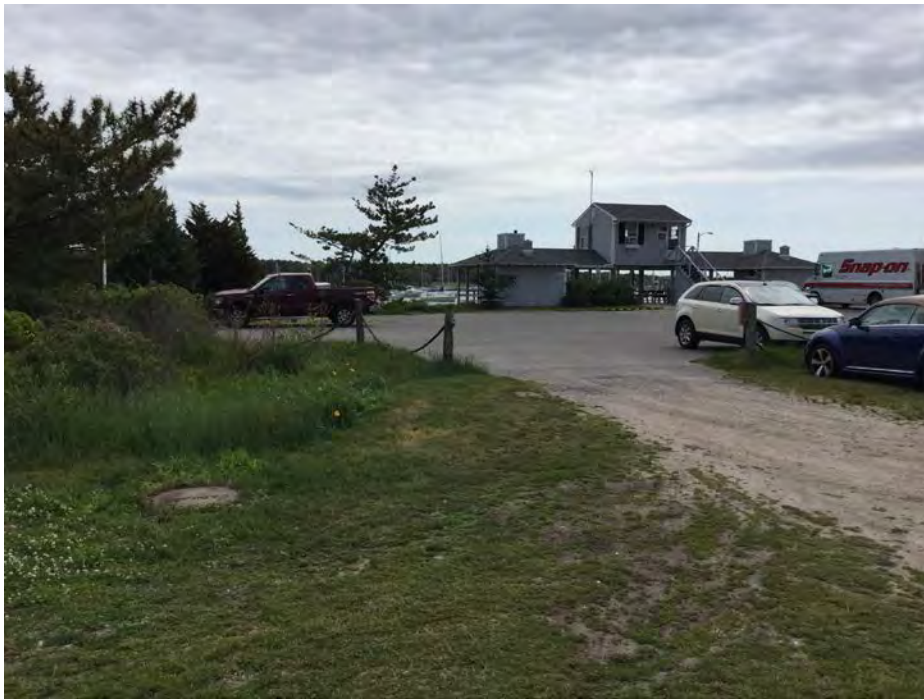
Bioretention and parking area.

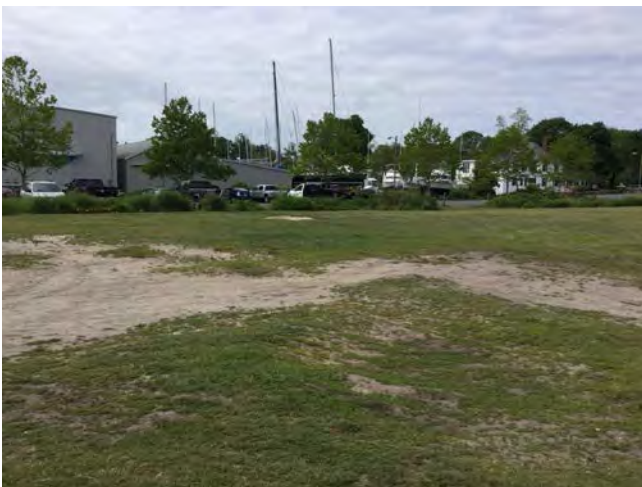
GENERAL INFORMATION	Site Visit
Elevation: 0.33 ft.	Weather: Clear
BMP Plant Health: Good maintenance. Cutting out woody. Some erosion on vegetated berm but otherwise okay.	Arrival Time: 10:02 AM
	Nearest Tide: Low, 6:21 AM
	Observers: Kirk Bosma, Elise Leduc (Woods Hole Group)
Observed Constraints: None	Date Assessed: 6/8/2015
	Outfall Details
	Outfall Observed: Submerged
	Outfall Notes: Outfall underwater at mean high tide.
	Outfall Photo:
Direction of Coastal Exposure: Southeast

Eroded grass.

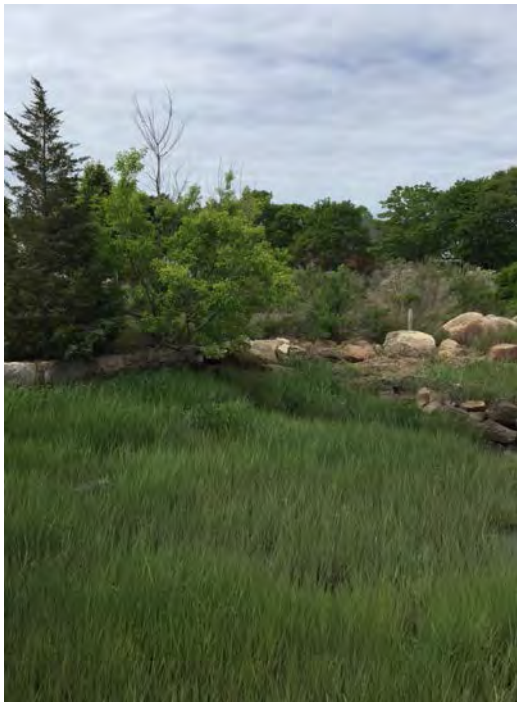
GENERAL INFORMATION	Site Visit
Elevation: 0.98 ft.	Weather: Clear
BMP Plant Health: Plants are doing well	Arrival Time: 10:11 AM
	Nearest Tide: Low, 6:21 AM
	Observers: Kirk Bosma, Elise Leduc (Woods Hole Group)
Observed Constraints: None	Date Assessed: 6/8/2015
	Outfall Details
	Outfall Observed: Yes
	Outfall Notes: Eroded channel at outfall. Observed some flow.
	Outfall Photo:
Direction of Coastal Exposure: Southeast

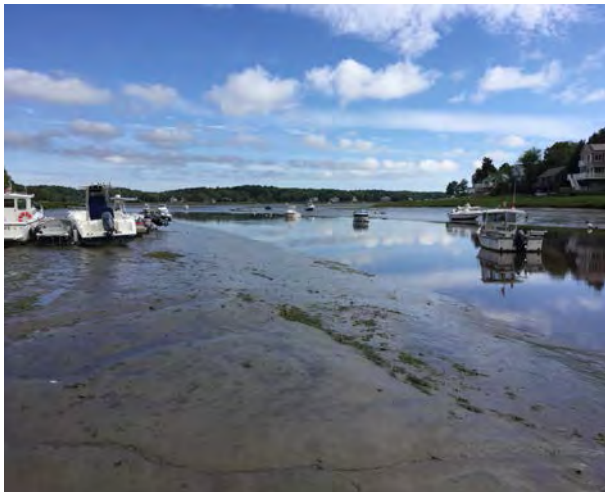
GENERAL INFORMATION	Site Visit
Elevation: 3.45 ft.	Weather: Clear
BMP Plant Health: NA	Arrival Time: 8:39 AM
	Nearest Tide: Low, 8:33 AM
	Observers: None
Observed Constraints: None	Date Assessed: 6/5/2015
	Outfall Details
	Outfall Observed: Yes
	Outfall Notes: Iron floc staining.
	Outfall Photo:
Direction of Coastal Exposure: East

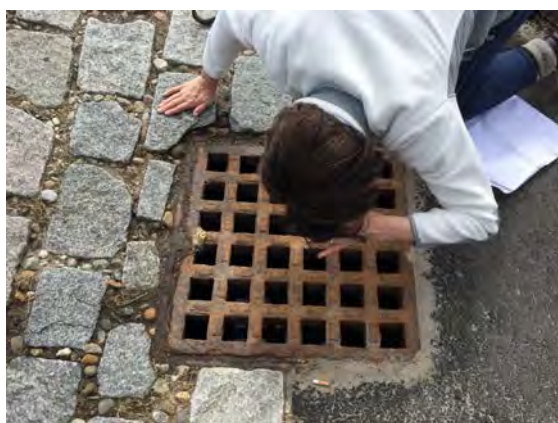
Hooded outlet pipe.

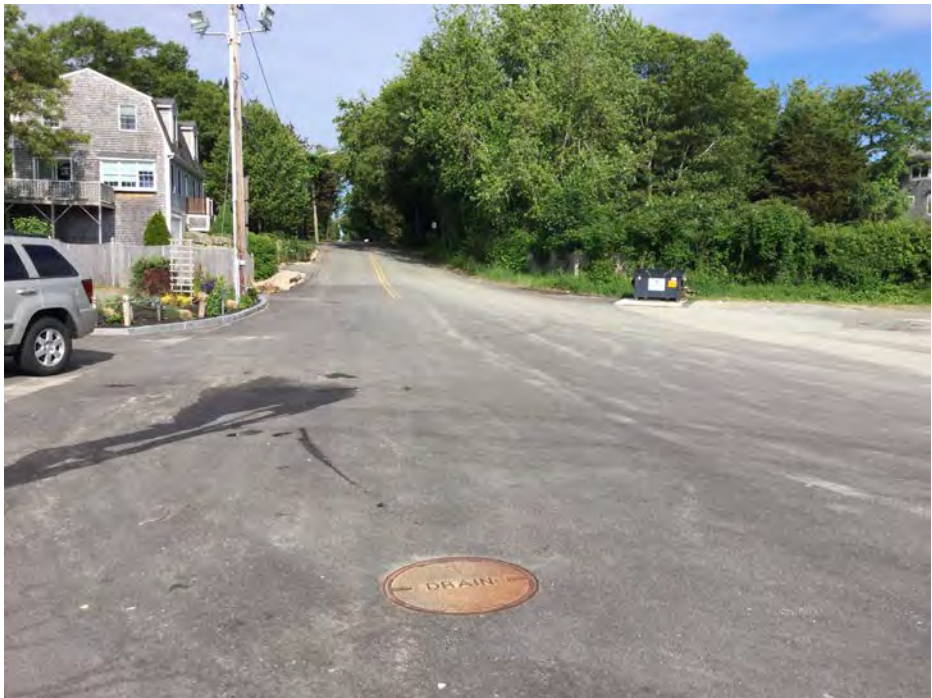
Looking uphill at drainage area.

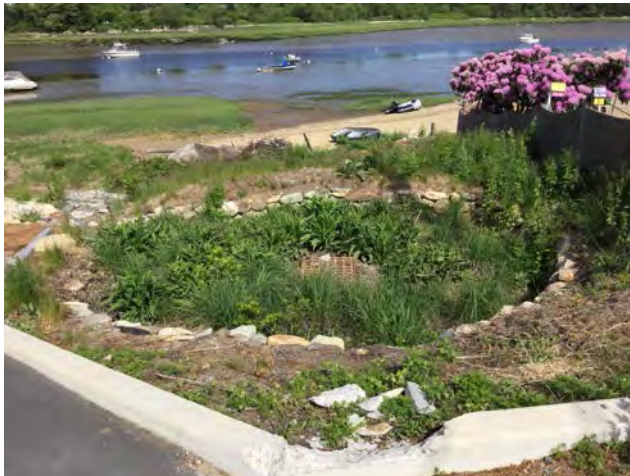
Rain garden immediately downgradient of Delano. Broken concrete curb.

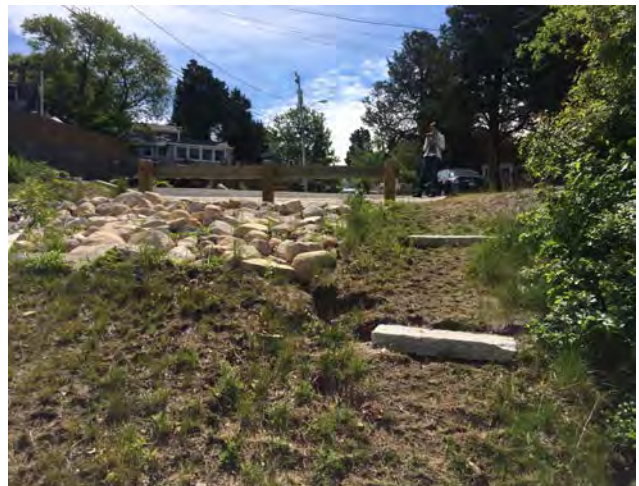
Second rain garden.

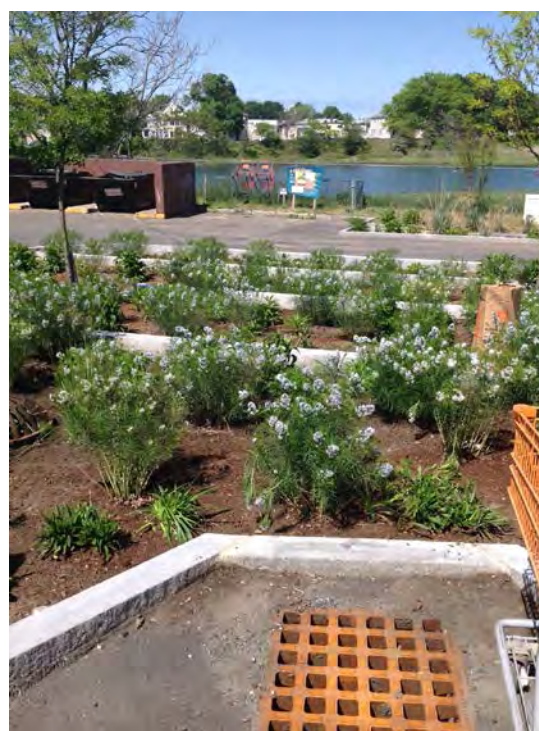
Maintenance underway.

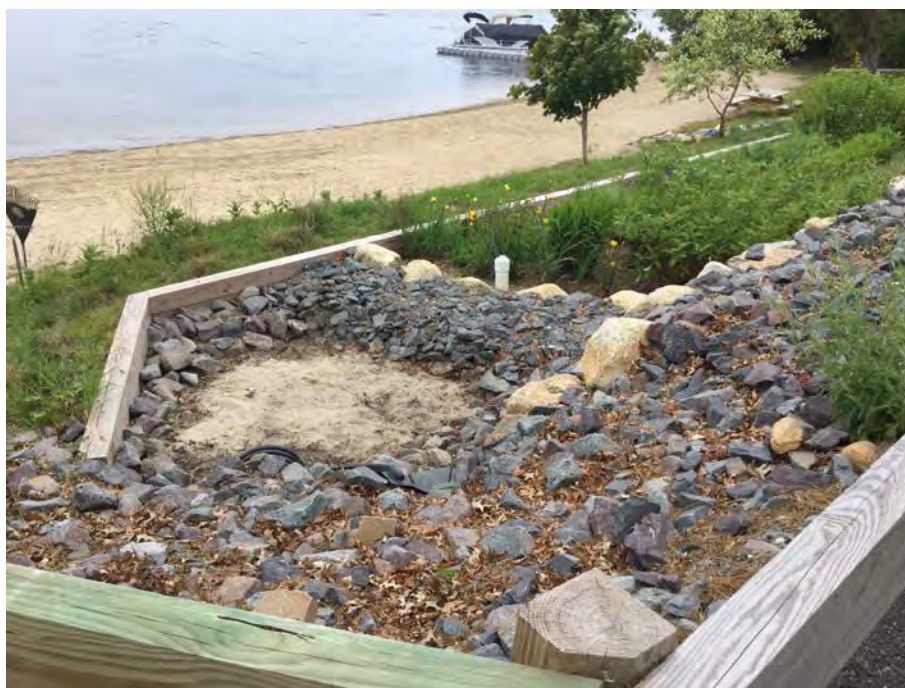
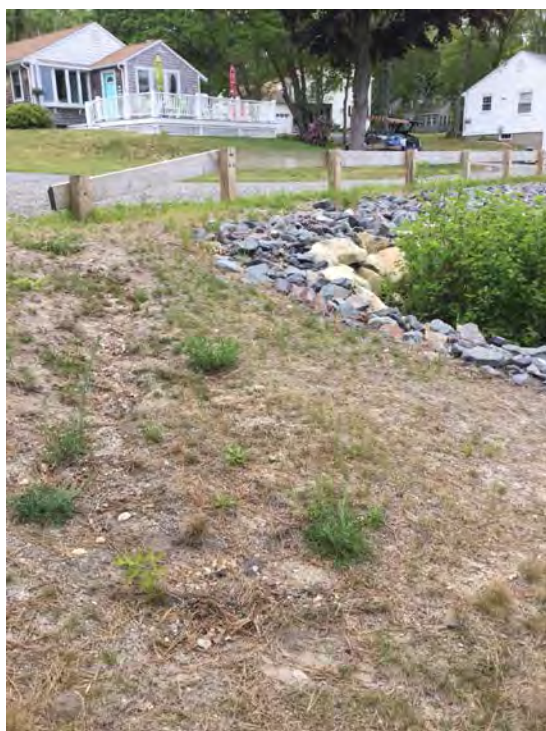
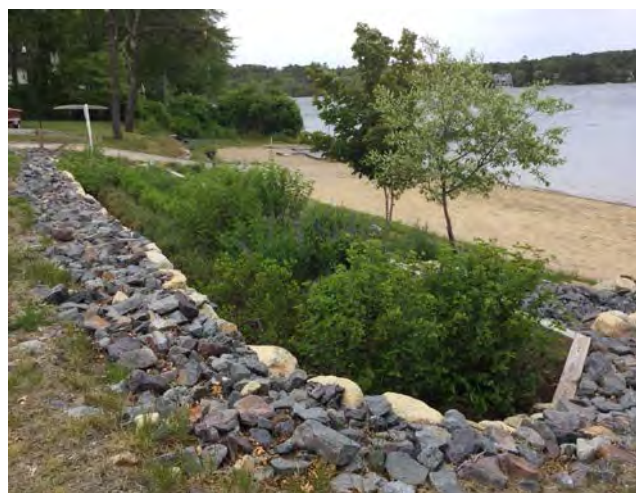
BMP Photos

Grant Funding Source/ID Number: CPR/2011		
Year Built: 2011		
Reference Plans: Pond Road Stormwater Improvements, dated March 2012		
Address: Pond Road, Plymouth		
BMP Condition: Bioretention in very good condition. Some sediment build-up on trench drain grate.		
Climate Change Risks: No recommendations. This practice is quite a bit higher than the adjacent water elevation.	Potential Retrofit:	
Notes: Sediment fore bay needs to be cleaned out. Pretreat tanks do not have access manholes
