PREPARED FOR:  
NEW BEDFORD PORT AUTHORITY

**ROUTINE INSPECTION REPORT UPDATE  
PORT OF NEW BEDFORD  
POPE'S ISLAND MARINA**

JULY 2020

**ROUTINE INSPECTION REPORT UPDATE  
POPE'S ISLAND MARINA  
NEW BEDFORD, MASSACHUSETTS**

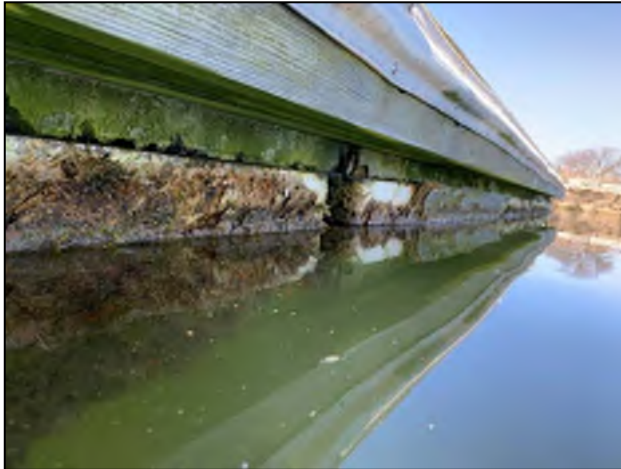
*Deterioration of the concrete modules along the waterline.*

The concrete overlay on the float modules was observed to be significantly deteriorated, soft, and missing in numerous locations along the waterline. The weakening of the concrete leads to an overall reduction in strength, which causes listing of the floats and increased deflection and articulation under wave loads, which further exacerbates the weakened condition. The exact number of deteriorated float modules has not been determined to date; this will require additional underwater inspection. However, inspection of the sides of the modules indicate that the majority of the modules are compromised. The underwater inspection noted that many of the float modules were exposed and extremely fouled with marine growth throughout the marina.

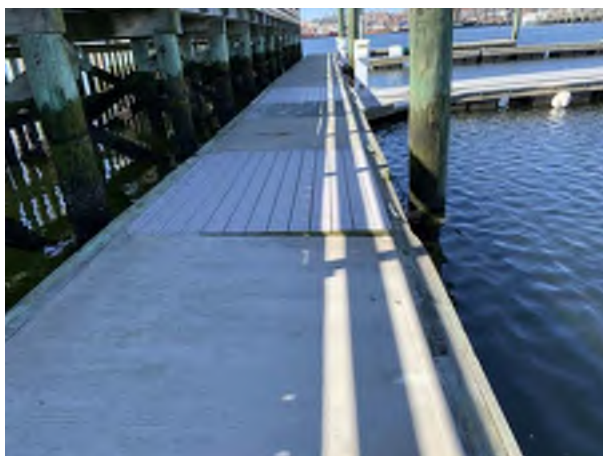
*Main float modules replaced with timber/composite floats with tripping hazard*

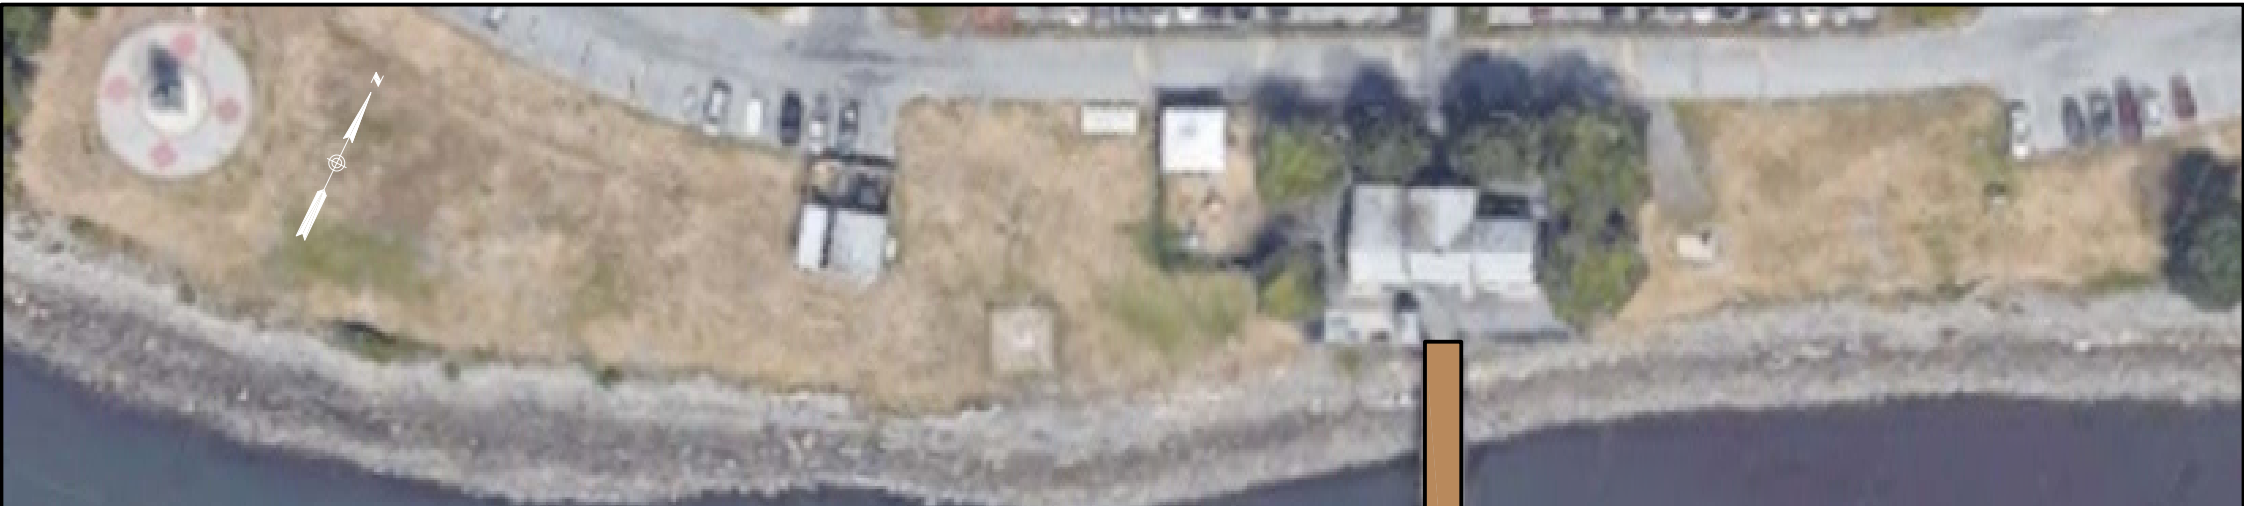
DRAWING NO.:  
**4.0**  
SHEET NO.: 4 OF 4

**E-DOCK &  
F-DOCK PLAN**

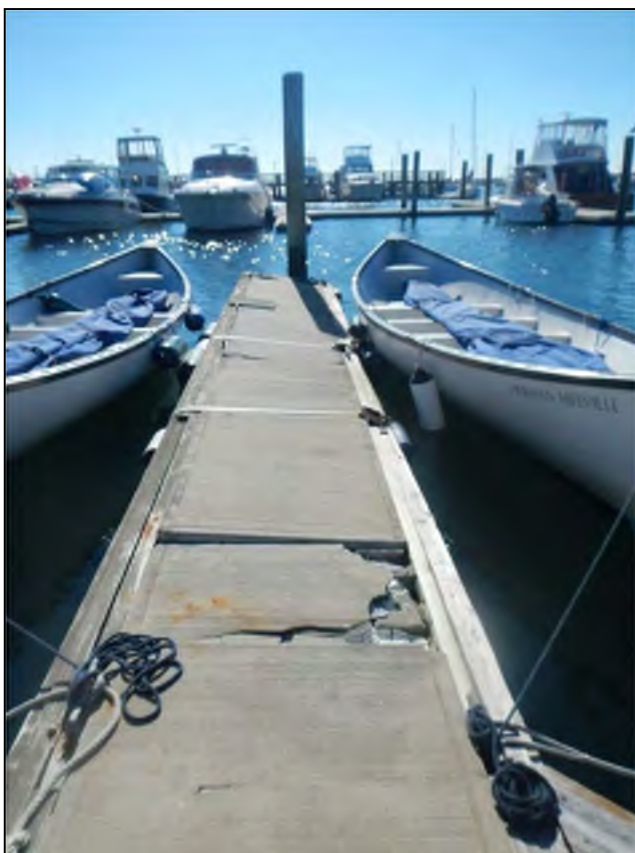
Photo No. 9: Listed finger float with displaced concrete panel creating a trip hazard.

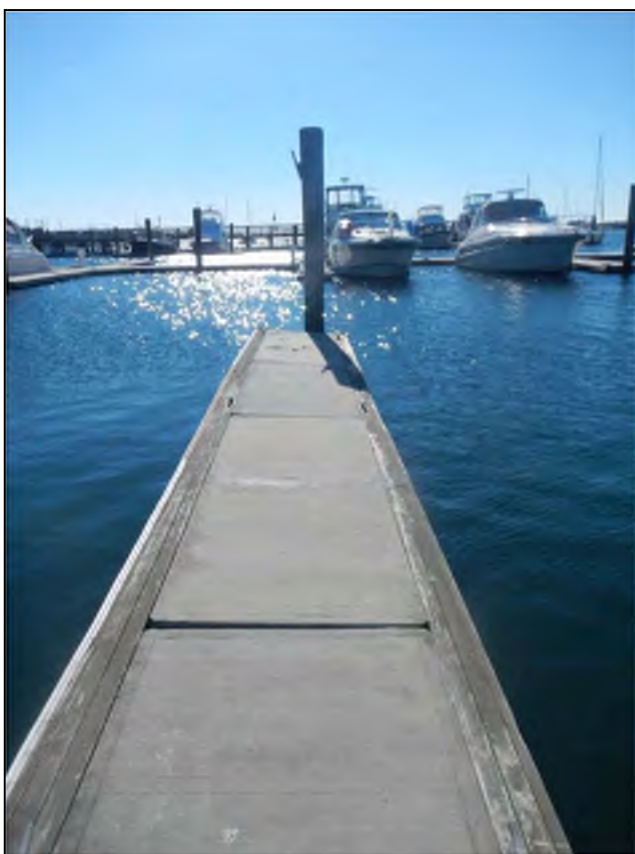
Photo No. 10: Typical view of displaced concrete panels with trip hazards.

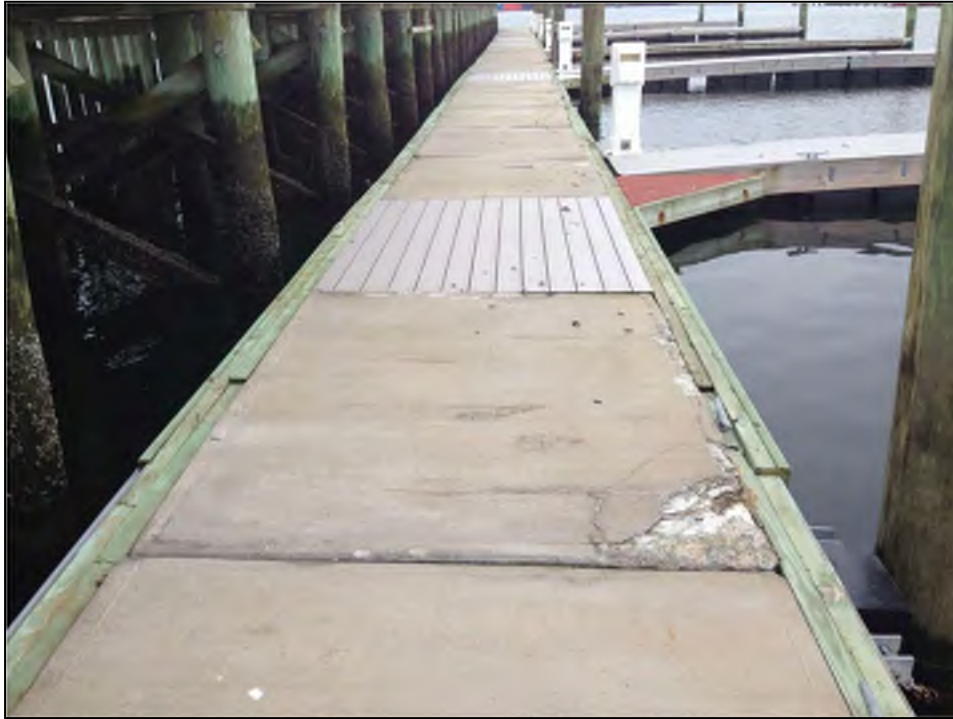
Photo No. 27: Composite decking replacing a concrete deck panel.

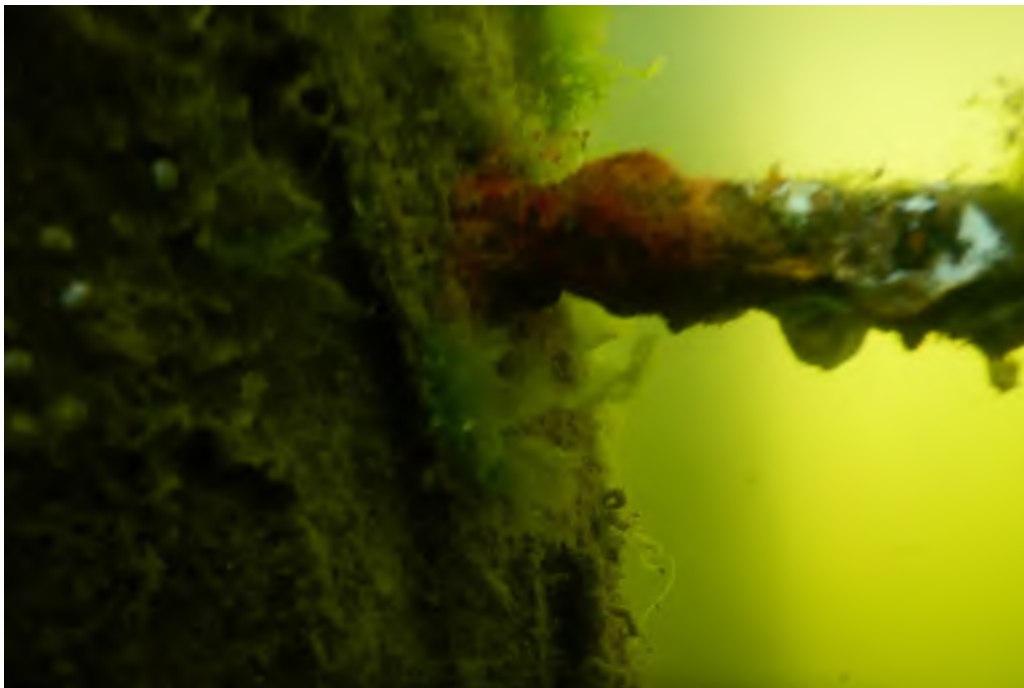
PHOTO #1, This is a typical fastener at low water holding a cross brace.

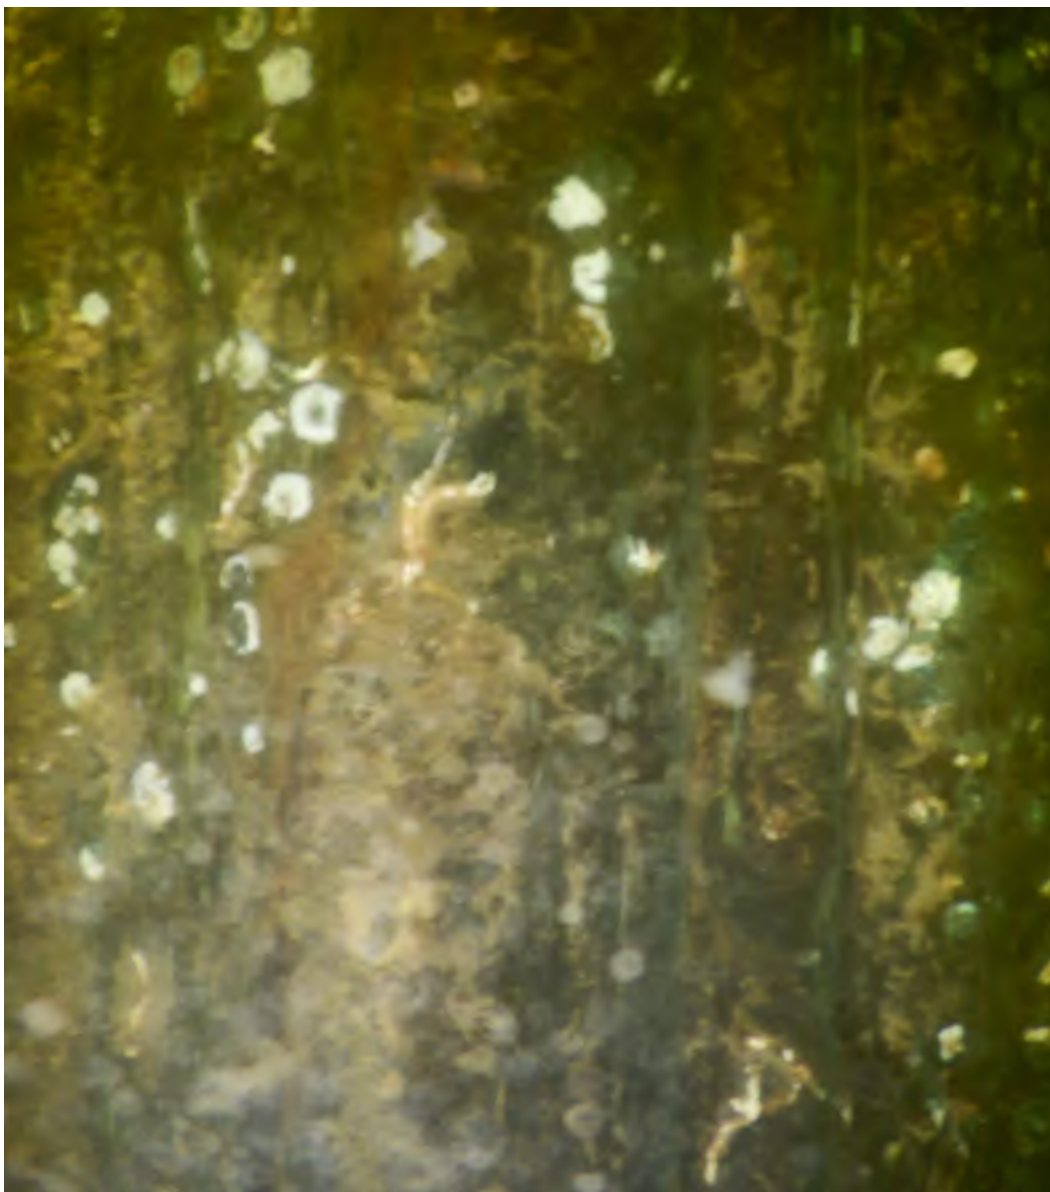
PHOTO #4, Typical pile in the West section. Piles were relatively smooth with some barnacle scars. The vertical scrapes in the picture are from the cleaning tool, the green wood treatment can be seen.

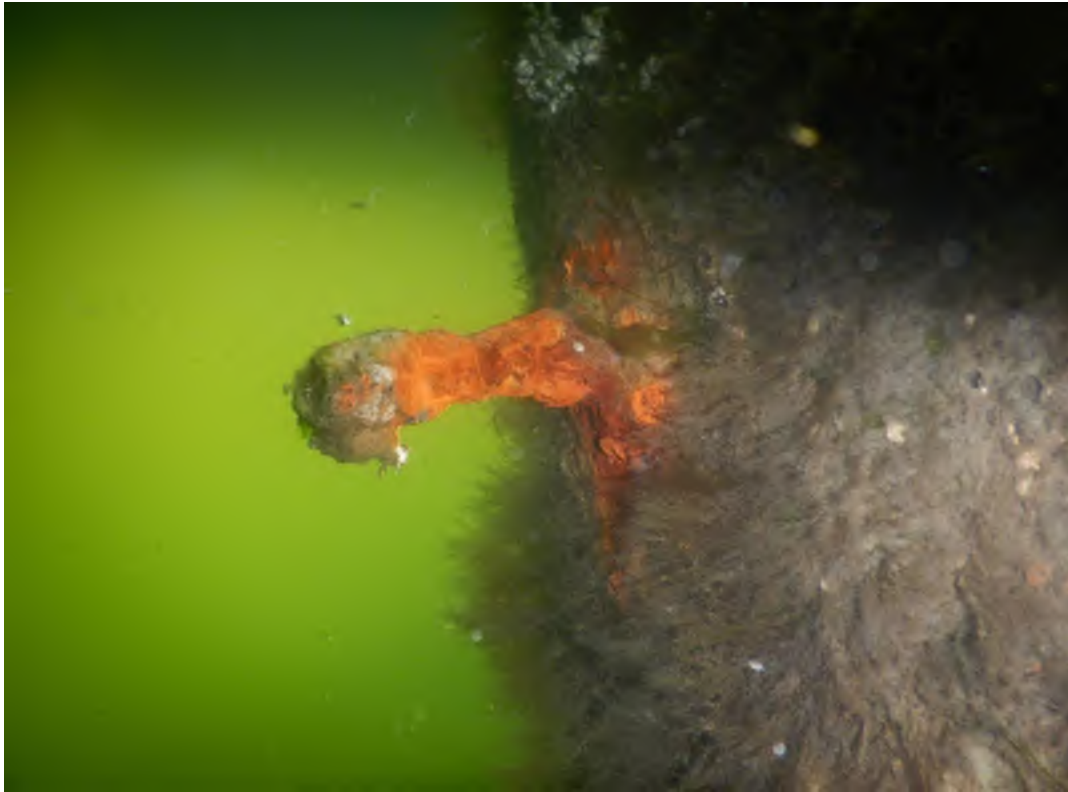
PHOTO #8, typical X brace fastener at low water.

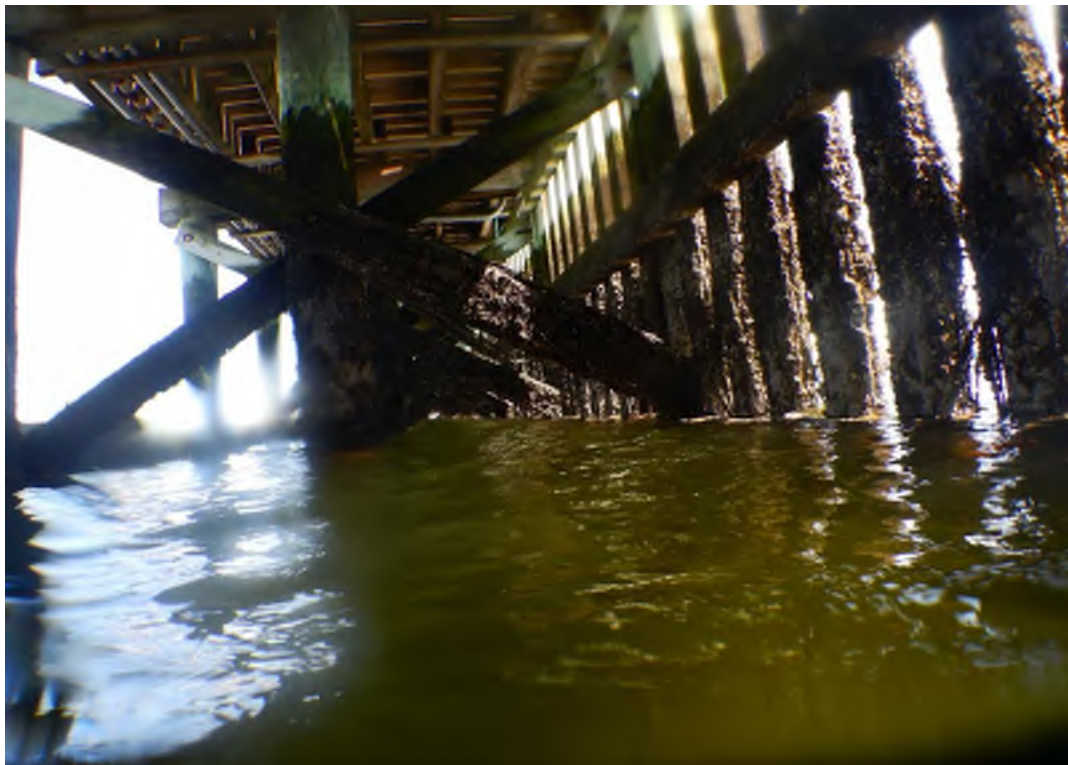
PHOTO #9, taken at low tide. Note the splintered braces at low water and splintered wave barrier blanks

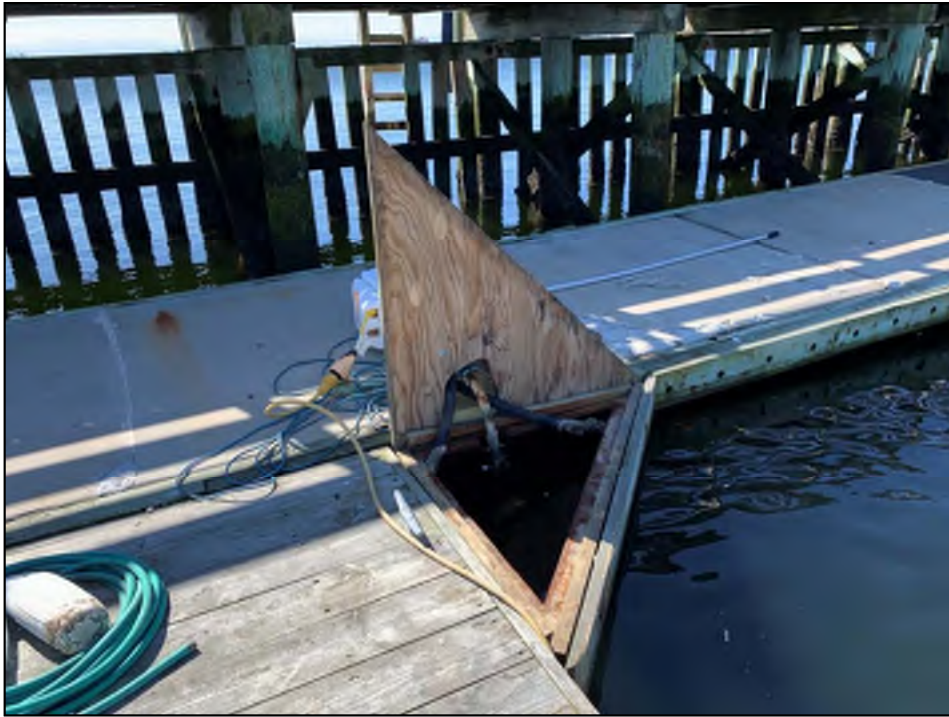
Photo No. 23: Disconnected timber triangle connection and overturned power pedestal.

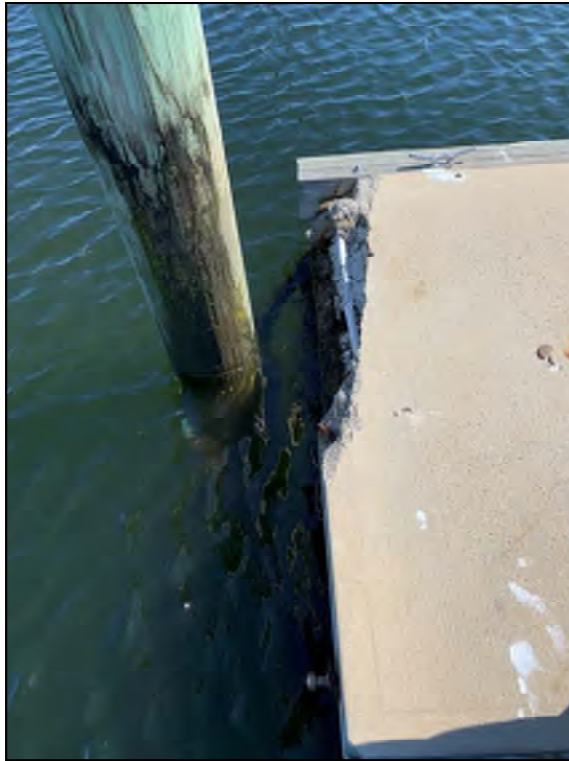
Photo No. 29: Concrete deterioration with exposed polystyrene float unit and steel reinforcement.

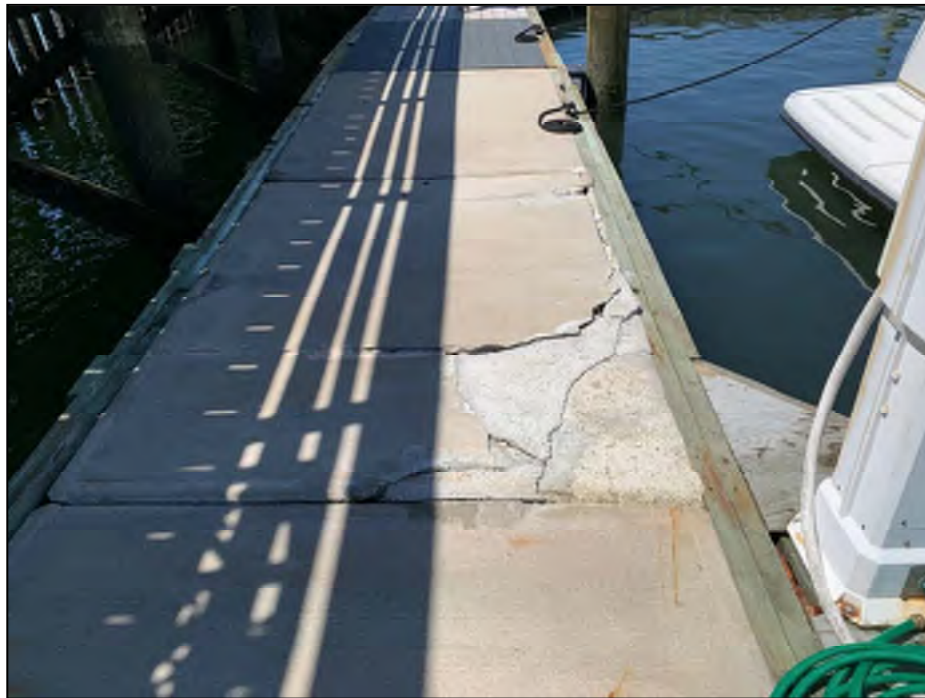
Photo No. 38: Deteriorated concrete main float along Dock D after storm with additional damage and trip hazard.

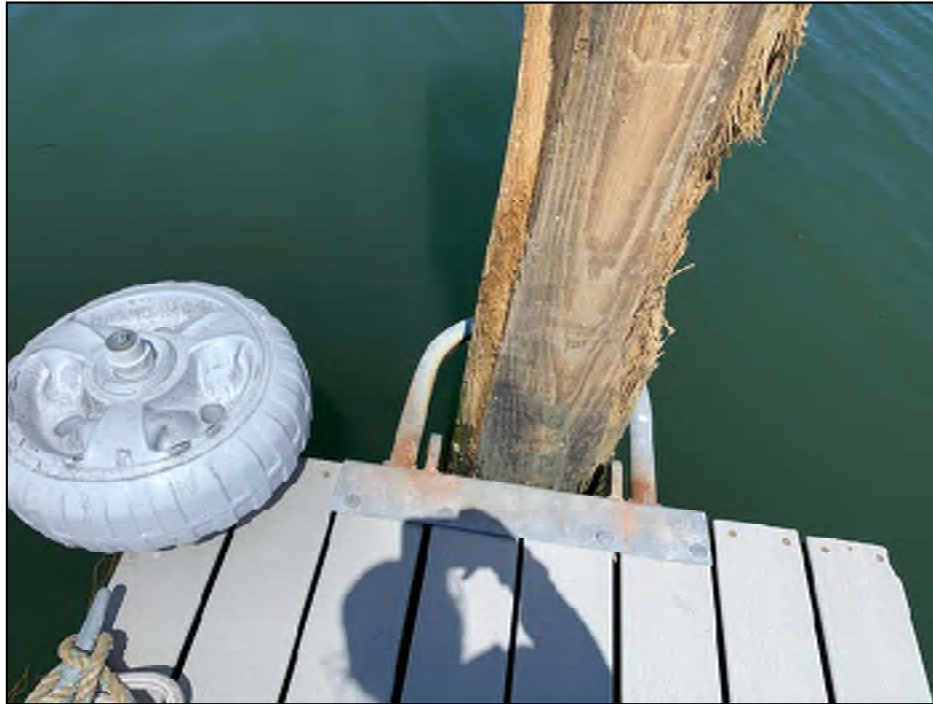
Photo No. 39: Timber pile damage from missing roller after storm.

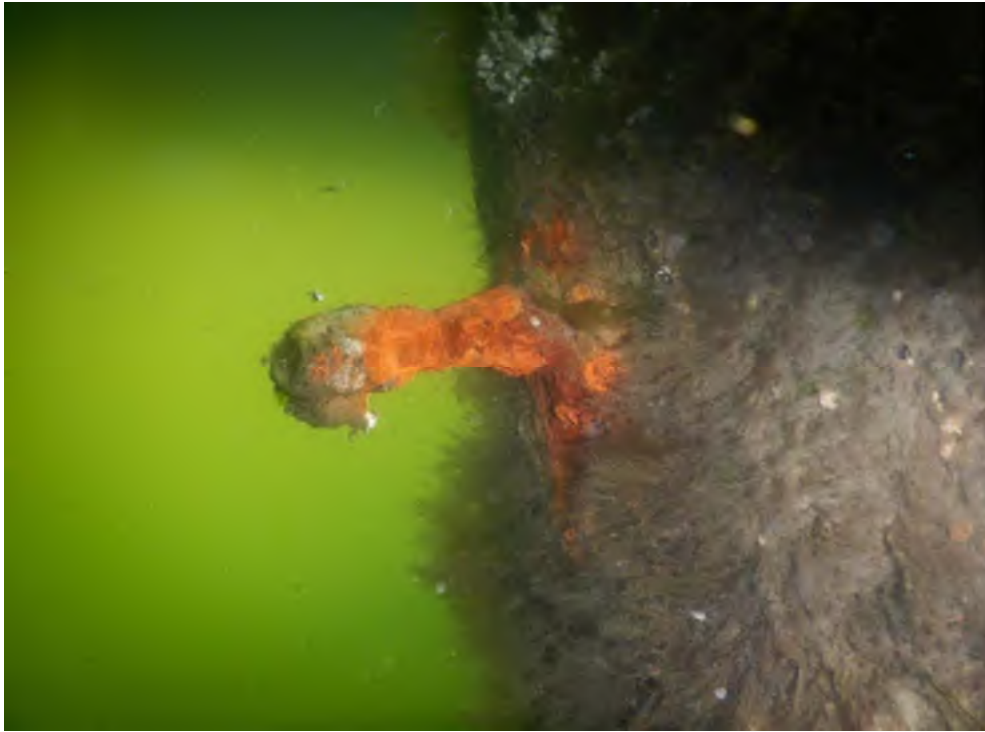
Photo No. 51: Bottom cross bracing hardware below water.
