PREPARED FOR:  
NEW BEDFORD PORT AUTHORITY

**ROUTINE INSPECTION REPORT UPDATE  
PORT OF NEW BEDFORD  
POPE'S ISLAND MARINA**

JULY 2020

**ROUTINE INSPECTION REPORT UPDATE  
POPE'S ISLAND MARINA  
NEW BEDFORD, MASSACHUSETTS**

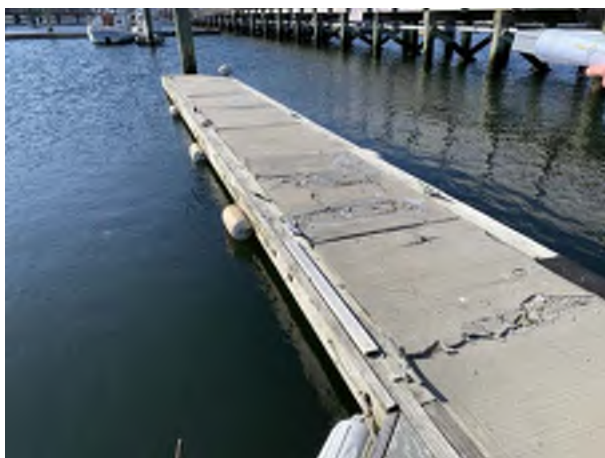
A-Dock is in overall poor condition. The concrete modules were observed to be deteriorated at the waterline. Nine (9) of the concrete finger floats and one (1) of the timber finger floats were observed to be listing.

*Deteriorated concrete finger float*

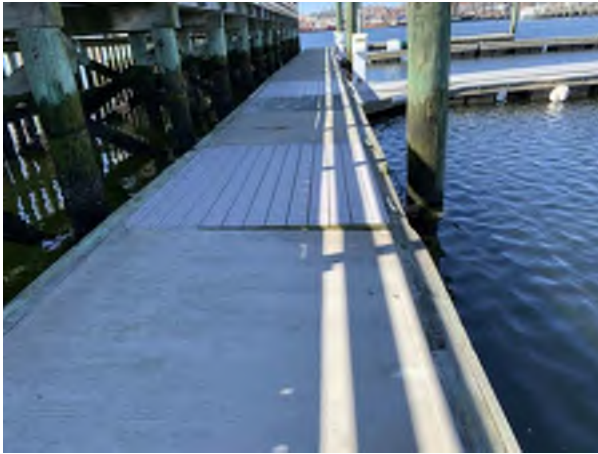
*Main float modules replaced with timber/composite floats with tripping hazard*

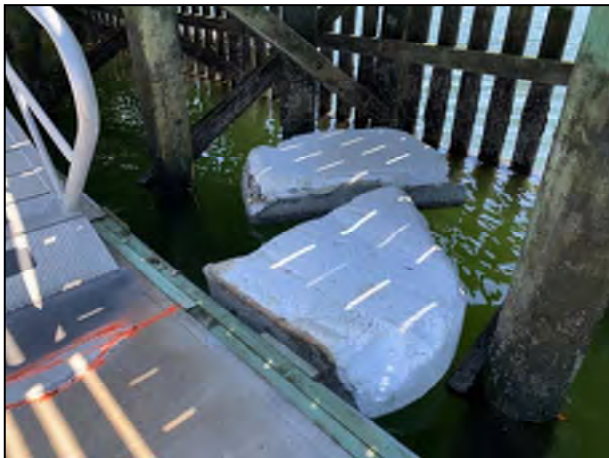
Pare visited the site on May 20, 2020 to observe damage to Dock D after a seasonal storm. The finger float for slip 137 appears to have become shifted, potentially from displaced polystyrene floatation units and several large pieces of polystyrene float modules have become dislodged from the concrete floats on Dock D, which appear to be from between slips 103/104 of the main floats. Several of the PVC rollers on the pile guides were observed to be cracked during the initial inspection, and Pare noted that after the storm several of the PVC rollers were missing, including at the finger floats for slips 108/109, 110/111, and 116/117, and along the main floats between slips 111-112.

*Displaced polystyrene float units after seasonal storm*

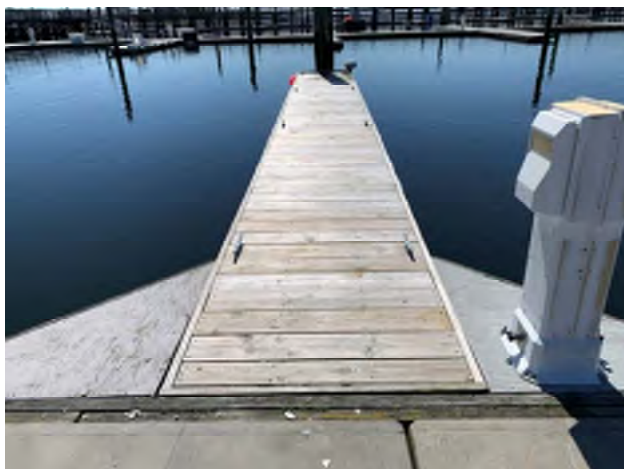
*Replacement timber finger float*

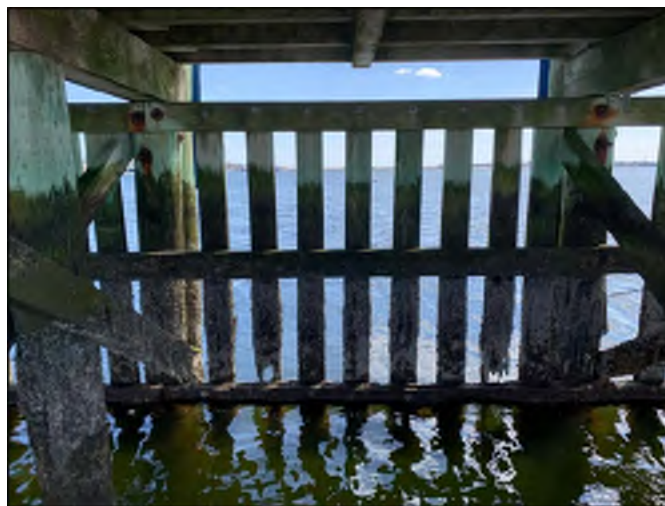
The timber wave fence is in poor to severe condition, with the majority of deterioration near mean low water. Deterioration of the bottom of the wave fence panels and severe corrosion of connection hardware was typical, and the lower wale was observed to be in critical condition or missing along the length.

*Timber wave fence along T-head of pier*

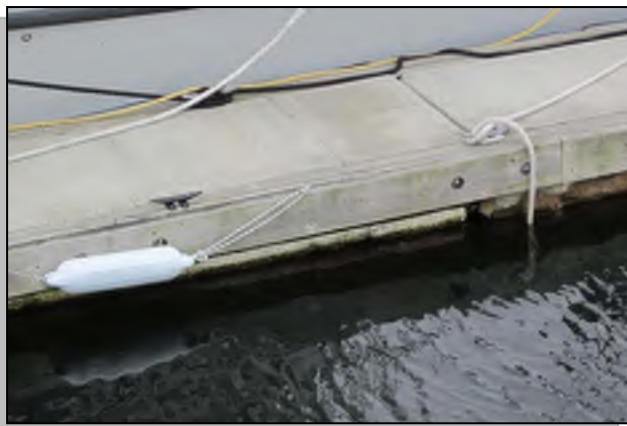
The concrete overlay on the float modules was observed to be significantly deteriorated, soft, and missing in numerous locations along the waterline. The weakening of the concrete leads to listing of the floats and overall reduction in strength. The reduction in strength leads to increased deflection

and articulation under wave loads, which further exacerbates the weakened condition. The exact number of deteriorated float modules has not been determined to date; this will require additional underwater inspection. However, inspection of the sides of the modules indicate that approximately 50% of the modules are compromised.

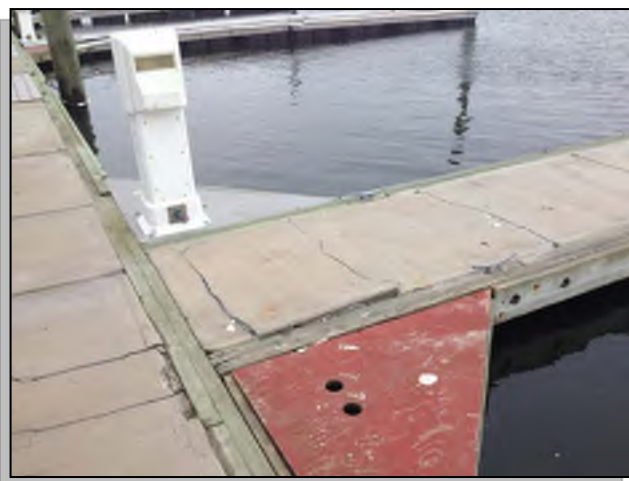
*Cracking and displacement of the concrete modules.*

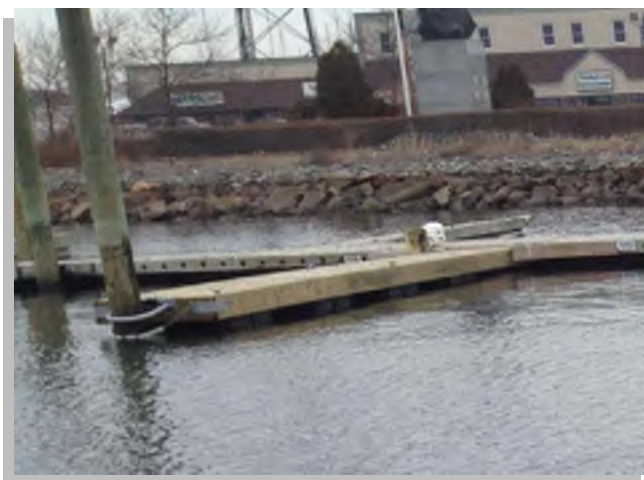
*New timber replacement float.*

Finger float 173/174 has been replaced with a timber float with timber decking. This heavy duty float was recently constructed by the HDC and Marina personnel.

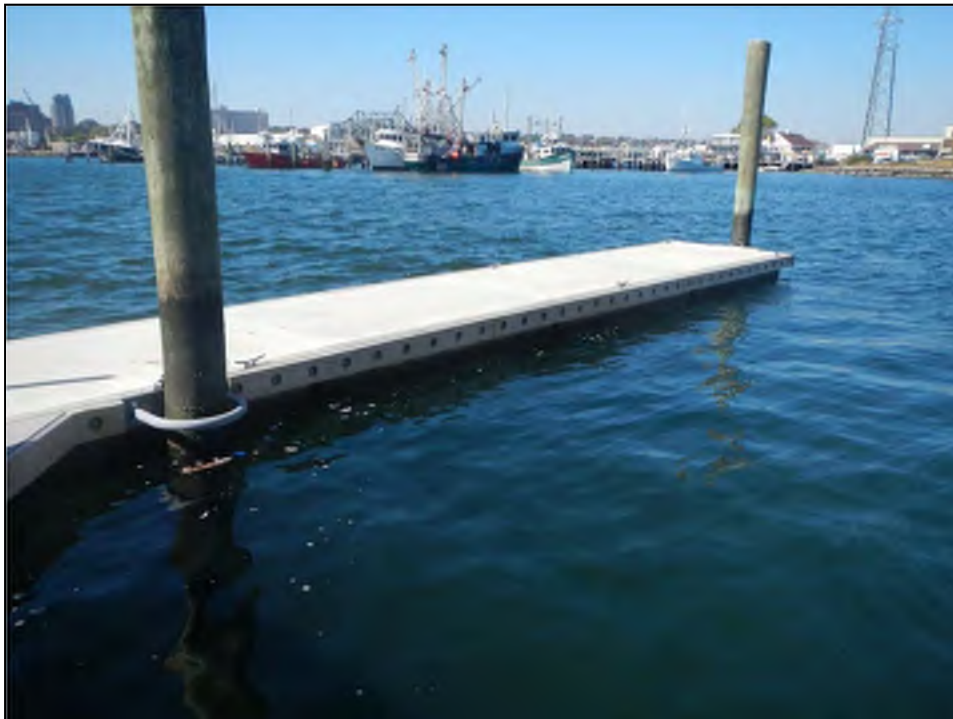
Photo No. 4: New concrete float at the end of F-dock.

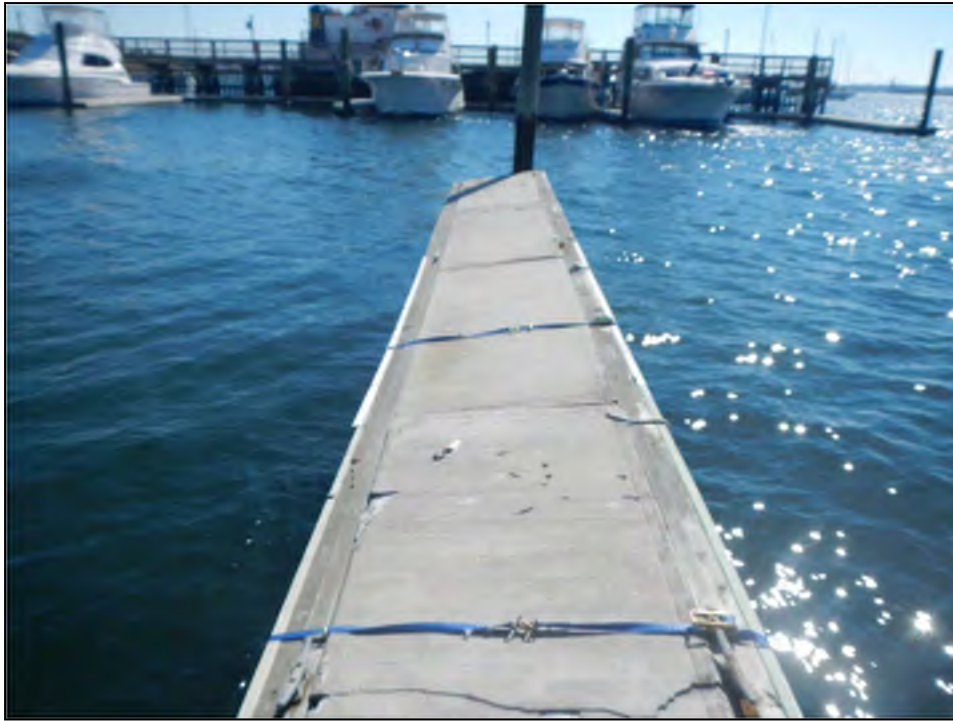
Photo No. 5: Listed concrete float along E-dock.

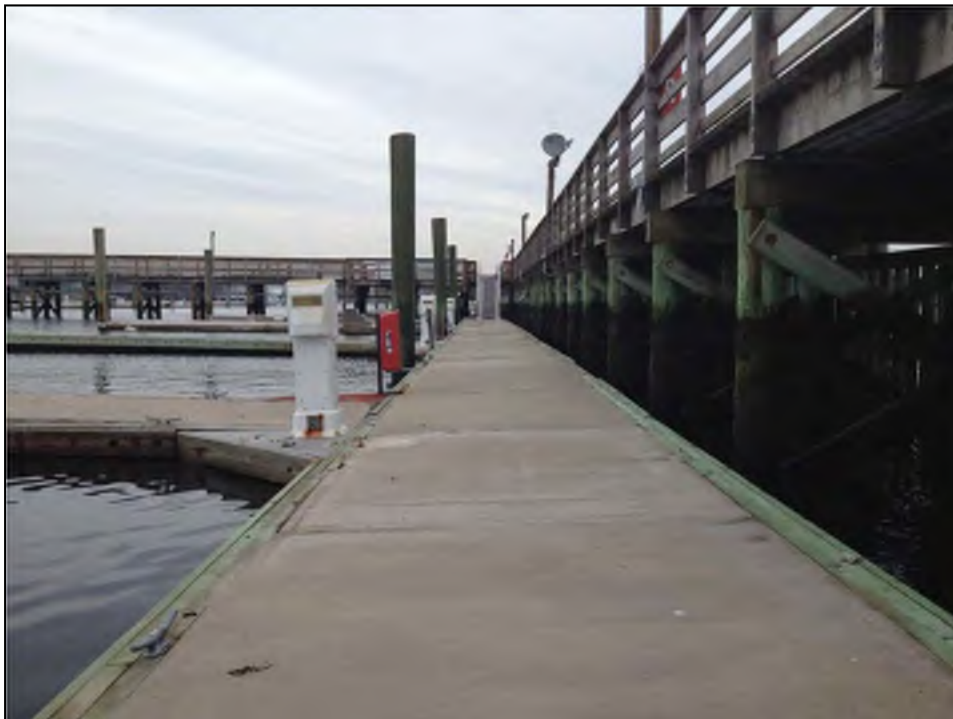
Photo No. 6: Listed concrete main floats along D-dock

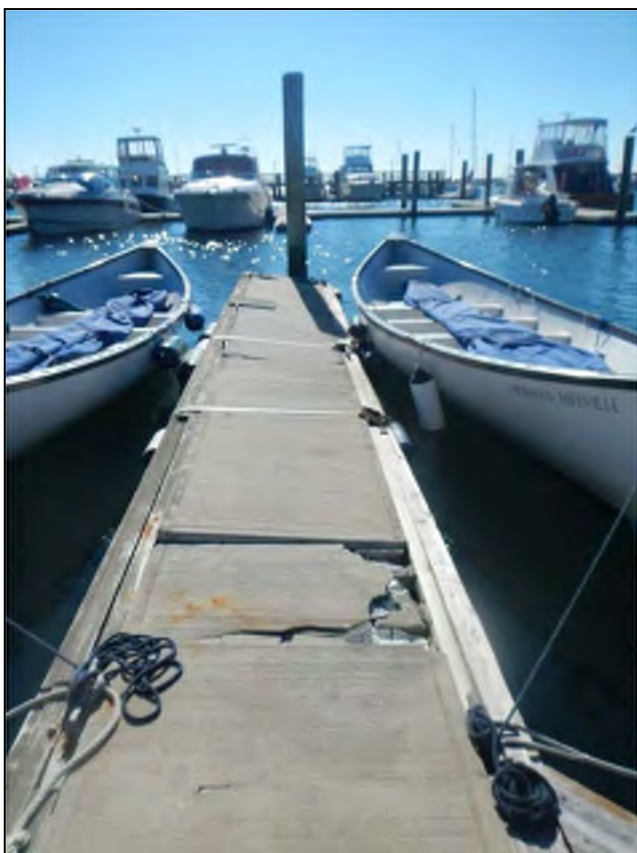
Photo No. 9: Listed finger float with displaced concrete panel creating a trip hazard.

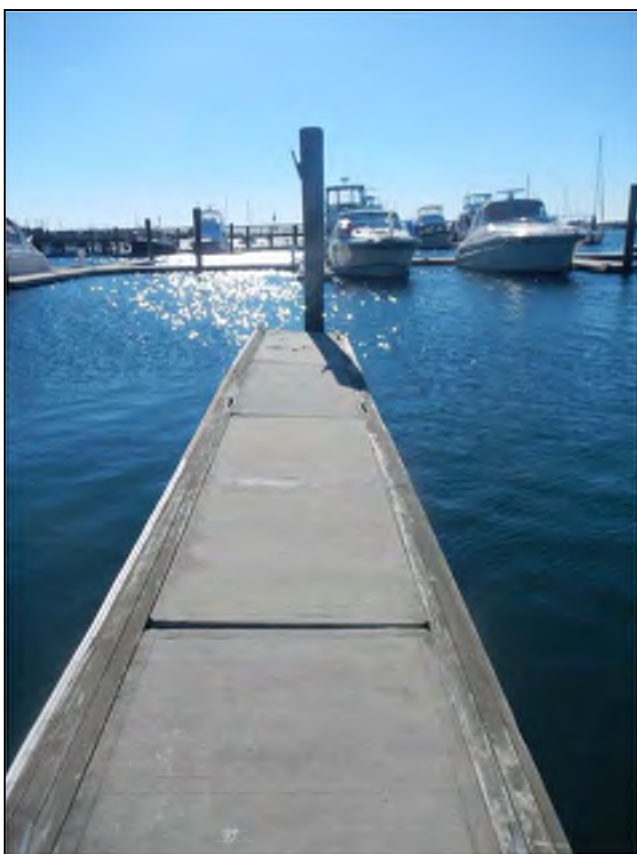
Photo No. 10: Typical view of displaced concrete panels with trip hazards.

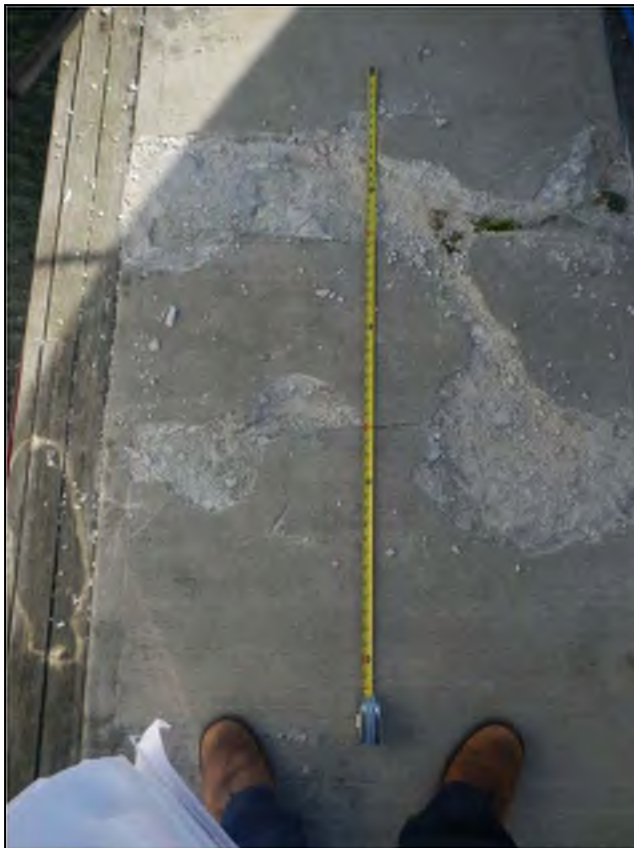
Photo No. 14: Typical concrete deck deterioration.

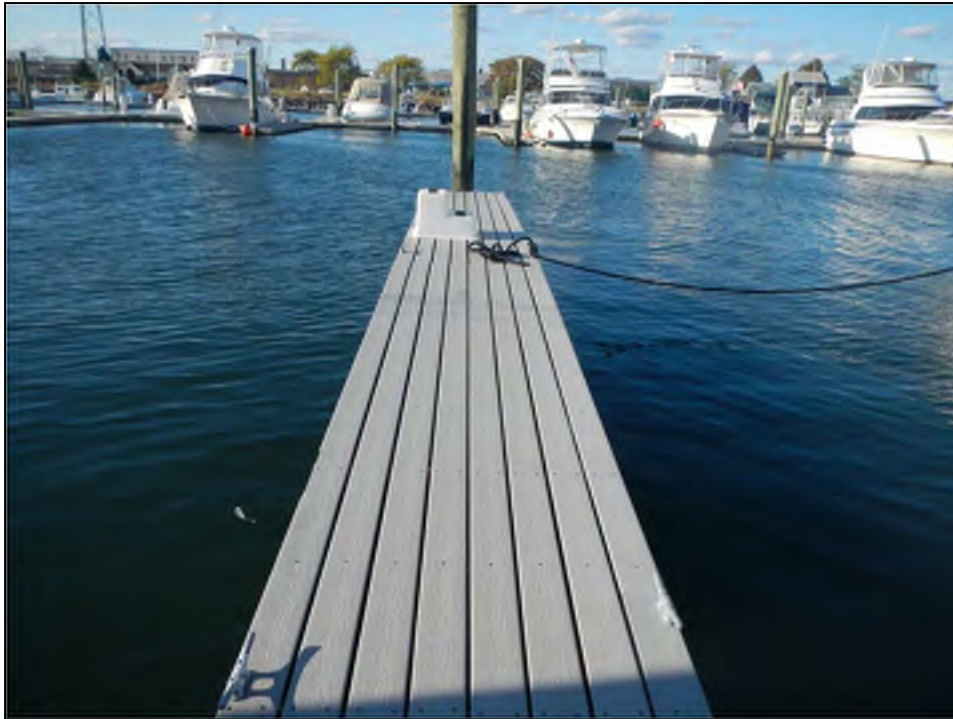
Photo No. 25: New timber float with composite decking.

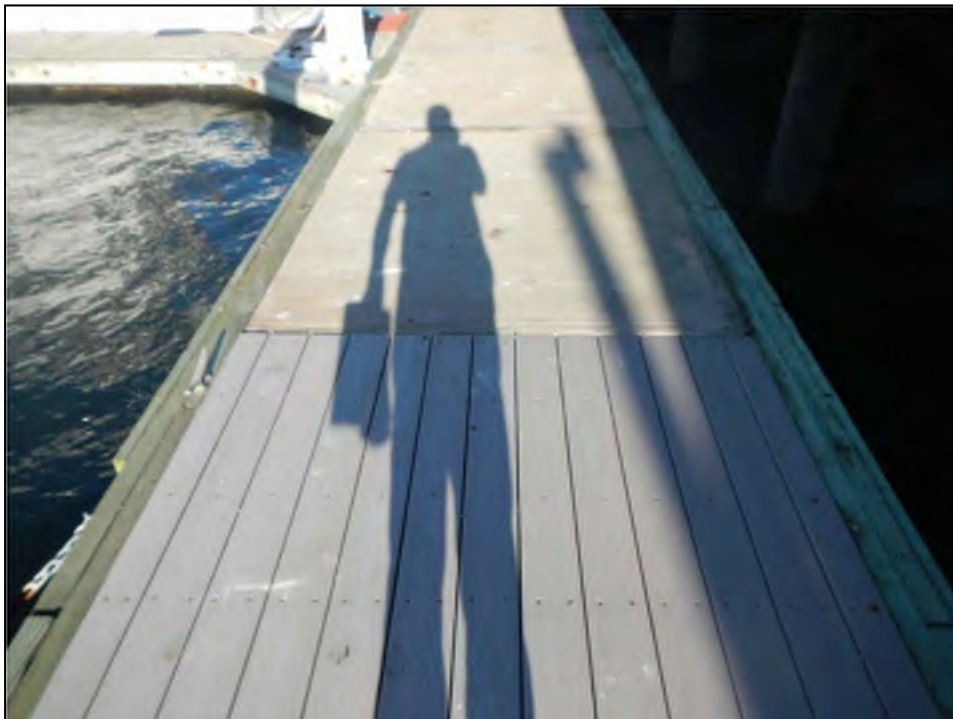
Photo No. 26: Composite decking replacing a concrete deck panel.

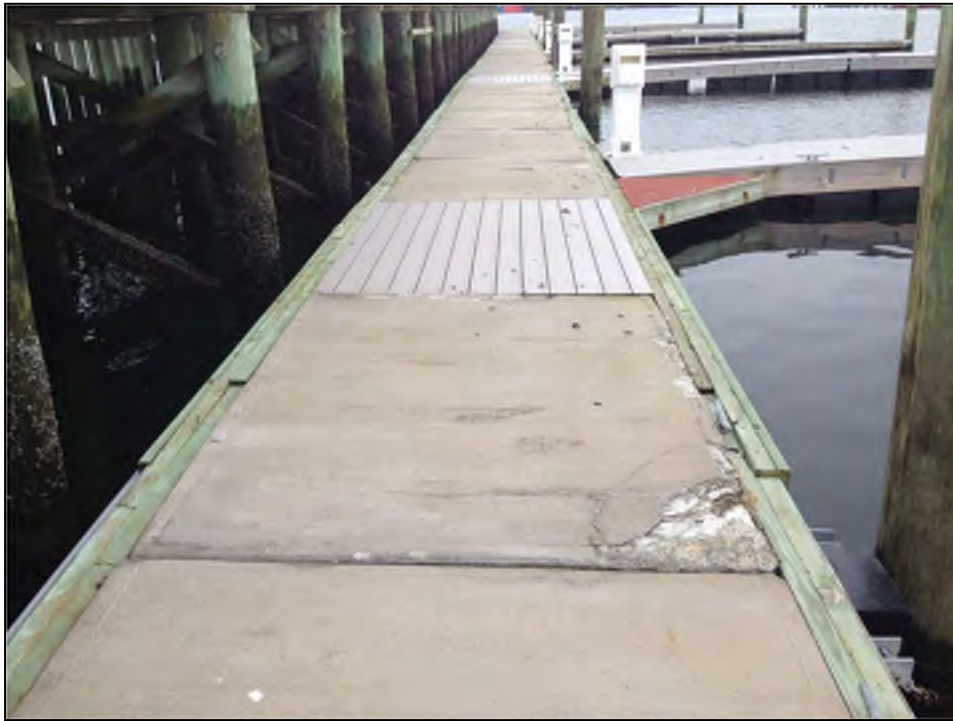
Photo No. 27: Composite decking replacing a concrete deck panel.

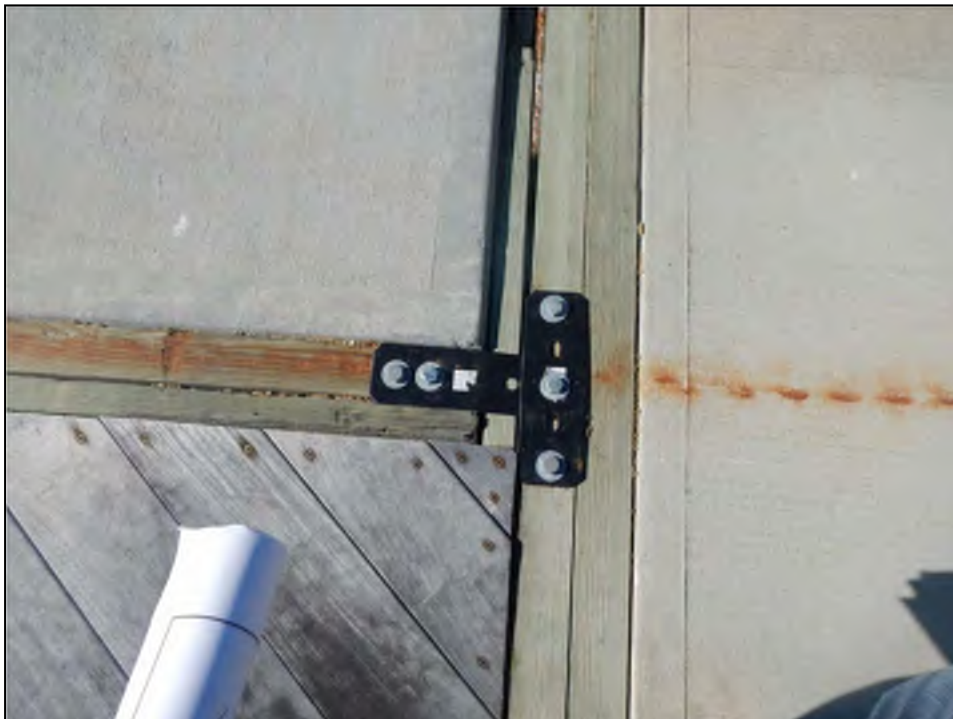
Photo No. 28: Steel plate float connection bolted to timber edge boards.

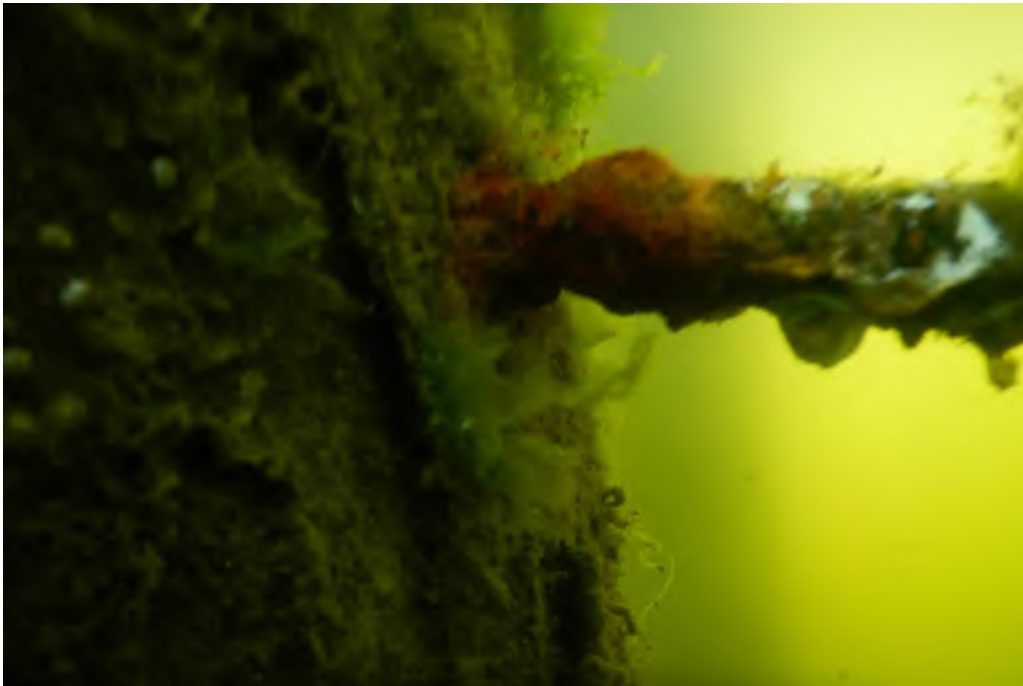
PHOTO #1, This is a typical fastener at low water holding a cross brace.

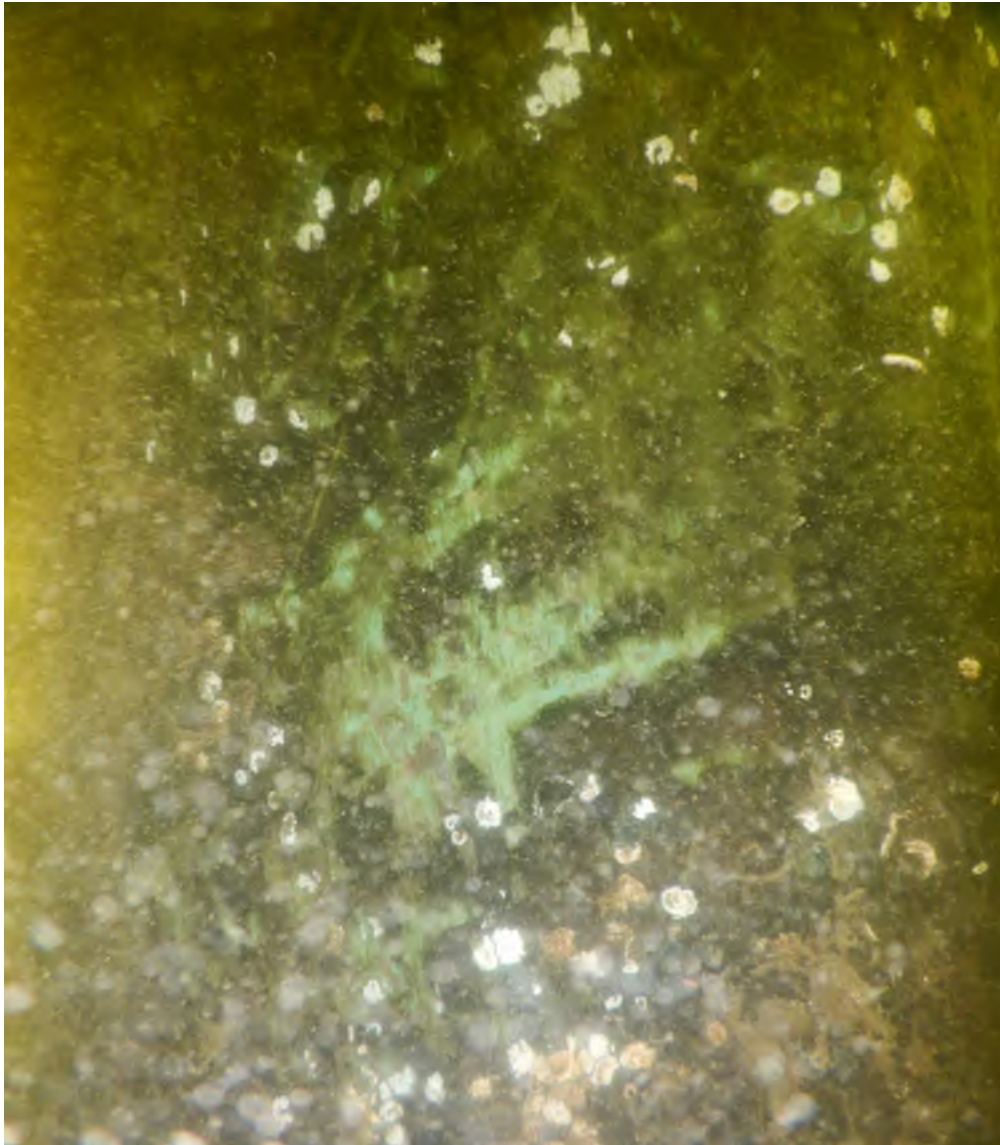
PHOTO #2, This is a photograph of a cleaned pile under the Main Pier. The pile was relatively smooth and undamaged, the green pile treatment can be seen, some barnacle scarring is present.

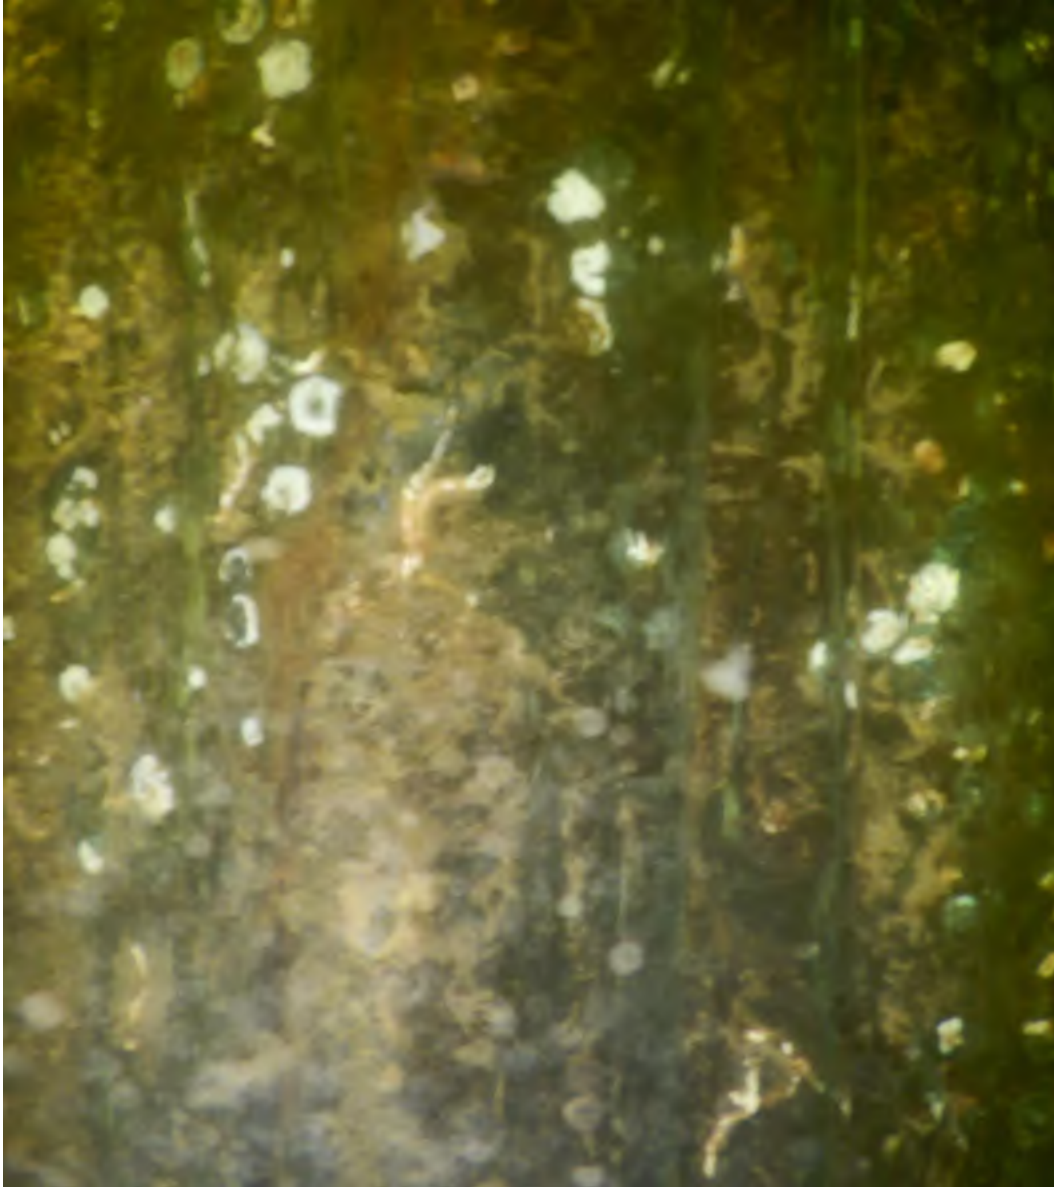
PHOTO #4, Typical pile in the West section. Piles were relatively smooth with some barnacle scars. The vertical scrapes in the picture are from the cleaning tool, the green wood treatment can be seen.

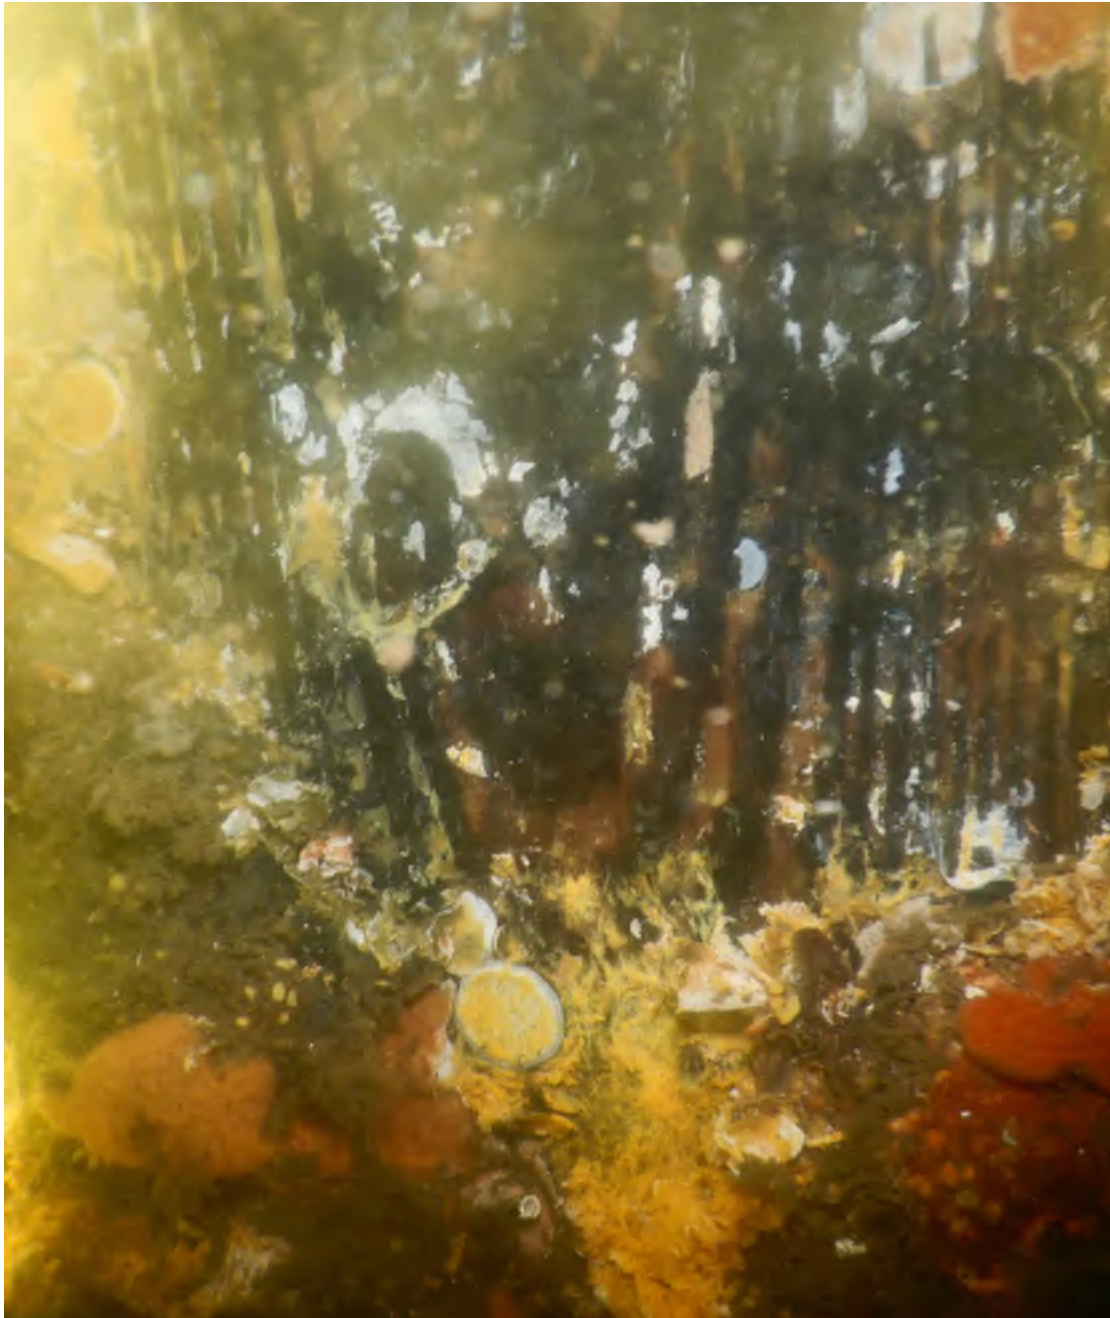
PHOTO #5, Another picture of a pile in the West section of the Marina, the camera gives a close-up view. The wood was hard and smooth to the touch, there is some superficial marine organism damage on the surface of the pile. The circular area mid photo is a "knot" in the wood, which was intact.

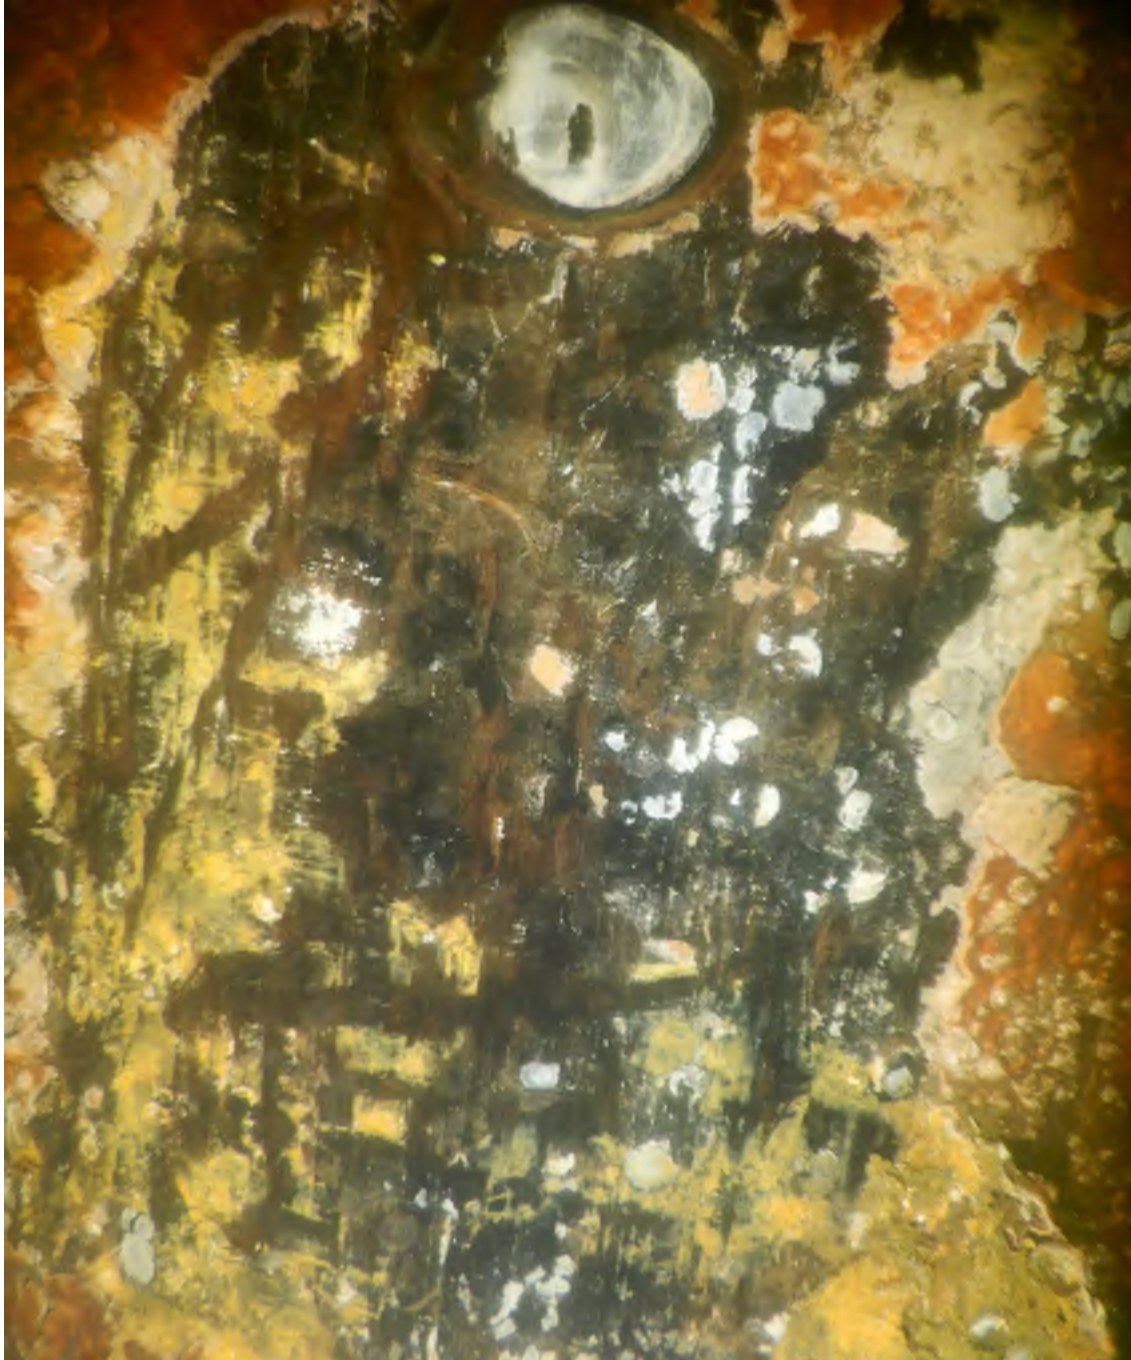
PHOTO #7, showing the surface of a random cleaned pile. The green CCA treatment can be seen, there are barnacle scars on the surface. The pile was hard to a hammer blow and smooth to the touch. The circular area top of photo is a knot in the wooden pile. The knot was not deteriorated and the wood sound. The different colored lines are from the scraping-cleaning process.

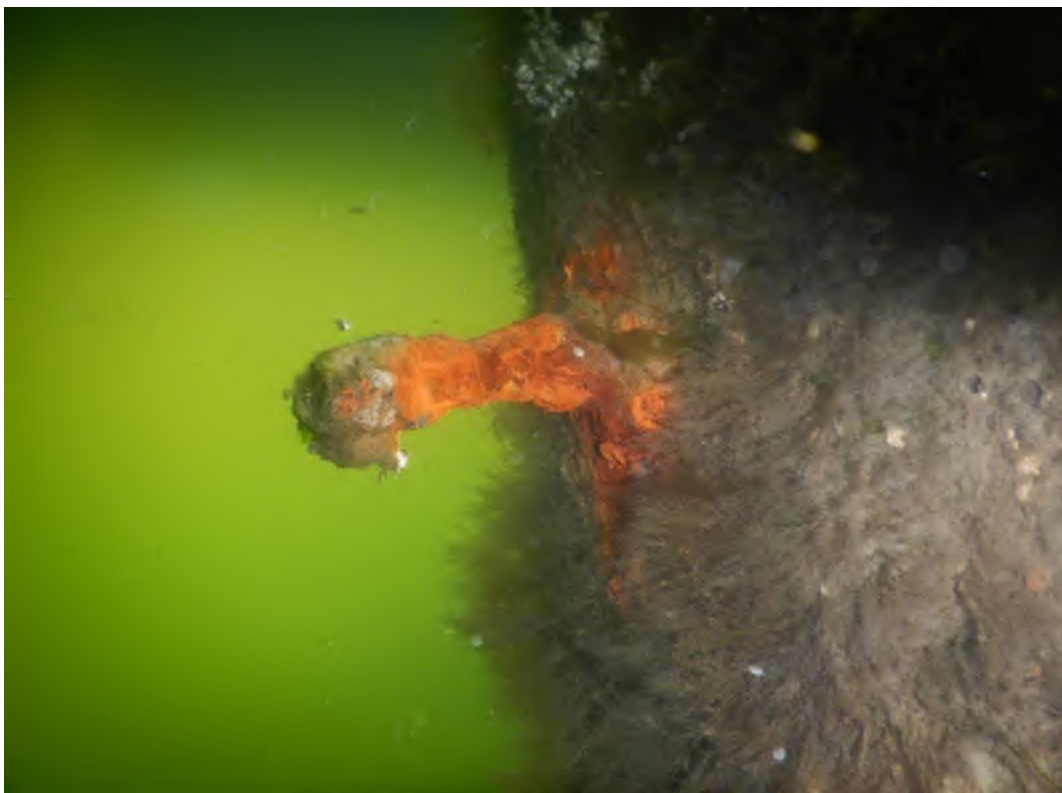
PHOTO #8, typical X brace fastener at low water.

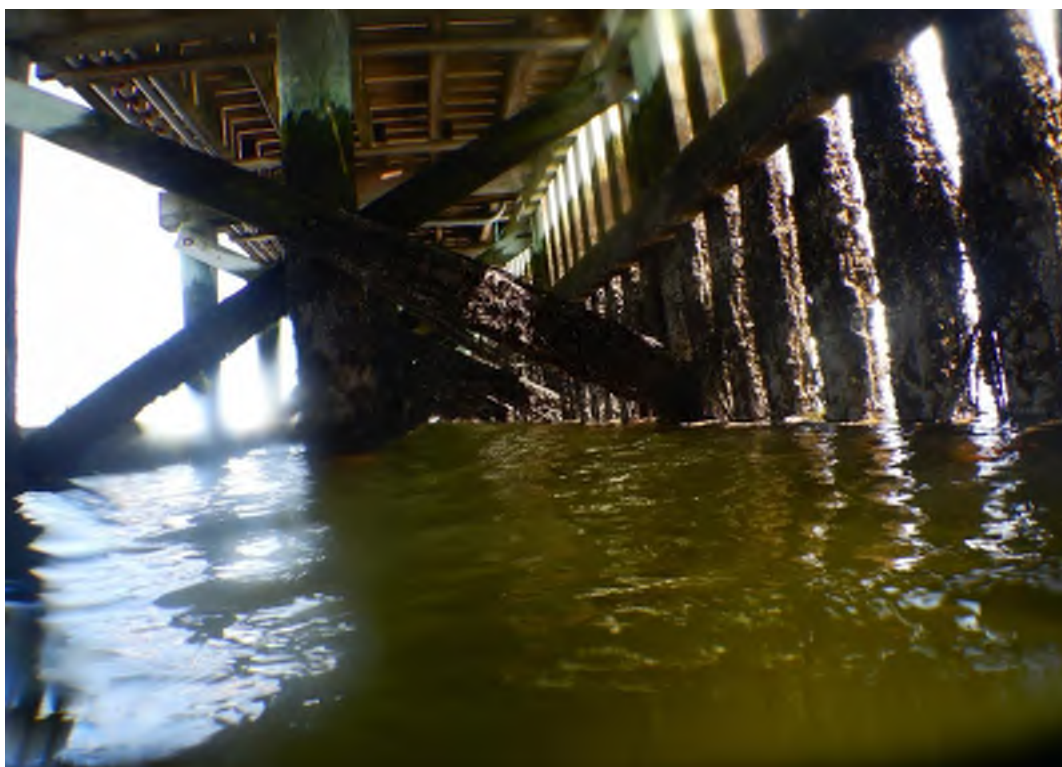
PHOTO #9, taken at low tide. Note the splintered braces at low water and splintered wave barrier blanks

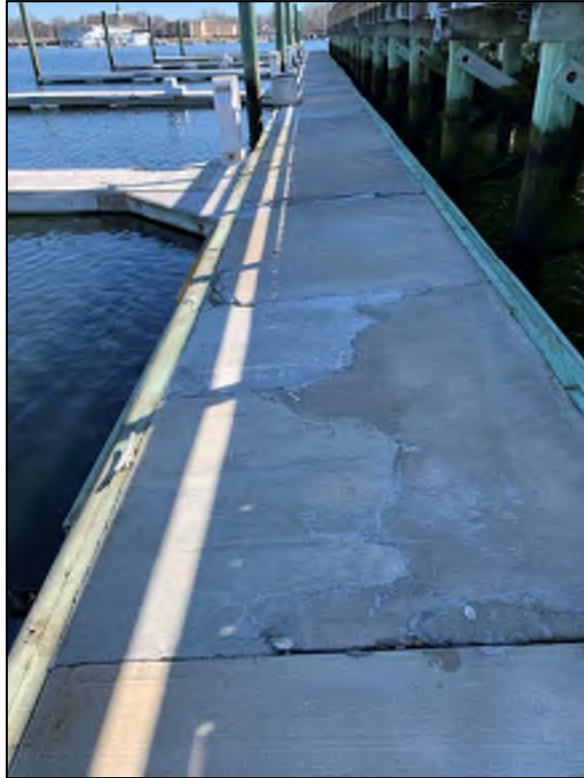
Photo No. 17: Previously repaired spalls with additional deterioration.

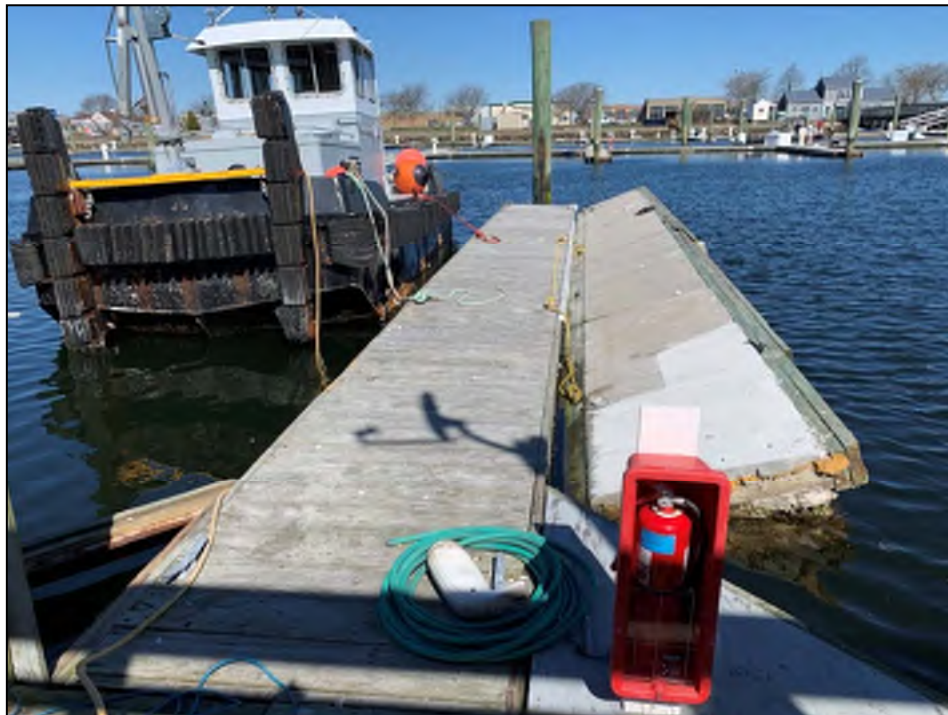
Photo No. 22: New timber finger float with abandoned concrete finger float at Dock D.

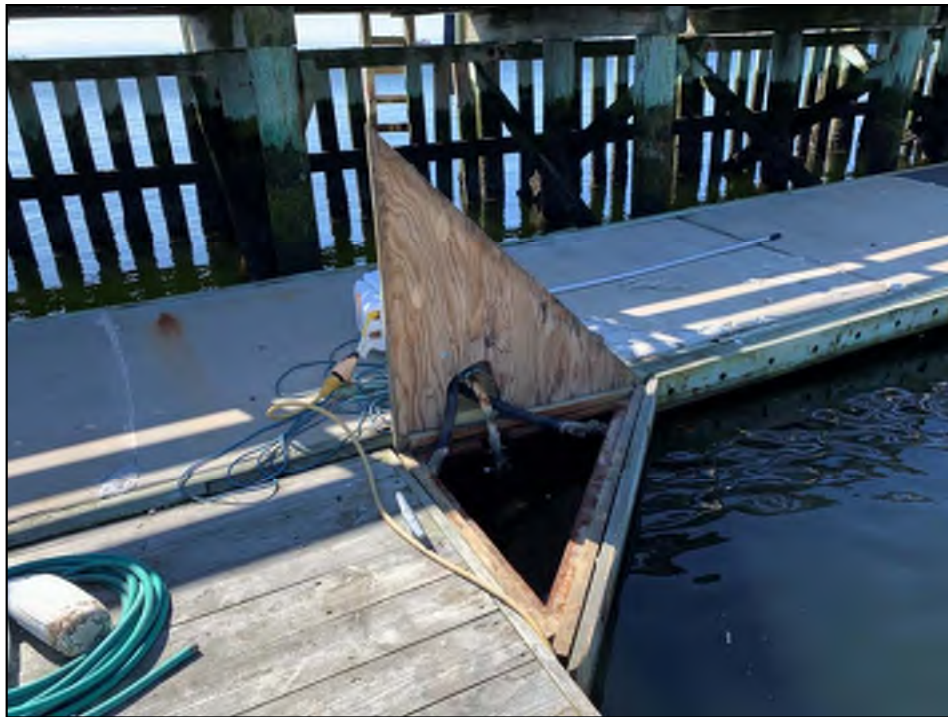
Photo No. 23: Disconnected timber triangle connection and overturned power pedestal.

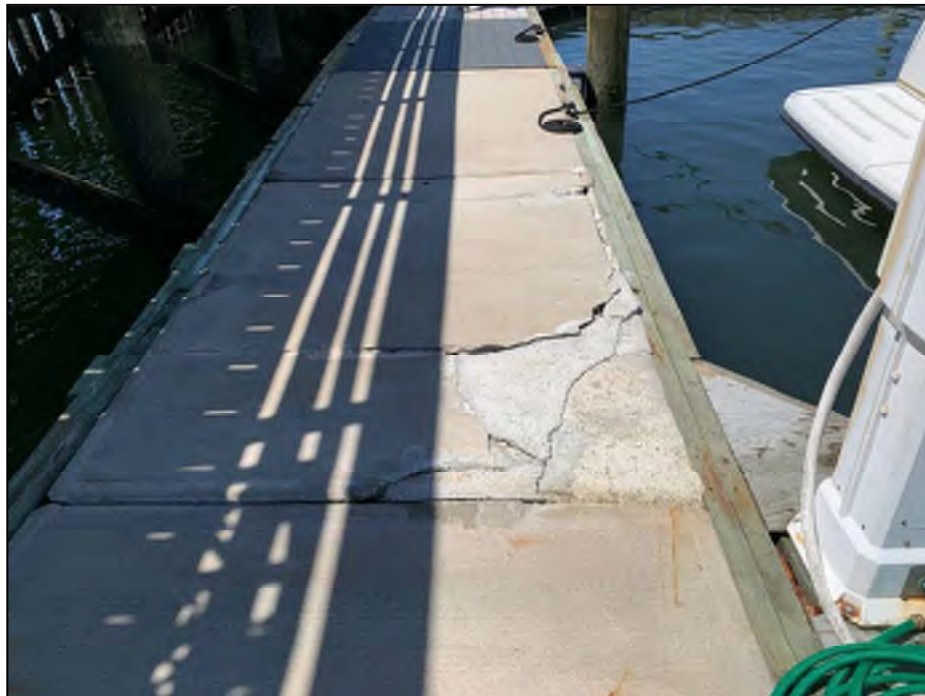
Photo No. 38: Deteriorated concrete main float along Dock D after storm with additional damage and trip hazard.

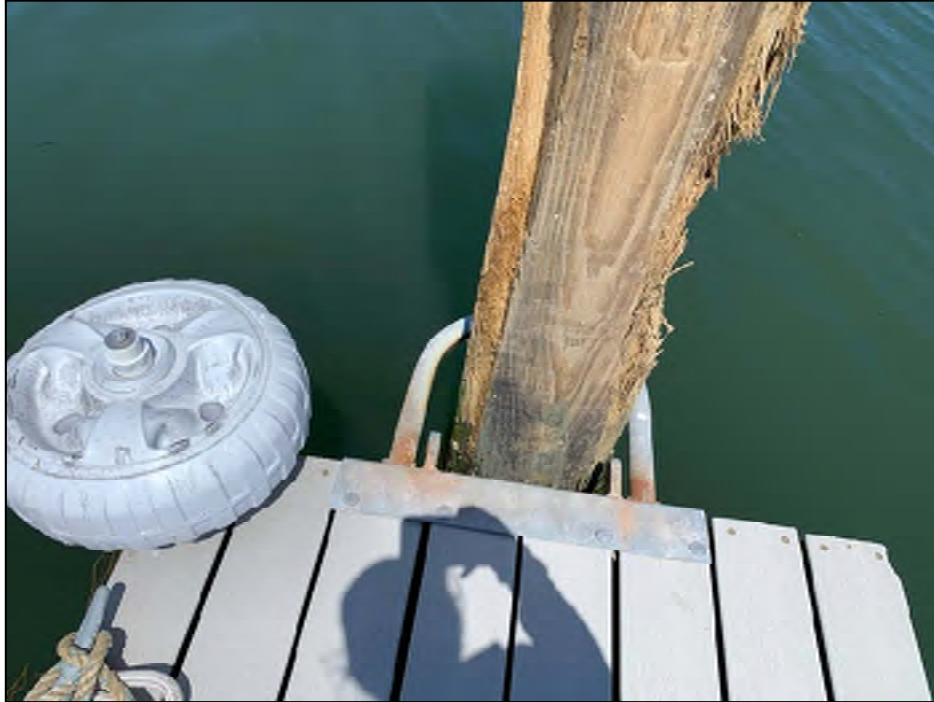
Photo No. 39: Timber pile damage from missing roller after storm.

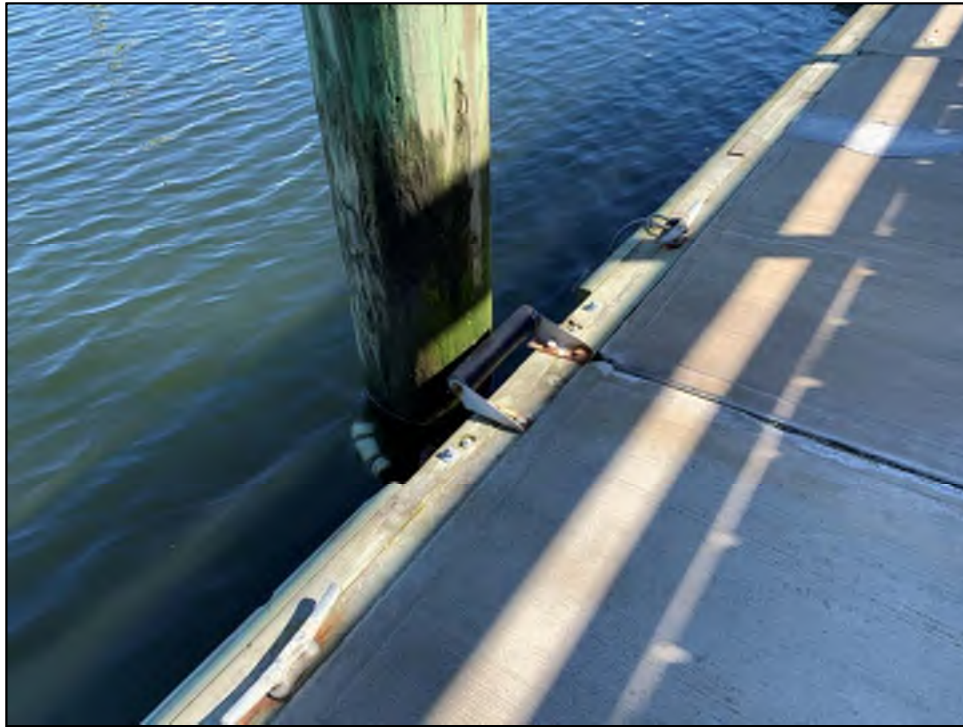
- Fifty (50) of the pile hoops have been replaced with galvanized chain guides and PVC pipe rollers. The galvanized chains may allow for more movement of the float system and lead to damage of the piles and should not be considered a long-term solution. the extent of deterioration of the chains was limited due to submersion in the water and significant marine growth. (Photos No. 8, 41)

Photo No. 41: Galvanized chain guide with PVC roller.

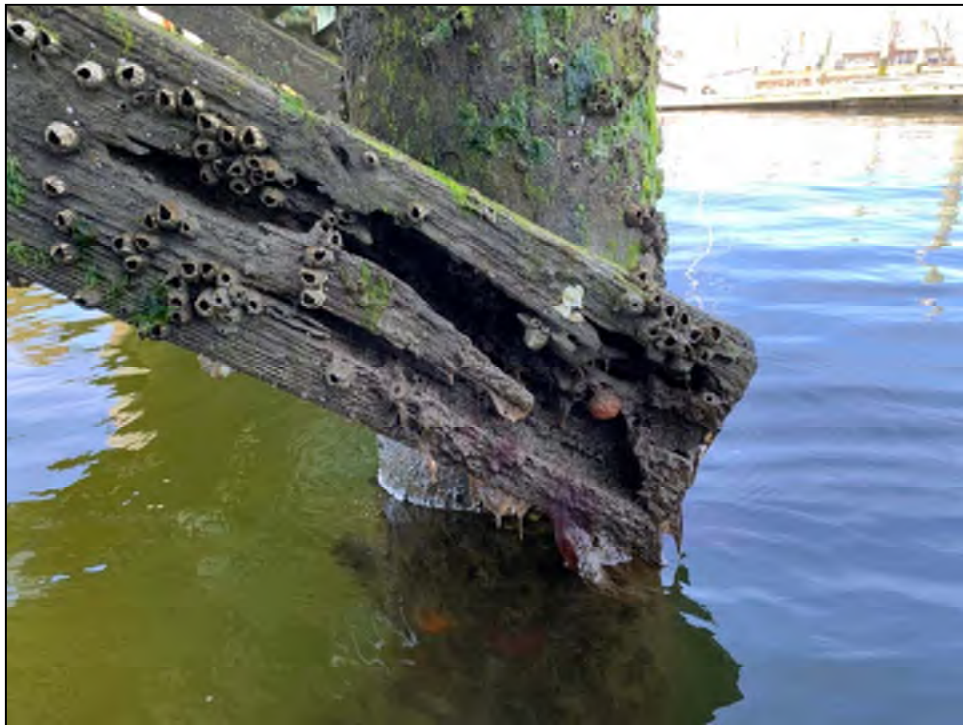
Photo No. 42: Timber cross bracing with up to 90% section loss typical along pile supported pier.

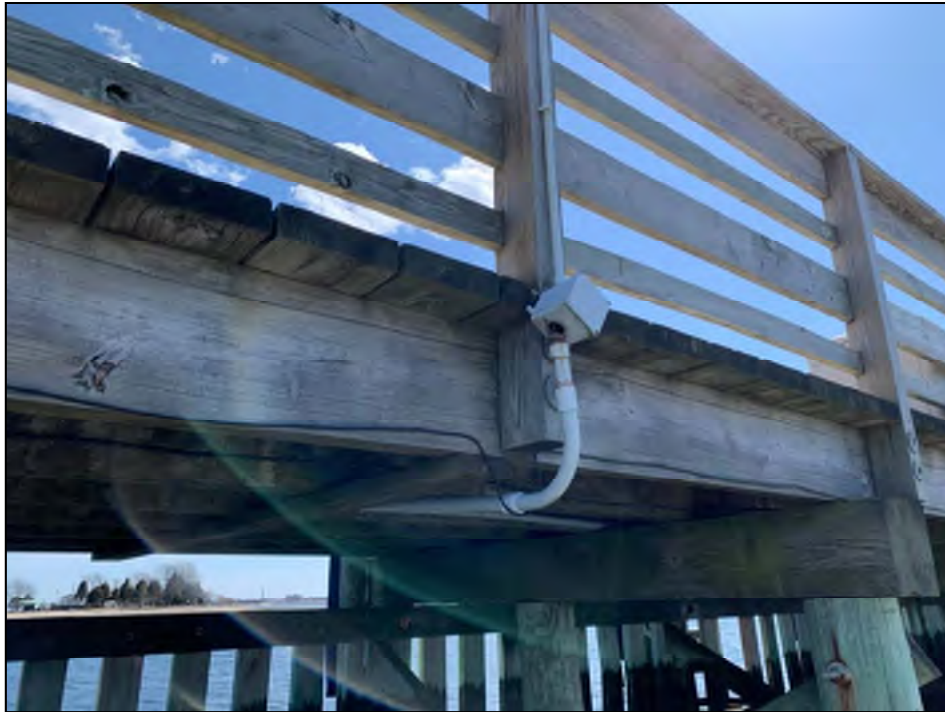
Photo No. 47: Dislocated conduit from light box at T-head.
