PREPARED FOR:  
NEW BEDFORD PORT AUTHORITY

**ROUTINE INSPECTION REPORT UPDATE  
PORT OF NEW BEDFORD  
POPE'S ISLAND MARINA**

JULY 2020

**ROUTINE INSPECTION REPORT UPDATE  
POPE'S ISLAND MARINA  
NEW BEDFORD, MASSACHUSETTS**

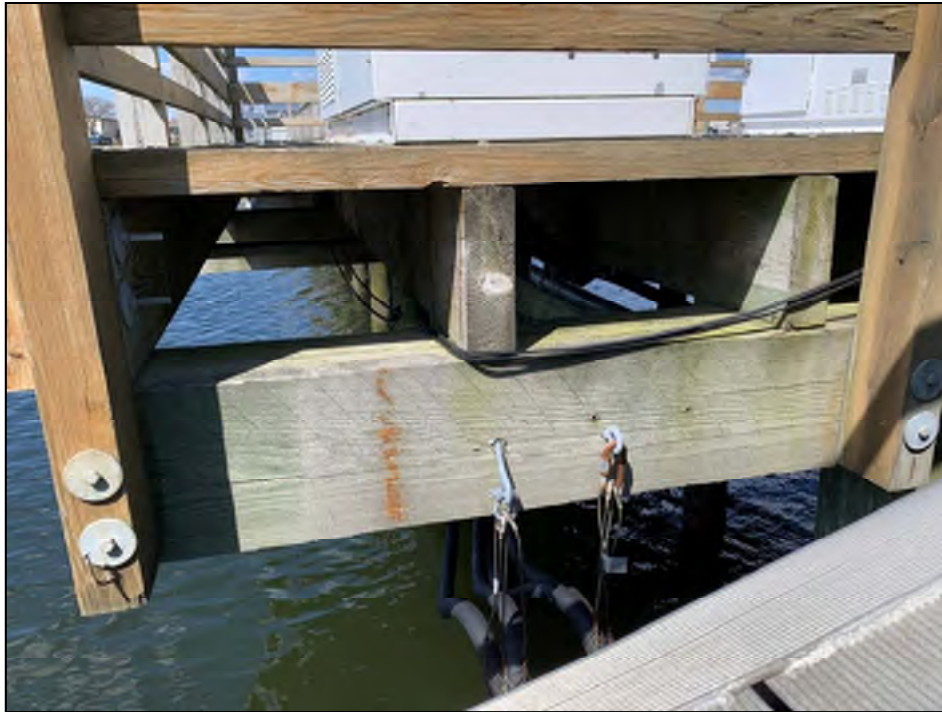
Photo No. 49: Timber framing along main pier bumpout.

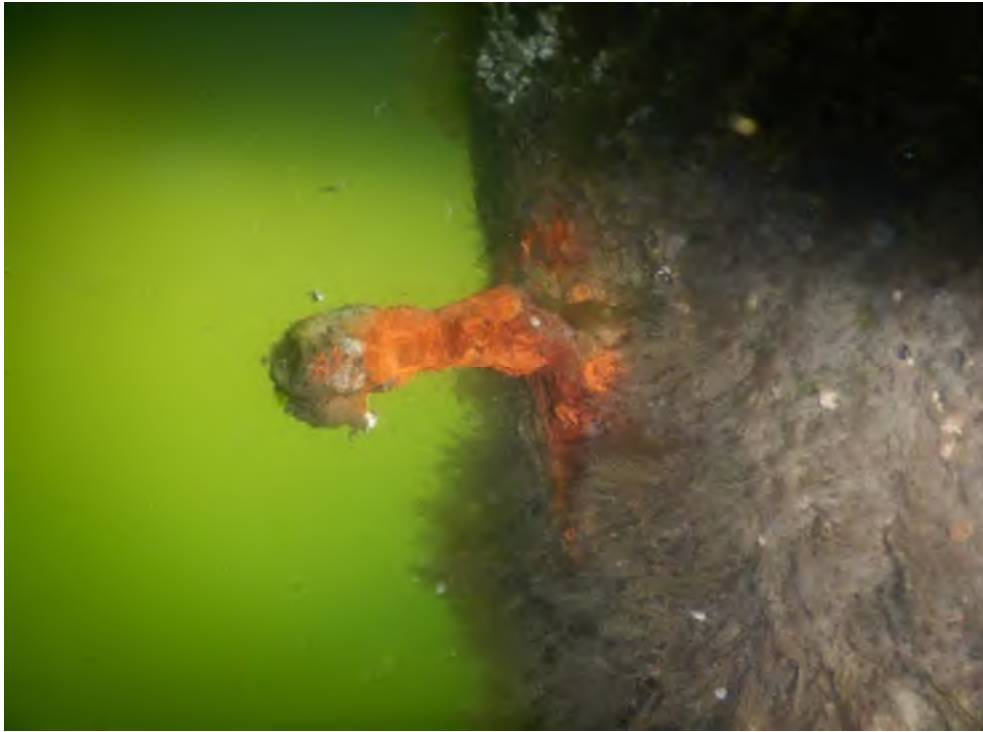
Photo No. 51: Bottom cross bracing hardware below water.
