Release Date: February 24, 2022

**HVAC Repairs
Springfield Court Complex
50 & 80 State Street
Springfield, Massachusetts**

Mass. State Project No. TRC 2111

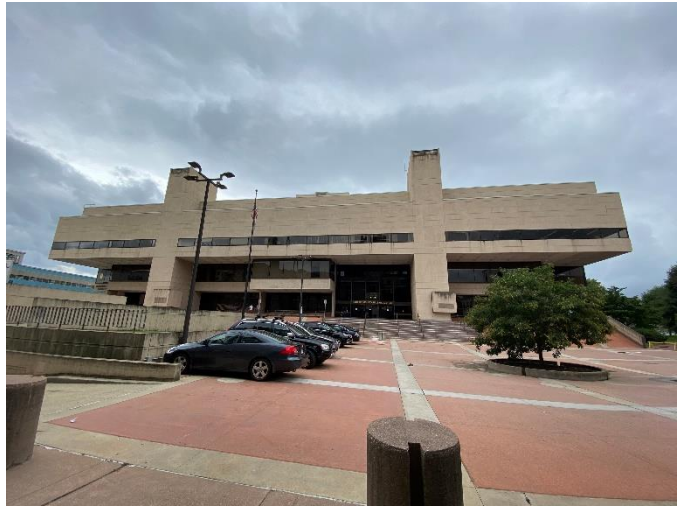
Photo 1: Eastern elevation and entry to Hall of Justice

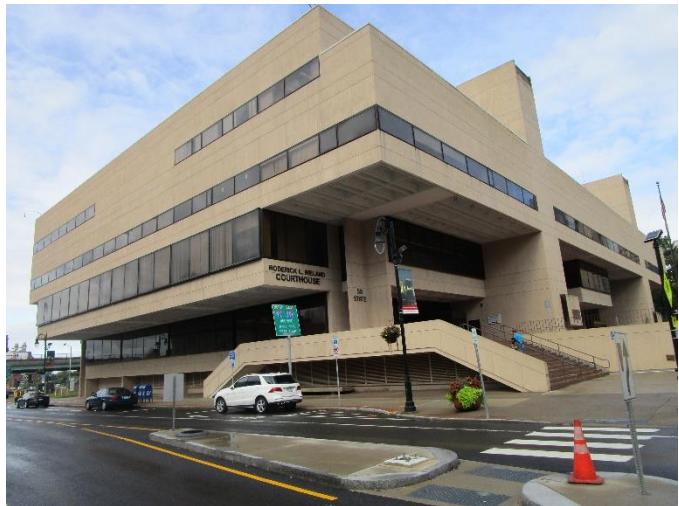
Photo 2: Vista from the street.

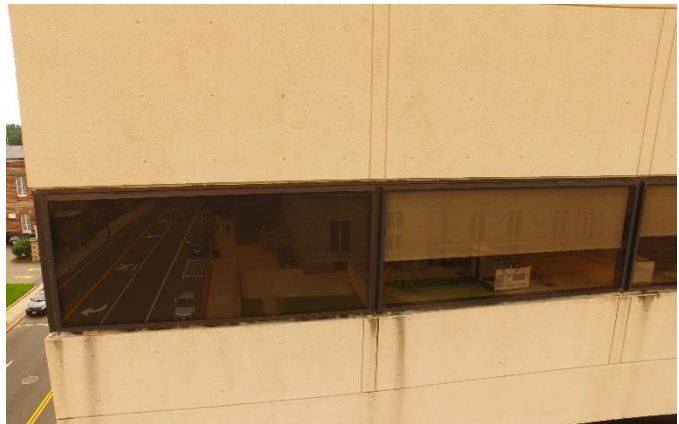
Photo 3: Discoloration of concrete at windowsill.

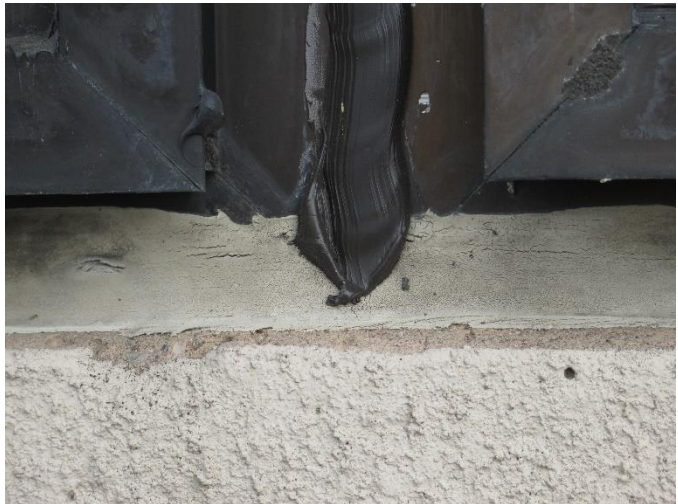
Photo 9: Deteriorated sealant at window.

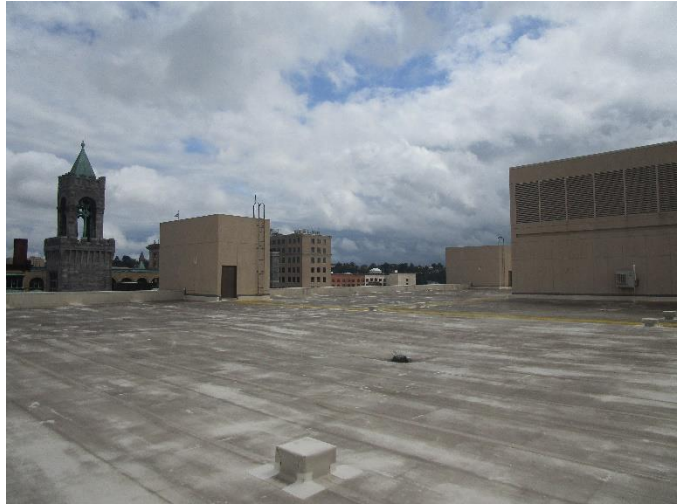
Photo 10: Thermoplastic roof with stair and mechanical penthouses.

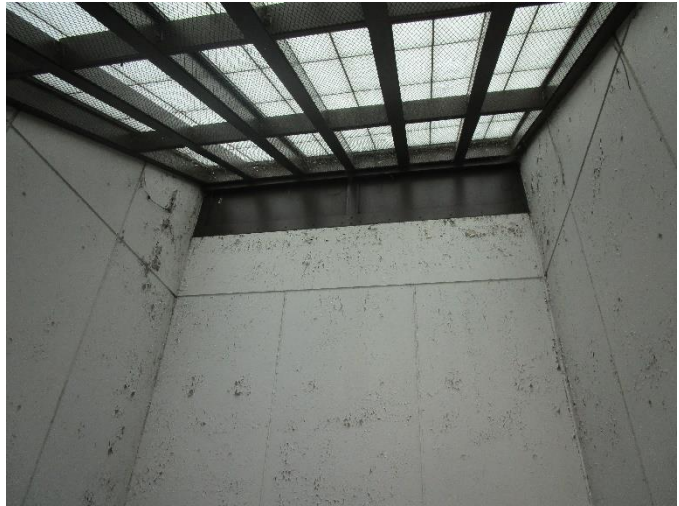
Photo 6: Peeling paint in stair tower.

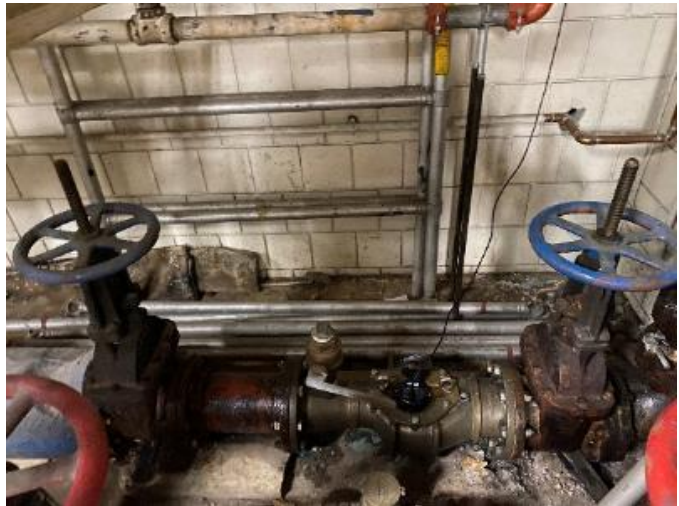
Photo 1: 6" Water Service Backflow Preventer.

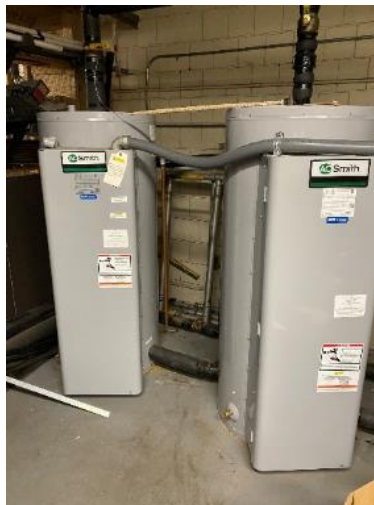
Photo 2: (2) A.O. Smith DRE-80 100 Electric Water Heaters.

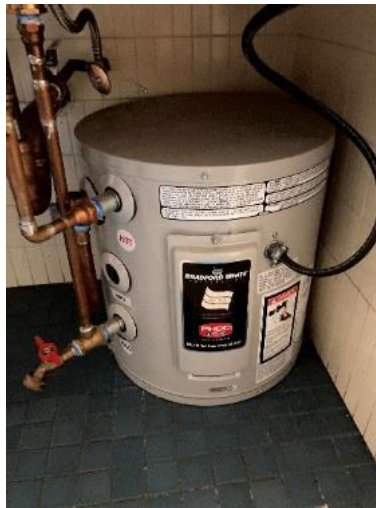
Photo 3: Bradford White LE11OU3-1NAL 10-Gal Electric Water Heater.

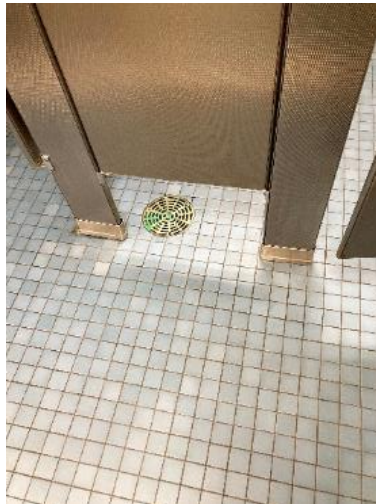
Photo 4: Inoperable Floor Drain.

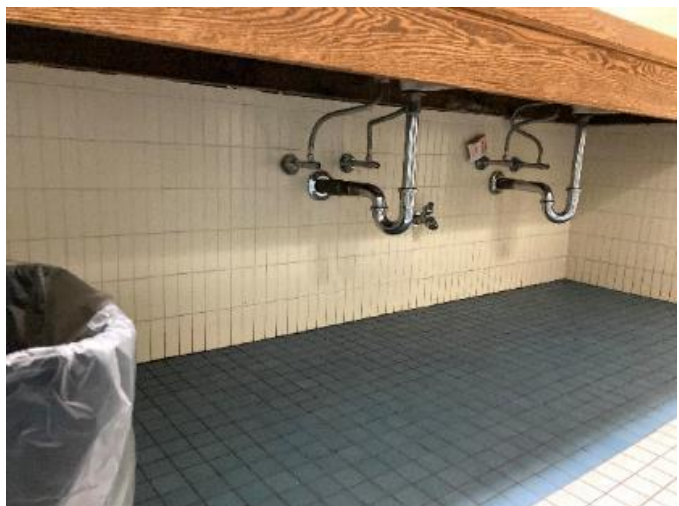
Photo 5: ADA Restroom Lavatory Tailpieces.

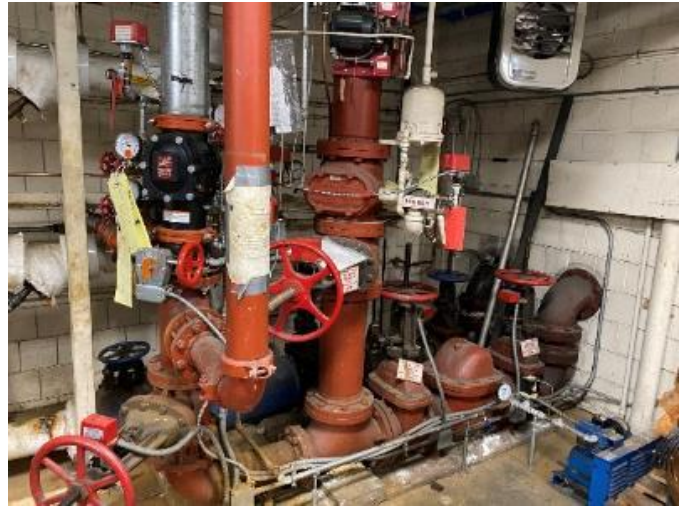
Photo 1: 8" Fire Service With 6" Wet Alarm
And 6" Dry Valves.

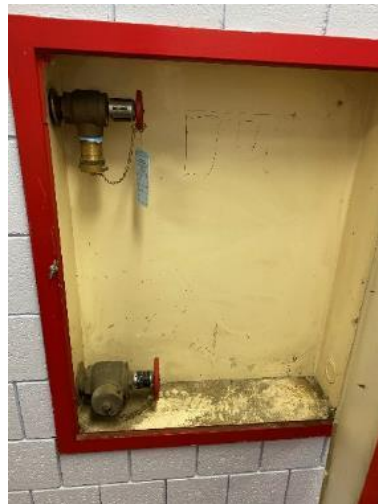
Photo 2: Fire Department Valve Cabinet.

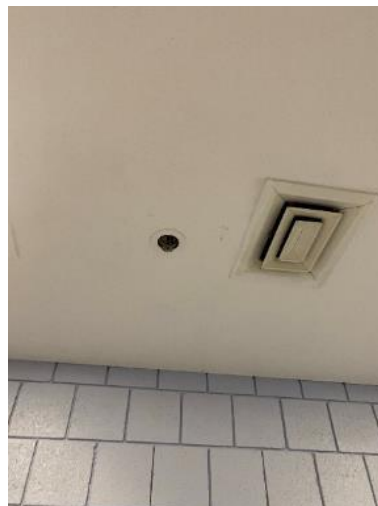
Photo 3: Standard Response Sprinkler
Heads.

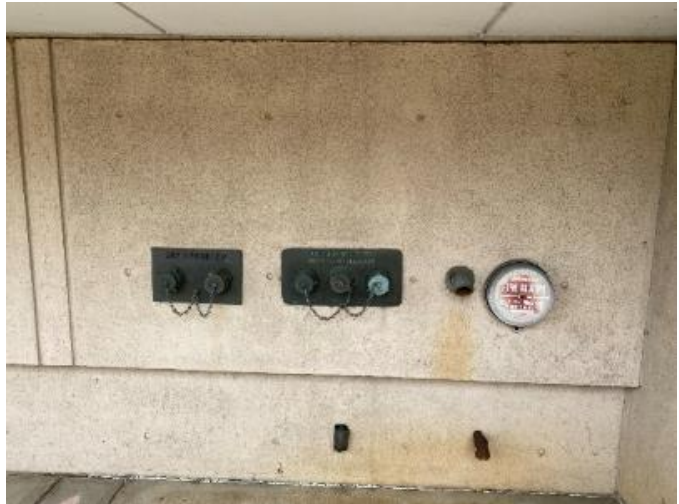
Photo 4: Fire Department Pumper Connections.

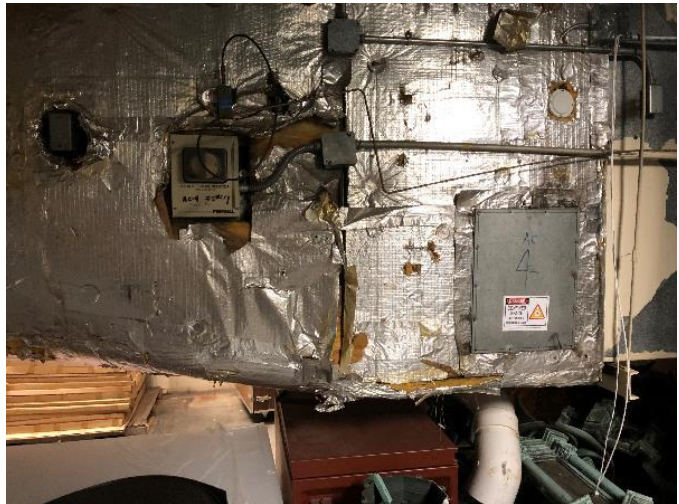
Photo 1: AC-4 Duct Smoke Detector & Existing Pneumatic Controls.

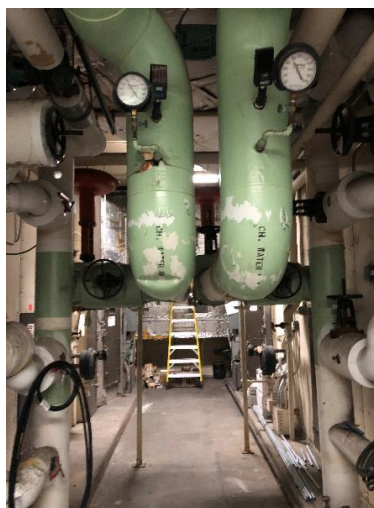
Photo 2: Chilled Water Piping Serving AC-3 & AC-4.

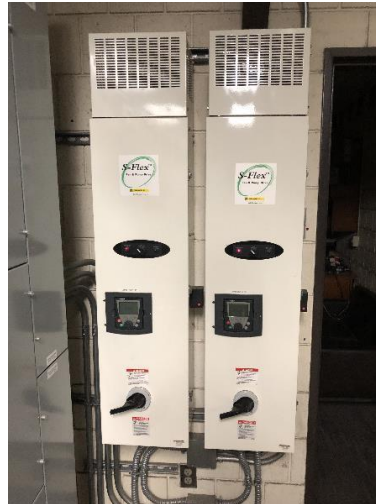
Photo 3: Cooling Tower Fan 1 & 2 Variable Frequency Drives (VFDs).

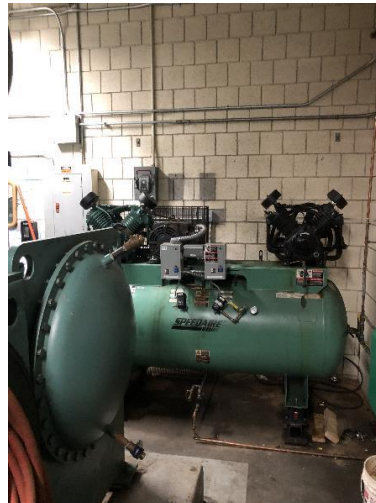
Photo 4: Air Compressor Serving Pneumatic Controls.

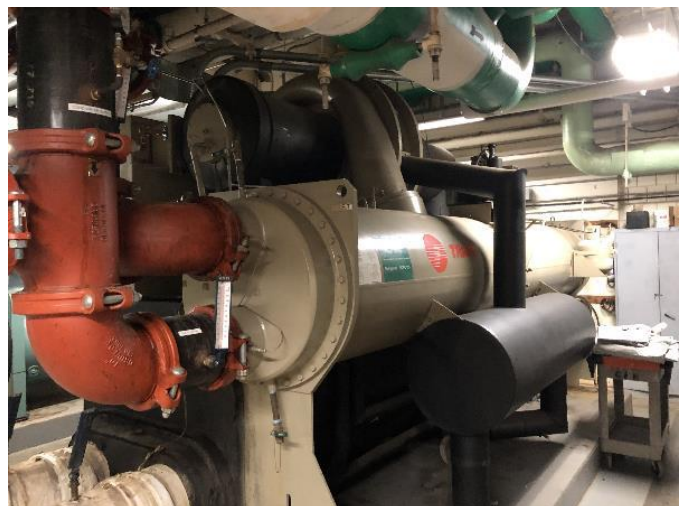
Photo 5: Trane Centrifugal Chiller.

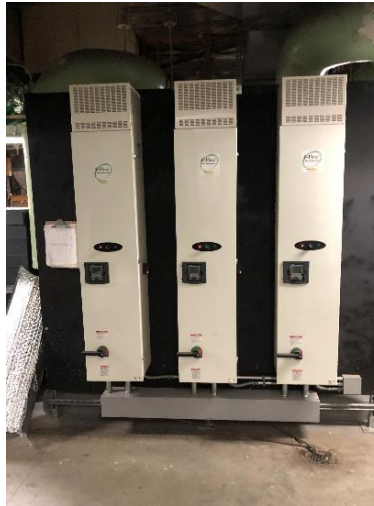
Photo 6: Chilled Water Pump Variable Frequency Drives.

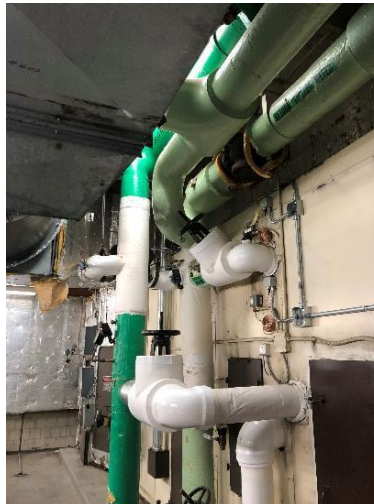
Photo 7: AC-2 Existing Conditions.

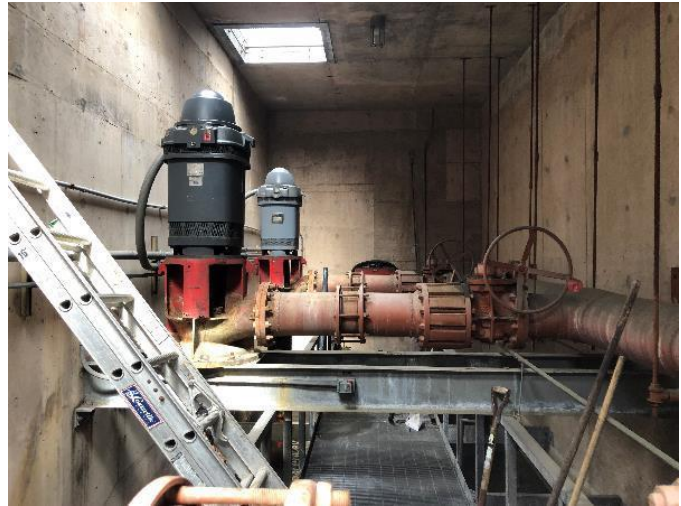
Photo 9: Geothermal Cooling Tower
(Inside).

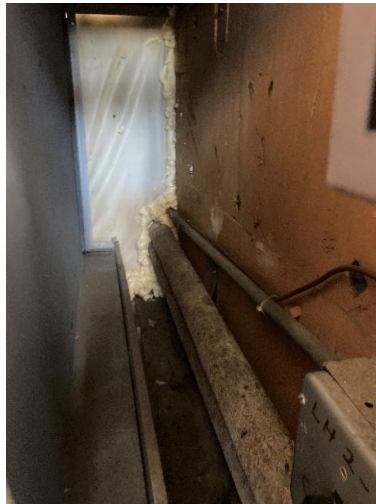
Photo 13: Perimeter Fan Coil Internal Condition.

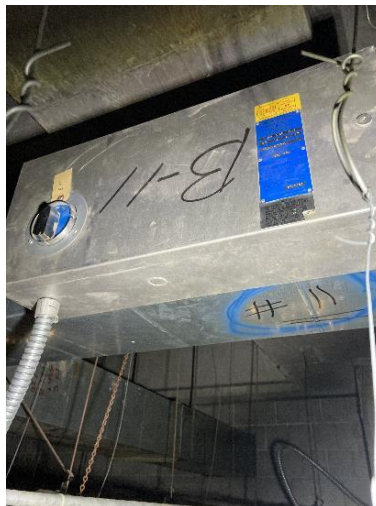
Photo 14: Typical Constant Volume Box.

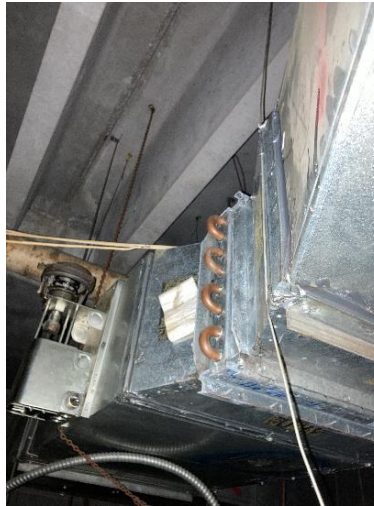
Photo 15: Typical Reheat Coil (Smaller than Upstream/Downstream Ductwork).

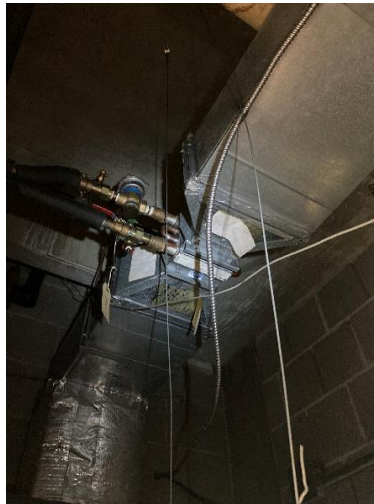
Photo 16: Typical Reheat Coil (Smaller than Upstream/Downstream Ductwork).

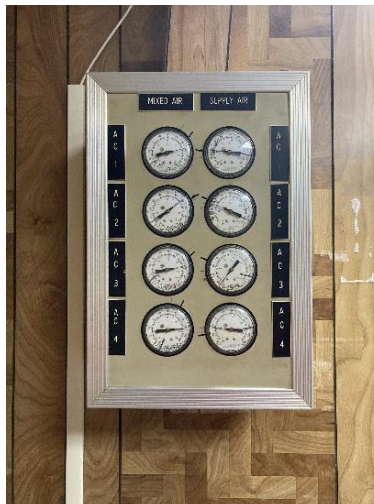
Photo 17: Existing AC Unit Pneumatic Control Panel.

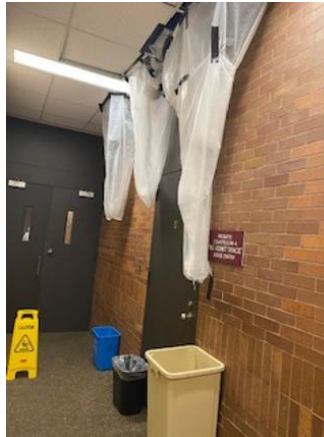
Photo 21: AC-1 Failed Drain Pan – Leaking
Above Hallway.

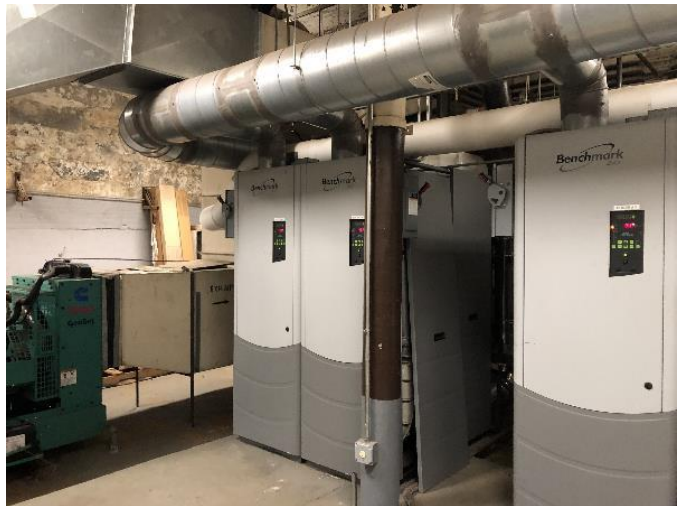
Photo 22: Aerco Condensing Boiler
Installation.

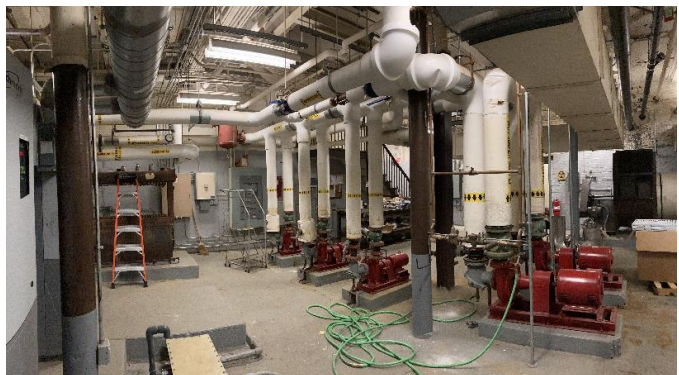
Photo 23: Typical Base-Mounted Hot Water
Pumps.

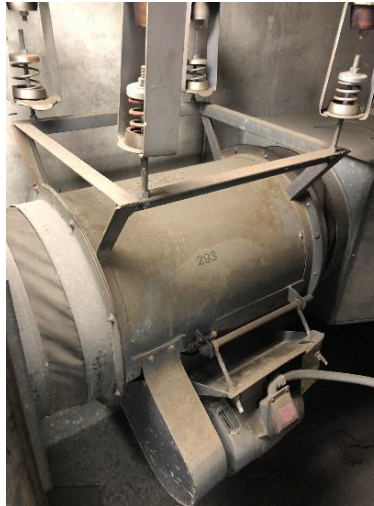
Photo 24: Supply Fan Believed to Serve
Smoke Control System.

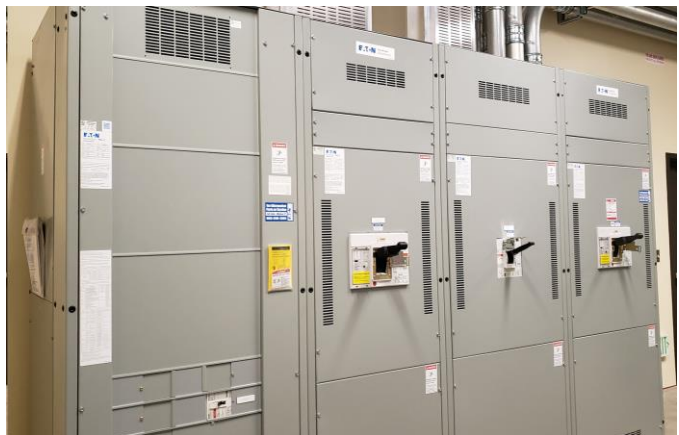
Photo 1: Existing 208/120V Switchboard in
Main Electrical Room.

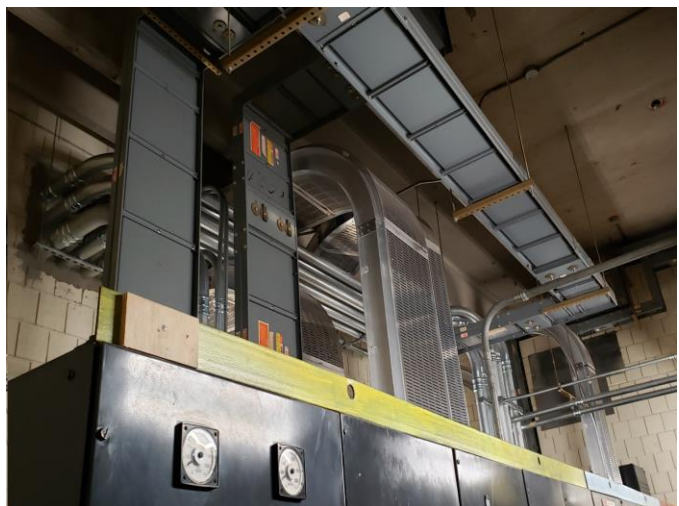
Photo 2: Above the original switchboard,
which provides a junction for the
old and new bus ducts.

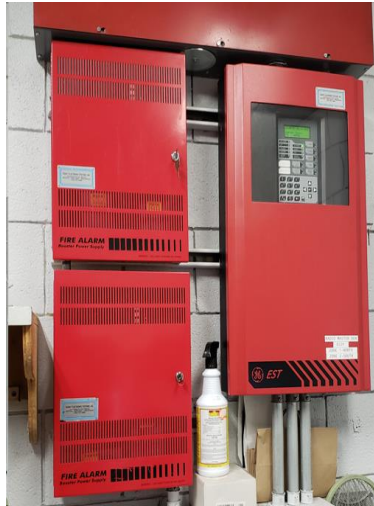
Photo 3: Fire Alarm Radio Master Box and Power Supplies by GE.

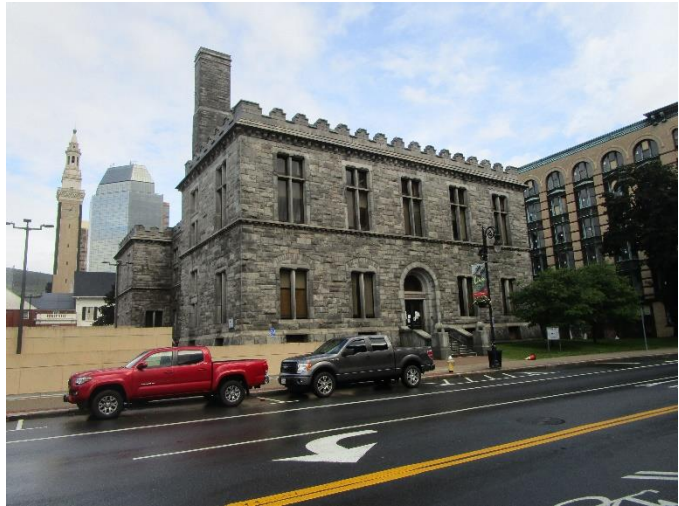
Photo 2: South Entry to Juvenile Court.

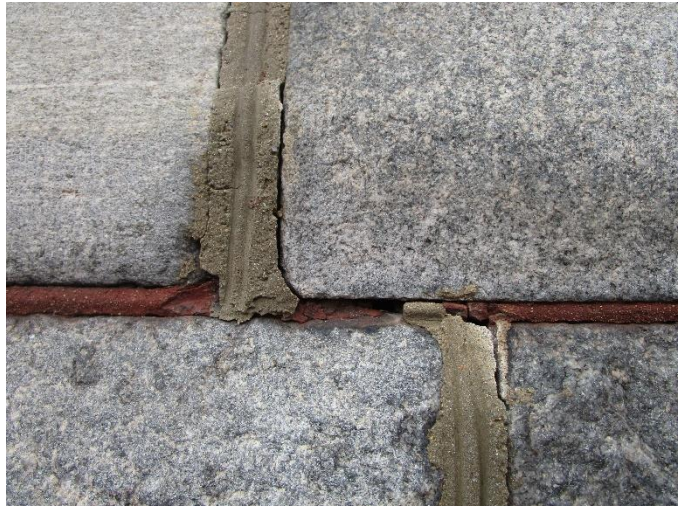
Photo 7: Example of grey and terracotta colored mortar in granite of Juvenile Court.

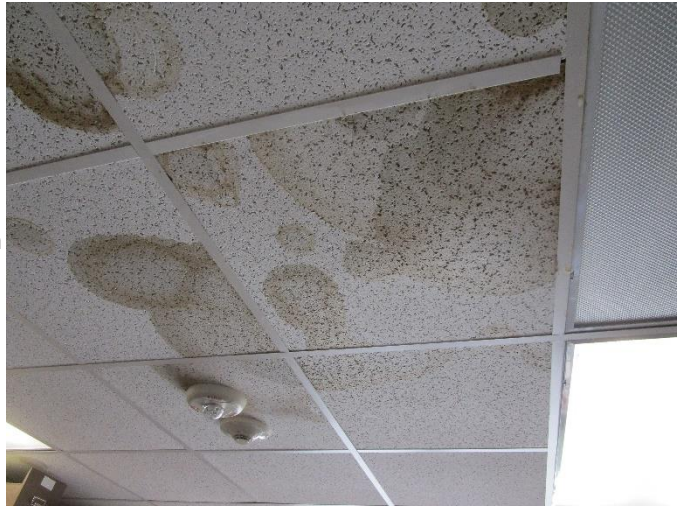
Photo 6: Damaged ceiling in Room 301, which is the room below the tower.

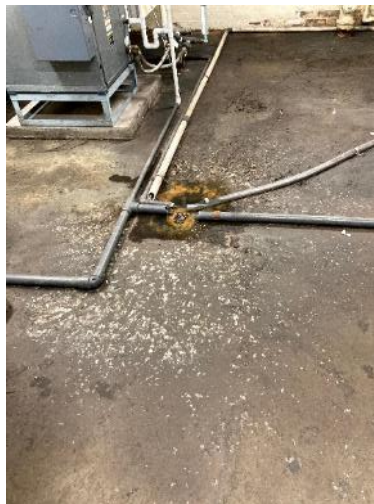
Photo 5: Mechanical Floor Drain Overflow.

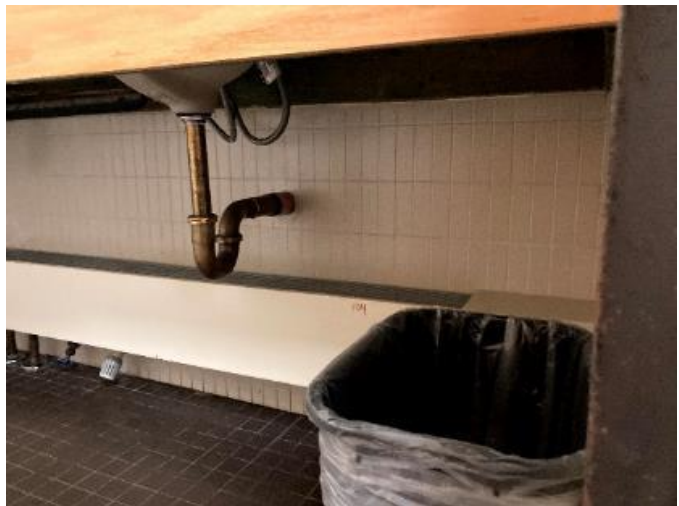
Photo 7: ADA Restroom Lavatory Tailpieces.

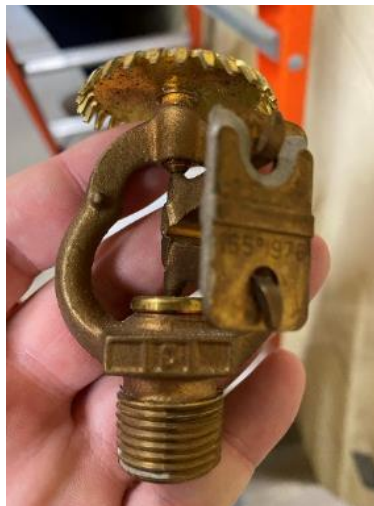
Photo 3: Standard Response Sprinkler Heads.

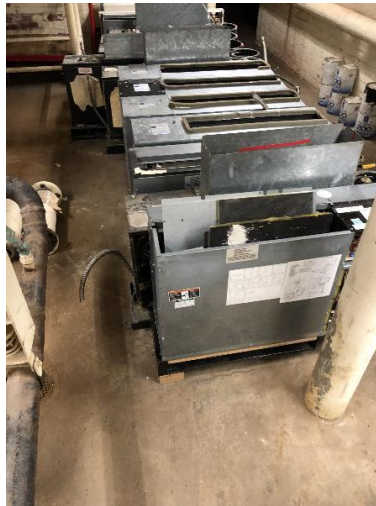
Photo 4: Existing Fan Coil Unit
Replacement Progress.

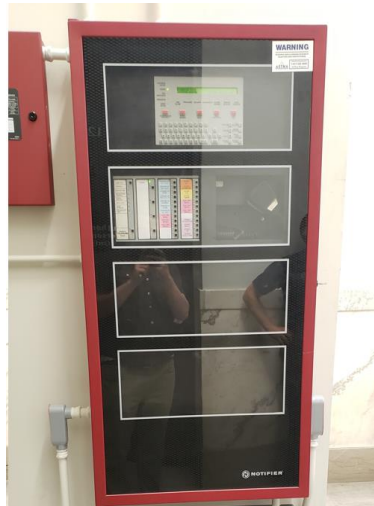
Photo 3: Notifier Fire Alarm Control Panel.

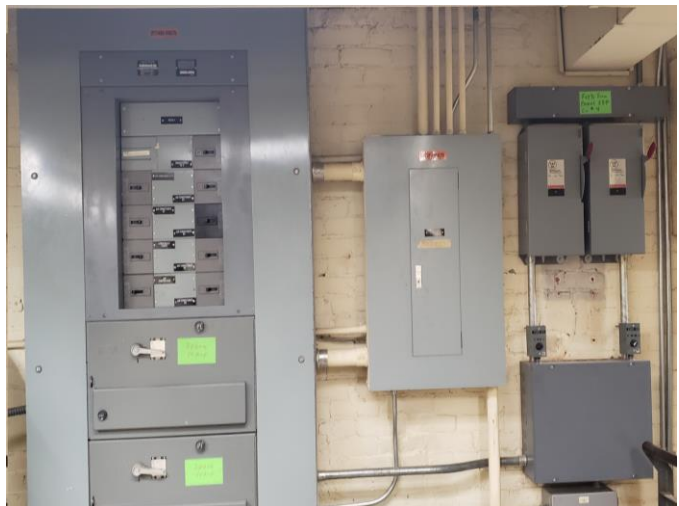
Photo 4: Vintage Power Distribution Equipment.

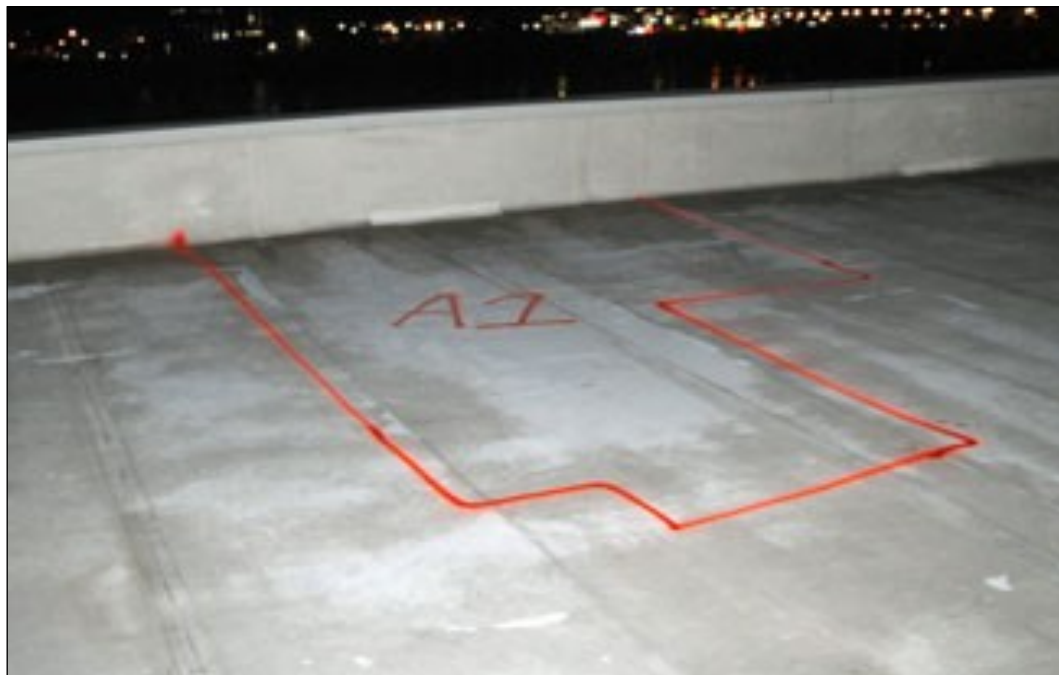
Reference Photo

The above thermal image is of Area A1 along the west wall of the main roof (Roof A). *Blue* areas in this and the following images are dry, while objects such as drains, mechanical equipment and masonry may appear warmer without containing moisture. The boundaries of wet areas are marked with orange spray paint, shown in the photo below.

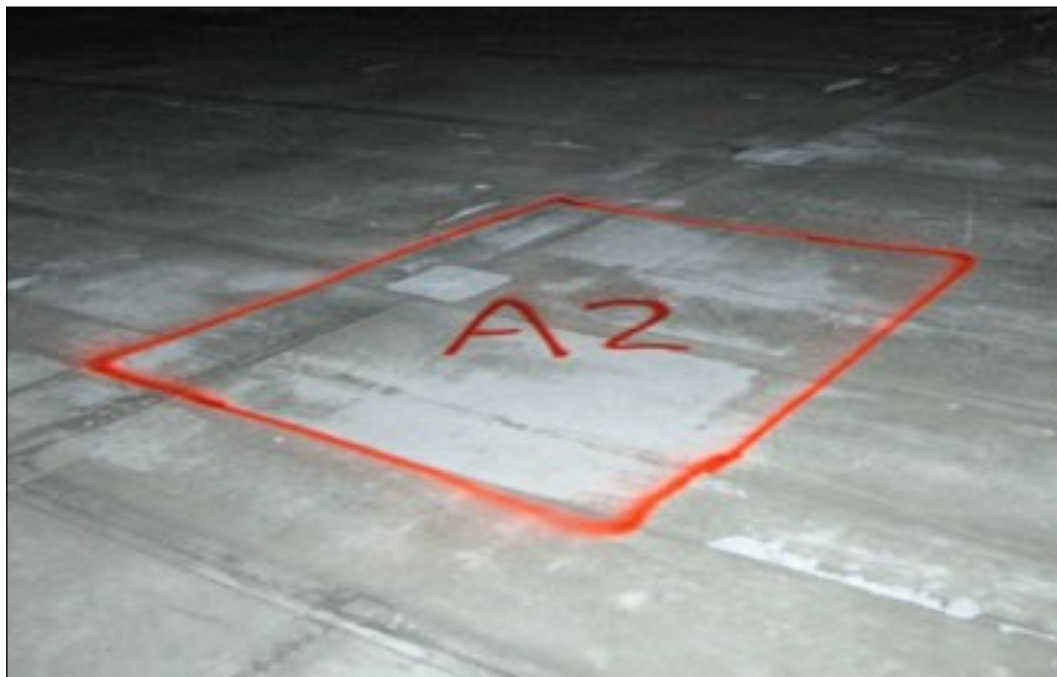
1

2
Thermal image of Area A2 on the south side of the main roof.

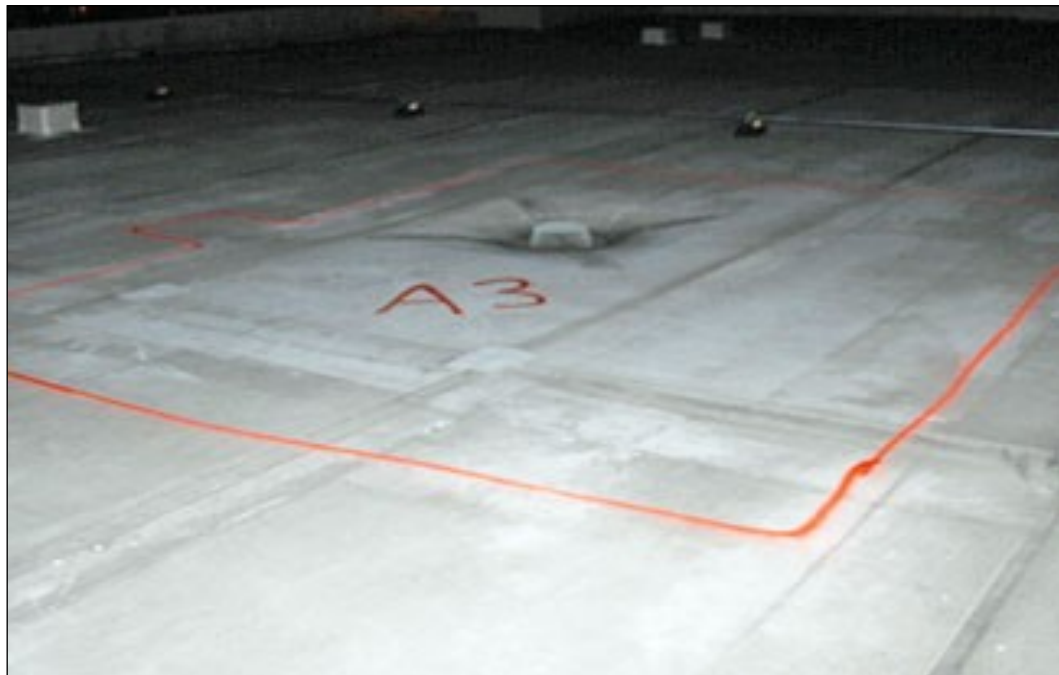
3

Thermal image of Area A3 around a roof drain on the south side of the main roof.

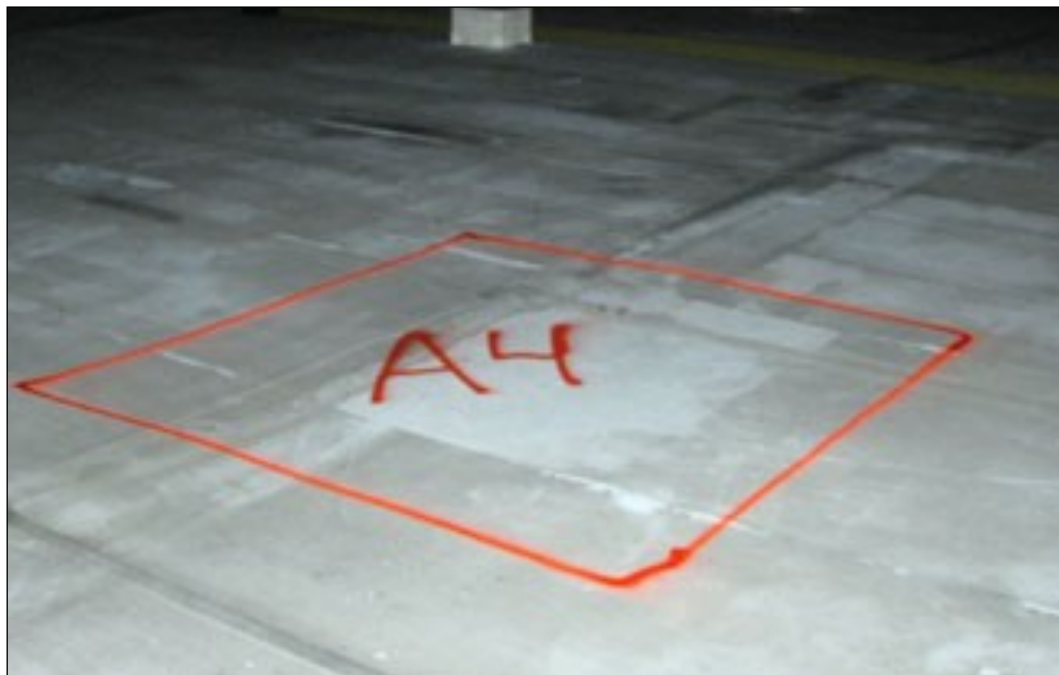
4

Thermal image of Area A4 on the south side of the main roof .

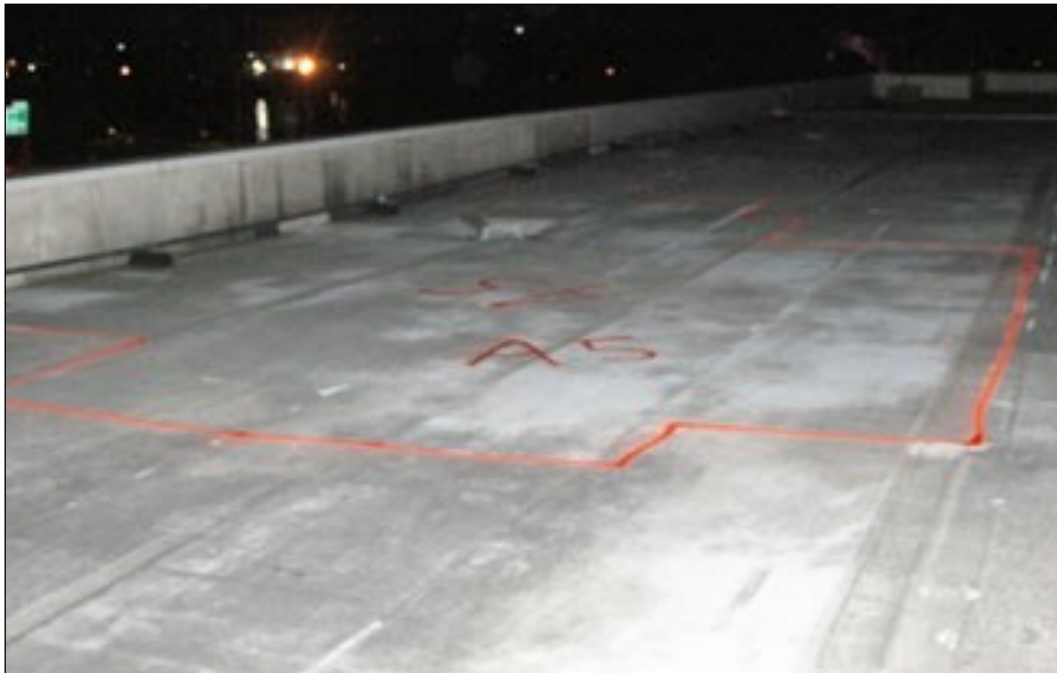
5

Thermal image of the Area A5 along the south edge of the main roof .

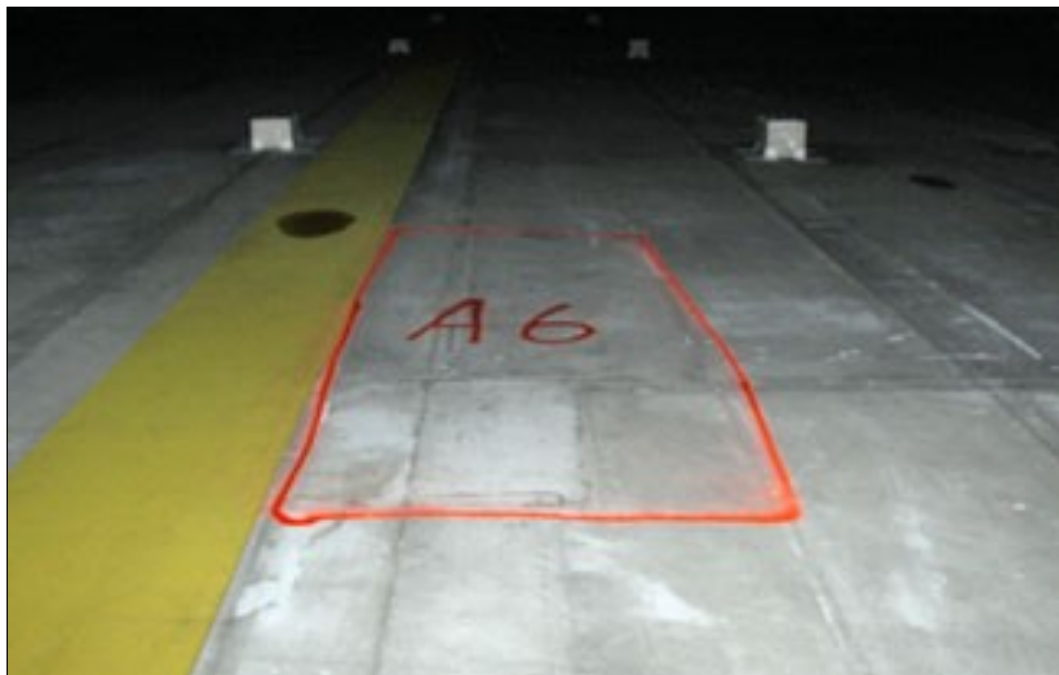
6

Thermal image of Area A6 on the north side of the main roof.

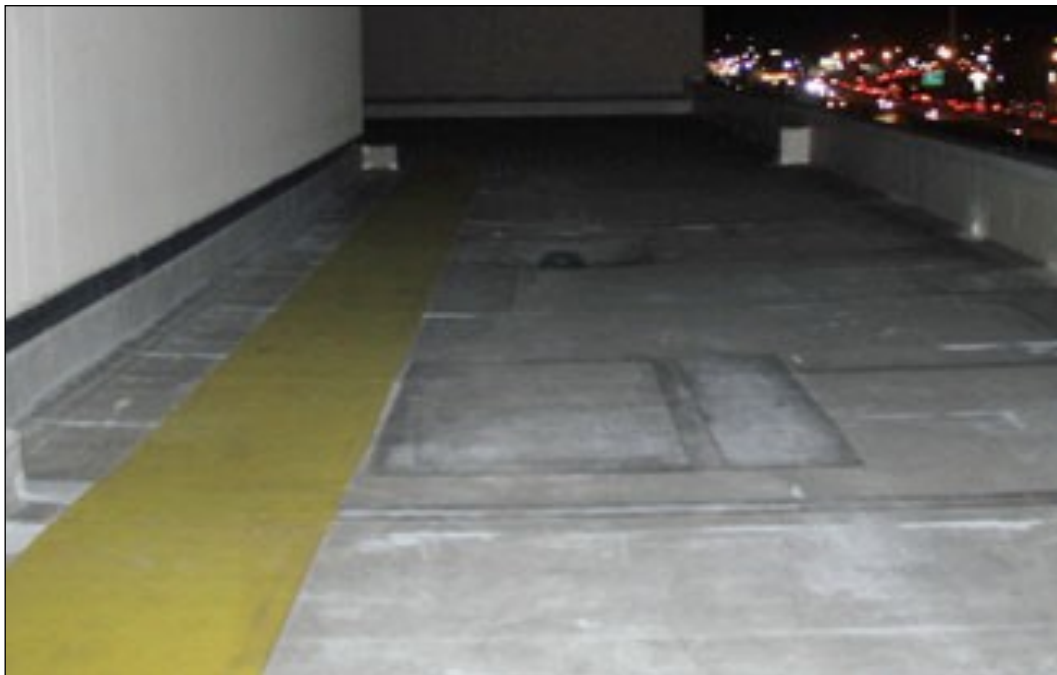
10

Another thermal image of the area of concern
No nuclear or thermal anomalies were detected in this area.
