**AGRICULTURAL INSPECTION AND ASSESSMENT OF
EIGHT AGRICULTURAL BUILDINGS AT THE
TEMPLETON DEVELOPMENTAL CENTER
STRUCTURAL ASSESSMENT BASIS AND METHODOLOGY**

August 4, 2019

**AGRICULTURAL INSPECTION AND ASSESSMENT OF
EIGHT AGRICULTURAL BUILDINGS AT THE
TEMPLETON DEVELOPMENTAL CENTER
STRUCTURAL ASSESSMENT
ELLIOT UPPER BARN**

**AGRICULTURAL INSPECTION AND ASSESSMENT OF
EIGHT AGRICULTURAL BUILDINGS AT THE
TEMPLETON DEVELOPMENTAL CENTER
STRUCTURAL ASSESSMENT
BROOK HOUSE BARN**

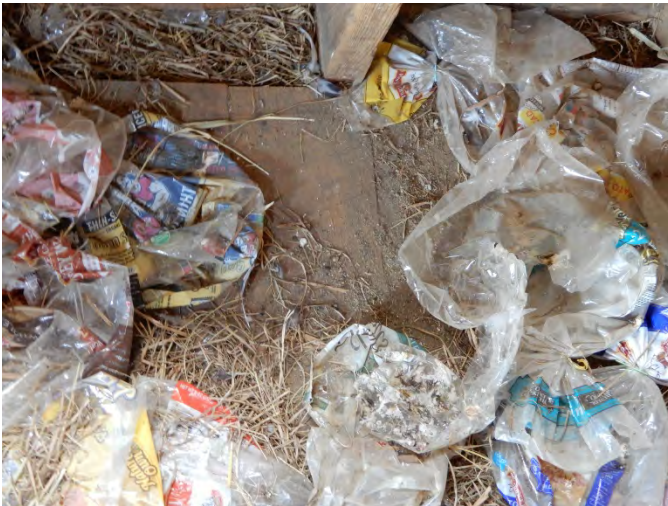
2. Organic debris on floor and in the wall on top of the wood sill.

7. Apply a spray of wood preservative such as Bora-Care to the sills and wood within two feet of the sills.
8. Carry a contingency for sill repair concealed by debris, hay bales, and siding. The extent of deficient sill is unknown if any exists. It is a common problem with wood structures, so a contingency is needed to adequately budget for hidden conditions.

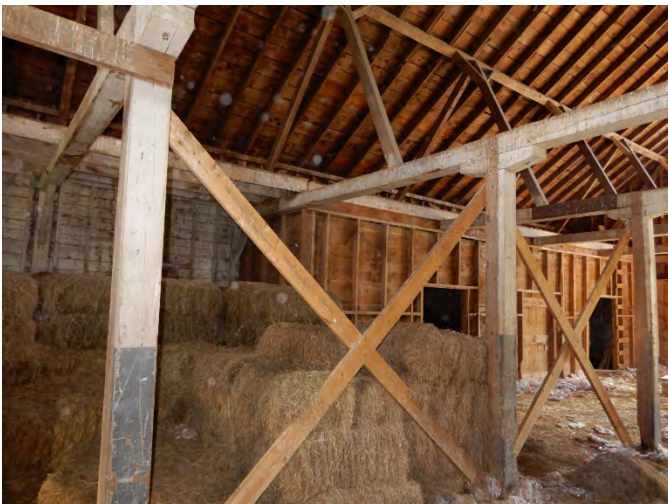
3. Roof purlin in the background propped on the eave tie beam.

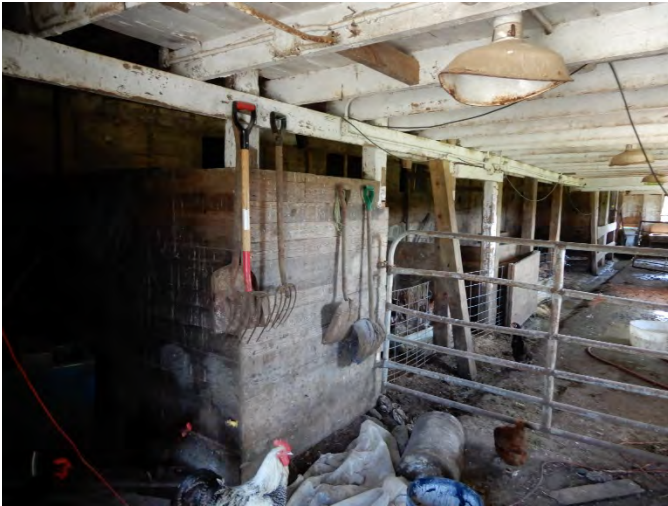
4. Lower shed space. Note in the background the large space between posts supporting the loft beam.

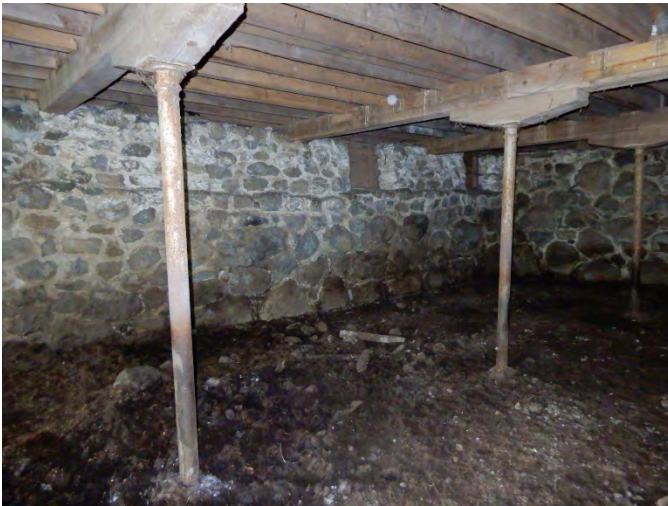
5. Posts supporting the first floor beams are immersed in wet soil that contains urine.

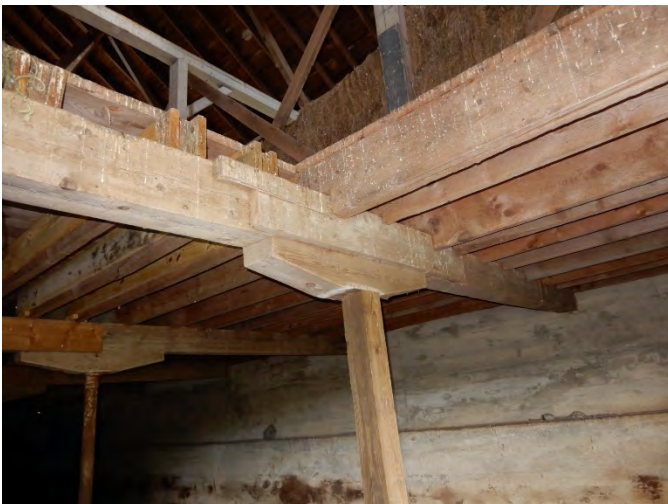
6. Post in upper background that supports the roof purlins is on the first floor beam and offset about two and one half feet from the lower post supporting the floor beam.

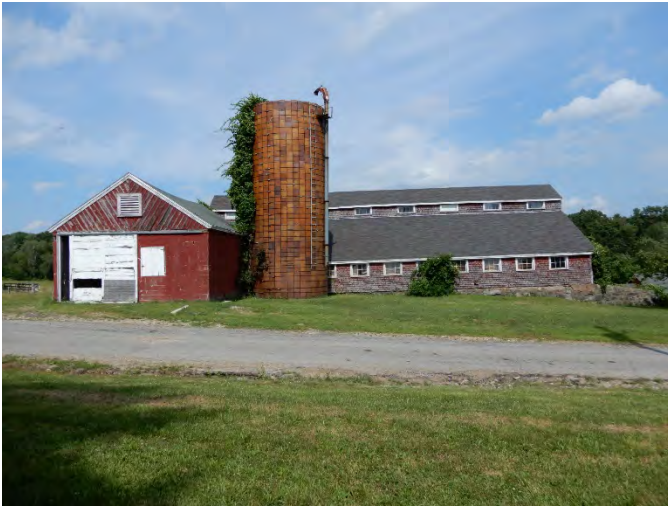
Most of the CMU walls are cracked apparently from equipment crashing into them. One wall with a door opening near the original barn is significantly buckled and in danger of collapse. This addition should be demolished soon. The walls are unreinforced and would need to be reinforced (replaced) if repaired.

1. Elliot Upper Barn viewed from the road. The original barn side wall is in the background. The silo at the center is slated for removal. The structure in the left foreground is an addition made of CMU walls and a wood framed roof.

9. Until the addition is removed, post a warning sign at entryways to the addition to warn people not to enter as a dangerous condition is present.

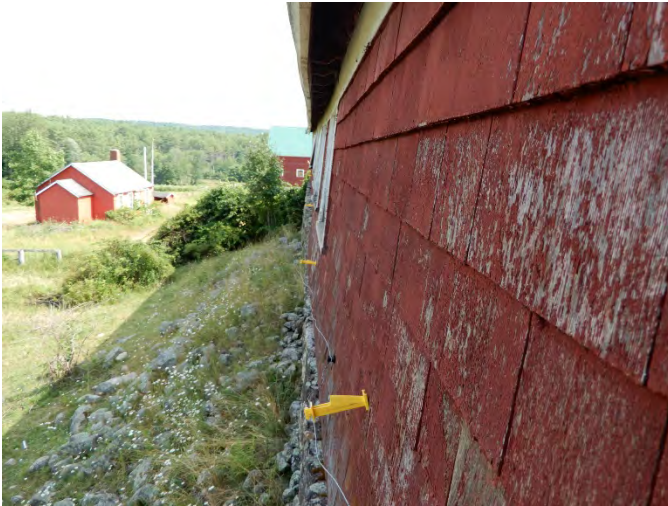
Sighting along the rear wall, it appears that the rear side wall is bowed outward along the floor sill level. It is likely that hay bales piled against the wall are pushing the sill outward. Another possibility is that the foundation side wall is tipping outward from unbalanced earth fill pressures.

4. The rear side wall appears bowed out in areas along the sill line.

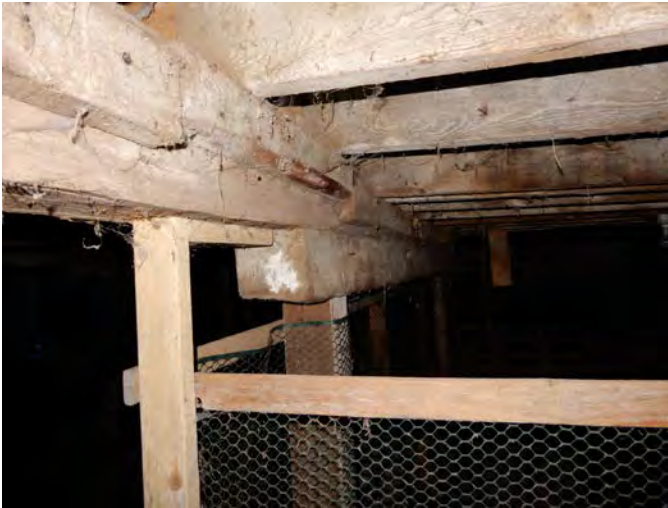
9. View of reinforcement under beam at first floor. The reinforcement is not consistent throughout the floor.

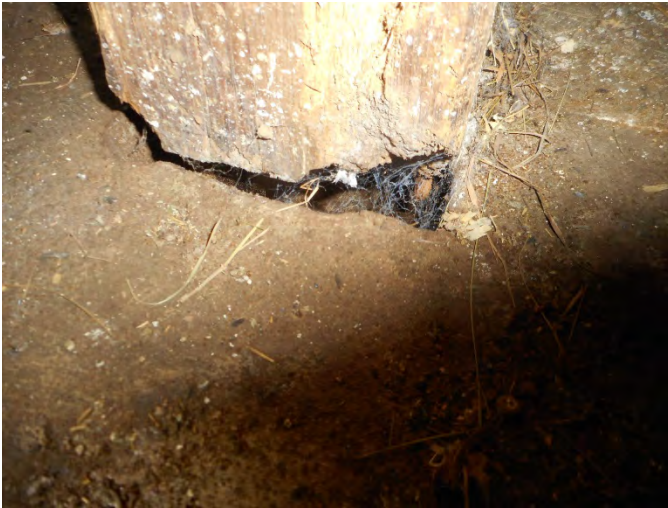
7. Close up view of interior column showing gap under post.

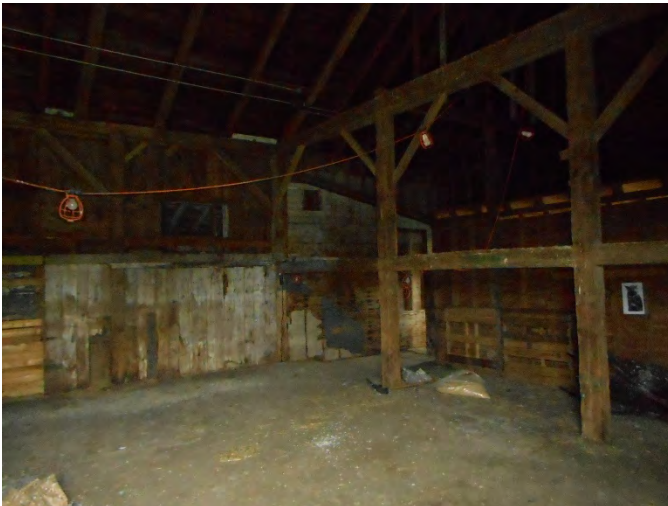
8. Some walls are covered on the interior side of framing as well as on the exterior concealing structure.

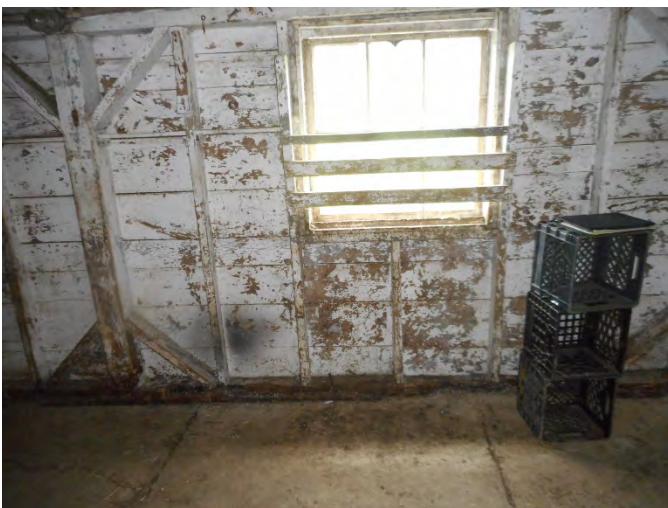
12. The sill of the rear wall is rotted in some locations.

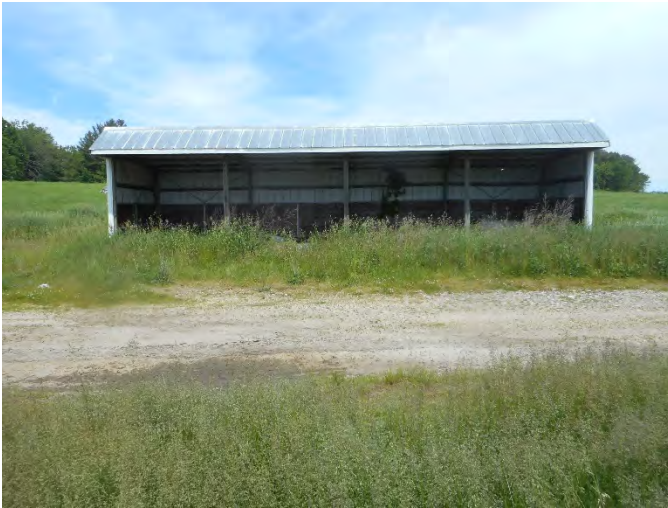
1. Morton Building viewed from the access road.

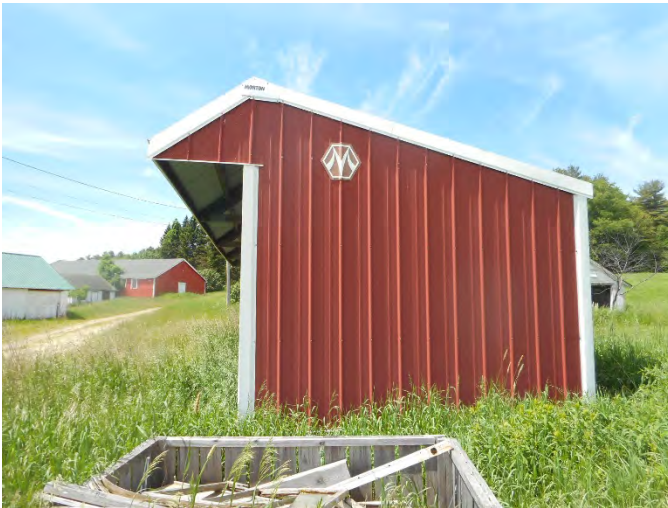
2. End wall view of Morton Building.

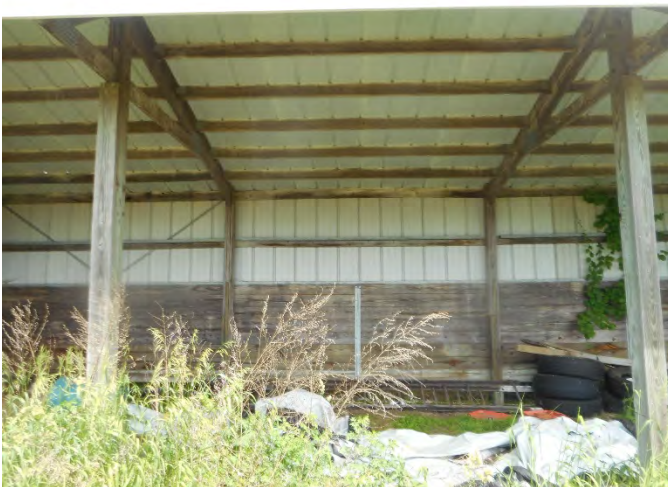
3. Front view of typical bay framing. Front and rear posts support a truss frame. The top chord, a 2x12, supports 2x6 rafters spaced at 24 inches.

Wall girts support metal siding spanning vertically.

The posts made of 3-2x6's are pressure treated and are embedded in the ground much like fence posts.

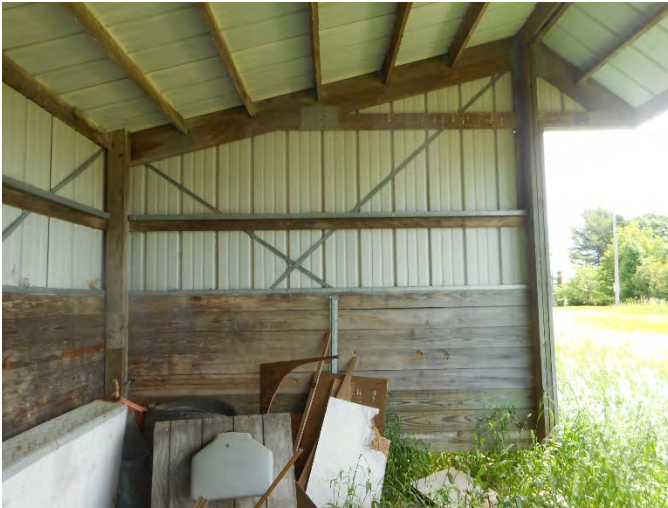
4. Interior view of end wall framing.

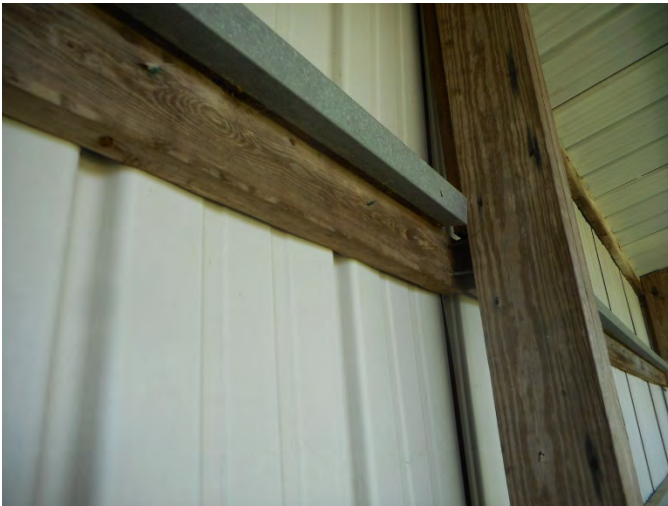
5. Wall girt pulled away from post likely the result of equipment bumping into the wall.

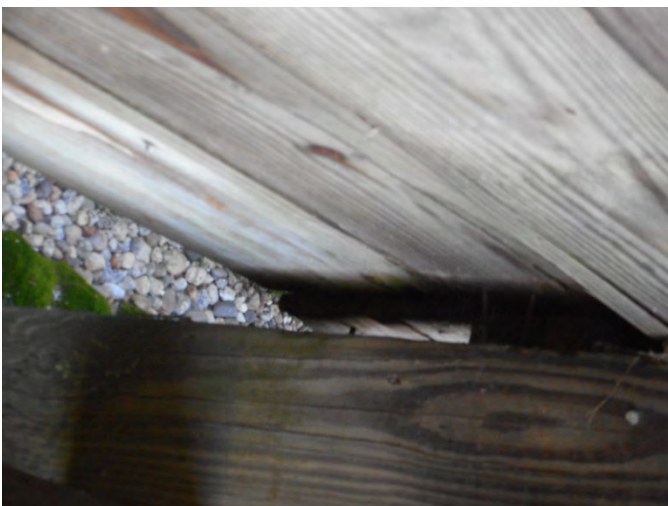
6. View of sheathing along the ground (photo is rotated 90° clockwise) is pulled away from the post likely the result of equipment bumping into the wall.

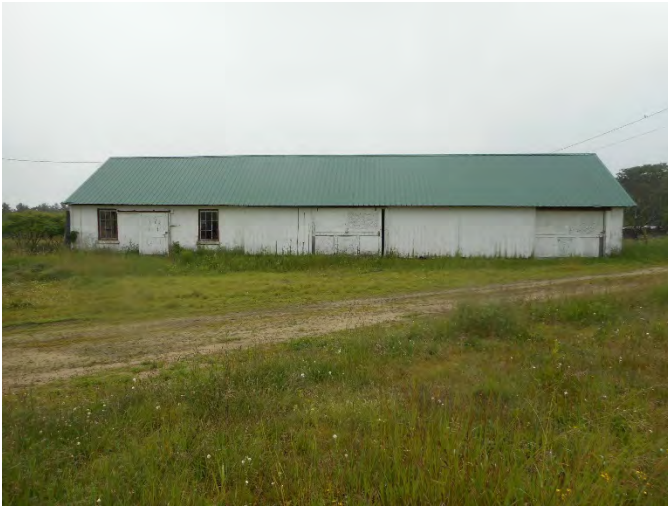
1. Front of Old Cow Barn
viewed from access road.
Portions of the wall are concrete,
and others are wood stud walls.

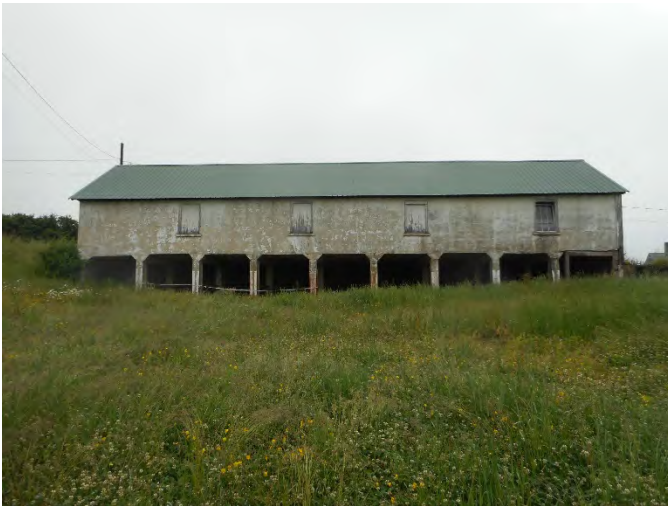
2. Rear of Old Cow Barn. The
rear upper wall is concrete.

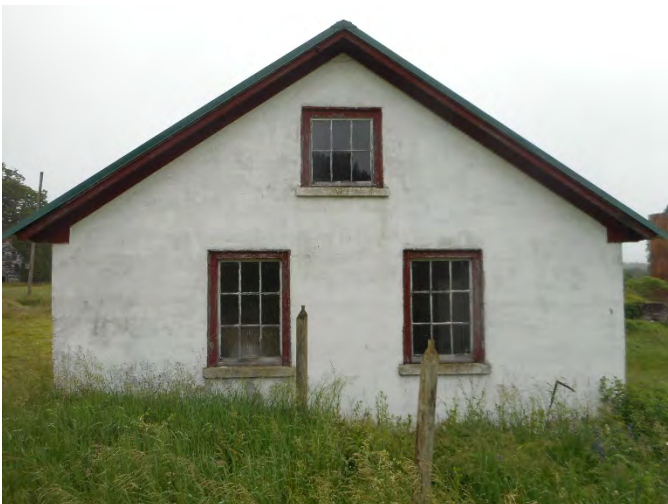
3. End wall to right of front.
This end wall is made of
concrete.

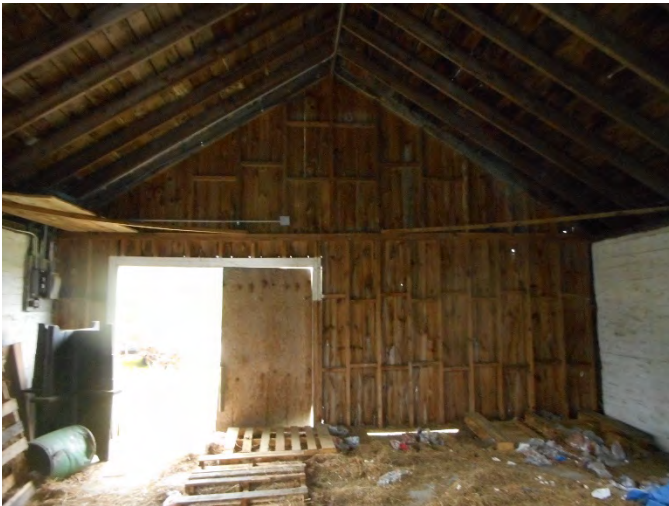
14. Upper end wall over shore stall below. This is a wood stud wall.

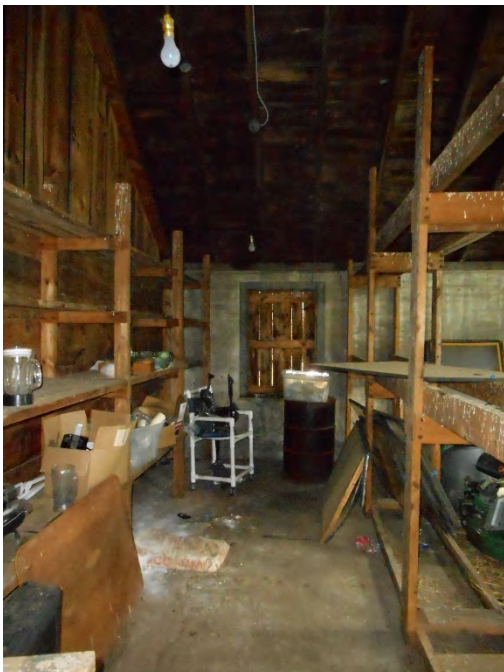
15. An interior wood stud wall partition on the left and a wood tie beam at eave level to the right.

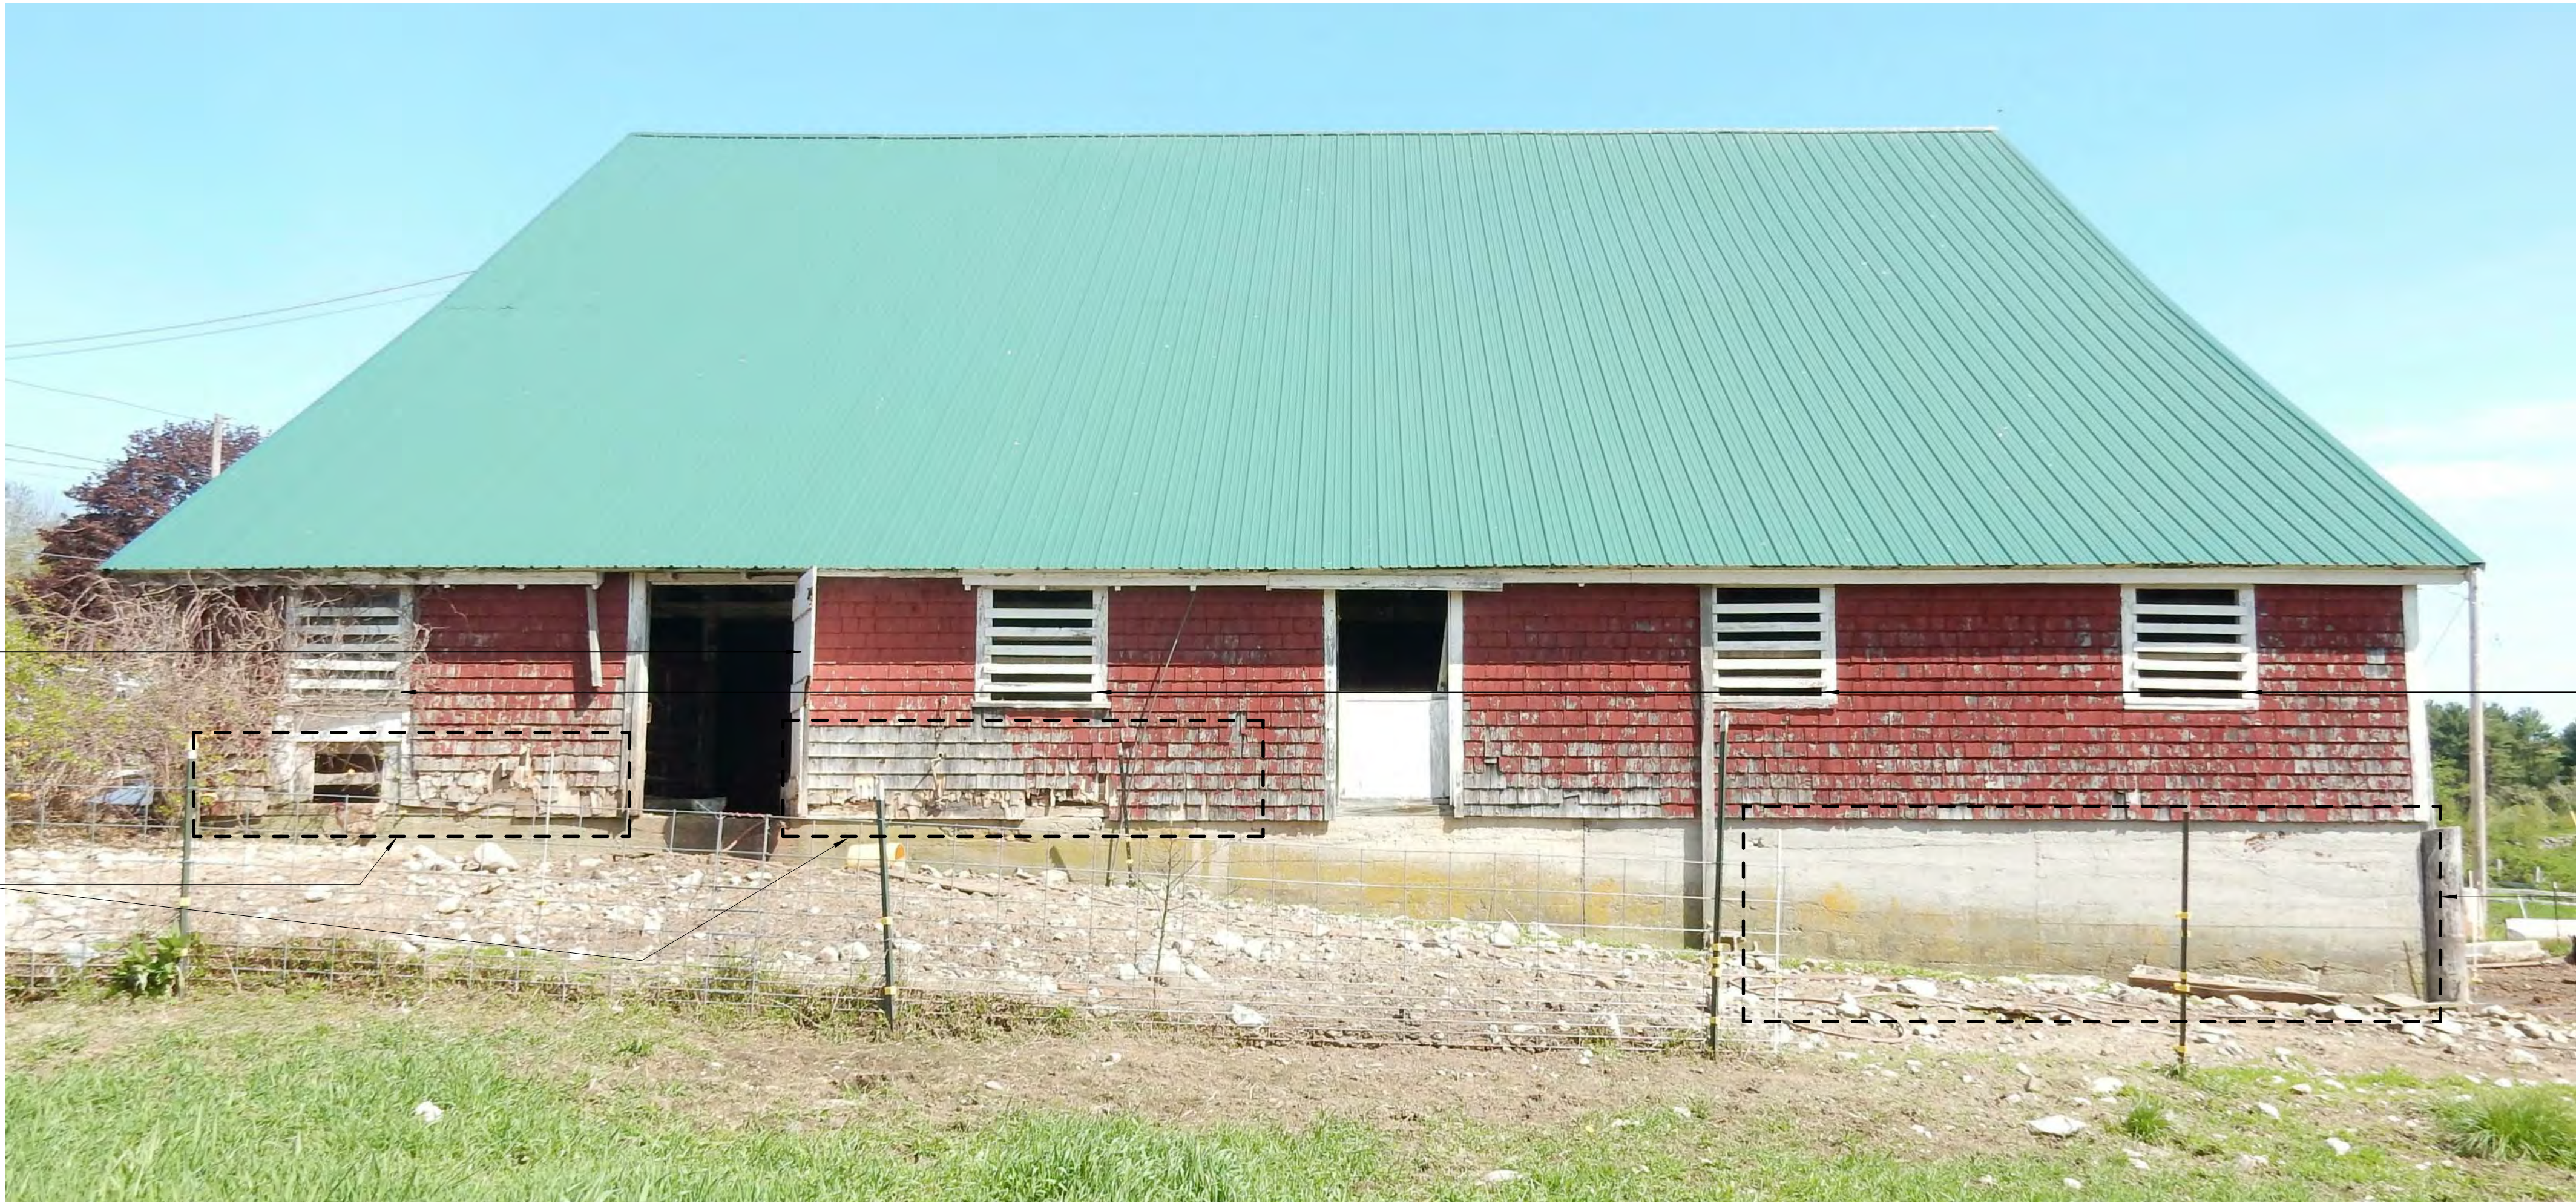
CRACKS IN FOUNDATION.
REFER TO STRUCTURAL
REPORT FOR FOUNDATION
INFORMATION.

CAT. 2: REPLACE WOOD
DOOR AND HARDWARE

CAT. 2: REPLACE
DETERIORATED WOOD
SHEATHING AND
SHINGLES

CAT. 2: REPAIR WOOD
WINDOW FRAMES AND
SILLS

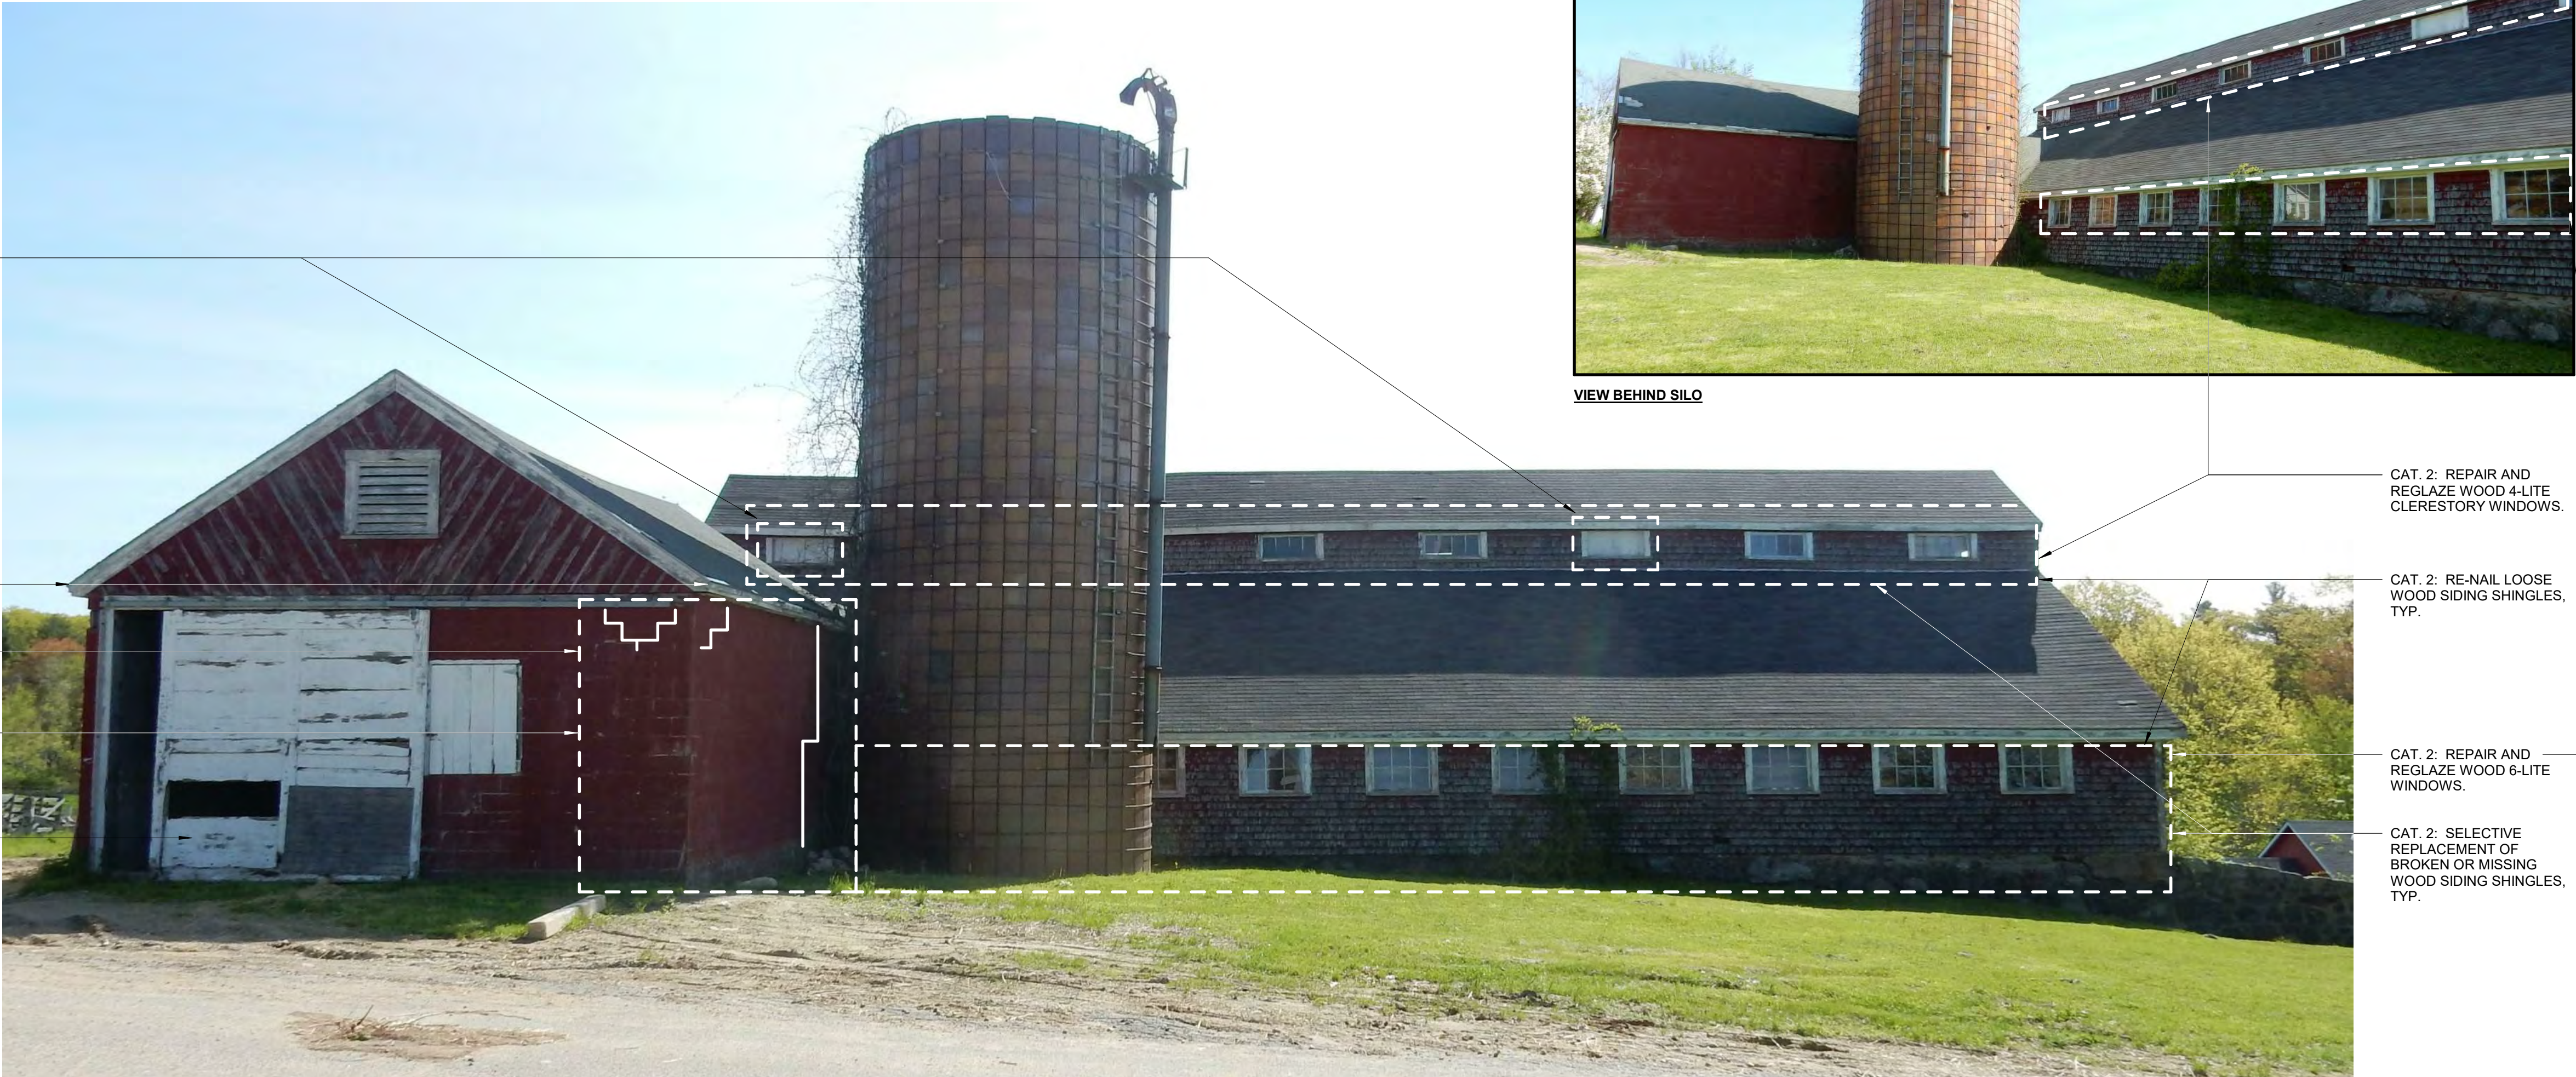
MULTIPLE STEP CRACKS
AT UNREINFORCED CMU
WALL. REFER TO
STRUCTURAL REPORT
FOR MORE INFORMATION.

CAT. 2: REPLACE WOOD
BOARD INFILL AT WINDOWS.

CAT. 2: REPAIR / REPLACE
WOOD FASCIA AND SOFFIT
(IF STRUCTURE REMAINS).

CAT. 2: REPAIR SLIDING
WOOD BARN DOOR (IF
STRUCTURE REMAINS)

CAT. 2: REPAIR AND
REGLAZE WOOD 4-LITE
CLERESTORY WINDOWS.

CAT. 2: RE-NAIL LOOSE
WOOD SIDING SHINGLES,
TYP.

CAT. 2: REPAIR AND
REGLAZE WOOD 6-LITE
WINDOWS.

CAT. 2: SELECTIVE
REPLACEMENT OF
BROKEN OR MISSING
WOOD SIDING SHINGLES,
TYP.

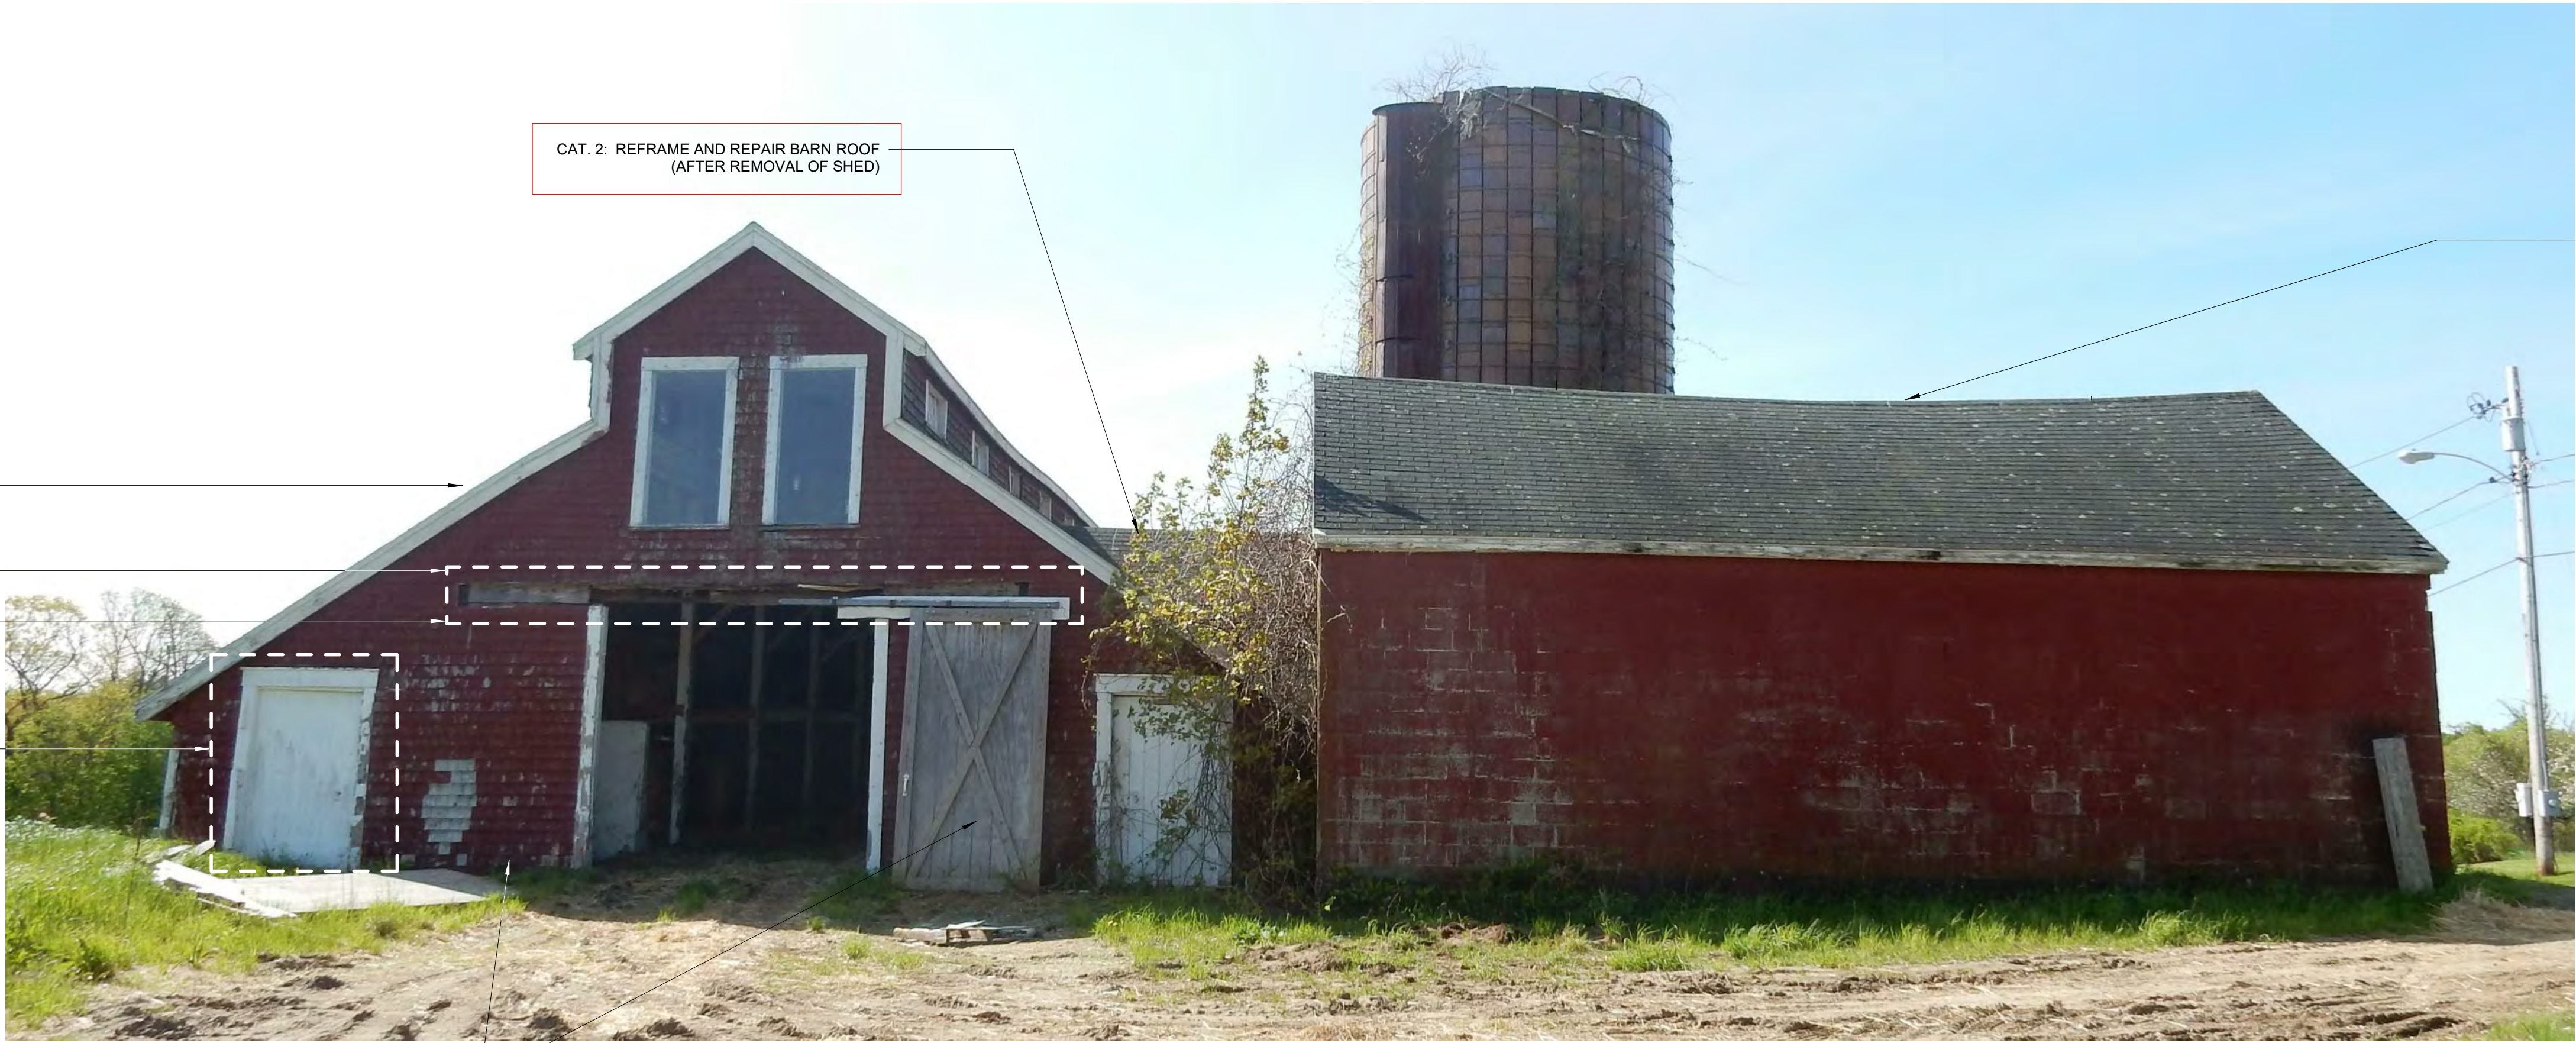
ROOF DEFLECTION 8" +/-.
REFER TO STRUCTURAL
REPORT FOR MORE
INFORMATION.

CAT. 2: REFRAME AND REPAIR BARN ROOF
(AFTER REMOVAL OF SHED)

CAT. 2: SELECTIVE REPAIR AND
REPLACEMENT OF WOOD SIDING
SHINGLES AND WOOD TRIM, TYP.

CAT. 2: REPLACE MISSING SLIDING
WOOD BARN DOOR HARDWARE

CAT. 2: REPLACE MISSING WOOD
HEADER

CAT. 2: REPLACE ROTTED WOOD
DOOR JAMBS AND DOOR FRAME.

CAT. 2: REPAIR SLIDING WOOD
BARN DOOR LEAF AND REPLACE
MISSING SLIDING WOOD BARN
DOOR LEAF.

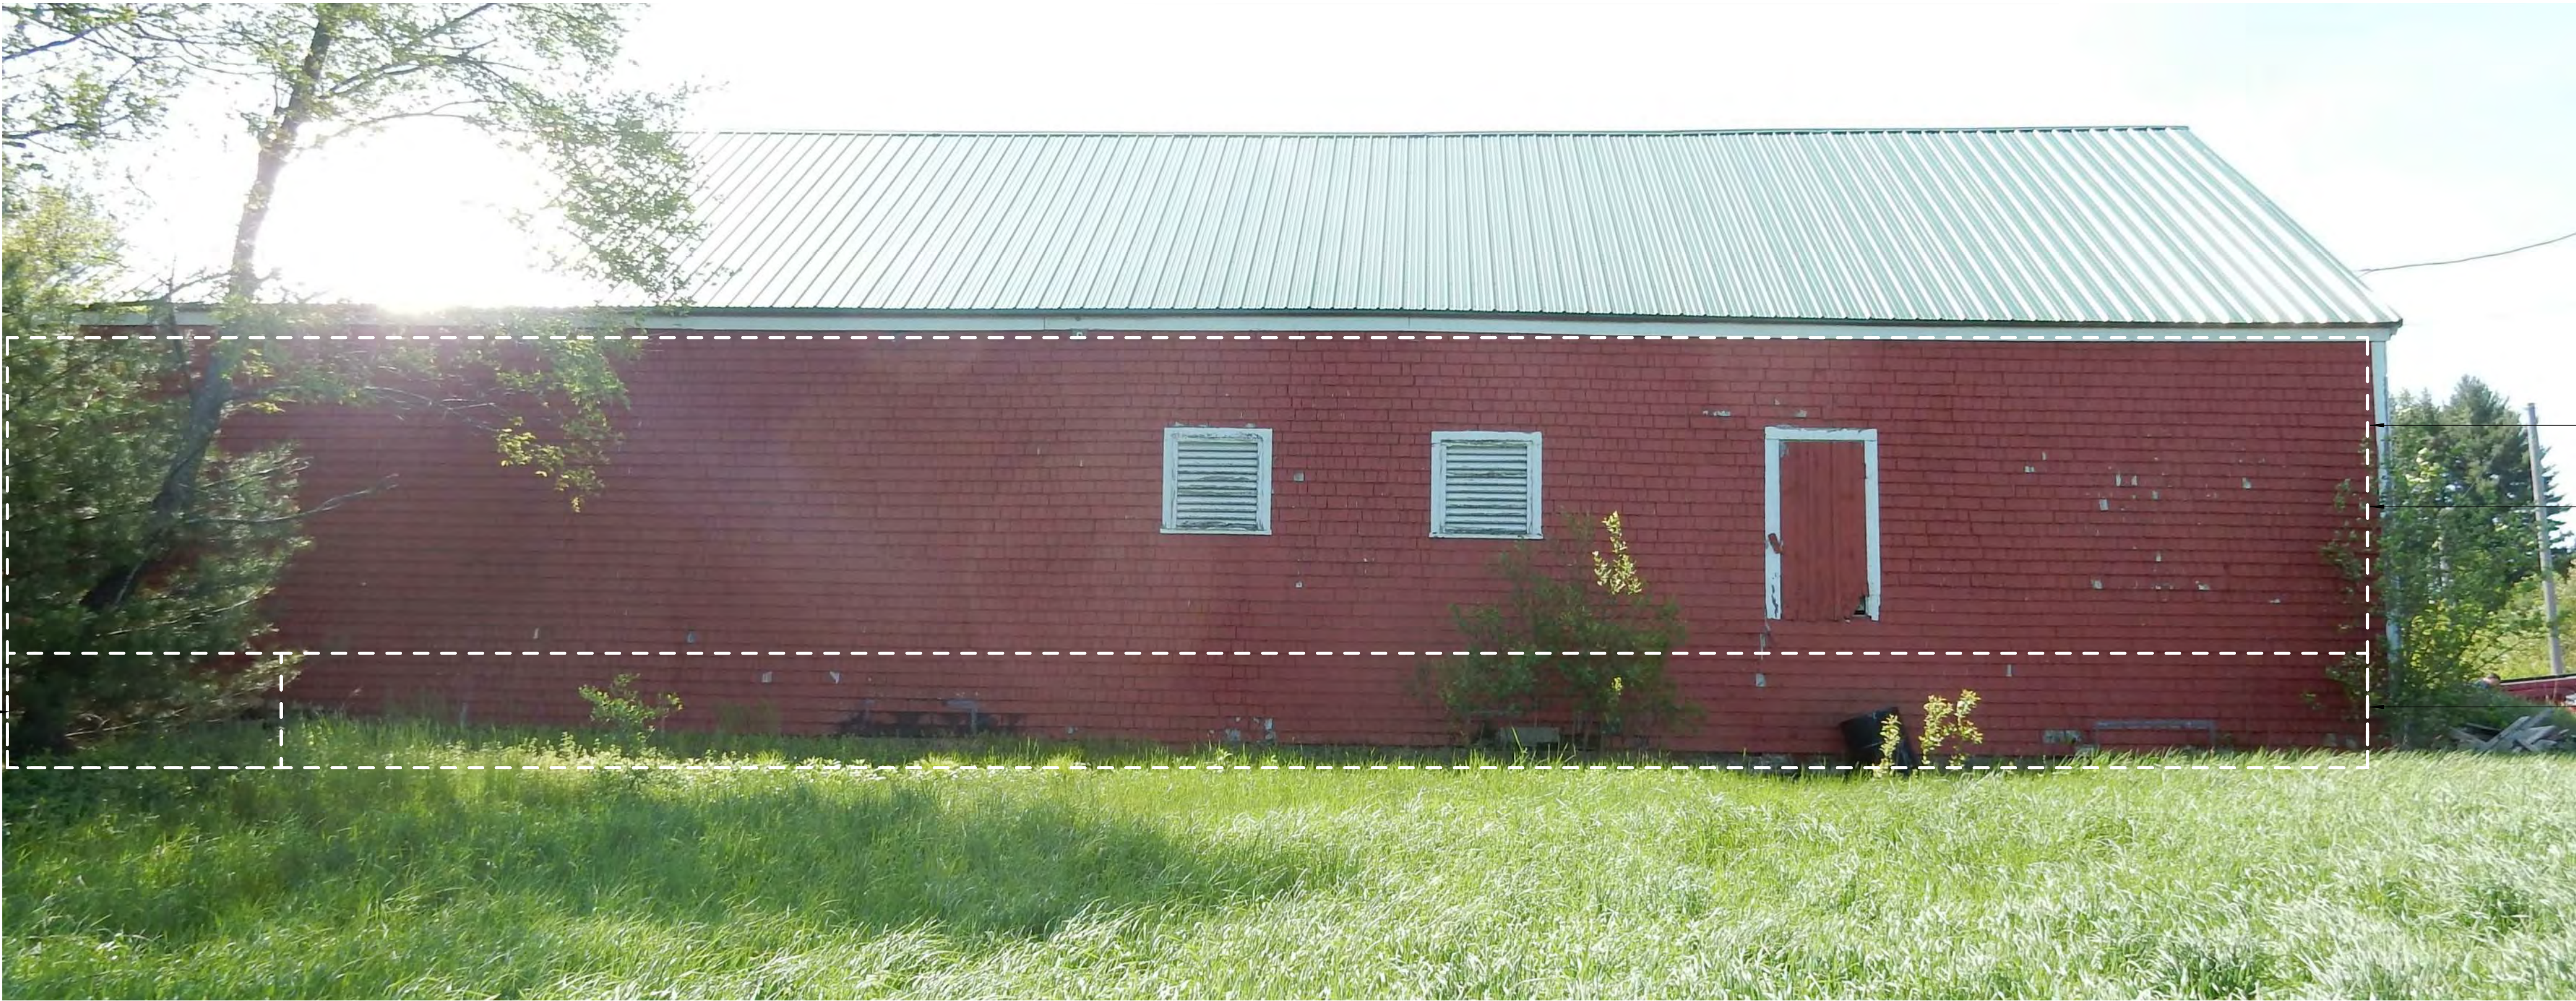
1 LA2 Brook House Barn -
North Elevation
NOT TO SCALE

1. ASPHALT ROOF CONDITION (THIS ELEVATION) IS FAIR (AND BETTER THAN WEST ROOF CONDITION).
2. ELECTRICAL SERVICE:
- METER HAS BEEN REMOVED, BUILDING CURRENTLY NOT POWERED
- MAIN PANEL: 225 AMPS
(2) 100 AMP BREAKERS
- SUB-PANEL: 100 AMPS, 40 CIRCUITS
(34) CIRCUITS IN USE
(6) BLANKS
- PANEL "L": (24) CIRCUITS
(8) CIRCUITS IN USE
(16) BLANKS

3. BOILER:
- OLDER UNIT, TO BE REVIEWED
4. MODINE UNIT (INTERIOR):
- TO BE REVIEWED

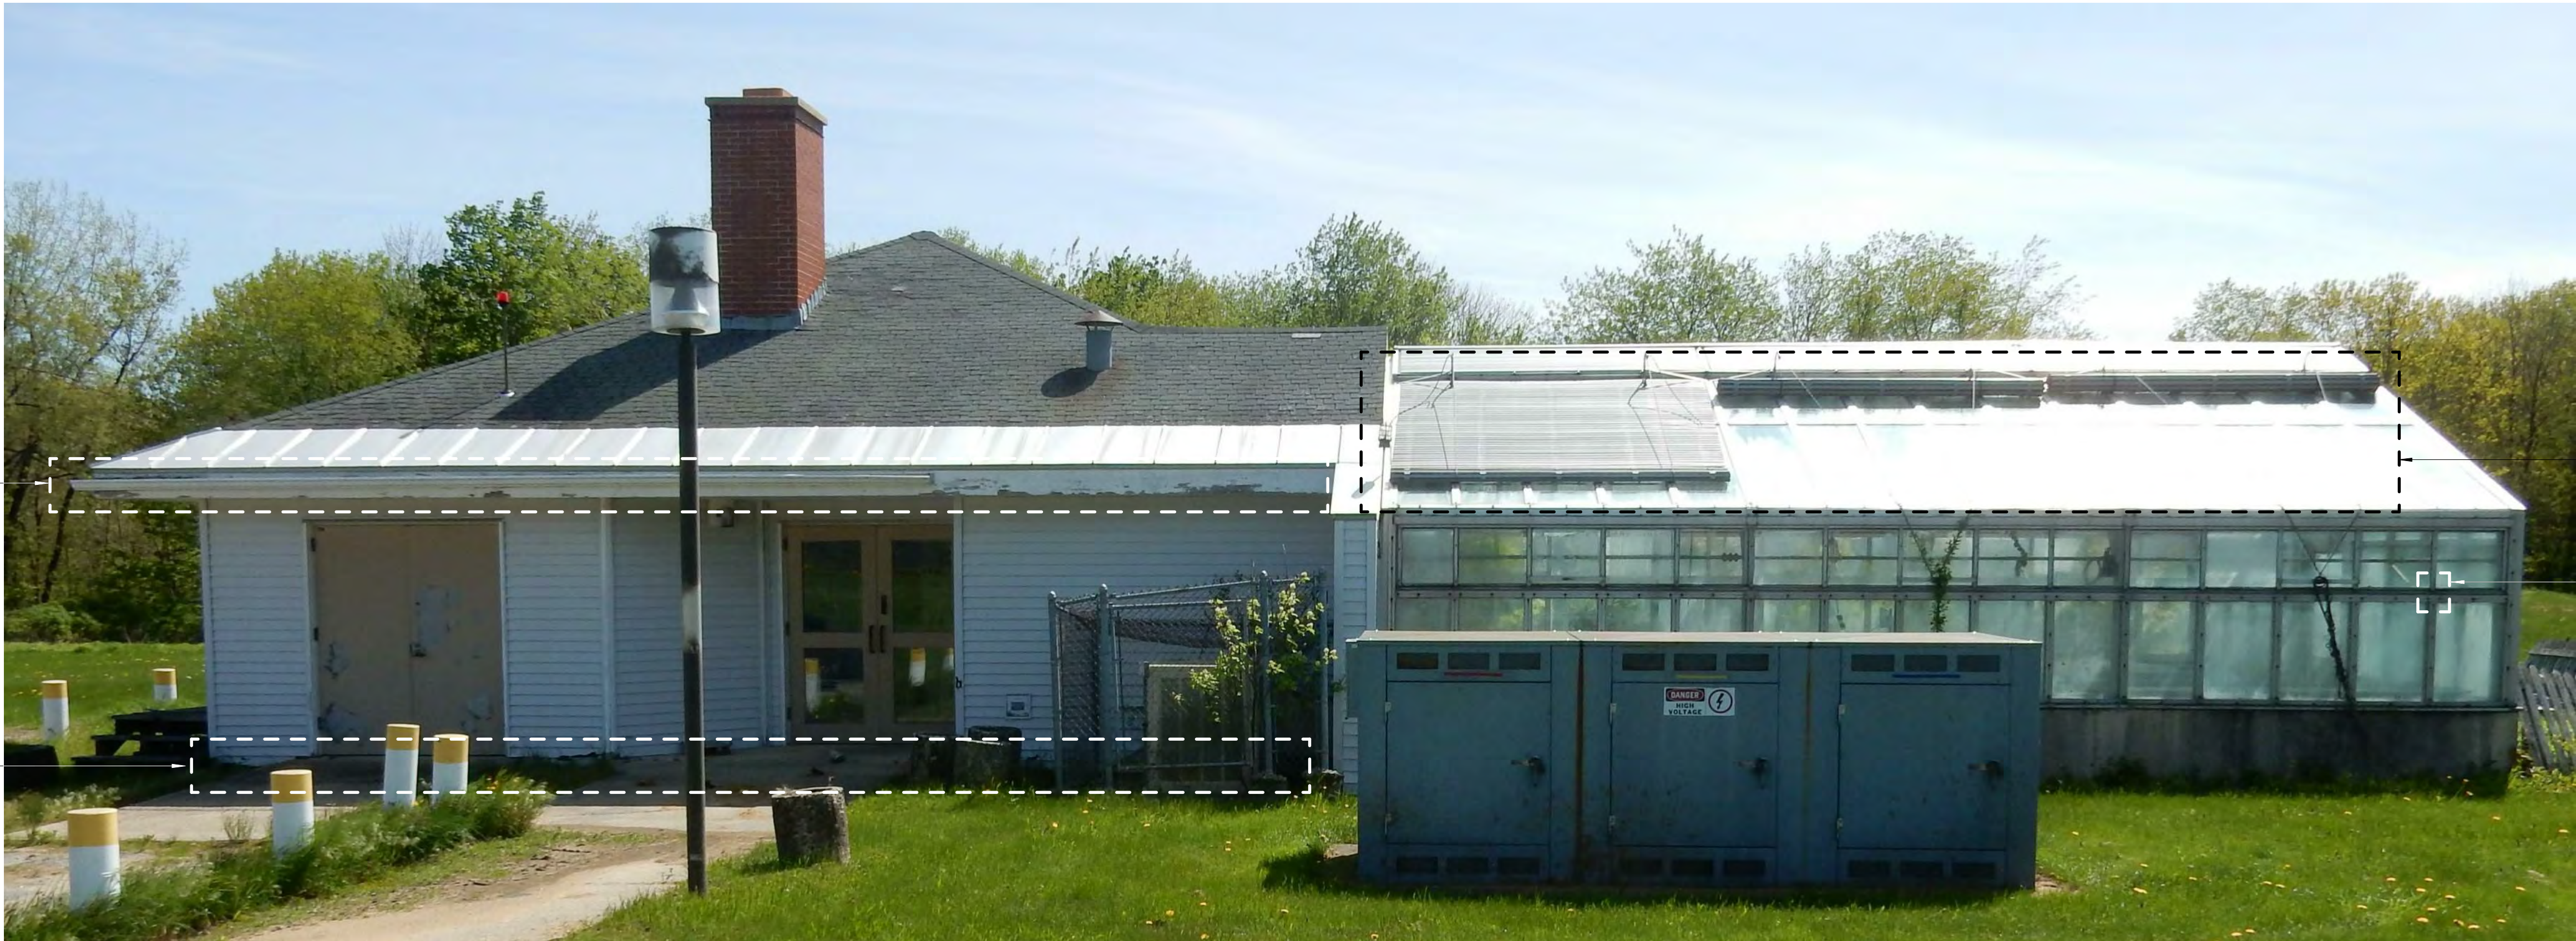
GENERAL NOTES:
ASPHALT SHINGLE ROOF CONDITION (THIS ELEVATION)
IS POOR, BUT WATERTIGHT.
