**AGRICULTURAL INSPECTION AND ASSESSMENT OF
EIGHT AGRICULTURAL BUILDINGS AT THE
TEMPLETON DEVELOPMENTAL CENTER
STRUCTURAL ASSESSMENT BASIS AND METHODOLOGY**

August 4, 2019

**AGRICULTURAL INSPECTION AND ASSESSMENT OF
EIGHT AGRICULTURAL BUILDINGS AT THE
TEMPLETON DEVELOPMENTAL CENTER
STRUCTURAL ASSESSMENT
ELLIOT UPPER BARN**

**AGRICULTURAL INSPECTION AND ASSESSMENT OF
EIGHT AGRICULTURAL BUILDINGS AT THE
TEMPLETON DEVELOPMENTAL CENTER
STRUCTURAL ASSESSMENT
BROOK HOUSE BARN**

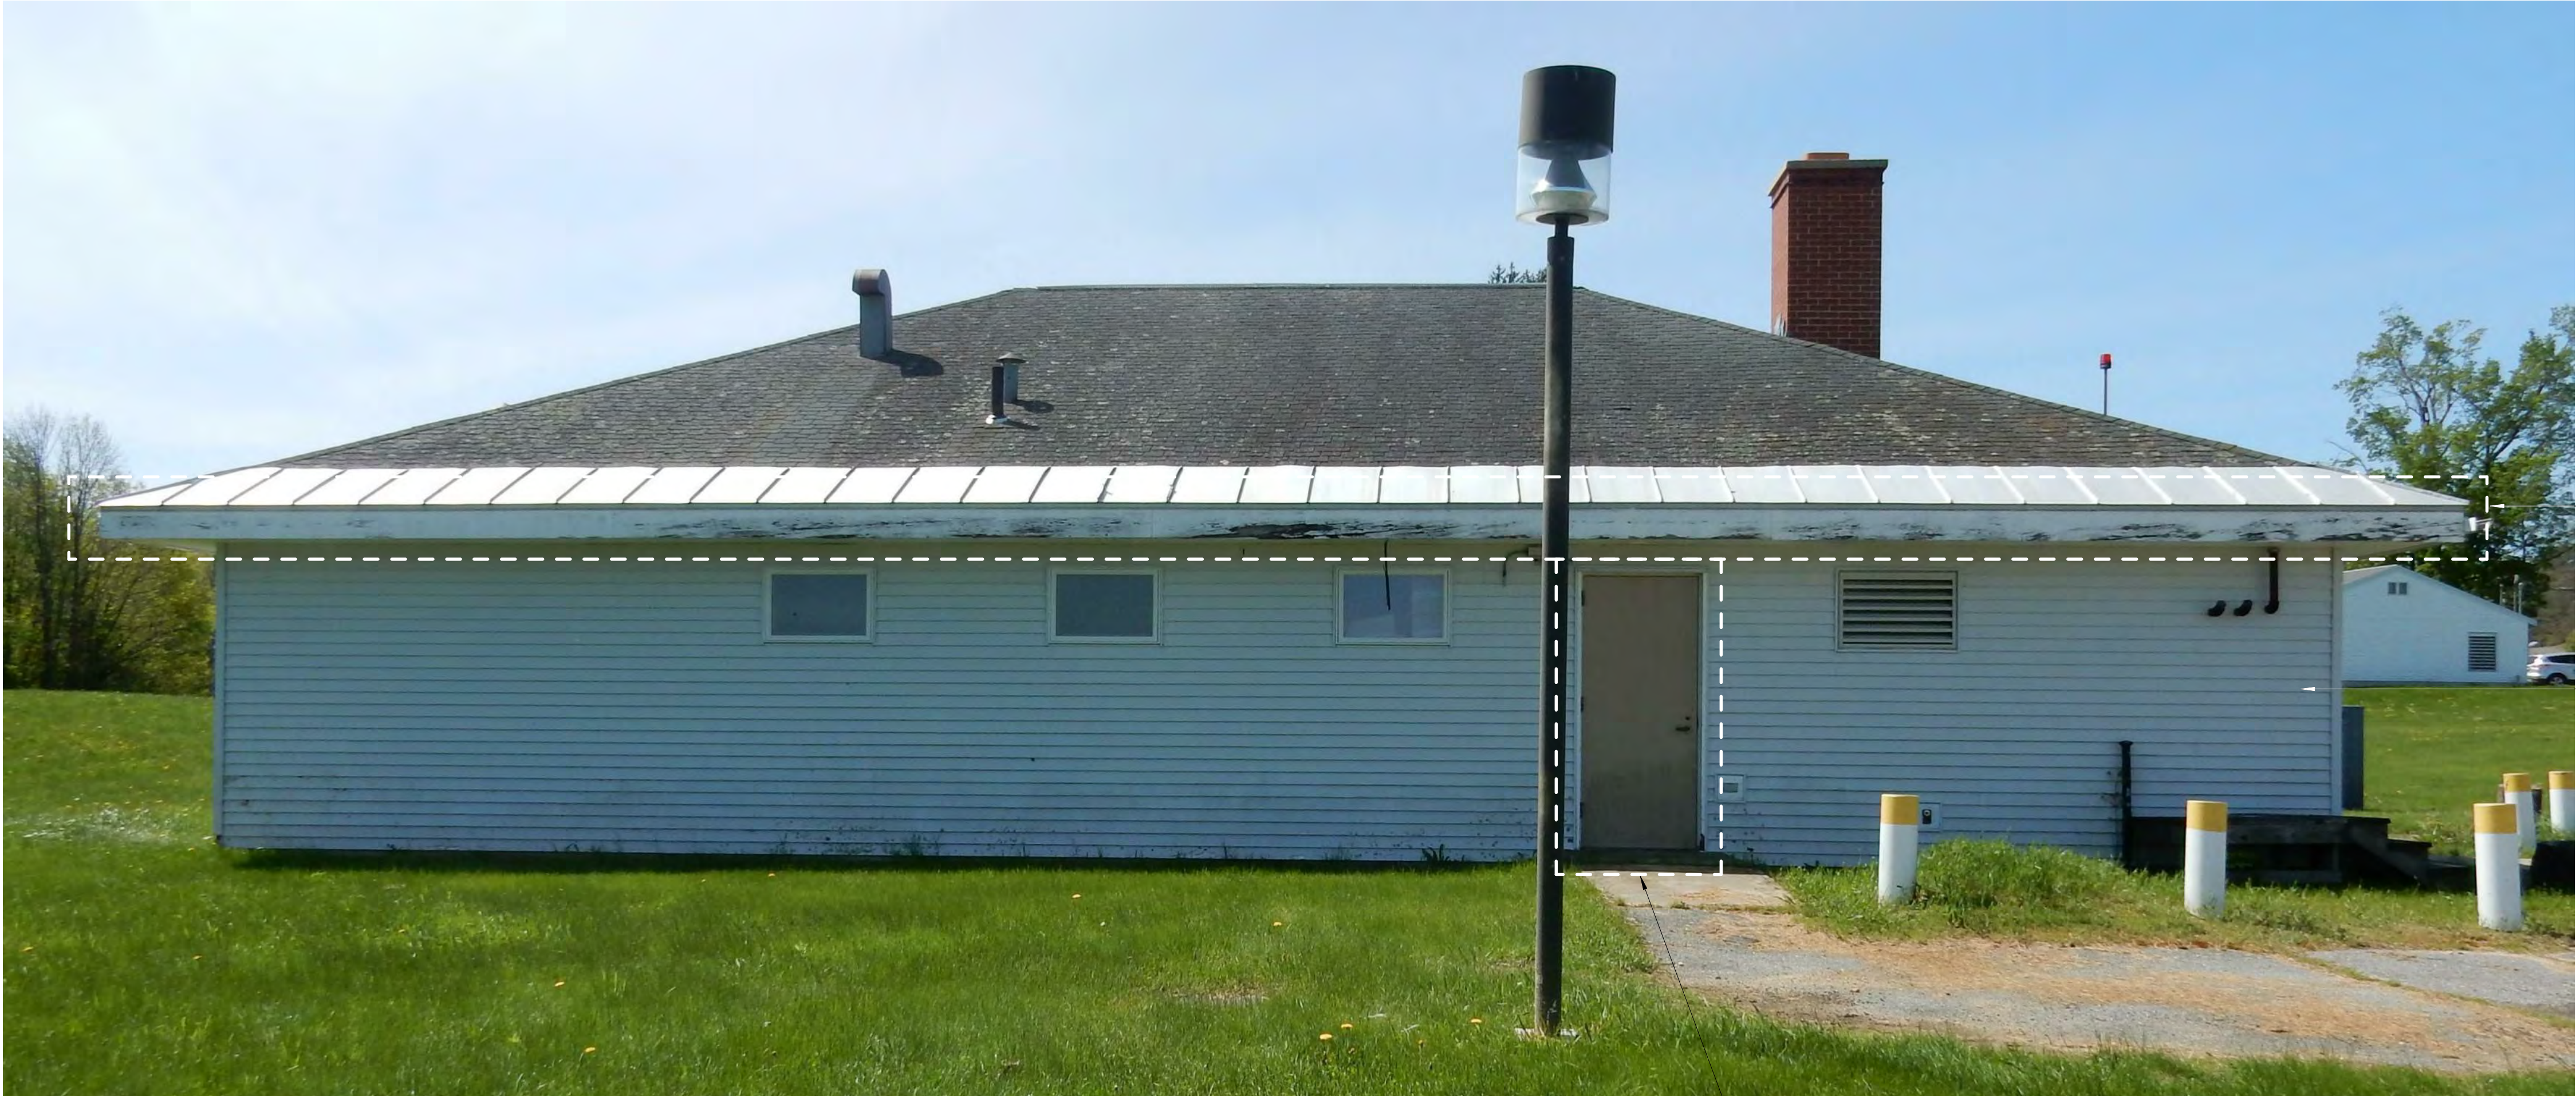
1 LA4 Greenhouse - North Elevation
NOT TO SCALE

GENERAL NOTES:
ASPHALT SHINGLE ROOF CONDITION (THIS ELEVATION) IS FAIR.

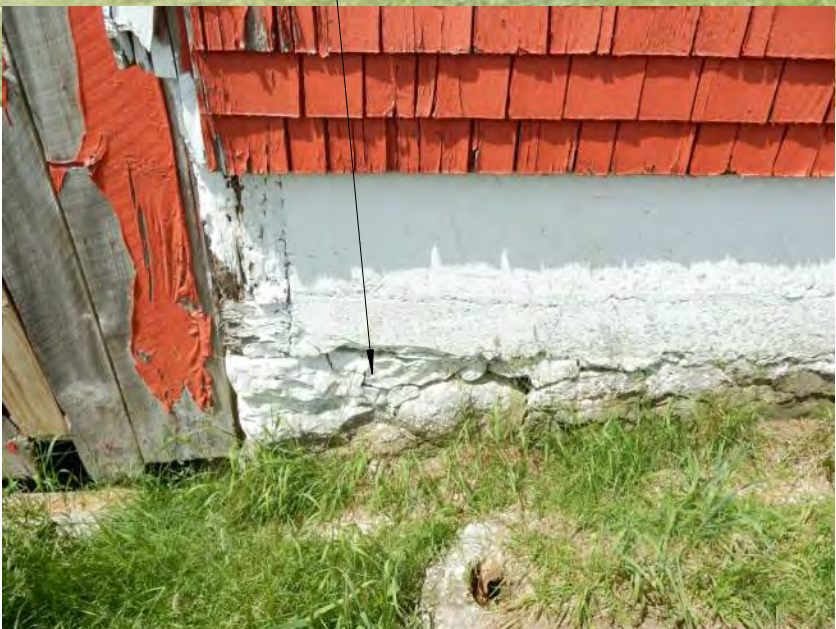
- CAT. 3: REPLACE BOTTOM 3'-0" OF CORNER WOOD TRIM
- CAT. 3: REPLACE VERTICAL WOOD SIDING BOARDS OR REMOVE SHED ADDITION
- RUBBLE FOUNDATION IS LOOSE AT CORNER. REFER TO STRUCTURAL REPORT FOR MORE INFORMATION.

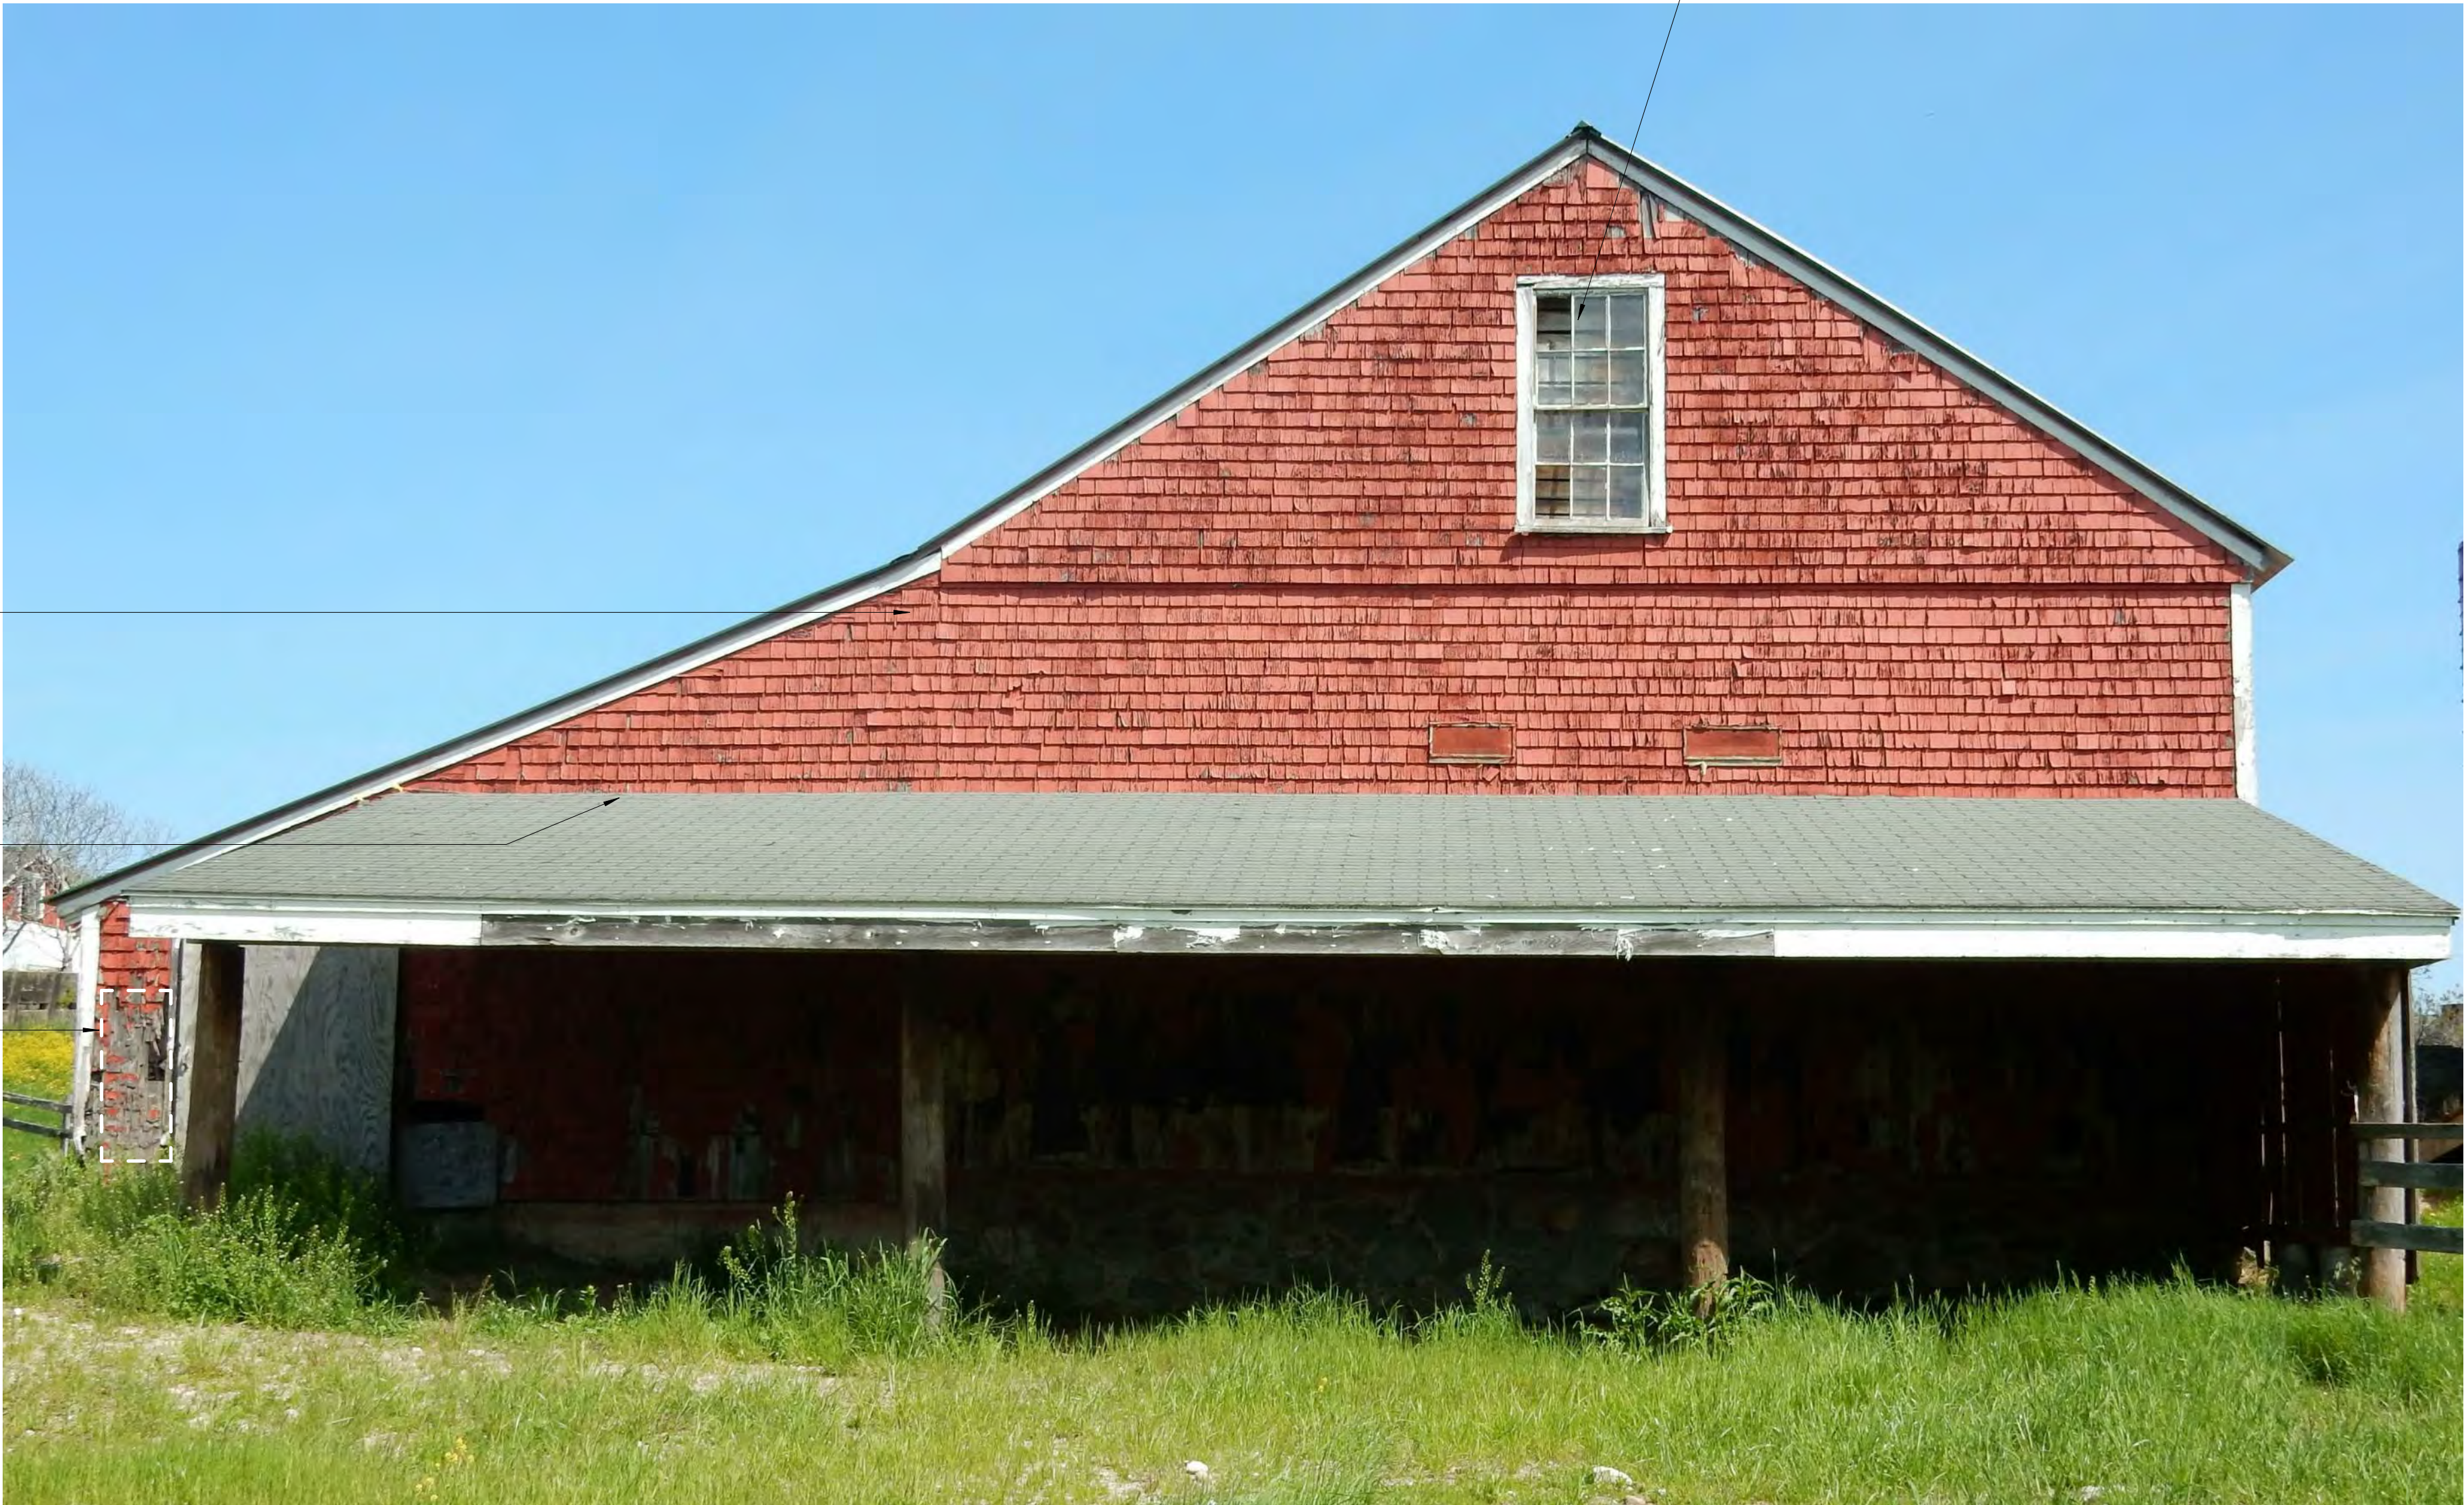
CAT. 3: REPLACE WOOD
SIDING SHINGLES, APPROX.
10% TYP. (SHINGLES IN FAIR
TO POOR CONDITION.)

- CAT. 3: REPLACE DETERIORATED WOOD BOARDS BELOW SHINGLES

- CAT. 2: REPLACE WOOD BOARD "AWNING" OVER SLIDING BARN DOOR HARDWARE.
- CAT. 3: RE-NAIL LOOSE WOOD SIDING SHINGLES, TYP.
- CAT. 3: SELECTIVE REPAIR AND REPLACEMENT OF WOOD SIDING SHINGLES, TYP. 5%
- REMOVE ALL DEBRIS FROM PERIMETER OF BUILDING, TYP.
- CAT. 3: REPLACE SCOTIA MOLDING AND LOWER WOOD PANEL AT WOOD DOOR
- CAT. 3: REPLACE BOTTOM 18" OF WOOD 2X DOOR FRAME.

CAT. 3: REPLACE WOOD
SIDING SHINGLES AND
SHEATHING, 15 SF.

CAT. 2: REPAIR AND REGLAZE WINDOW

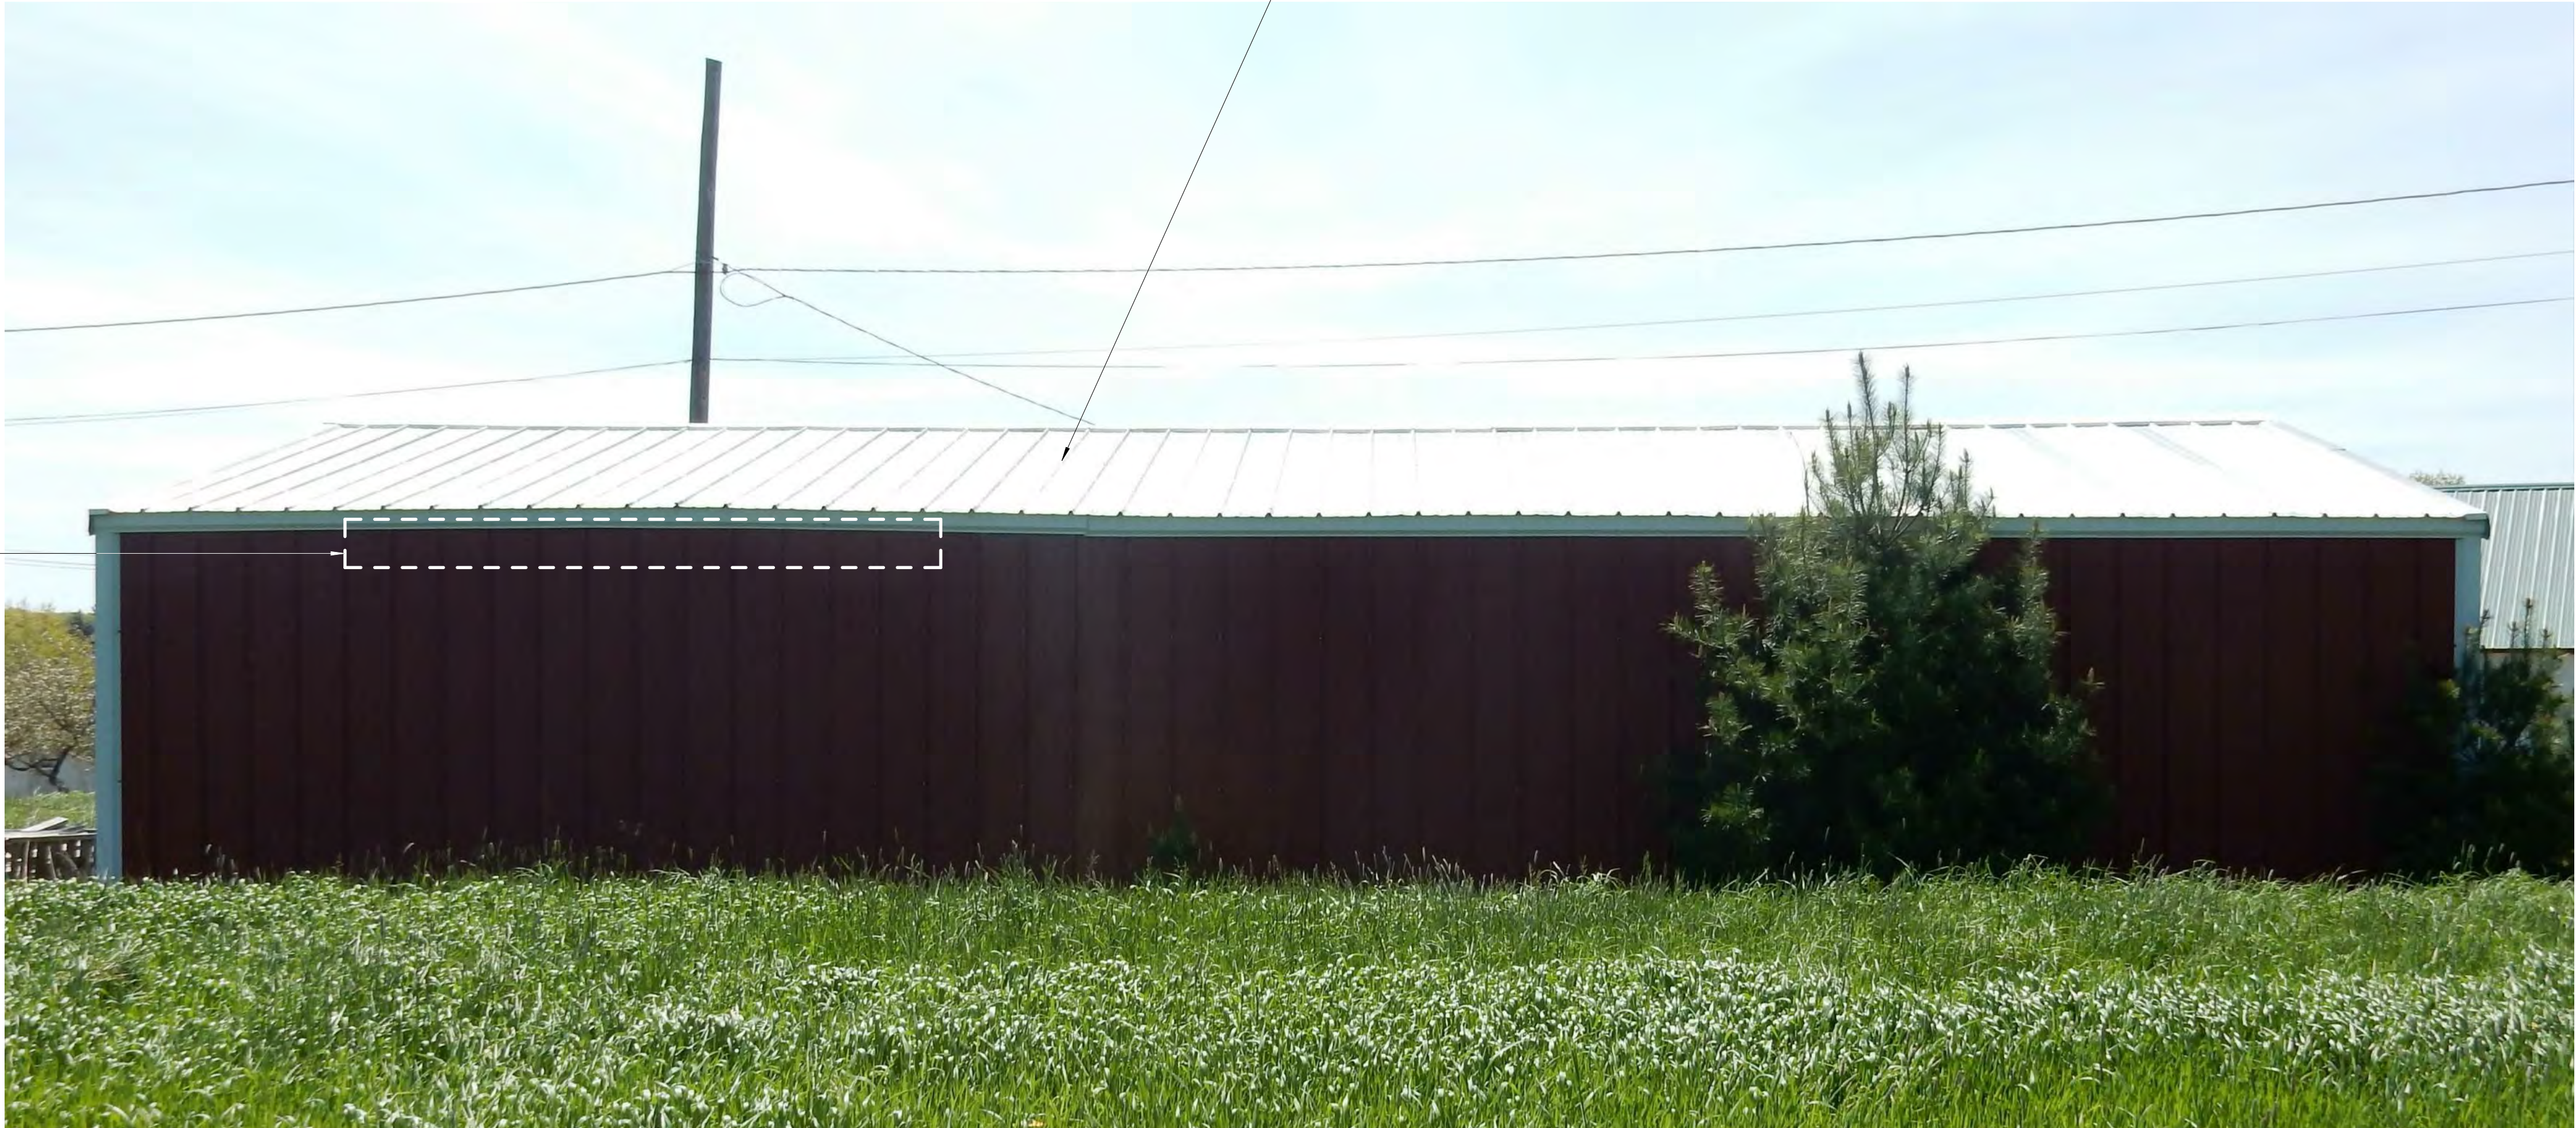
FIELD OBSERVATION: BEAM DEFLECTION. REFER TO SHEET A7.2 FOR MORE INFORMATION. REFER TO STRUCTURAL DRAWINGS FOR ANY NECESSARY REPAIRS.

THE PAINT ON THE STANDING SEAM ROOF HAS FAILED. THE PAINT FAILURE IS VISUAL AND NOT AN IMPORTANT PERFORMANCE ELEMENT. RECOMMENDATION - NO ACTION

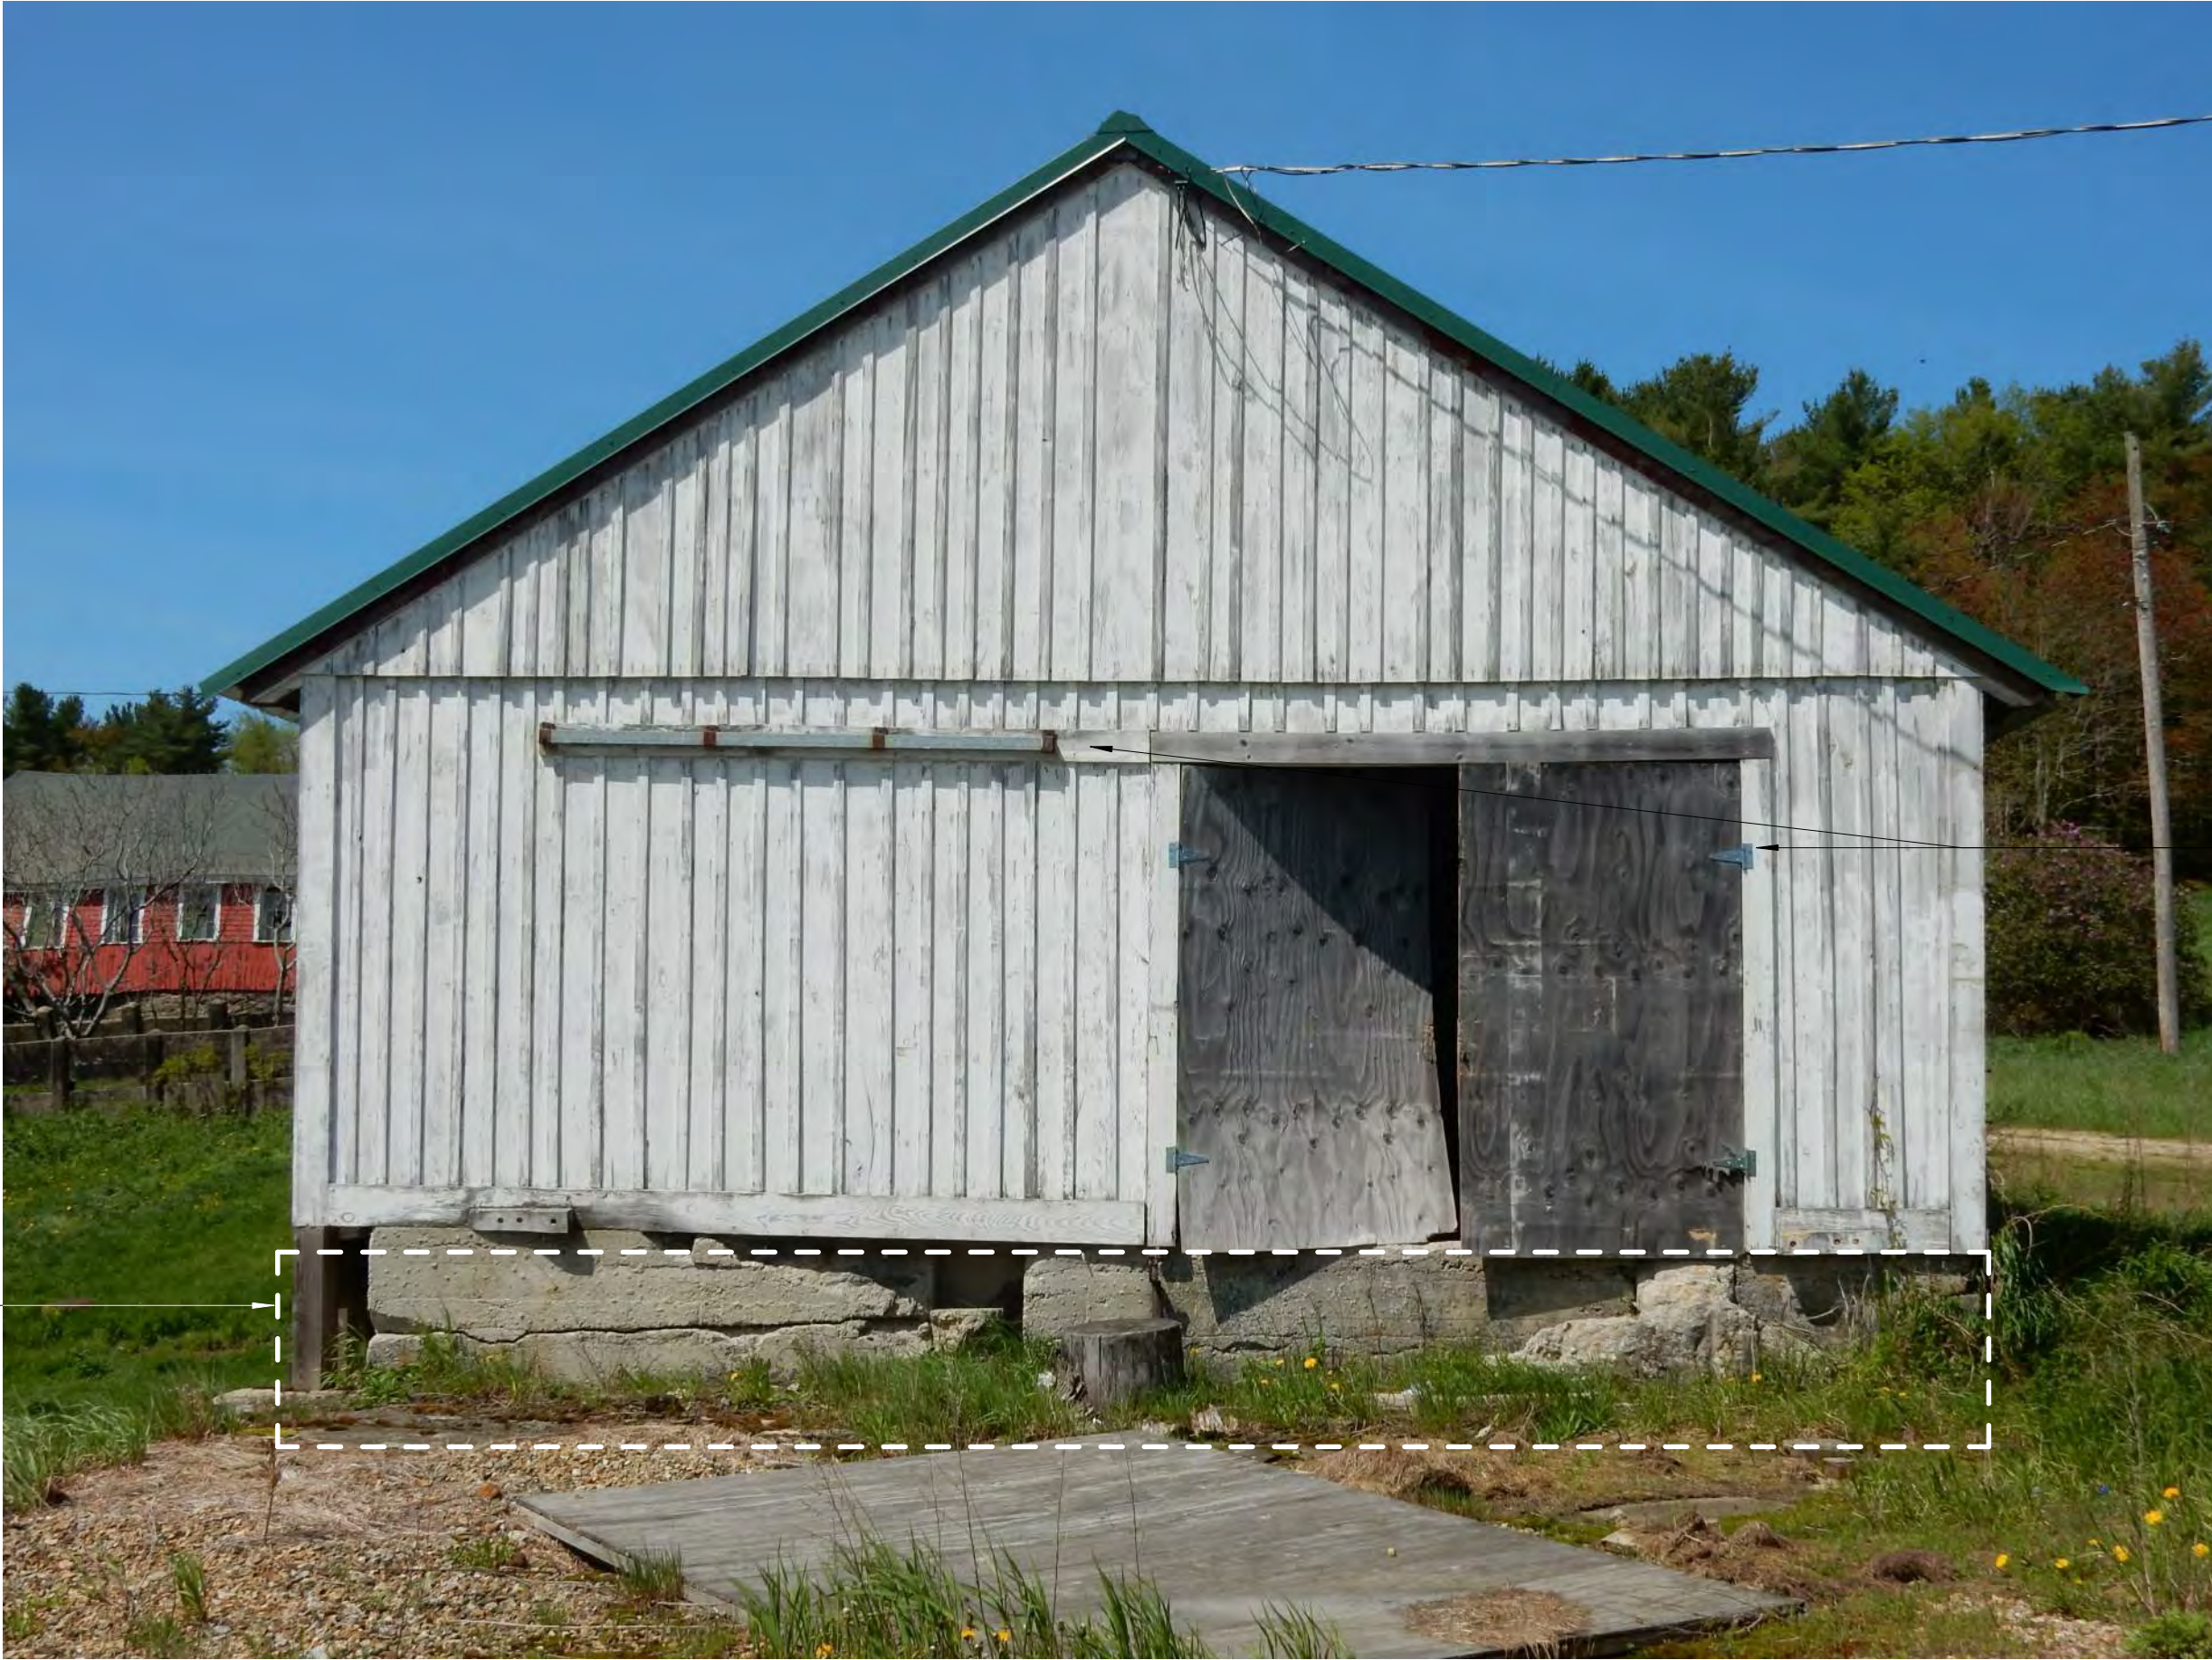
1 LA5 Old Cow Barn - East Elevation
NOT TO SCALE

REFER TO STRUCTURAL REPORT
FOR FOUNDATION INFORMATION

1. ELECTRICAL SERVICE: ABANDONED 60 AMP
FUSED MAIN DISCONNECT (BULLDOG BRAND)
WITH ANTIQUATED (5) CIRCUIT MAIN PANEL
- SERVICE WIRE TO BUILDING HAS BEEN
DISCONNECTED.

CAT. 2: REPLACE WOOD
SLIDING BARN DOOR AND
HARDWARE
