Comprehensive Wastewater Resilience Feasibility Study

Town of Scituate, Massachusetts

June 30, 2019

File No. 01.0173977.00

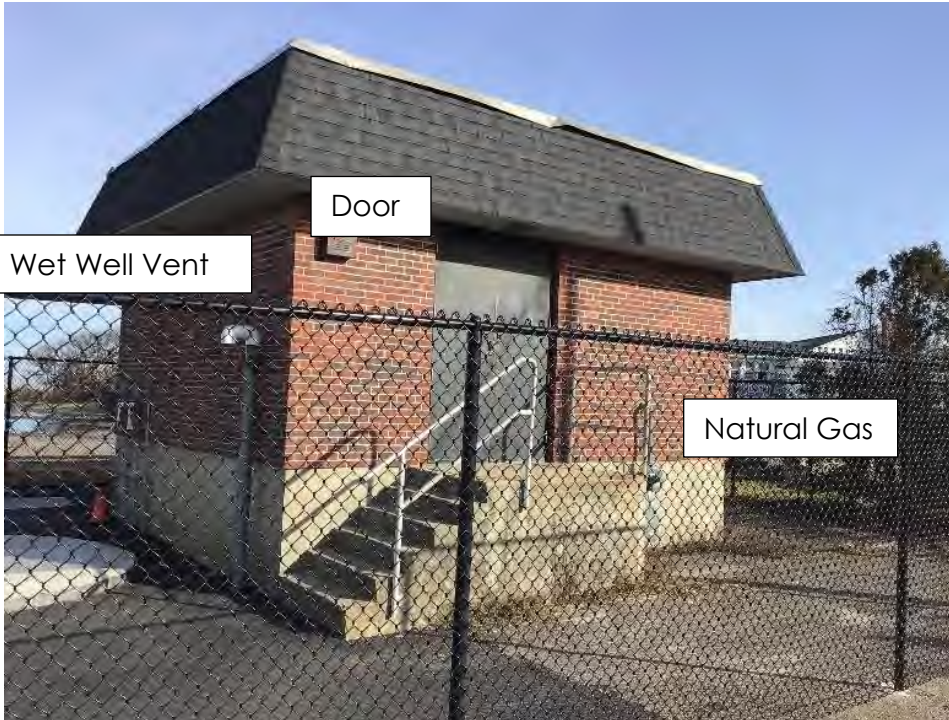
Photo 1 Chain Pond PS Entrance

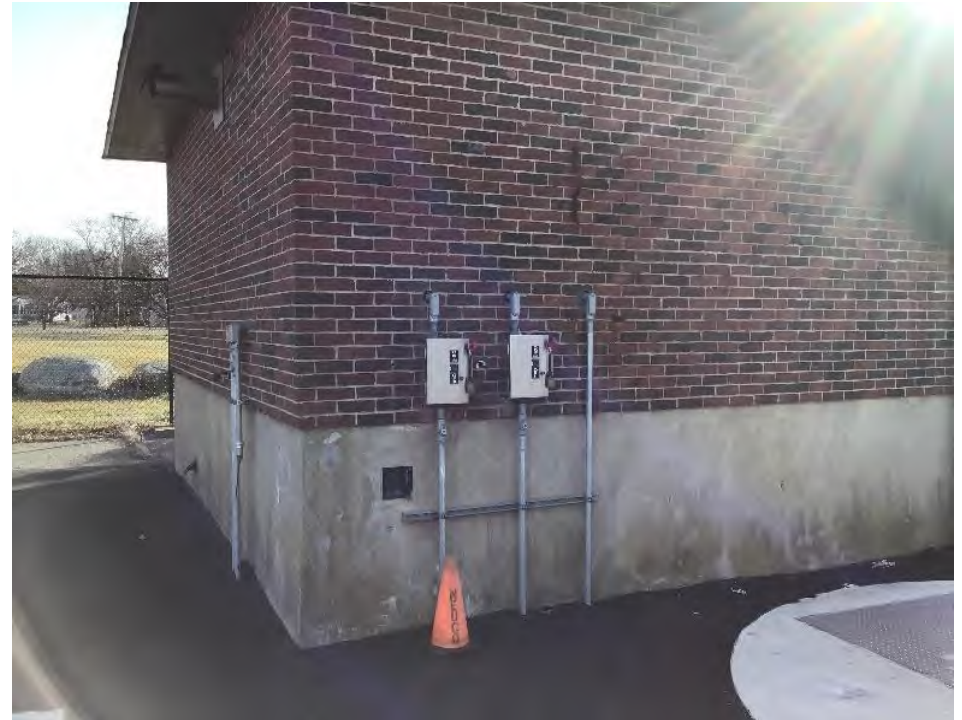
Photo 2 Chain Pond PS Electric Conduits

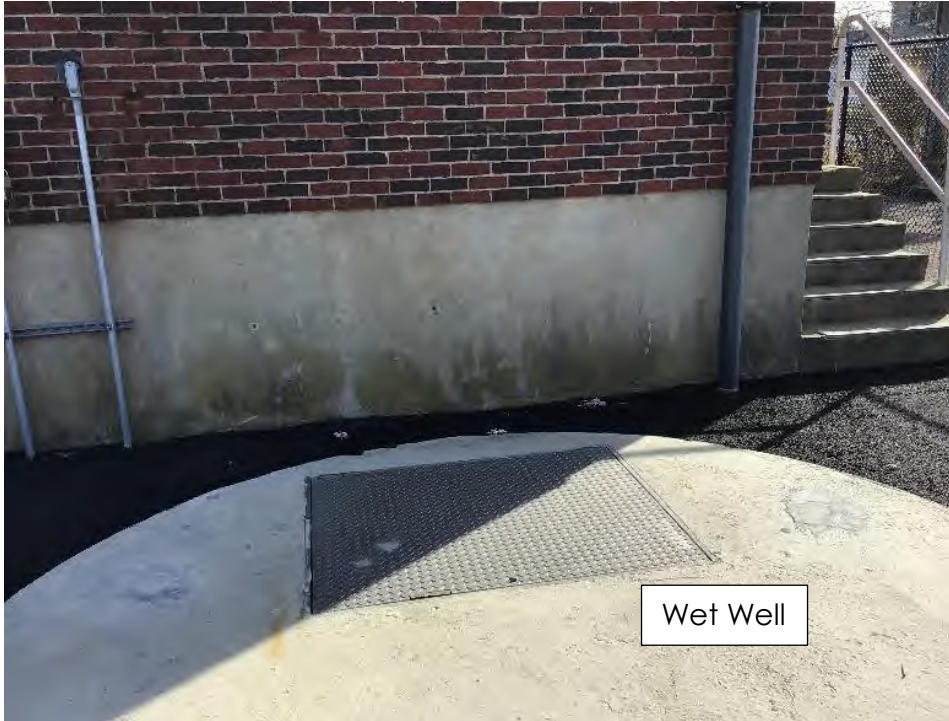
Photo 3 Chain Pond PS Wet Well

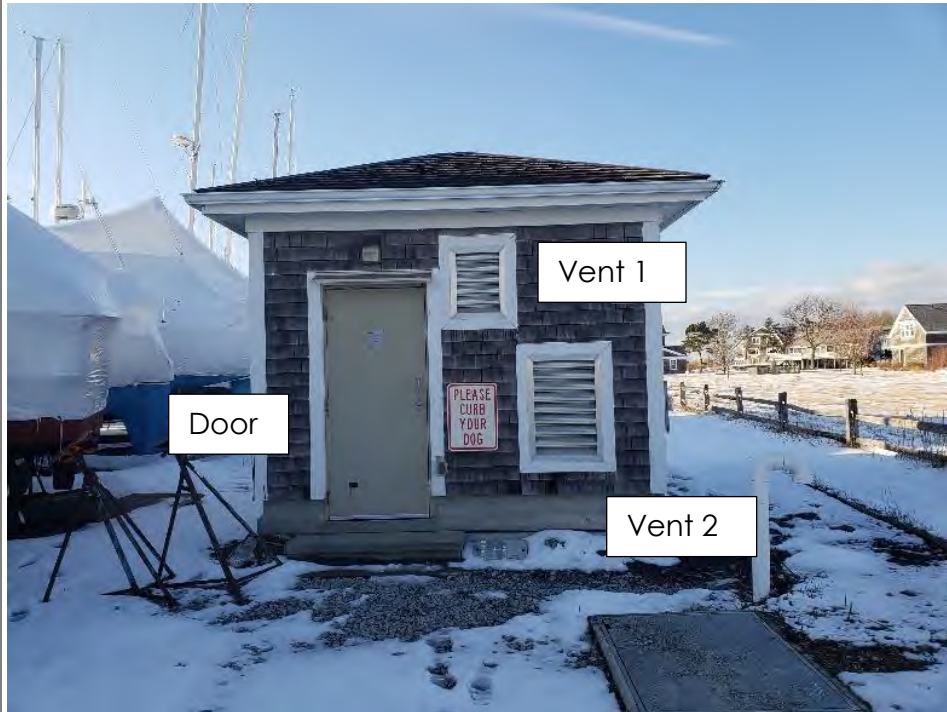
Photo 1 Edward Foster PS Entrance

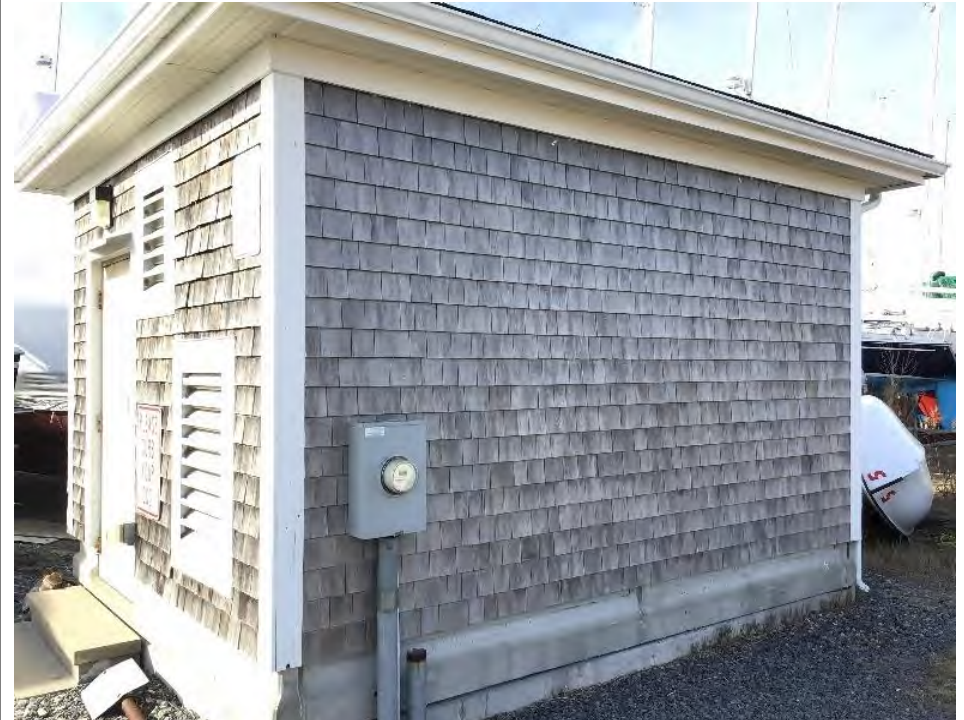
Photo 2 Edward Foster PS Electric Meter

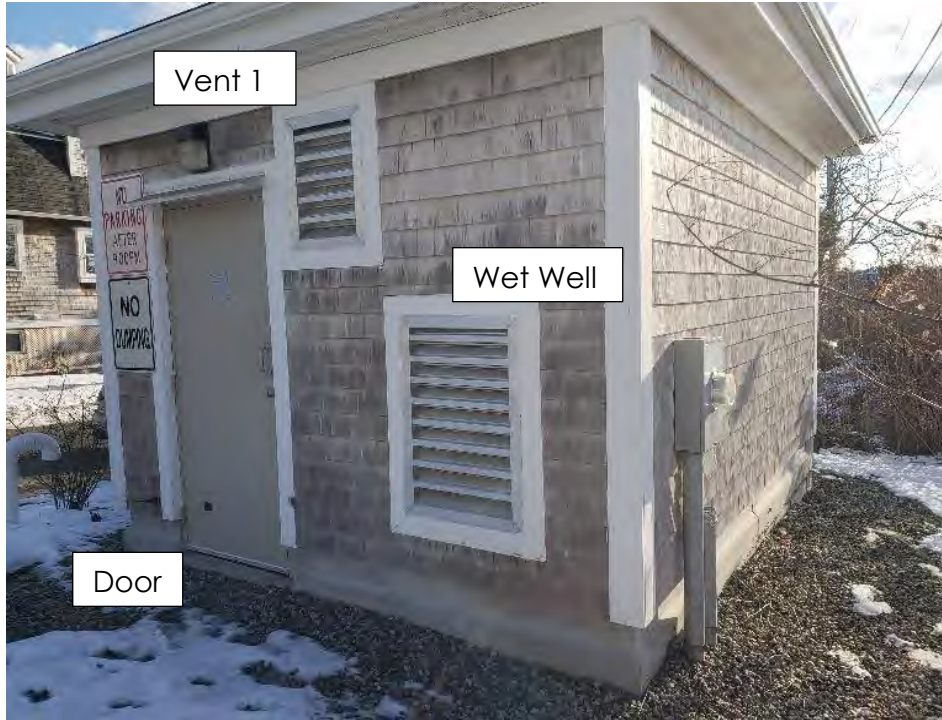
Photo 1 Peggotty Beach PS

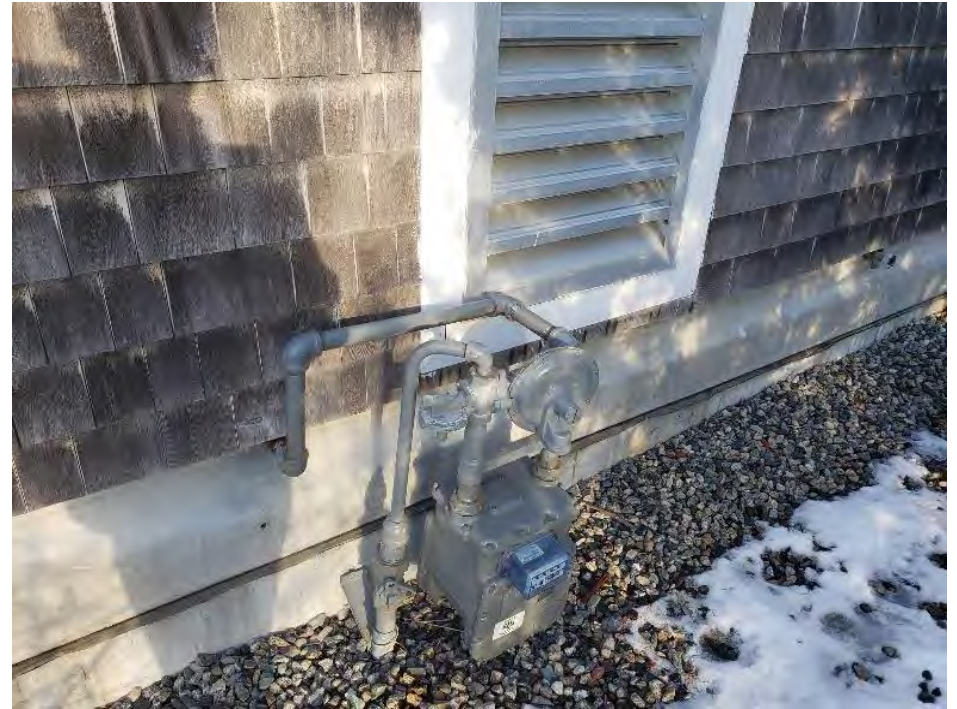
Photo 2 Peggotty Beach PS Gas Meter

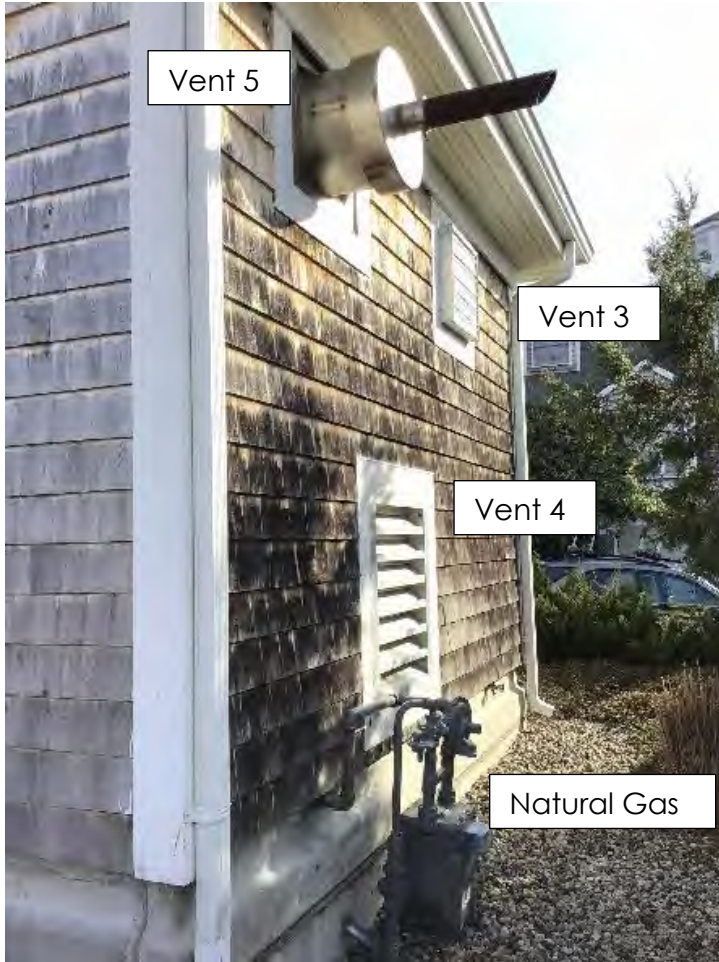
Photo 3 Peggotty Beach PS Exhaust Vents

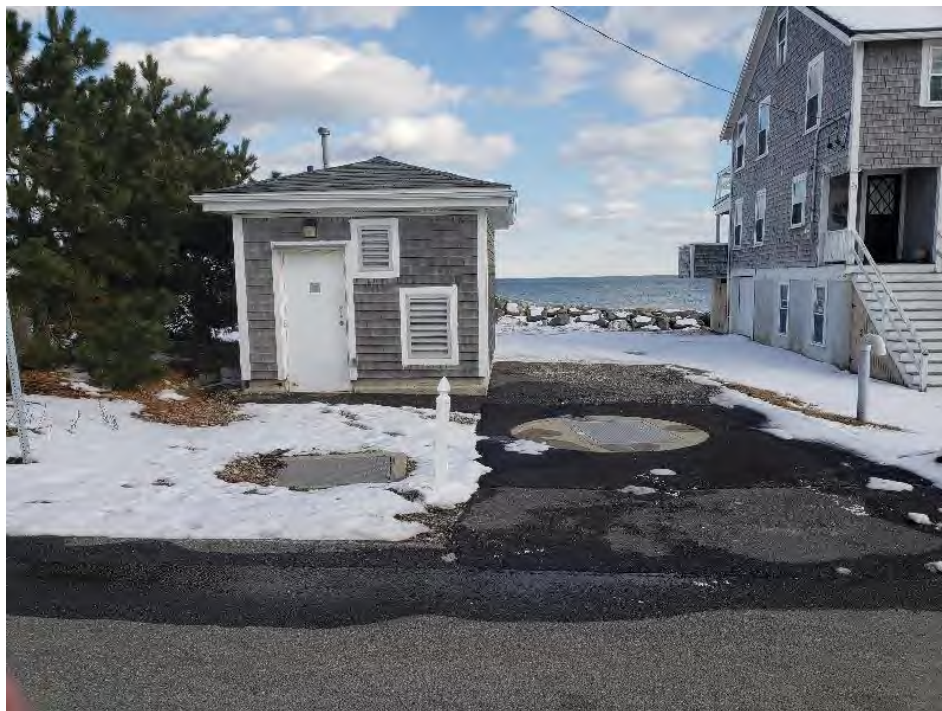
Photo 1 Collier Road PS

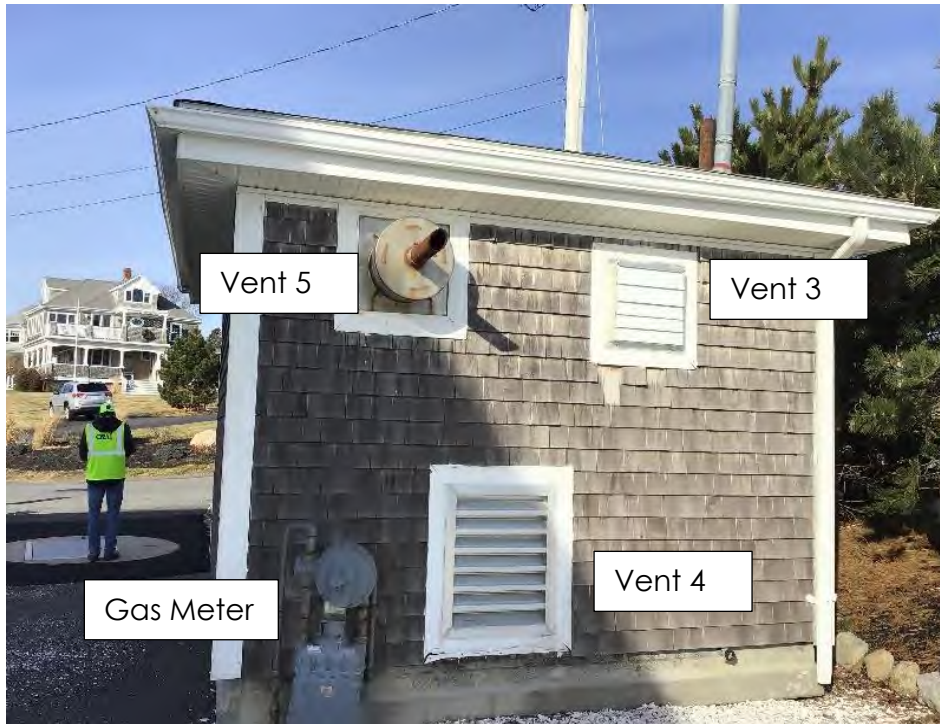
Photo 3 Collier Road PS Exhaust Vents

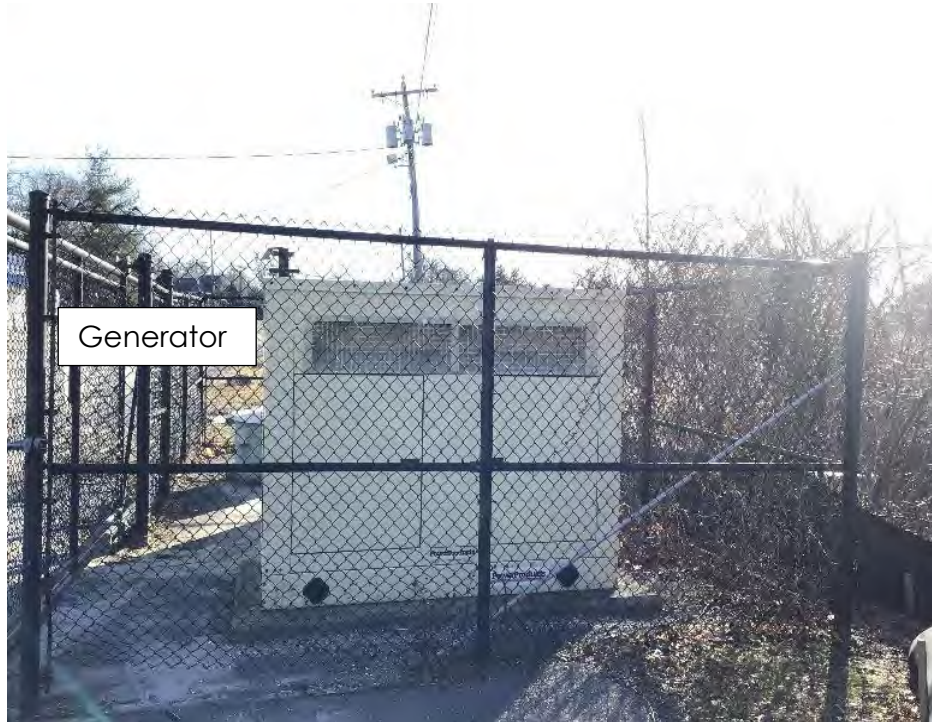
Photo 3 Photo 27 Herring Brook PS Generator

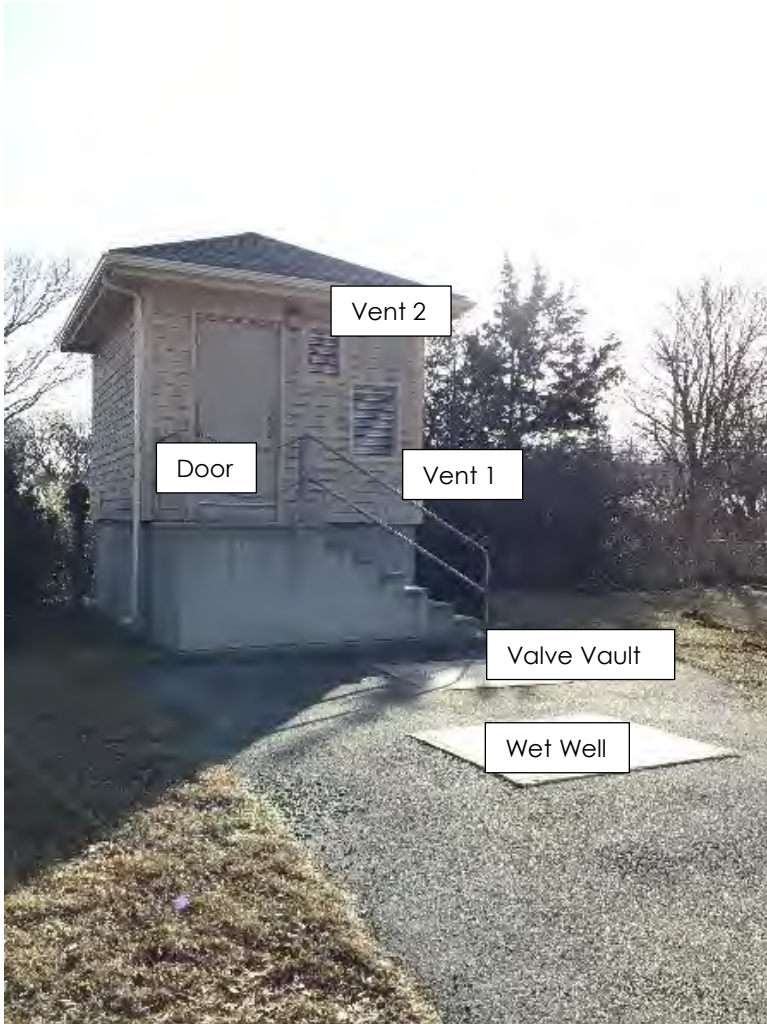
Photo 1 Musquashicut Avenue PS Entrance

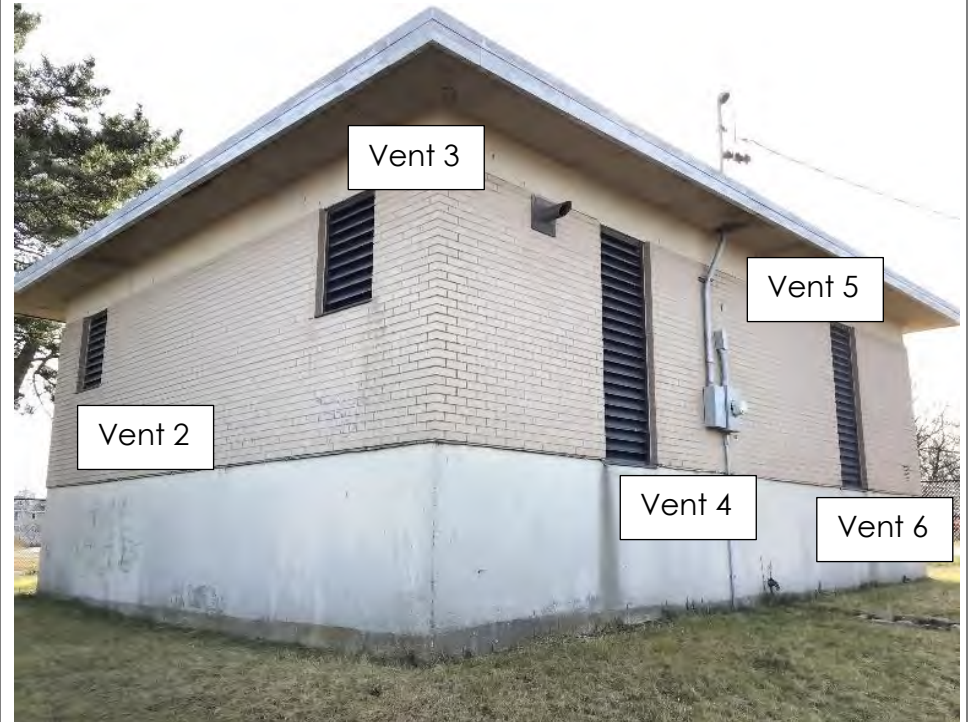
Photo 3 Photo 23 Sand Hill PS West Side

Vent 7

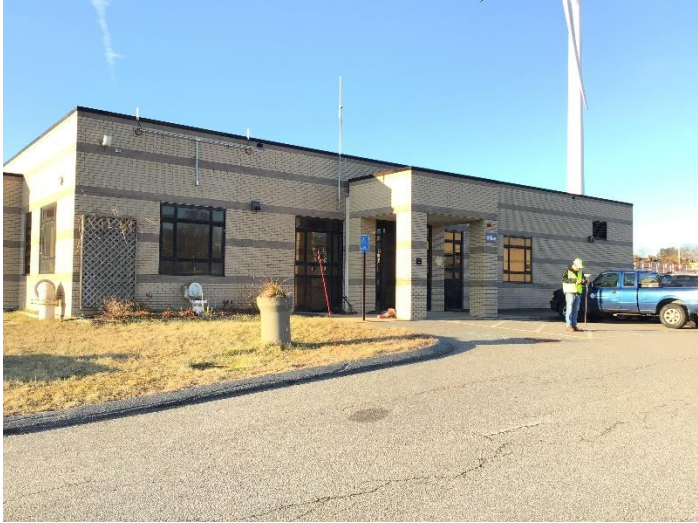
Client Name: Town of Scituate		Site Location: Scituate Waste water Treatment Plant		Project No. 01.0173977.00	
Photo 1 Office Building/ Filter Building Main Entrance			Photo 2 Door and Garage on East Side of Filter Building

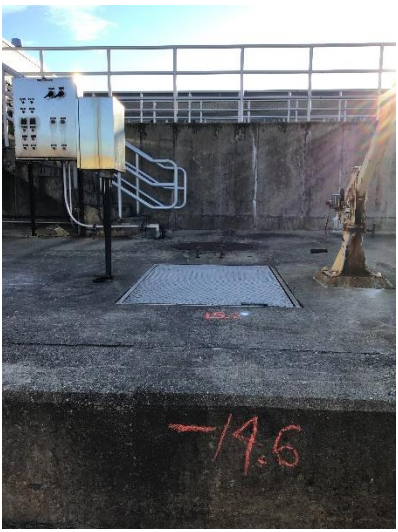
Photo 9 Electric Box on West Side of Filter Building		Photo 10 Wet Well Manhole on NorthSide of Filter Building
