Report of
Facility Condition Assessment

Bay State Correctional Center
28 Clark Street
Norfolk, Massachusetts 02056

September 29, 2019

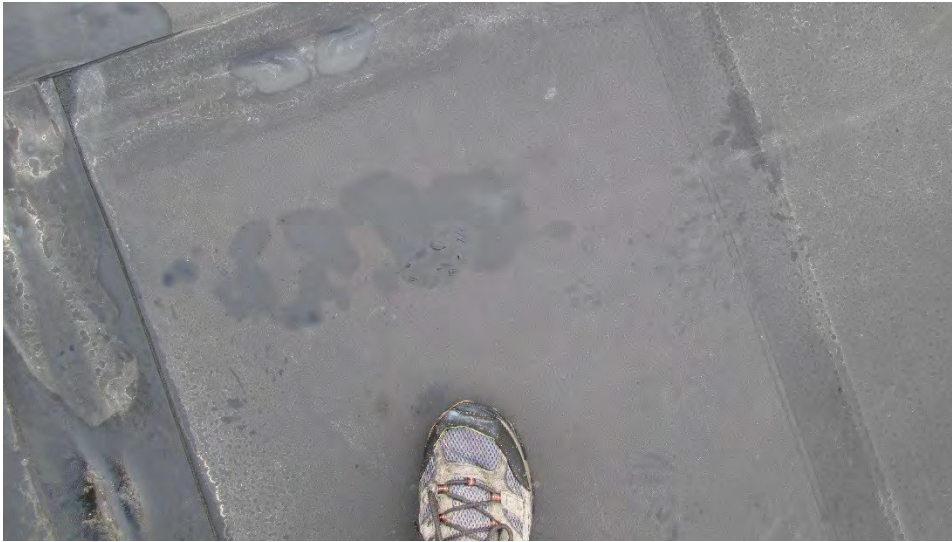
Photograph No. R-1

Gate House roof.

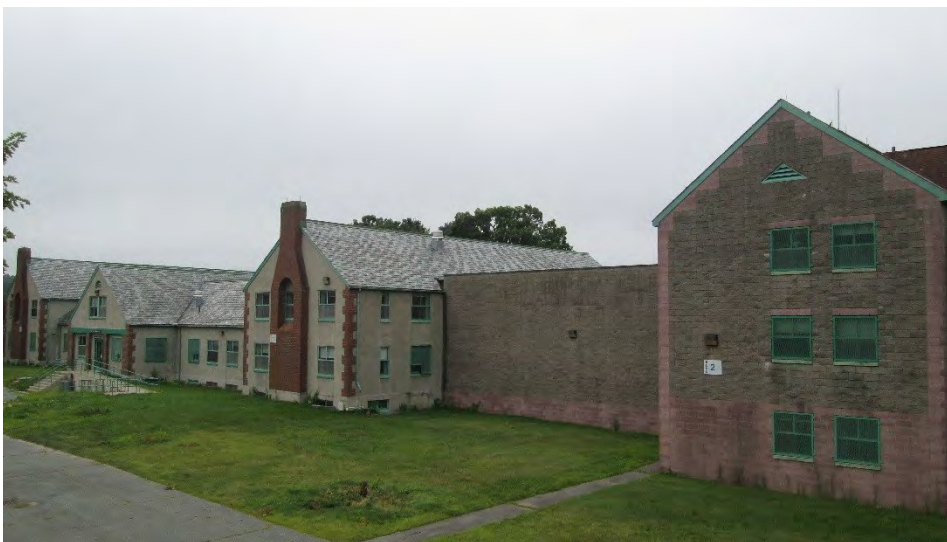
Photograph No. EX-4

Visitor building.

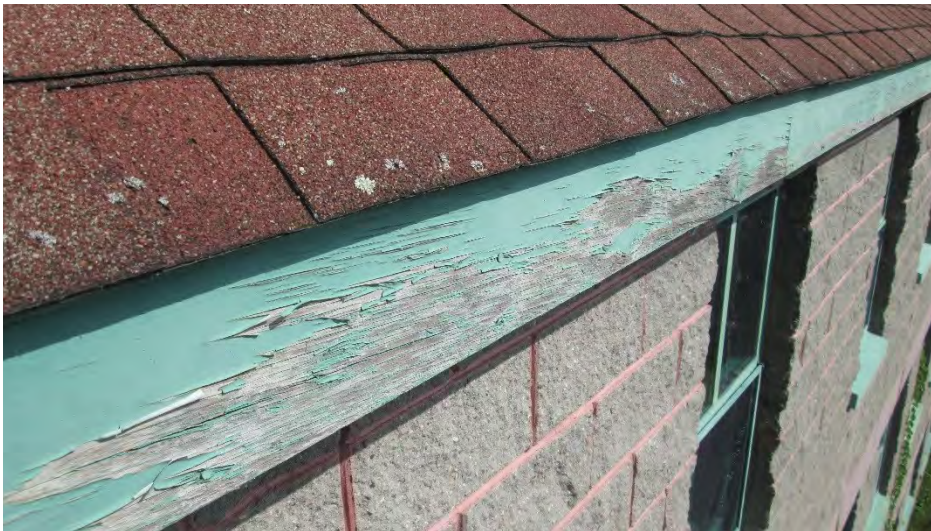
Photograph No. EX-11

Failed paint at Administration Building fascia resulting from lack of gutter.

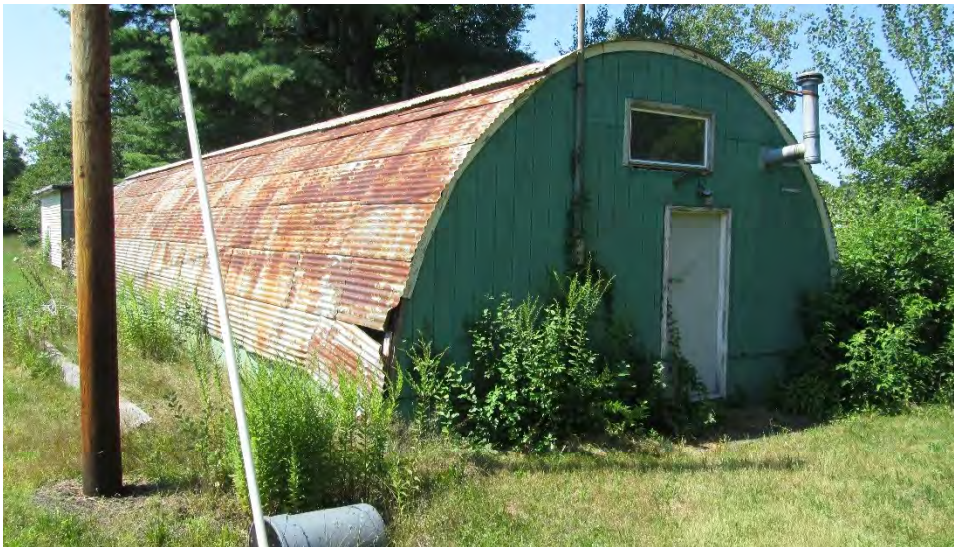
Photograph No. EX-14

Morton building.

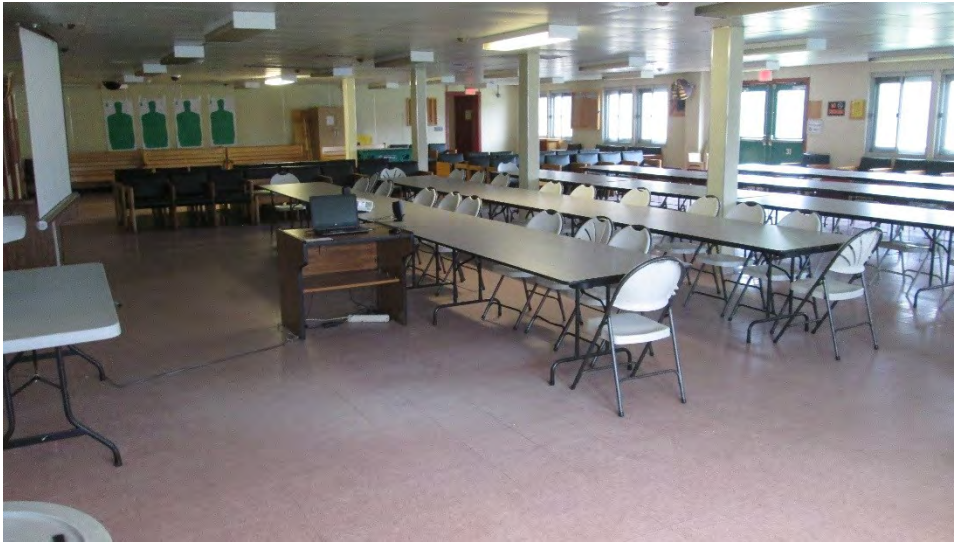
Photograph No. I-1

Interior of Gate House.

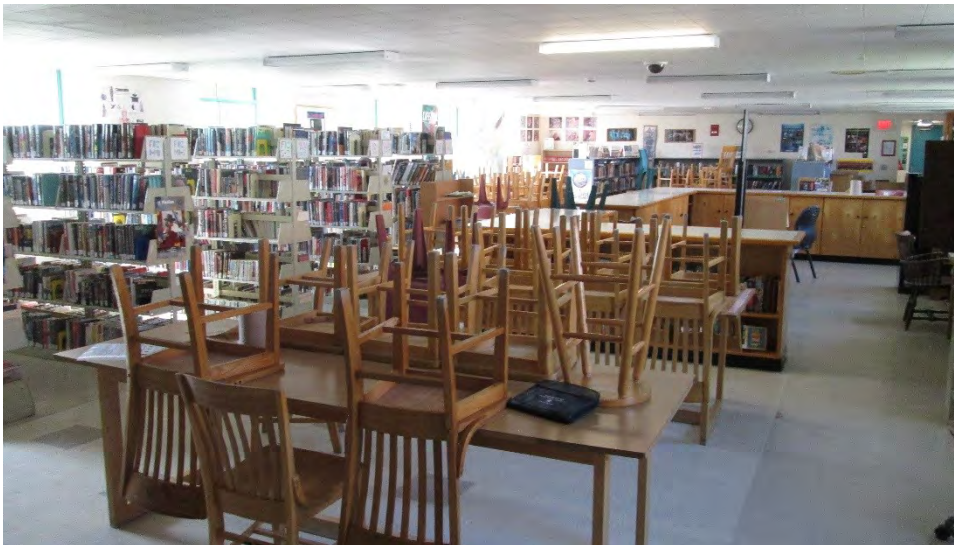
Photograph No. I-2
Interior of Visitor Building.
