**Report of**  
**Facility Condition Assessment**  
South Middlesex Correctional Center  
135 Western Avenue  
Framingham, Massachusetts 01702

July 26, 2019

Reference: Report of Facility Condition Assessment  
South Middlesex Correctional Center  
135 Western Avenue  
Framingham, Massachusetts 01702  
Faithful+Gould Project No. 100066196

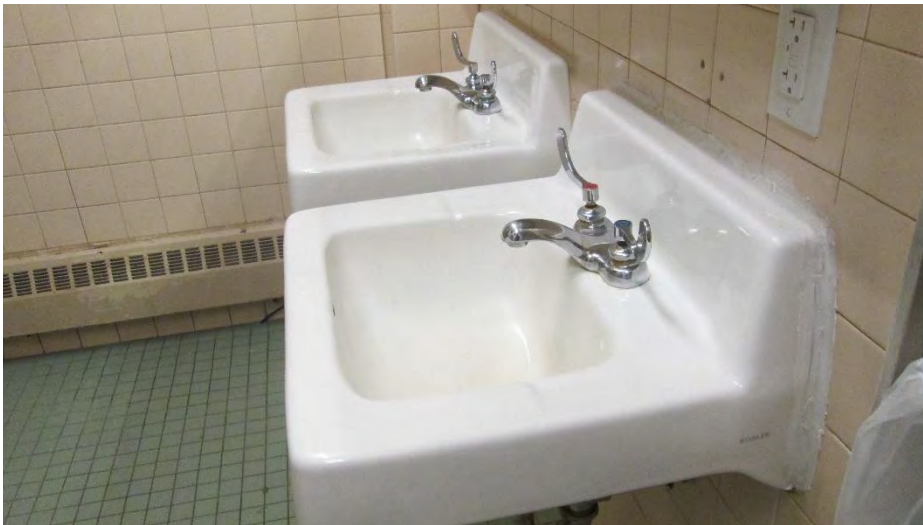
**Photograph No. P-05**

Typical Bathroom Fixtures and Finishes

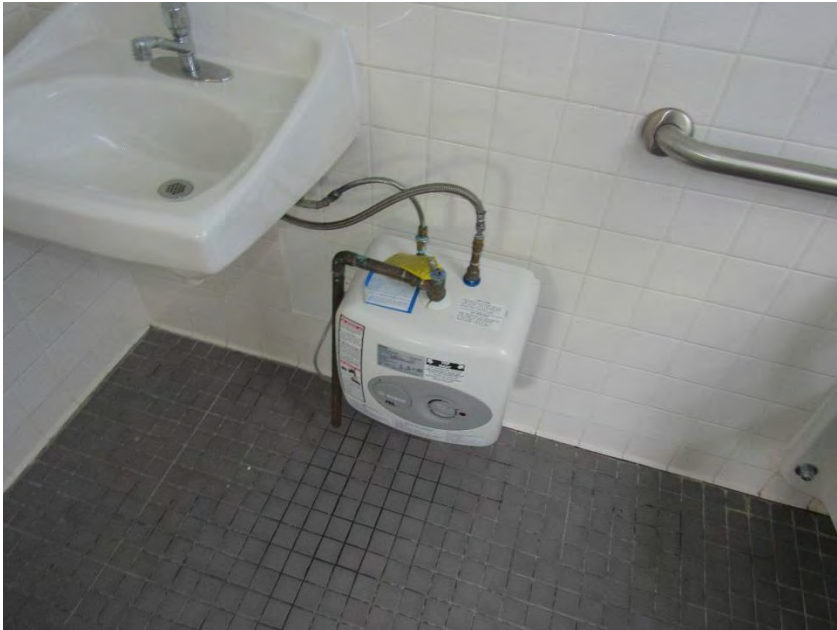
**Photograph No. P-06**

Typical Bathroom Fixtures and Finishes

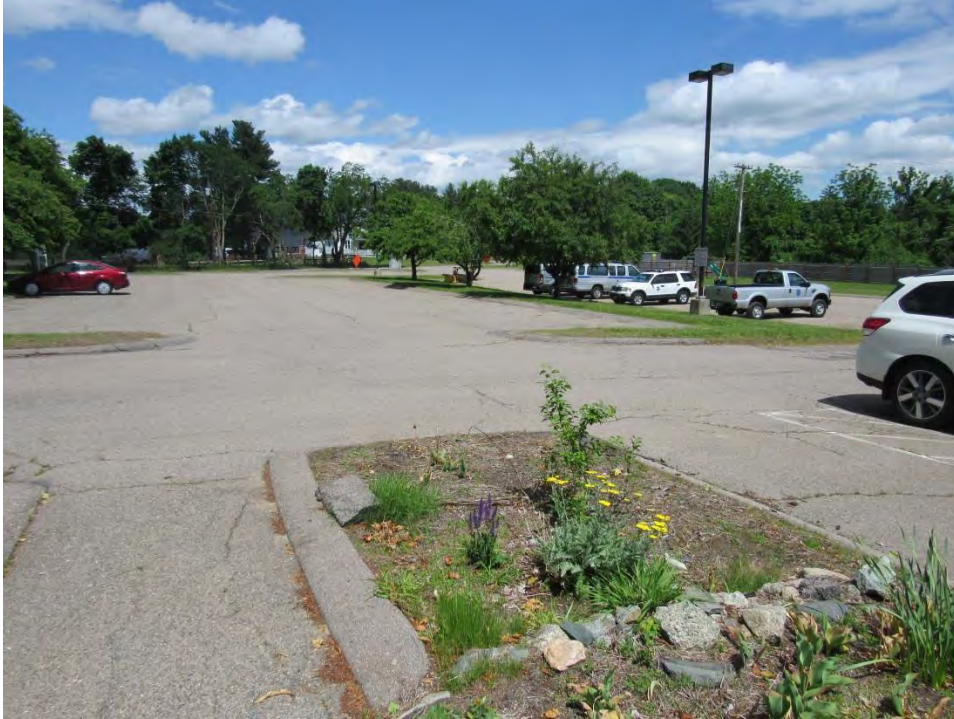
**Photograph No. ST-02**

Visitor Parking Lot

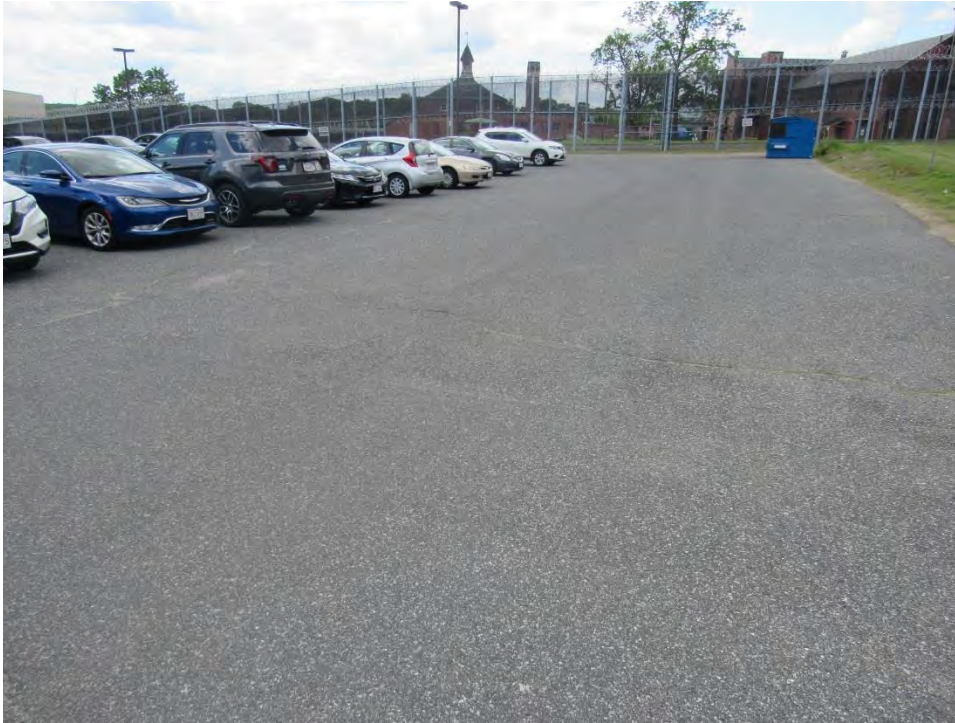
**Photograph No. ST-04**

Deterioration of Asphalt at  
Entrance to Staff Parking  
Lot

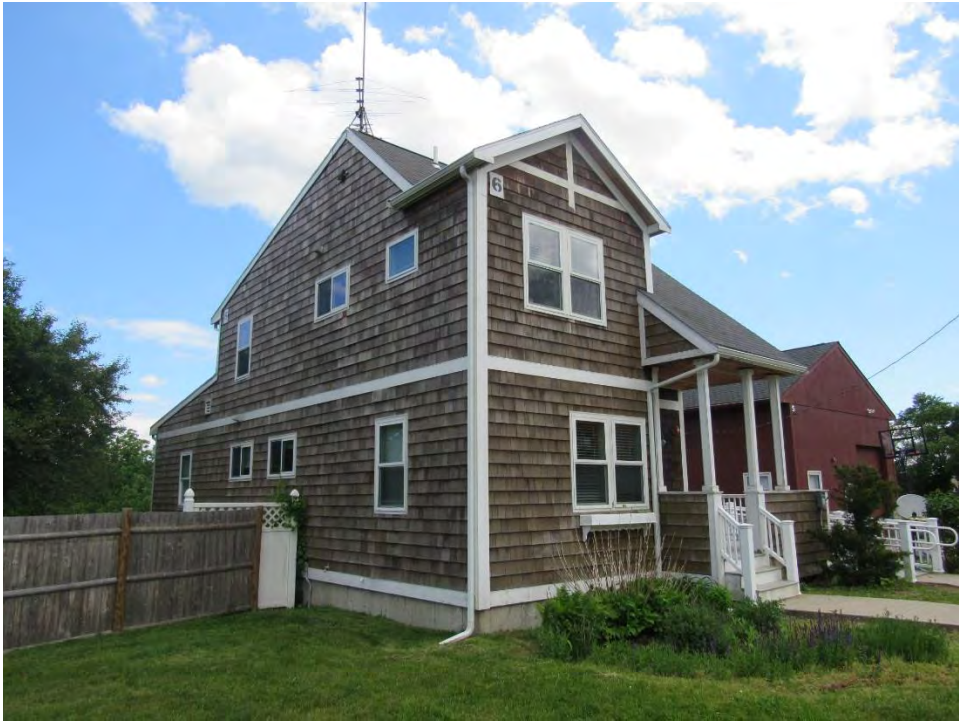
**Photograph No. EX-10**  
Front Elevation of  
Automotive Garage
