Springfield Prep Charter School

# Feasibility Study

2071 Roosevelt Ave, Springfield MA

# ACQUISITION PROPERTY CONDITION REPORT

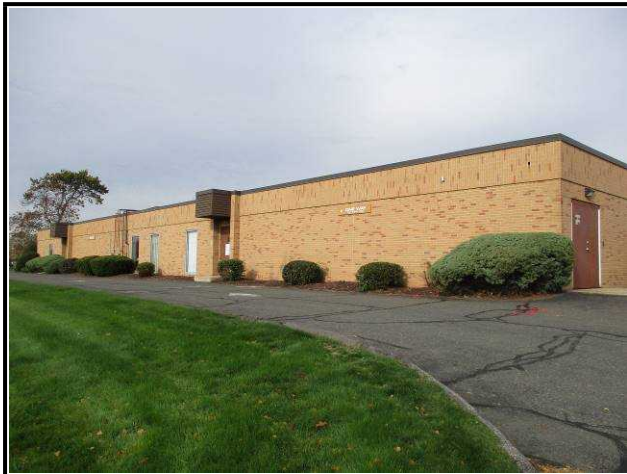
Mature landscaping provided at all sides of the building.

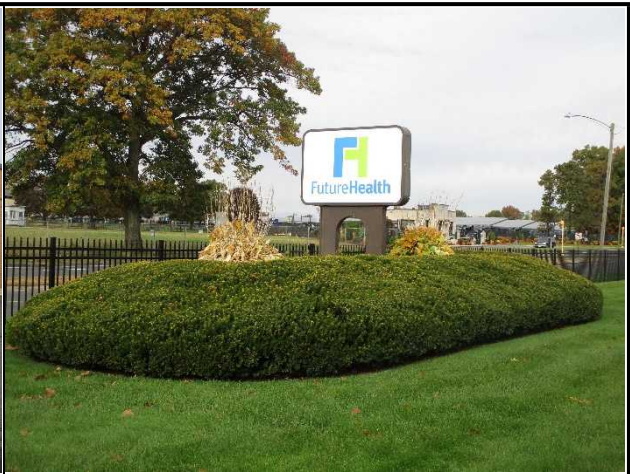
Large pylon sign along front property line.

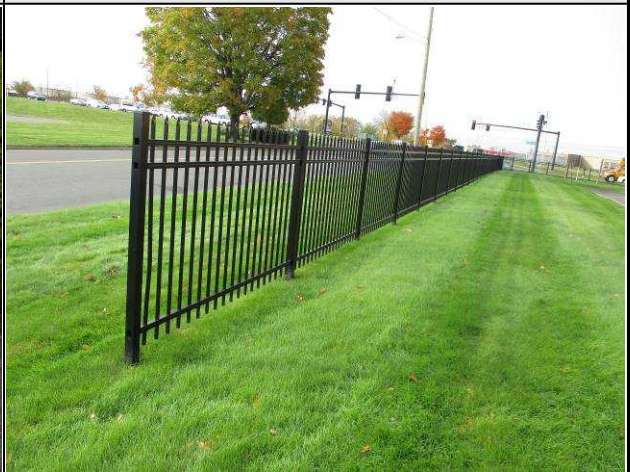
Painted metal fencing along the front and southeast property lines.

The fencing along the northwest and northeast property lines is in good condition and will be maintained at the property as part of operational expenses during the analysis term.

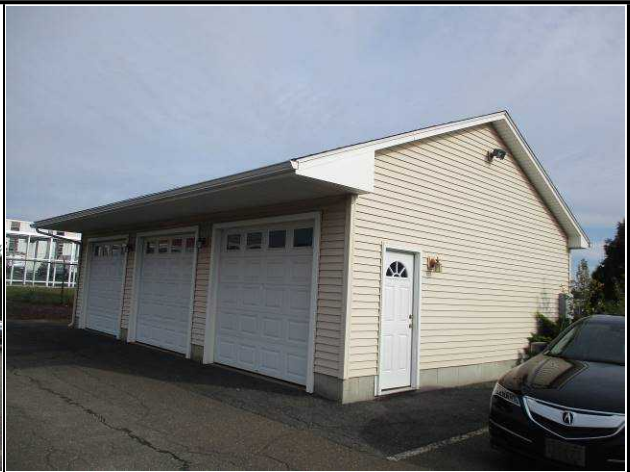
Maintenance garage building front and south side.

Of note, stored materials were observed at the side of the garage building. Based on the observed conditions, Short Term Repairs are recommended to remove all stored materials.

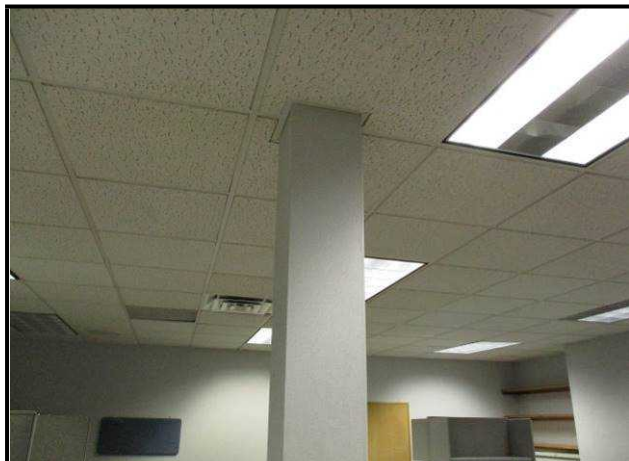
Typical column.

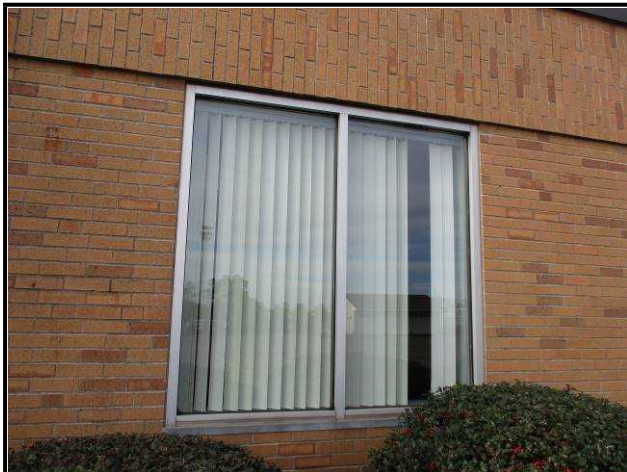
Typical fixed, punched, aluminum-framed window.

The observed windows appeared to be weather tight and in good overall condition. Based on the reported age, current condition, and expected useful life, Replacement Reserves are recommended for window replacement during the analysis term.

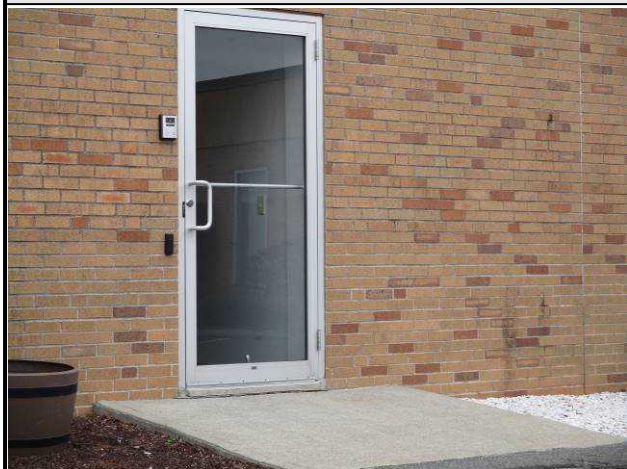
Typical aluminum and glass door.

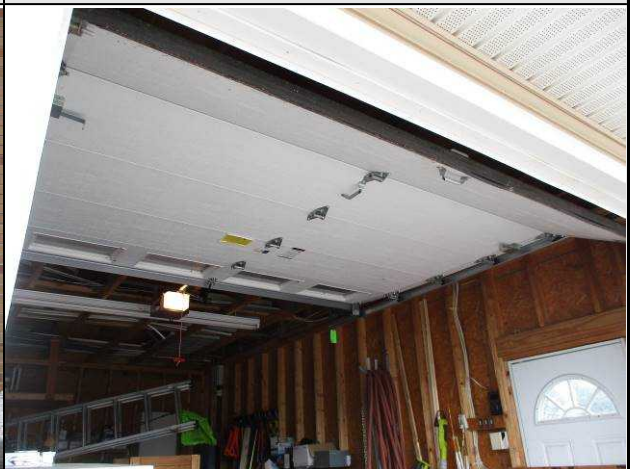
Typical overhead sectional garage door.

Aside from normal wear, the observed private garage doors appear to be in good condition and will be maintained at the property as part of operational expenses during the analysis term. Based on their observed condition, reported age and average effective useful life, Replacement Reserves are recommended for renewal of the sealants around the windows and doors during the analysis term.

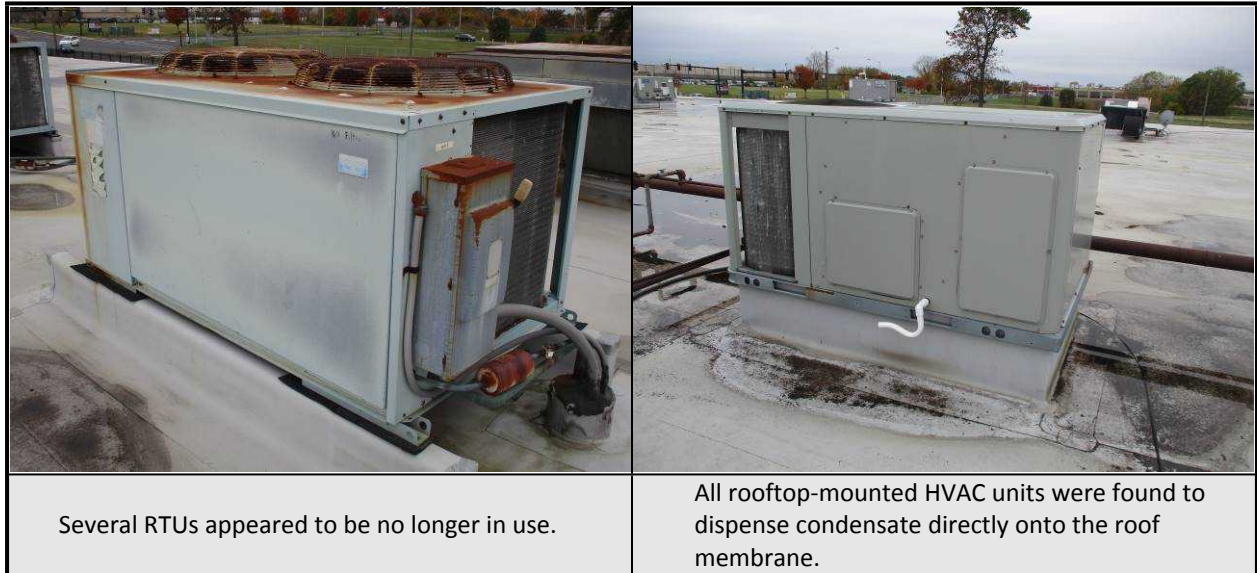
Several rooftop HVAC units, equipment, and components were abandoned in place on the Subject Property roof. Based on observed and reported conditions, Immediate Repairs are recommended for removal of the abandoned HVAC equipment on the roof and the installation of a proper curb and cover.

All rooftop-mounted HVAC units were found to dispense condensate directly onto the roof membrane. This can lead to advance degradation of the roof surface at these locations. Based on the observed conditions, Immediate Repairs we recommend all condensate be piped to roof drains.

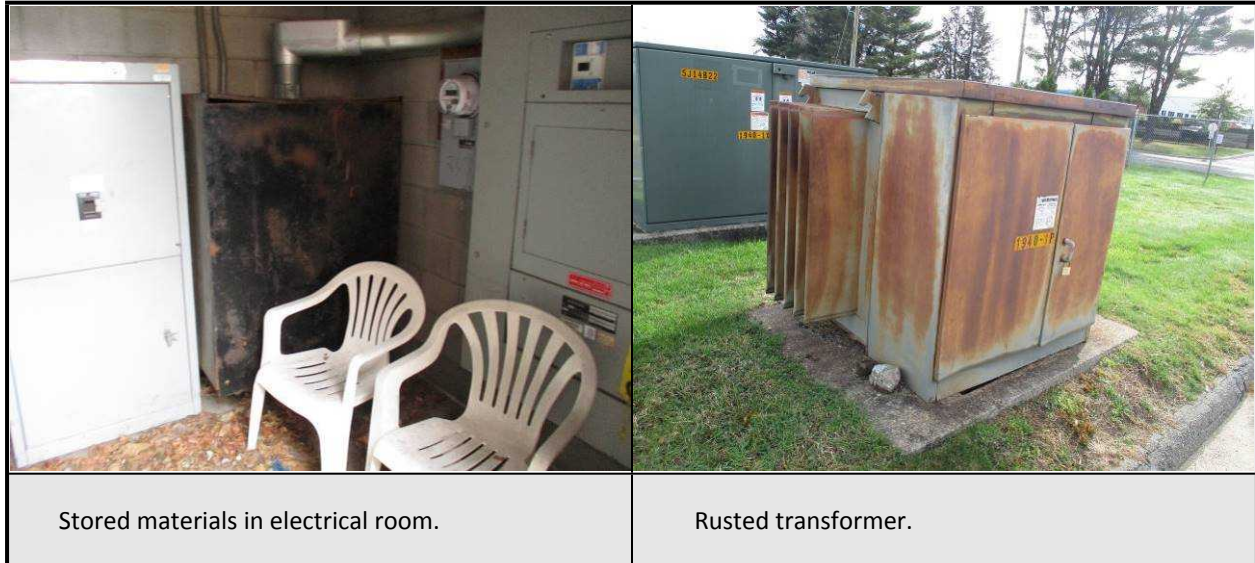
Of note, stored materials were observed in the electrical room housing Main 1. Based on the observed conditions, Immediate Repairs are recommended to remove all stored materials. There were no other reported or observed problems with the electrical system sizes or capacities. This utility appears to be configured and operated in a manner consistent with its intended use, and adequate for the use type.

Additionally, one of the transformers located at the southeast corner of the Subject Property was found to have a rusted exterior casing. Based on the observed conditions, Short Term Repairs are recommended to prepare, prime, and paint the transformer casing.

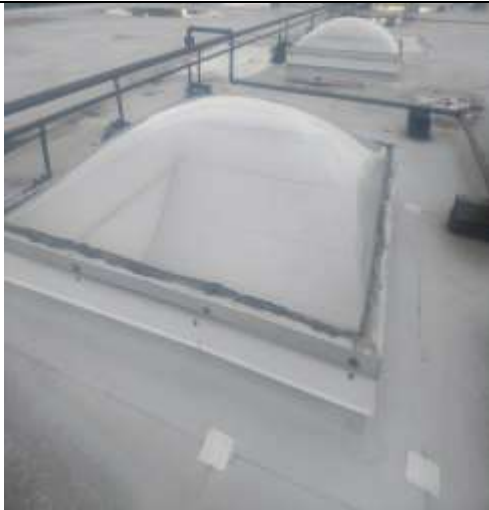
Skylights

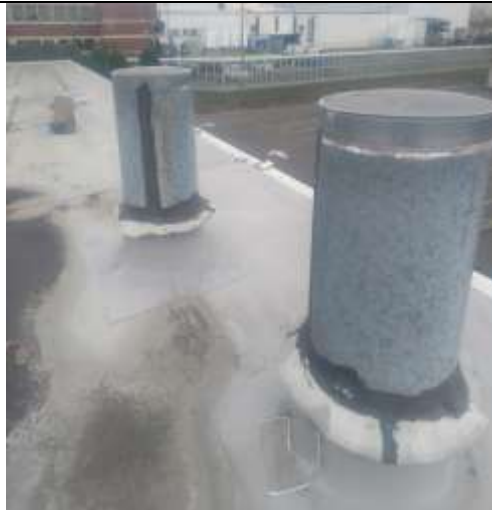
Exhaust seam

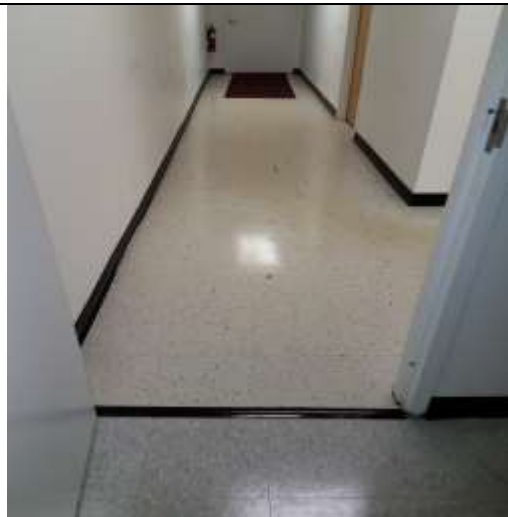
Kindred rear hall with double layer floor tile

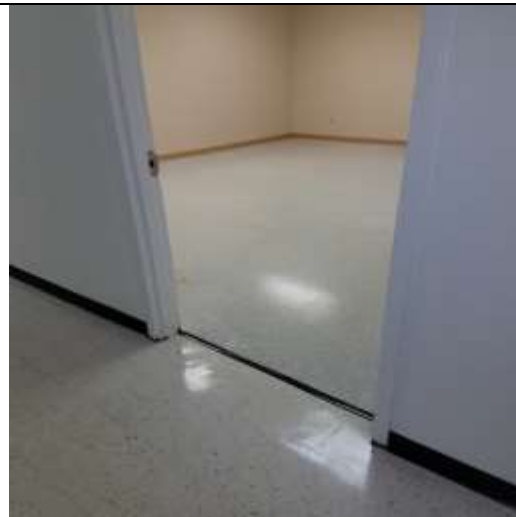
Kindred rear room with double layer floor tile
